CROWN PILLAR ASSESSMENT

**Crown Pillar Assessment and Remediation
Plan for the Tanco Mine, Bernic Lake,
Manitoba**

Document No. 1301660300-REP-R0001-04

JUNE 2013

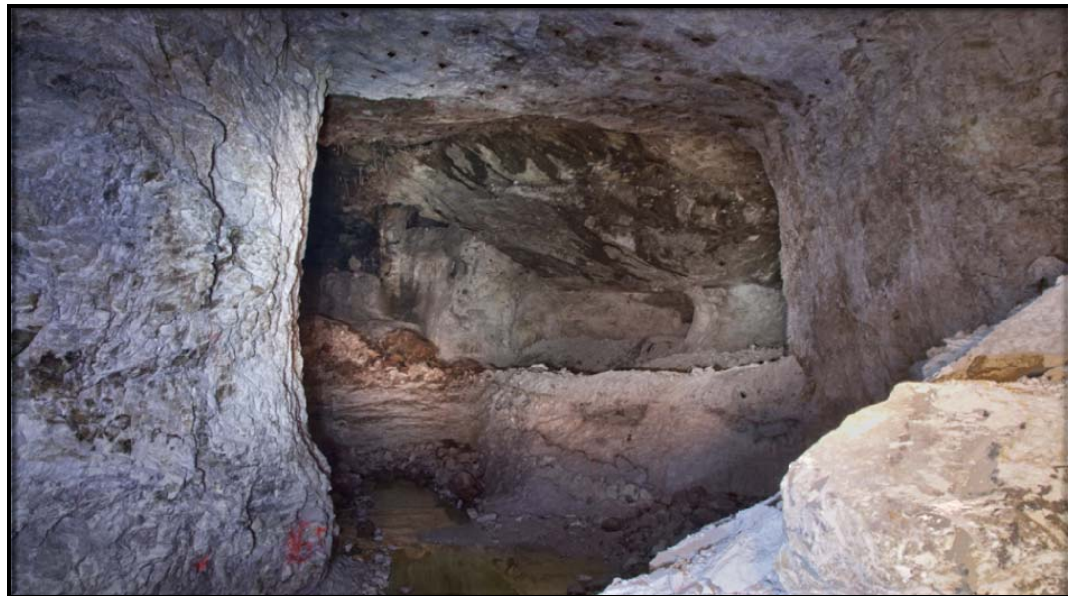
Figure 2.1 Underground Picture of the Affected Roof

Ground water was observed in the area of concern. Water seepage is apparent through fractures within the fall of ground area. Close to this area the Tetra Tech team observed a few bolts in the roof that were showing water leakage. There is no information that would allow the postulation of a causal effect with the fall of ground. Nevertheless, these fractures point to the existence of some water flow through the rock structures in that location.

A view of the roof conditions in the area of concern is shown in Figure 2.1. On the left hand-side of Figure 2.1 the remaining rock bolts can be observed to be still partially in the roof (9 m (30 ft) in three sections). The sections sticking out would represent the first 3.7 m (12 ft) of these bolts from the face plate when originally installed. In some instances the bolt plate is still in place while for some it has been apparently sheared off. The screen installed at the time of this first rehabilitation work has failed and portions of it are still hanging from the roof. The apparent conditions of the roof and bolts indicate that the rock has failed through an unraveling mechanism. The 3.7 m (12 ft) long bolts had been installed as well in that area. These are most likely the bolts that could be observed in the pile of broken material on the floor.

Water infiltrates, seeps, into the mine at particularly conductive geological structures such as slip planes and gouge filled faults and/or mining induced openings such as cable or diamond drill holes in or close to the roof. In particular water was observed in the area of crown pillar instability, area 14-P. Reviews of pumping records from June 1 to 6, 2013 show a mean inflow of 1,100 m³/day (200 gpm). No mining occurred during this time so it is reasonable to conclude that the water is representative of groundwater seepage only. This inflow does not appear to be changing over the period of observation. Mine staff continues to monitor inflows through pumping records and use of an appropriately located conductivity meter. In the event that inflows were to increase, the conductivity meter is triggered to alarm/notify personnel.

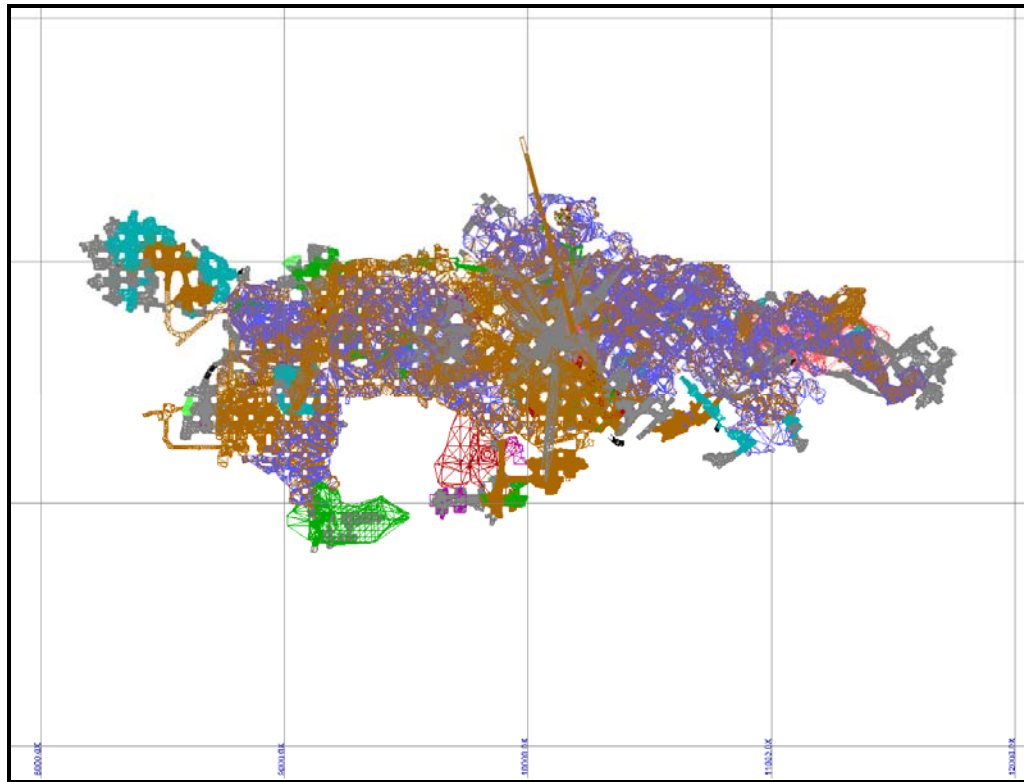
Figure 2.2 Underground Mine Footprint with Fall of Ground Area Identified

The following diagram illustrates the footprint of the underground mine with the fall of ground area (14-P) indicated in grey. It is important to note that the location of this area is under Bernic Lake and is in the vicinity where the lake reaches its’ deepest point of approximately 7 m.

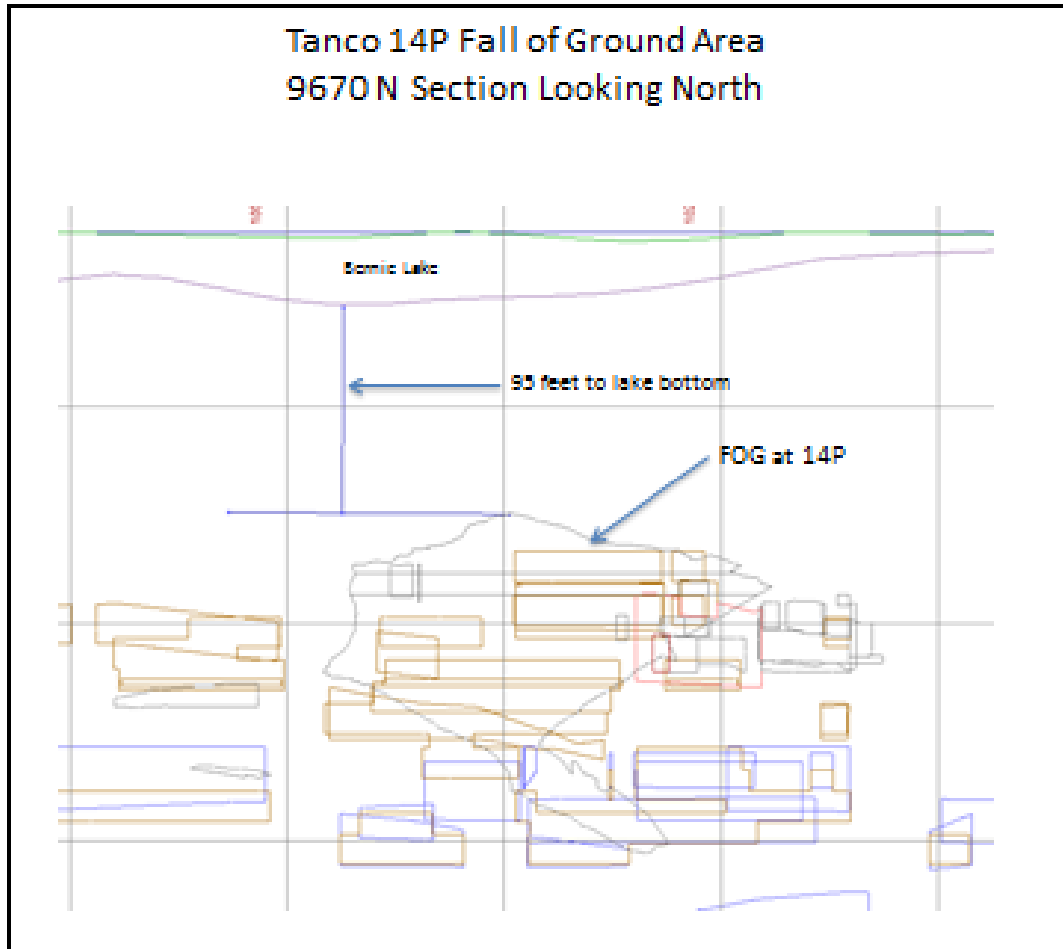
Figure 2.3 CMS Reconstructed Section Showing Excavation Geometry

Figure 2.3 illustrates an elevation view of the most recent survey (CMS) provided by the mine staff. In terms of the underground openings, the maximum current span is 50 m (165 ft). The remaining thickness of the crown pillar is 29 m (95 ft).

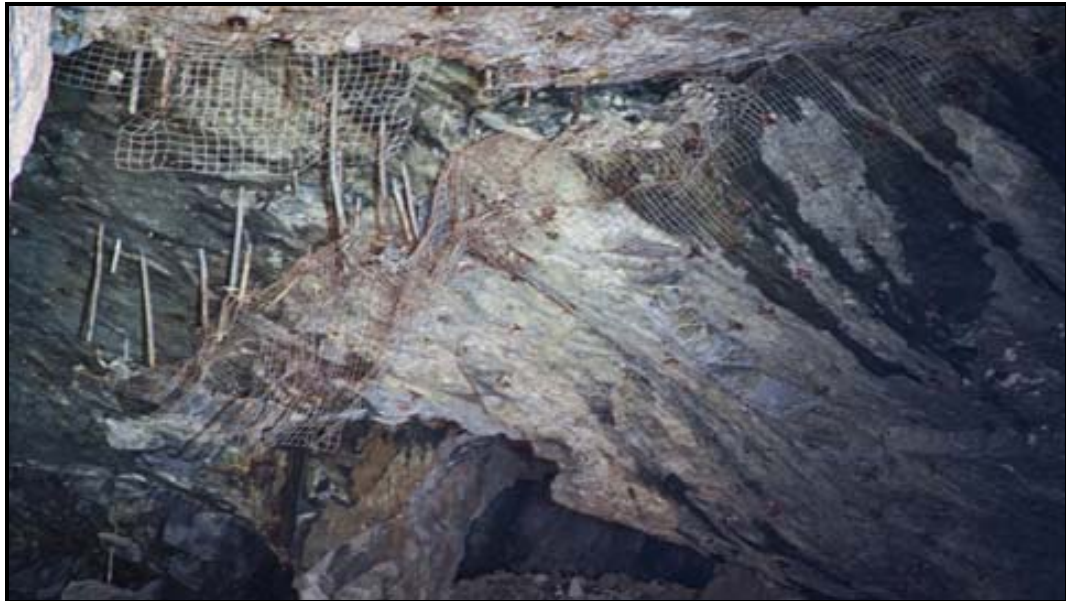
Figure 2.4 Close-up Picture Showing Condition of the Failure Zone

To the right hand-side of Figure 2.4 the typical rock unit forming the back (amphibolite and gabbro) can be observed. A closer look at this image shows that the shear faults creates a layering effect in the rock mass. These planes form an angle relative to the horizontal. The drillhole data analysis performed by the mine staff shows that these layers have a thickness that range from 0.5 m to 7 m (1.5 ft to 2 ft). In this picture we can confirm, at least for the first apparent layer, the thickness is approximately 0.5 m (1.5 ft) thick. A dense pattern of rock bolts (reported to be 3.7 m (12 ft) long by the mine personnel) can be observed in Figure 2.4. This in essence means that within that area the first 3.7 m (12 ft) could be considered to be one layer. As will be discussed later, this could be one of the factors contributing to the surprising stability exhibited by the roof so far. At this stage this portion of the roof is still showing good condition and the bolts in place are still looking intact.

The right hand-side of Figure 2.4 indicates that the rock conditions are markedly different. The layering observed and general conditions would indicate a buckling failure mechanism potential in that portion of the roof. As the volume of rock (left side of Figure 2.4) keeps unraveling, ultimately the exposed length of the layered rock will increase. A likely failure scenario would be the unraveling of the blocky volume of rock followed by the buckling failure of the layered gabbro. Since two very different failure mechanisms are involved, the application of empirical methods only must be treated with caution.

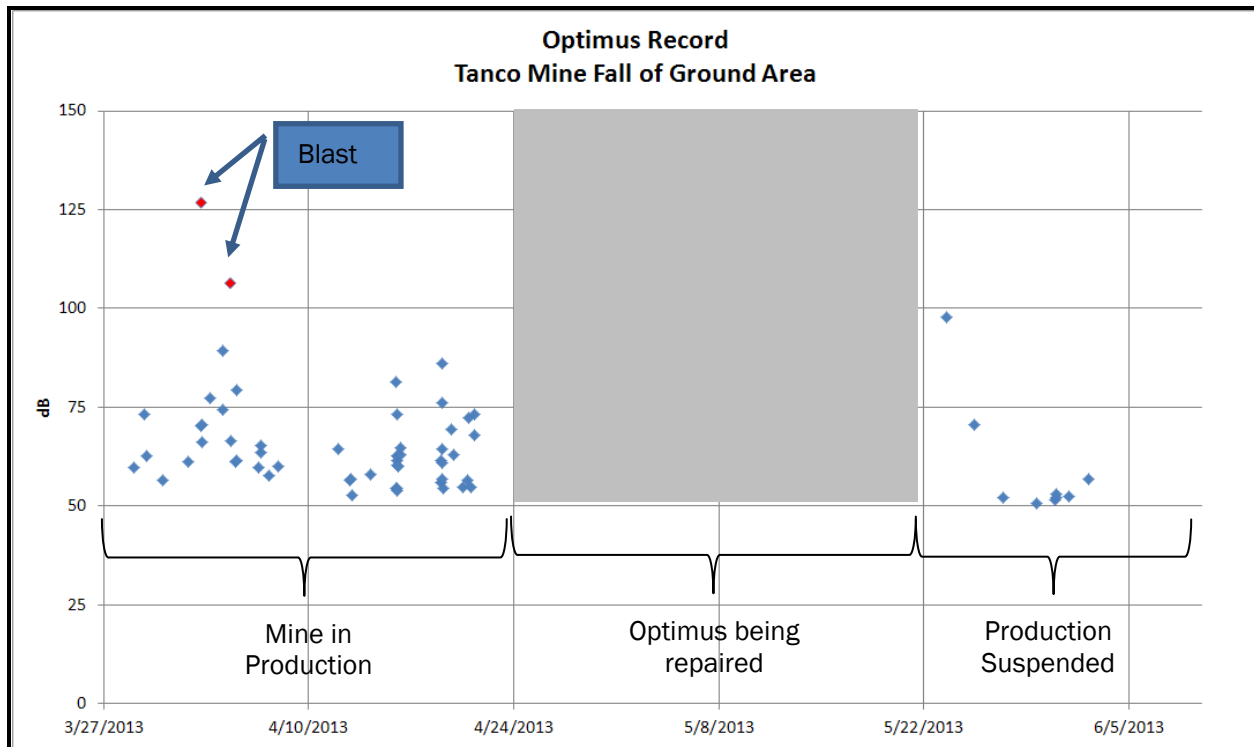
Figure 2.6 Nighttime Optimus Decibel Record – March 27 to June 5th, 2013

Observations as shown in Figure 2.6, span a period of active mining, a period of no reading, when the Optimus was being repaired, and finally a period of 10 days when there was no mining activity.

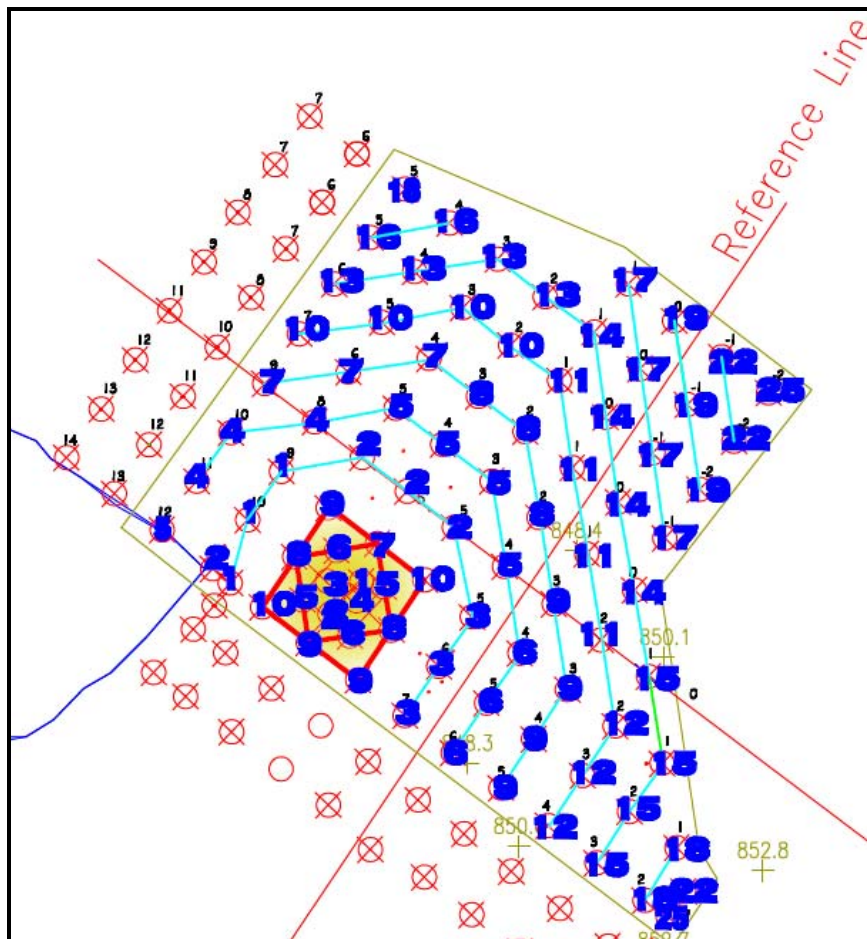
Figure 2.7 Plan View - Delay Plan for 19N-1 Longhole Blast

Mining activity in the vicinity of the unstable zone has an impact. Blasting places force on the rock mass which needs to be redistributed by the pillars, sills, and crowns. In mining it is common to expect the ground to absorb and redistribute impact stress. Over time, competence of pillars and sills is expected to degrade. Engineers and operators know, and expect, that repeated blast impacts will accelerate degradation.

Tetra Tech believes that this is an appropriate adjustment to minimize risk of overloading the host rock with blast stress. The data collected from the monitoring equipment will significantly accelerate our learning curve for the behaviour, and timing and nature of failure, of the crown pillar.
