Water and Waste Department • Service des Eaux et des Déchets

**Re: North End Water Pollution Control Centre (NEWPCC)
Flooded Pump Drywell Incident, September 16, 2002 - Interim Report
Our File No. 020-17-06-01-00**

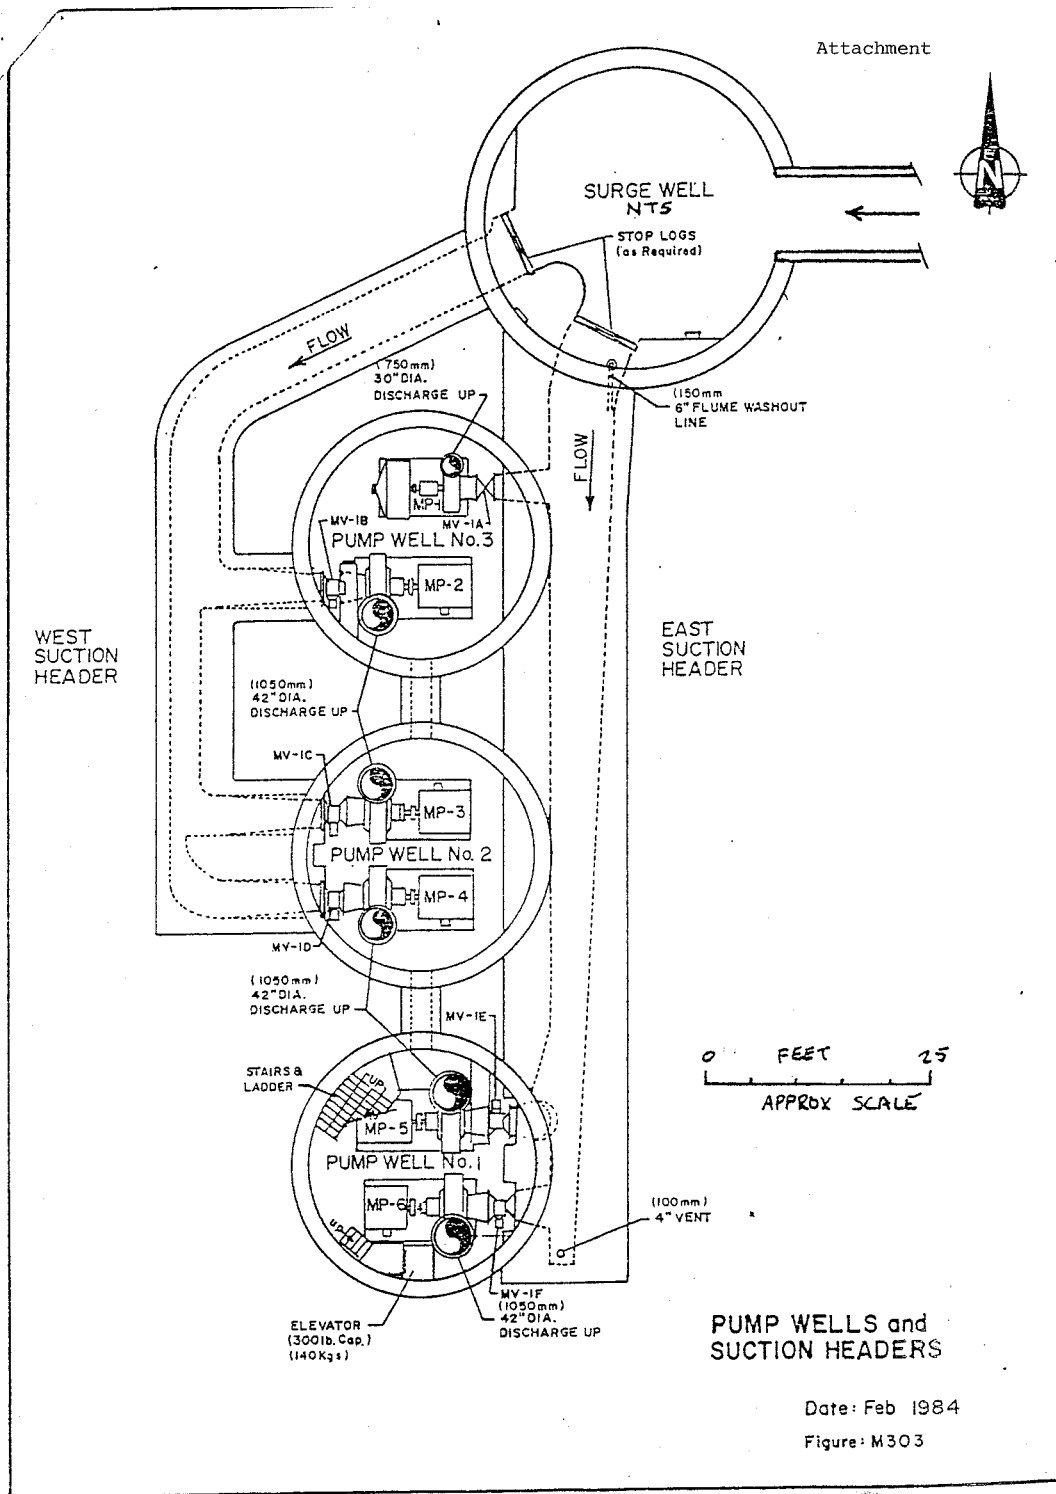
Figure: M303

At approximately 1:15 p.m., Monday, September 16, 2002, a Wastewater Operator, with the assistance of a licensed Inter-Provincial Industrial Mechanic, was in Pump Drywell #1 (57 feet deep), in the process of removing an inspection plate on Main Pump MP5, one of the plant's six main pumps. The layout of the NEWPCC drywells and main pumps is shown on the attached figure.

The 36-inch diameter pump suction gate valve had been closed and a 12-inch diameter pump inspection plate had been loosened previously. The liquid behind the loosened plate had stopped draining. The operator jiggled the plate, and it started draining again. The operator backed off the nuts on the inspection plate to loosen it further and improve the drainage, intending to leave it until the draining stopped. Suddenly, the inspection plate ejected, and sewage escaped, rapidly flooding the 3 interconnected drywells with sewage. The power was turned off, preventing further serious equipment damage, and no one was seriously injured. However, this incident put the plant out of service. Establishing the cause of the incident will require inspection of the MP5 suction valve.

The Water and Waste Department is continuing to investigate the incident. In addition, the Department has engaged a consultant-engineering firm to design works to isolate the 3 pump wells so that a similar incident will not re-occur. These works will be implemented as soon as possible.

Also, the consultant-engineering firm is designing a process to isolate the east suction header while maintaining the plant in operation, in order to permit inspection of the suction valves and removal of the MP5 valve. This valve is sealed in order to assure it's position at the time of the incident, and will not be disturbed without witness by environmental authorities. The City will be notifying the authorities in advance of this operation. Following this procedure, staff will be isolating the west suction channel and inspecting the pump suction valves on that side.
