June 27, 2025

WO# 500170-2

**RE: SUMMARY REPORT, LIMITED FUNGAL ASSESSMENT, 45124 RD 164N
(CARNIE RIDGE ROAD), RM OF GRAHAMDALE**

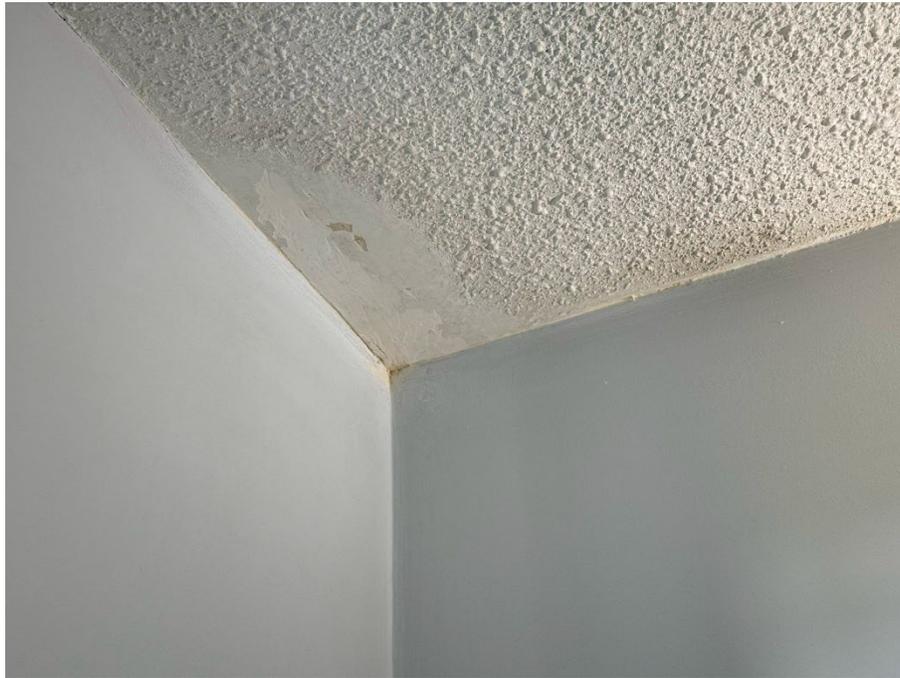
Photograph 1: Post Remediation, Main Floor, Kitchen Location 1.

Inspection of the residence revealed no evidence of oxidation on copper piping or calcification, which would typically indicate prolonged moisture exposure. The fungal contamination previously identified in the kitchen and bedroom ceilings was successfully remediated. Post-abatement inspection confirmed that the affected areas were thoroughly cleaned and have been treated with an antifungal coating to prevent future regrowth.
