**PHASE I ENVIRONMENTAL SITE ASSESSMENT  
FINAL REPORT**

**SITE B: # 2 POINT DOUGLAS AVENUE (South)**

**File 04-217-02**

**December 2004**

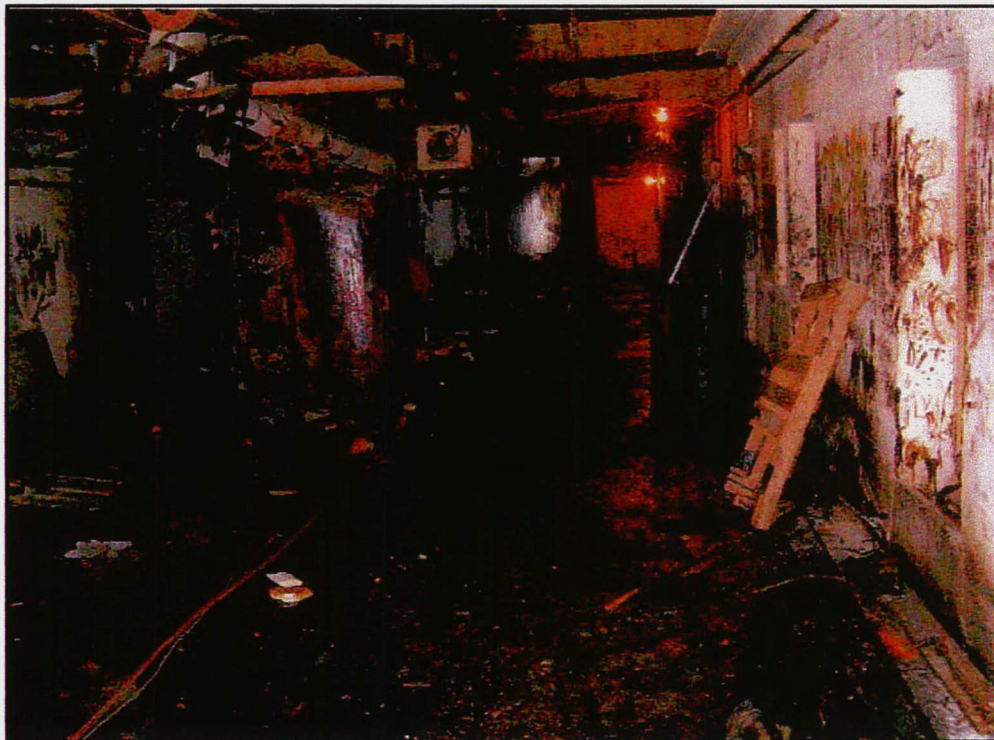
Two-thirds of the basement of the roofing felt paper operation in Building E is covered in tar from a burst pipe. This may create hazardous working conditions or be a concern if the building is demolished.

**PHOTOGRAPH #10: View of the tar covered concrete floor in the basement of Building E.**

- Two-thirds of the basement of the roofing felt paper operation in Building E is covered in tar from a burst pipe. This may create hazardous working conditions or be a concern if the building is demolished. Most of the excess tar has been removed off of the floor, however the walls and the floor still remain covered in a thin layer of tar.

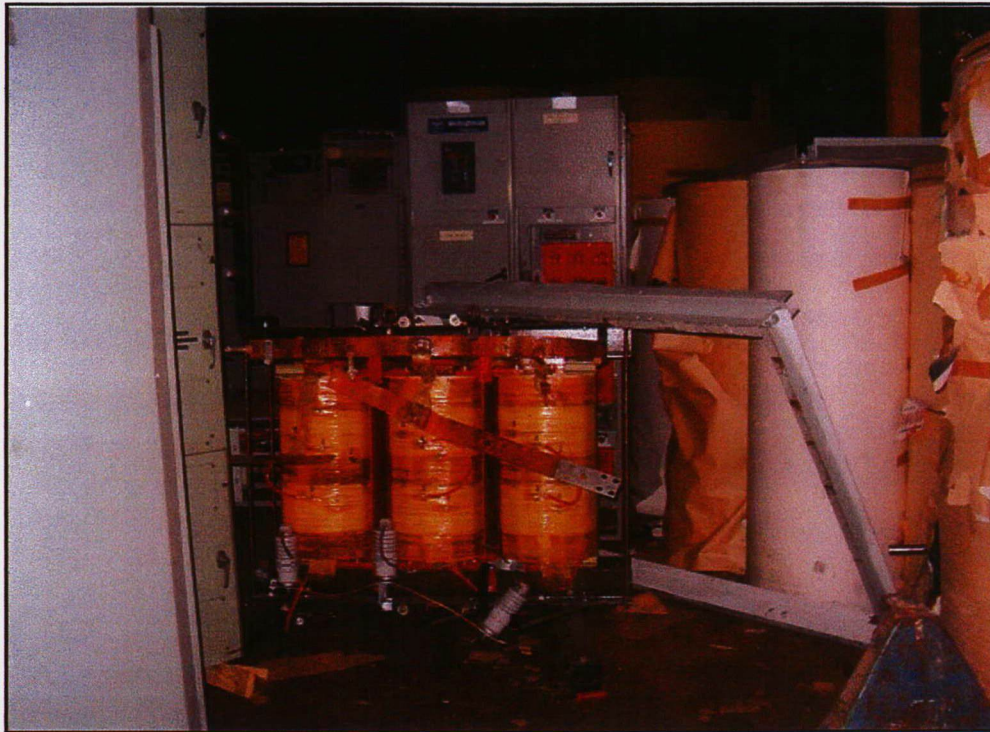
**PHOTOGRAPH #11: View of two partial transformers stored in Building E.**

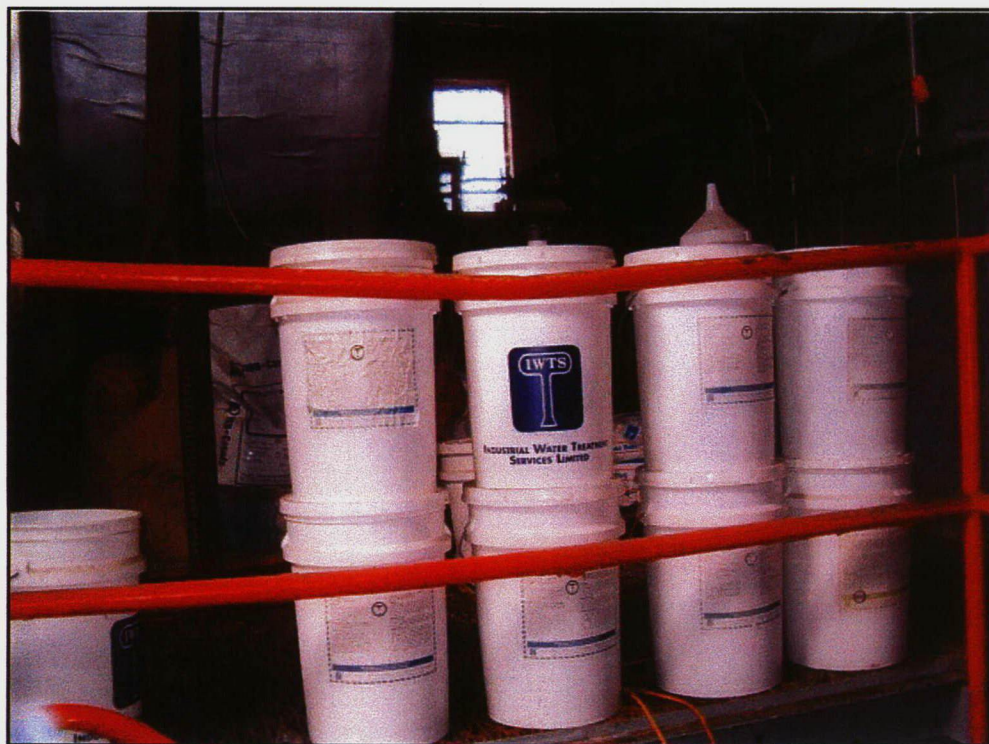
Approximately a dozen containers of industrial waste phosphate treatment solution are stored in Building I and are used for a boiler treatment and as a water conditioner. Soap and soap by-products are stored at various locations around the Site, the majority of which is in Buildings A and B. Water-based inks used for printing soap labels are stored in Building F. The floor in the storage area is concrete. The potential environmental concerns of the above mentioned chemicals is low and required.

**PHOTOGRAPH #14: Industrial waste phosphate treatment containers in Building I.**

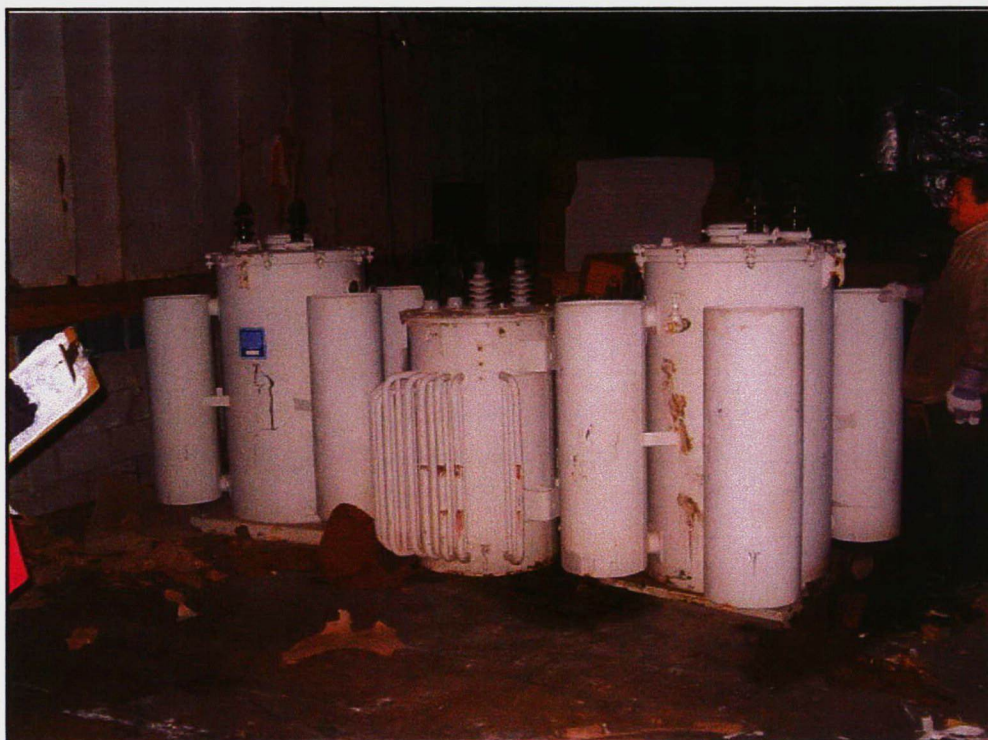
**PHOTOGRAPH #16: Three transformers stored in Building J.**

- The five transformers stored in Building J were purchased from the United States, and as a condition of the sale were to be PCB free. Documentation confirming this is unavailable. Consequently, oil from the transformers should be tested for PCB content in a Phase II ESA.

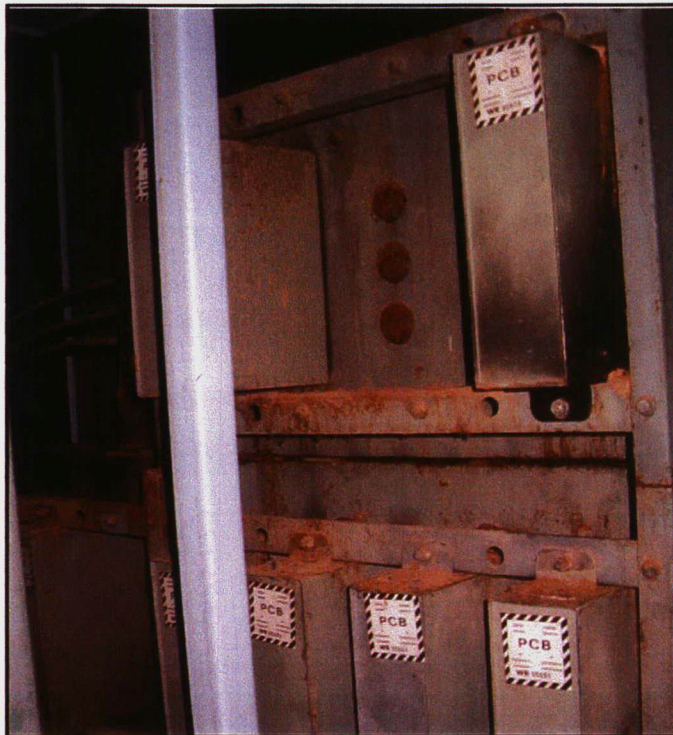
Several transformers that may contain PCBs are located throughout the Site. One transformer in Building K had nine (9) banks labelled to contain PCBs, as shown in Photograph 19. No leakage was noted beneath the transformer. Two partial transformers are stored in Building E, reportedly brought to the Site without their outer casings as shown in Photograph 11. The five transformers stored in Building J, three of which are seen in Photograph 16, were purchased from Perth Amboy in New Jersey, USA, by Gateway Industries Ltd. and as a condition of the sale were to be PCB free. Documentation confirming this is unavailable. Three (3) transformers are located east of Building C among surplus metal and paper storage and may contain PCBs.

**PHOTOGRAPH #19: View of a transformer with 9 banks containing PCBs in Building K.**

- The three transformers stored outside, east of Building C should be tested for PCB content in a Phase II ESA.
- One transformer is located in Building K with nine (9) banks labelled as containing PCBs. No leakage was noted by the transformer, therefore, no immediate action is required at this time. However if Building K were to be decommissioned, the transformer should be disposed of in accordance with the Federal Government's regulations, administered by Environment Canada, regarding disposal of PCB containing material or hazardous waste for commercial or industrial properties.

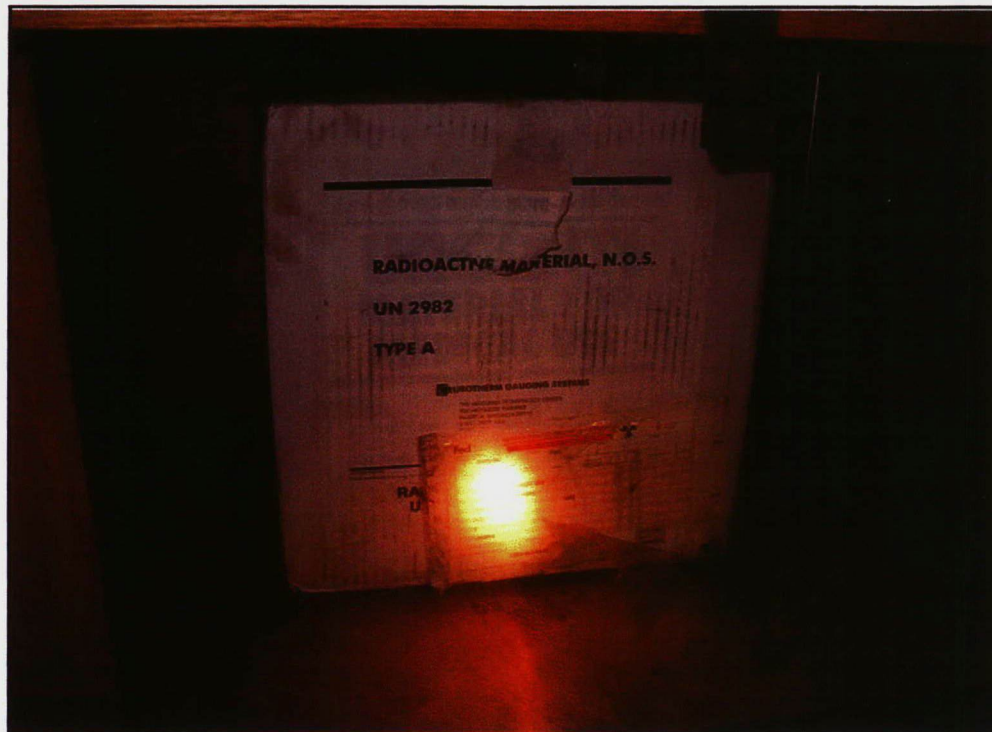
**PHOTOGRAPH #21: View of nuclear densometer in the laboratory in Building K.**

- A nuclear densometer is located in Building K. Proper licensing and documentation should be maintained and transporting of this equipment should be done in accordance with the Canadian Nuclear Safety Commission.
- Thermostats located in many of the Buildings may contain trace amounts of mercury. No immediate action is required, however if the buildings are to be decommissioned, the thermostats should be disposed of in accordance with the Federal Government's regulations, administered by Environment Canada, regarding disposal of hazardous waste for commercial or industrial properties.

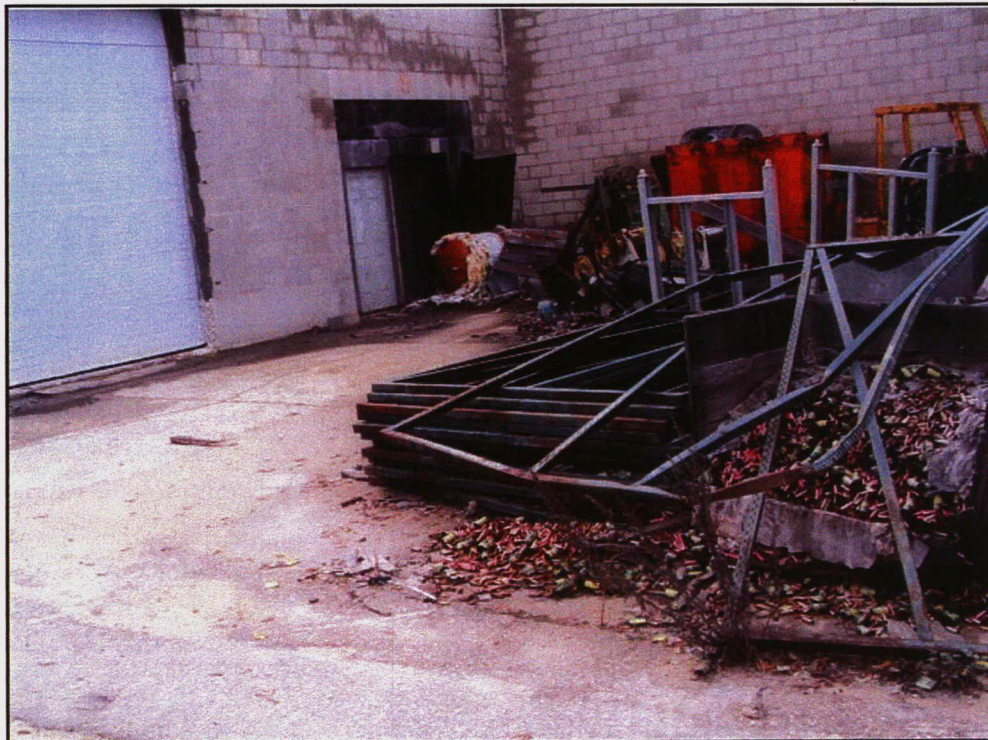
**PHOTOGRAPH #32: View of empty battery casings near the northeast corner of Building A.**

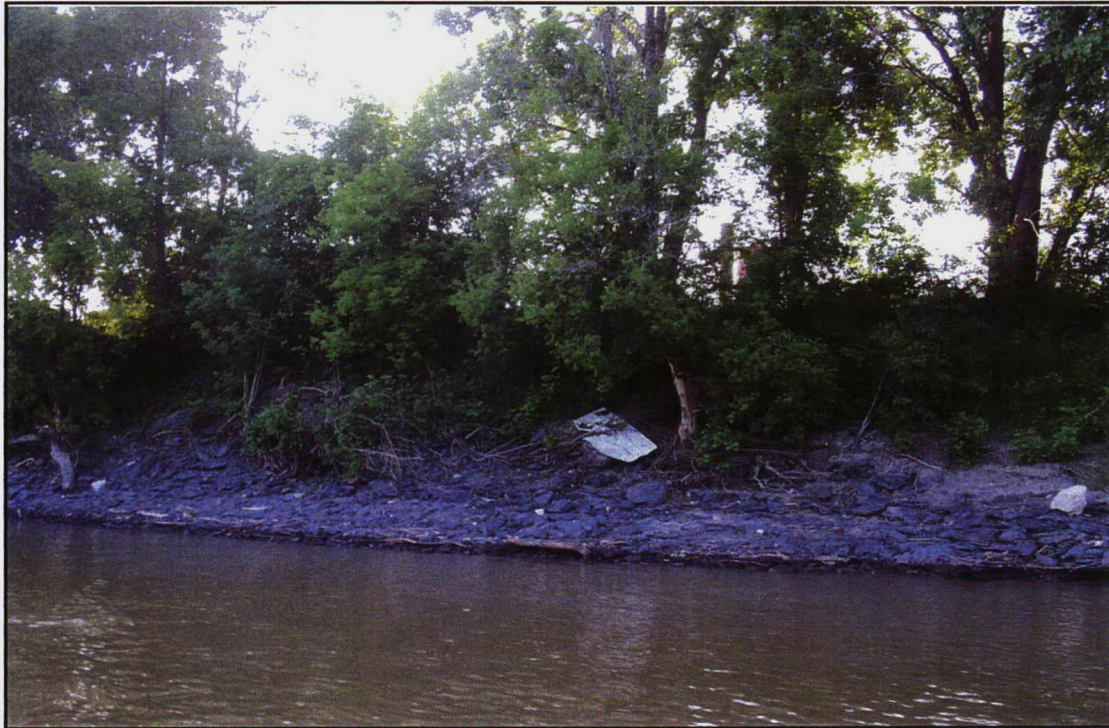
A visual review of the riverbank along the Site noted that asphaltic shingles have been dumped along the riverbank and overtime have conglomerated becoming embedded in the riverbank, as seen in Photograph 33. The shingles were reported to have been placed along the bank when Building Products of Canada Ltd. occupied the Site.

**PHOTOGRAPH #33: View of embedded shingles along the riverbank, facing north.**

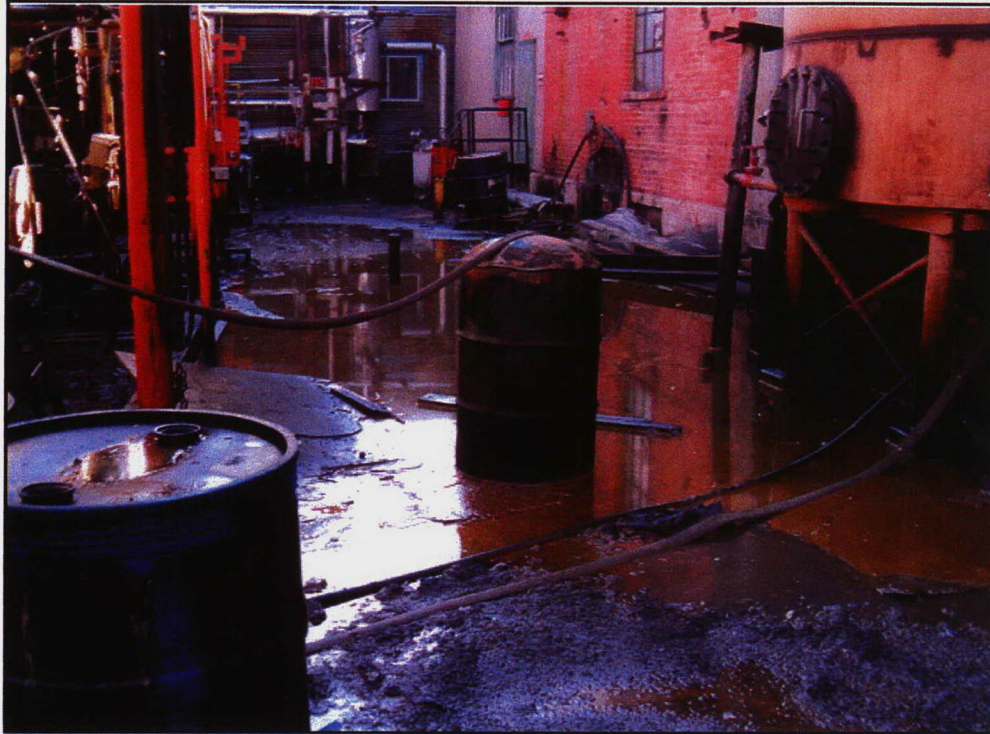
A pool of reddish brown water with what appears to be oil was noted outside along the east side of Building E. The water was contained within a shallow concrete berm. Several blue barrels were adjacent to the area as seen in Photograph 35. Two barrels, shown in Photographs 36 and 37, are located southeast of Building K. One barrel was labelled as containing caustic soda and is presently filled with water. The second barrel had no label but contained a reddish brown liquid with no noticeable odour. Caustic soda tanks are located in Building K used in the paper making operation.

**PHOTOGRAPH #35: View of an apparent oil spill along the east side of Building E.**

- Five asphalt tanks are located between Buildings E and K. A Phase II ESA should be conducted to investigate soil contamination around the tank.
- A pool of reddish brown water with what appears to be oil was noted outside along the east side of Building E. A Phase II ESA should be conducted to test the observed liquid for hydrocarbons and drilling and soil sampling should be conducted in the area to determine if any soil contamination has occurred.

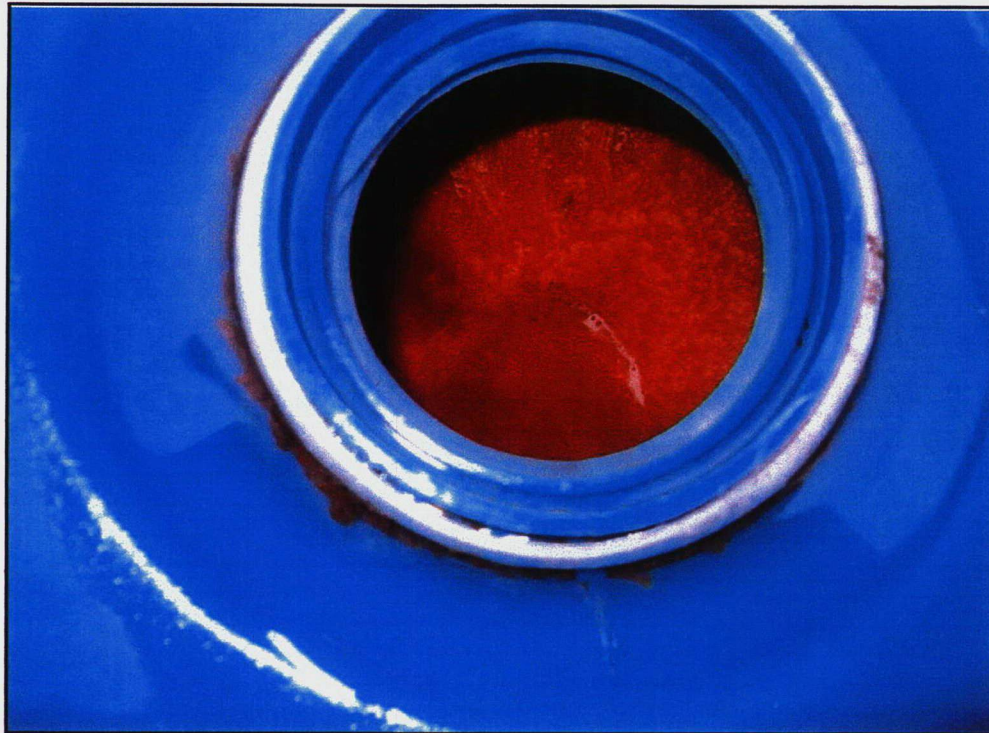
**PHOTOGRAPH #37: View inside an unlabeled storage barrel, southeast of Building K.**

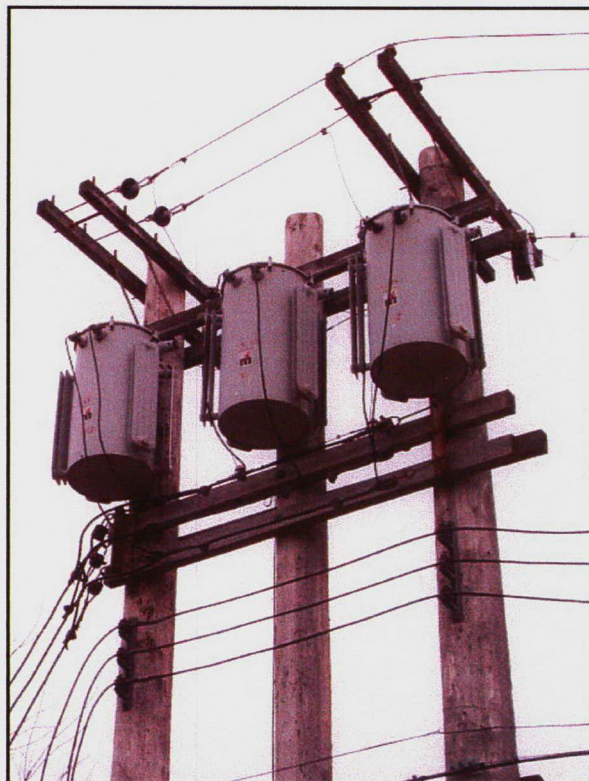
Pole mounted transformers were noted at several locations on the exterior of the Site. A pole at the northwest corner of Building F supports three transformers. A white sticker is present on the transformers indicating that they are PCB free, as seen in Photograph 38. A pole at the southwest corner of Building A, north of the rail spurs, supports three transformers, as shown in Photograph 39. Yellow stickers were noted on the transformers indicating that they contain 0 to 44 ppm PCBs. No leakage or staining was noted beneath the pole. A single pole mounted transformer, located approximately 30 m east of the previously mentioned utility pole, is also marked with a yellow sticker again indicating that it contains 0 to 44 ppm PCBs. No leakage or staining was noted beneath the pole as seen in Photograph 40. Three pole mounted transformers are located in the Point Douglas Avenue right of way on the south side of the Site's narrow panhandle. All of the transformers appeared to be newer, with one transformer having a white sticker, indicating it to be PCB free. No leakage or staining was noted beneath the poles.

**PHOTOGRAPH #38: Three pole mounted transformers northwest of Building F.**

- It was not considered a significant concern that low to trace quantities of PCBs may be located in the transformers mounted on utility poles at the Site. No signs of leakage were noticed from the transformers at the time of the Site visit. As such, further assessment for PCBs in the transformers mounted on utility poles is not warranted.

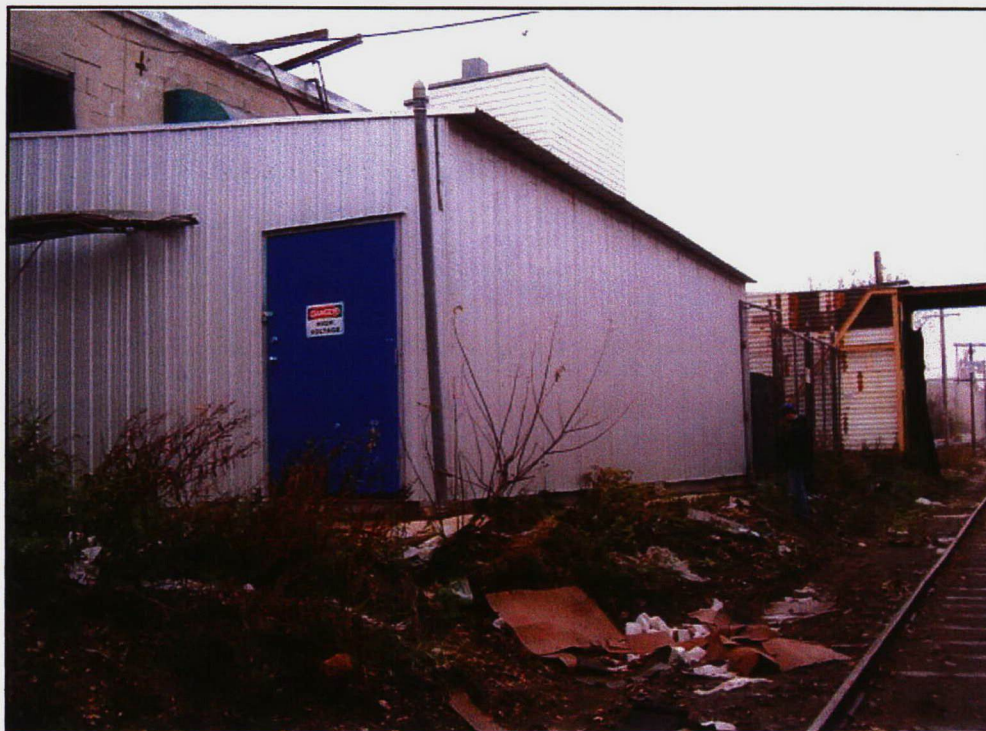
**PHOTOGRAPH #41: Metal shed containing 9 transformers adjoining Building K.**

- Nine transformers are located on a concrete pad, between Buildings B and K, enclosed in a metal shed. In 2002, ENG-TECH was retained by Gateway Industries Ltd. to conduct PCB sampling and testing at the Site. The testing revealed that all of the samples were below current CCME guidelines for commercial/industrial sites, however, all four (4) soil samples were above the guidelines for residential/parkland sites. As such, it is recommended that a Phase II ESA be conducted at the Site, to test for PCBs with depth in this area.

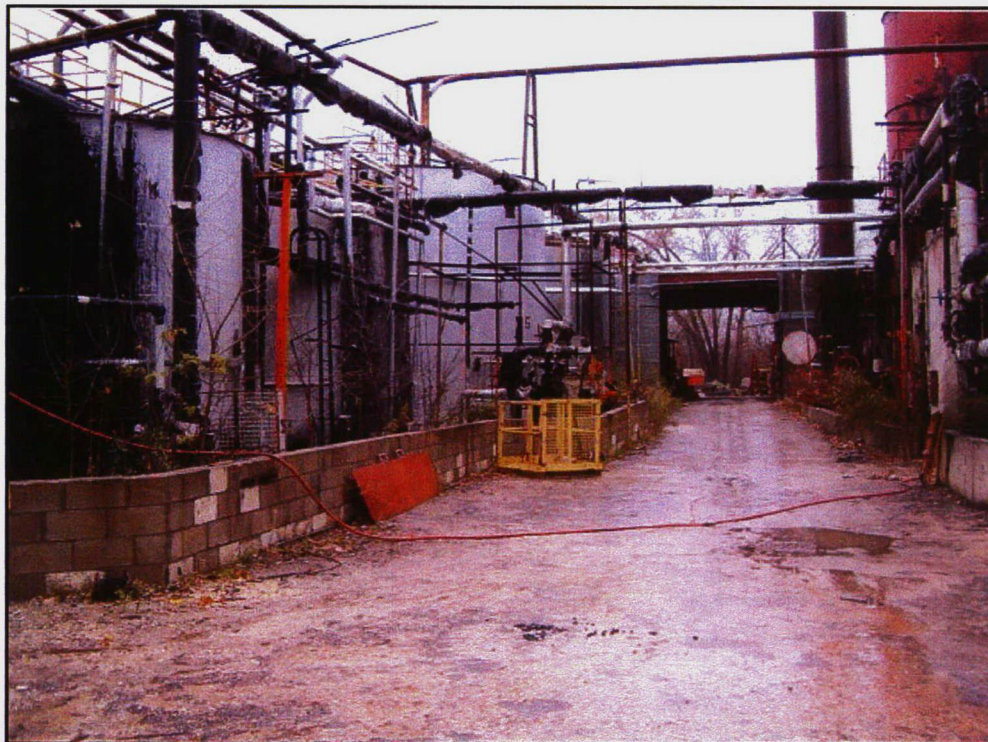
**PHOTOGRAPH #44: View of asphalt tanks between Buildings J and E, facing south.**
