# **Phase I Environmental Site Assessment**

## **515 Munroe Avenue**

## **Winnipeg, Manitoba**

June 18, 2009

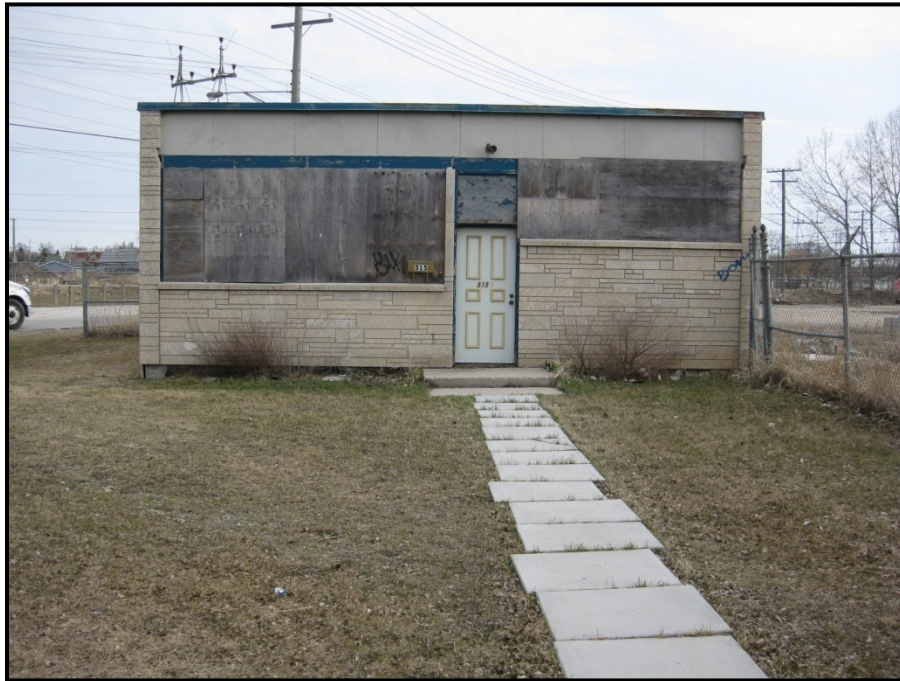
Photo 1 – The Site Building located at 515 Munroe Ave., Winnipeg, Manitoba

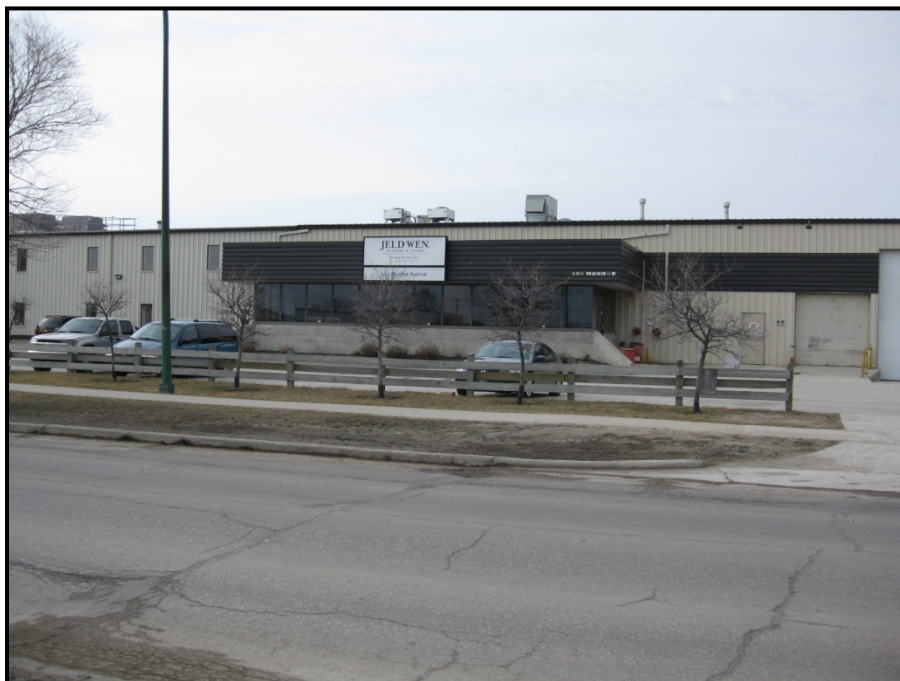
Photo 2 – Light industrial building located south of the Site.

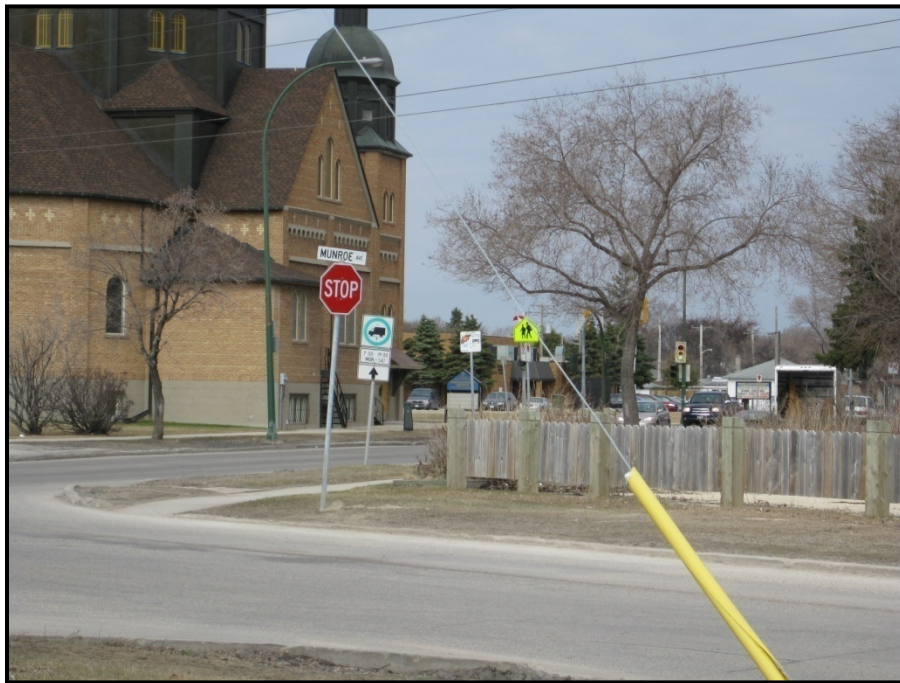
Photo 3 – Munroe and Golspie Intersection - Church located east of the Site

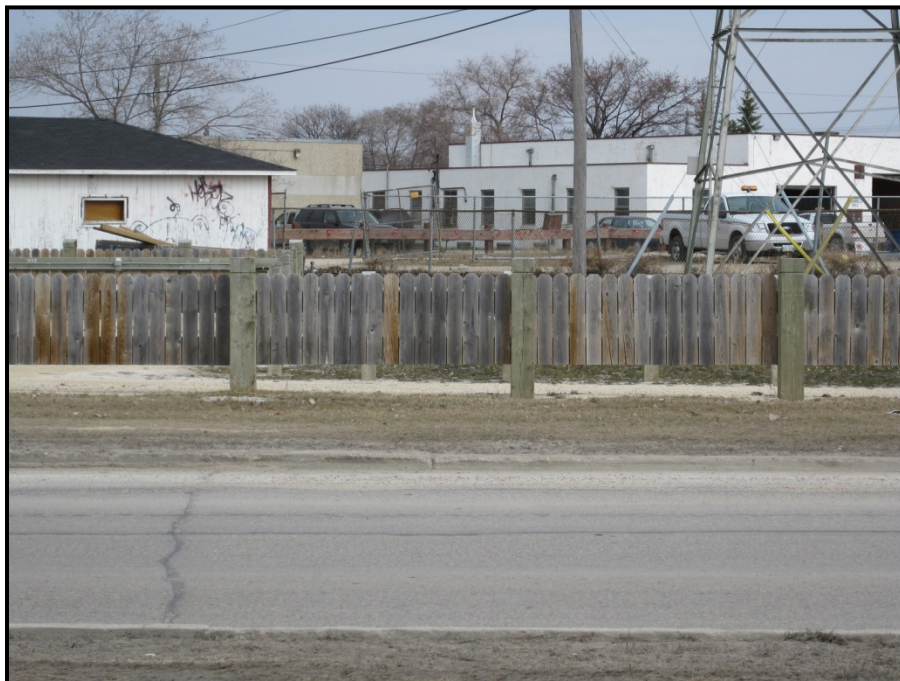
Photo 4 – Commercial buildings located northeast of the Site

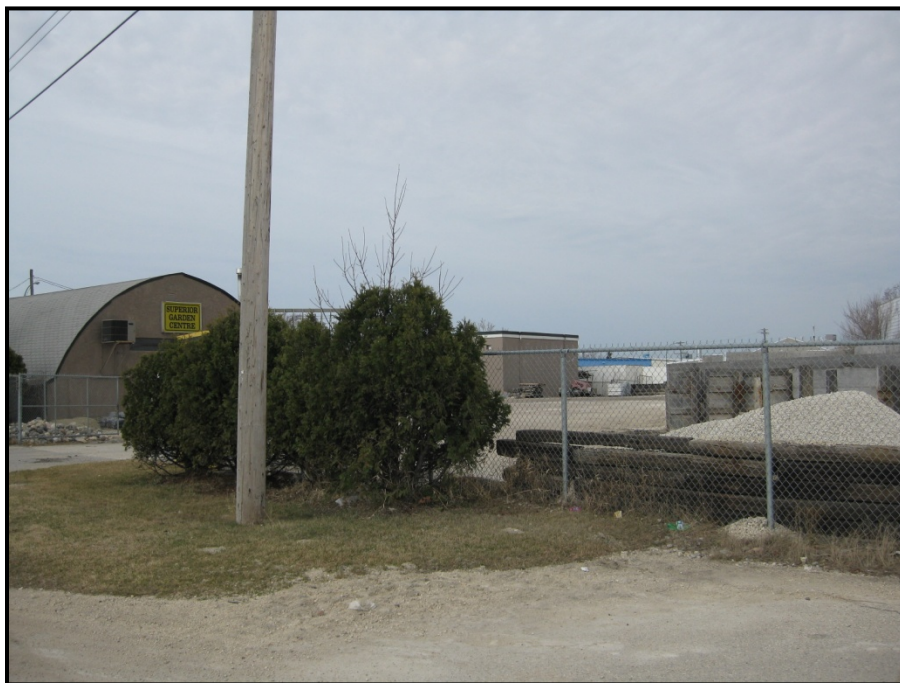
Photo 5 – Commercial building located east of the Site

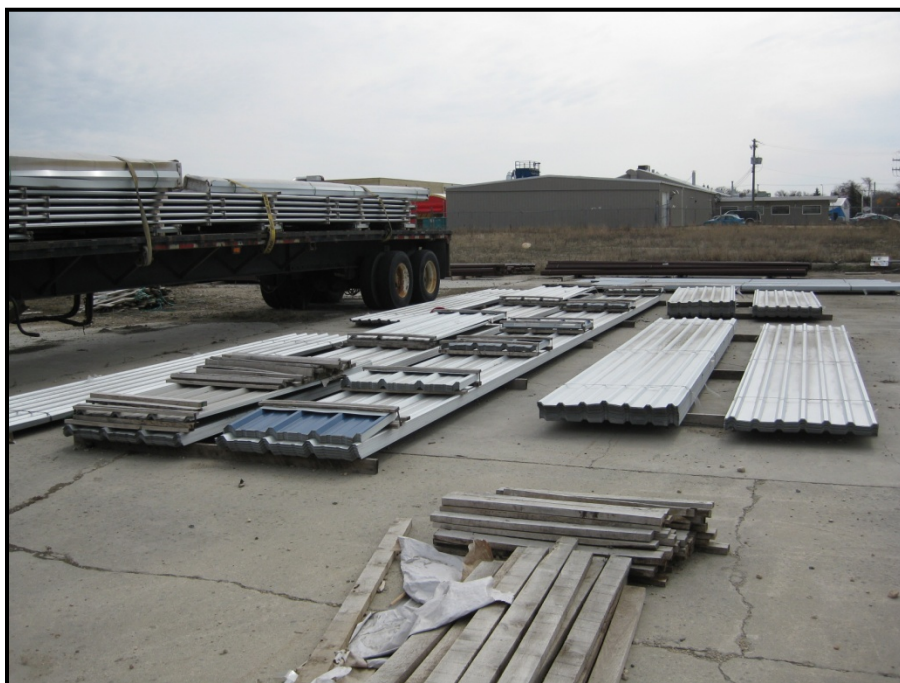
Photo 6 – Building materials stored on the southeast portion of the Site
