UPPER PEMBINA RIVER WATERSHED FISHERIES AND RIPARIAN AREA SURVEY

Prepared By Aquatic and Environmental Consultants 2006

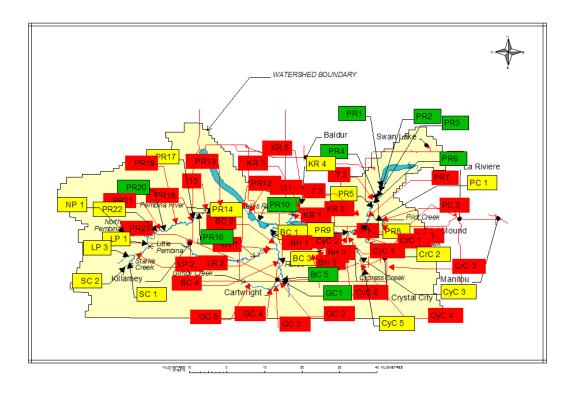
Figure 3: Potential Project Locations

Badger Creek			
BC-1	9	Cattle grazing, some erosion	Low-
			Medium
BC-2	10	Heavy grazing, unrestricted access, heavy erosion	High
BC-3	11	Cattle grazing, some erosion	Medium
BC-4	12	Heavy grazing, erosion, need drainage plan for operation	High
BC-5	13	Cattle grazing to edge, some trampling	Low
	<u> </u>		
Gimby Cre	rek		
GC-1	14	Lagoons with short run to creek	Low
GC-2	15	Heavy use both sides, heavy erosion and trampling	High
GC-3	16	Heavy use, trampling, stream blockage, erosion	High
GC-4	17	Very heavy use, trampling, erosion, bank collapses, unrestricted access, improper crossing	High
GC-5	18-20	Very heavy cattle use, trampling erosion, bank collapse, several owners over 2 mile stretch	High
		1, 1, 1, 1, 1, 1, 1, 1, 1, 1, 1, 1, 1, 1	
Kellys Rav	ine		
KR-1	2	Cattle in greak heavy trampling	Lligh
KR-1	4	Cattle in creek, heavy trampling	High
KK-Z	4	Heavy cattle use, trampling, erosion, bank slumping, cattle in creek	High

<u> </u>				
Little Pemb	ina				
LP-1	215	Cattle in river, erosion	Medium		
LP-2	216	Grazing to edge, unrestricted access	Medium		
LP-3	219	Cattle, trampling, partial stream blockage	Medium		
Starke Cree	e k				
SC-1	186	Grazing to edge, bank slumping	Medium		
SC-2	188	Grazing to edge, bank slumping, some erosion	Medium		
Unnamed T	Unnamed Tributaries				
T-1	75	Heavy cattle use, trampling, bank slumping, north	High		
		branch of Pembina River near Rock Lake			
T-2	101	Unnamed tributary near Swan Lake, heavy cattle	High		
		use, erosion, loss of riparian area			
T-3	99	Cattle yard on small tributary near Pembina River	High		
		at Swan Lake, trampling, runoff management

Pelican Lak	e, Rock La	LAKE PROJECTS nke, Swan Lake	
Lake-1		All amorting activities along lakeshama mand to be	Medium
Lake-1		All grazing activities along lakeshore need to be curtailed. All lakes showed some evidence of this.	Medium
Lake-2	la a ti	Numerous access roads have been built to the lakes. Most do not have any controls on runoff, and provide a direct conduit to the lake, bypassing the riparian zone. Proper berms and velocity controls are needed.	High
Lake-3	d a s	Pelican Lake and Rock Lake are extensively developed for cottages, with more development anticipated. Need continued public information sessions on riparian zone management to ensure takeshore integrity and nutrient input.	High
Lake-4	t t	Numerous large upland livestock operations may be nutrient loading lakes due to drainage system that often bypasses the riparian zone. Need runoff management study for the area.	Medium
