A. What We Heard

1. Introduction

In February 2012, the Province of Manitoba established an independent Task Force to examine many aspects of Manitoba's historic 2011 flood, including preparedness and response, flood forecasting, public communications, operation of flood control infrastructure and flood protection. The work of the Task Force included gaining an understanding and providing an overview of what happened, what worked and did not work, and what could be done better in the future.

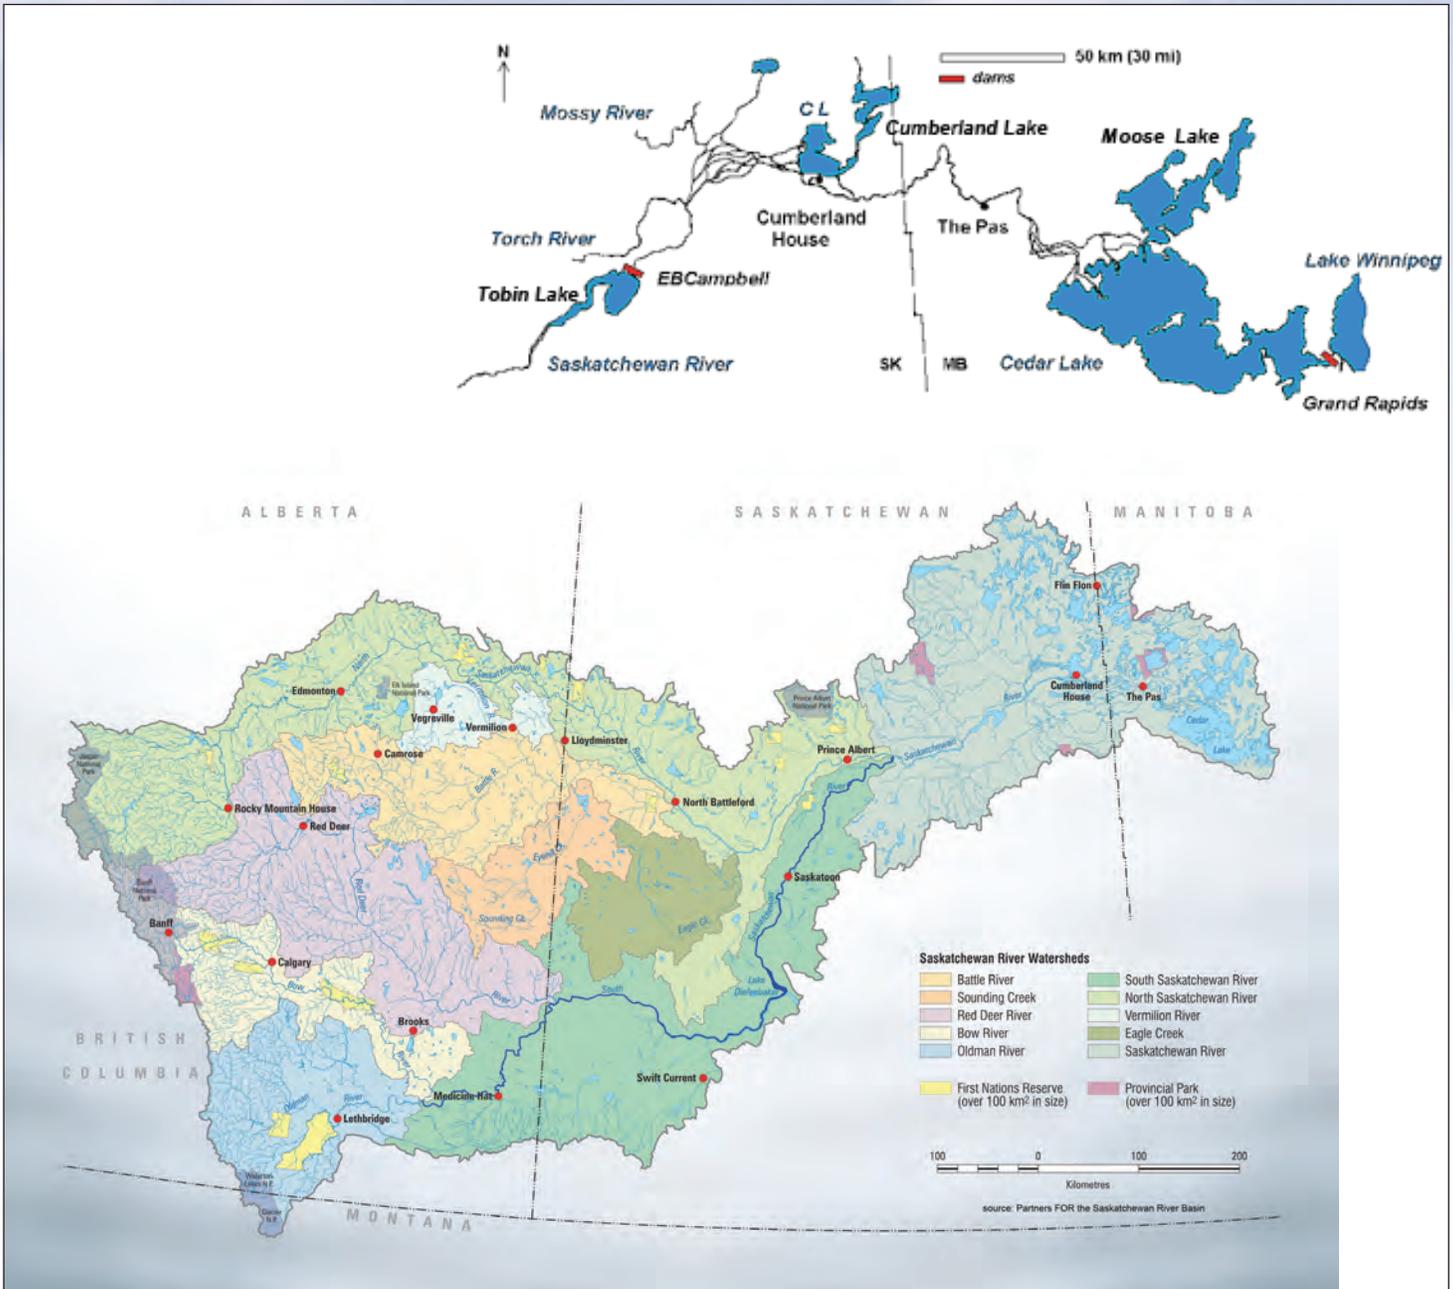
Figure 2: Saskatchewan River basin.

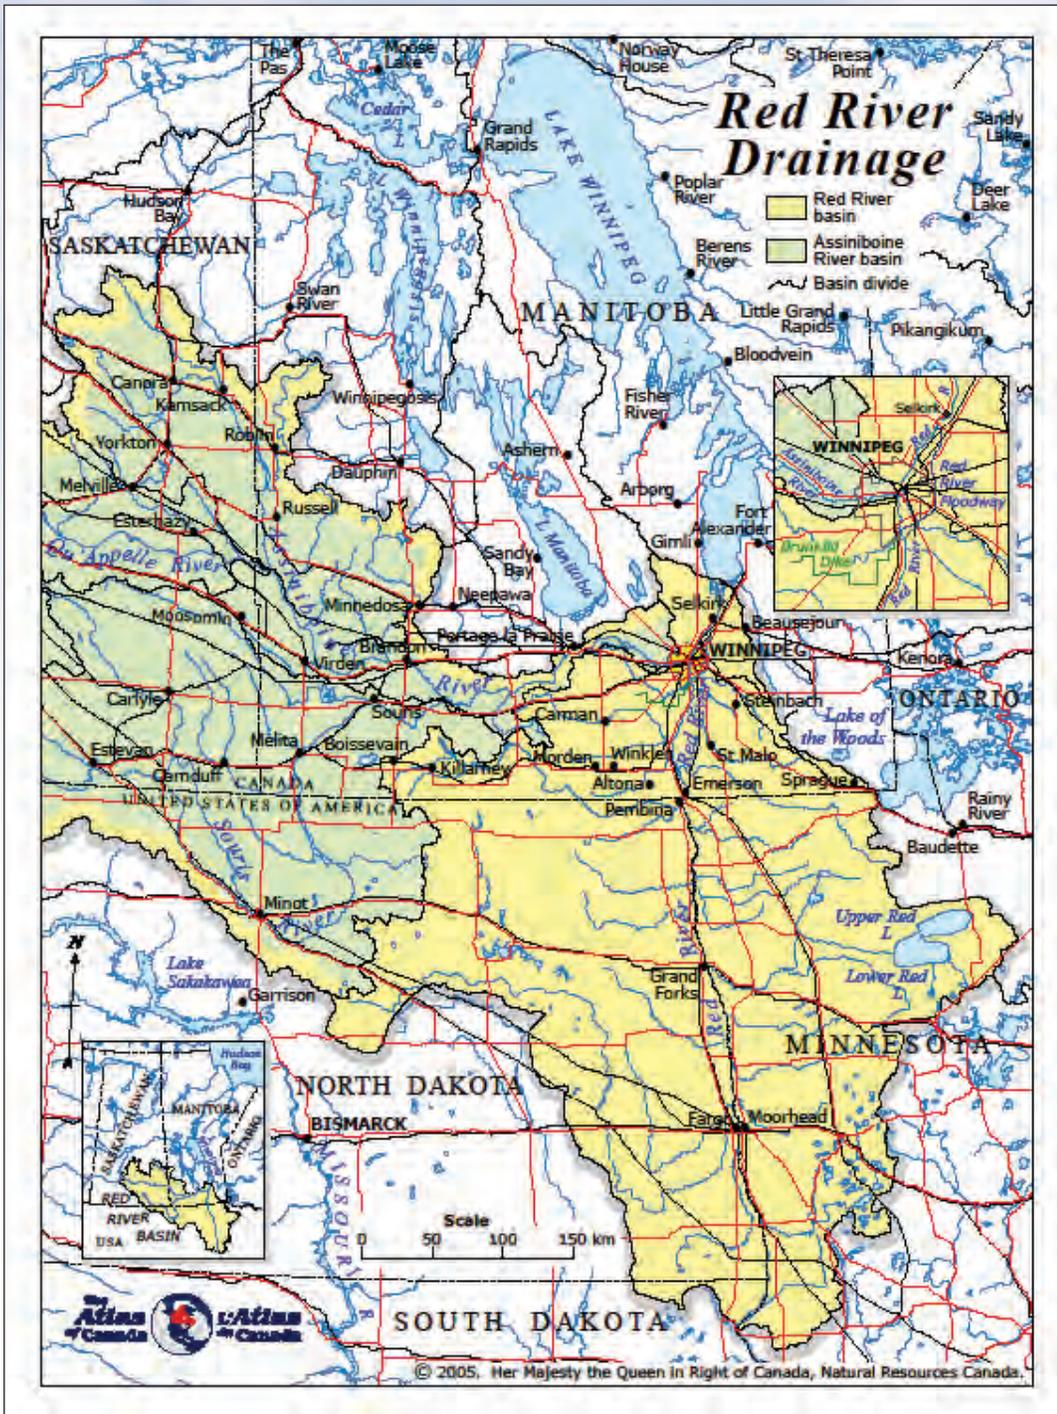
Figure 4: Red River basin.
