ICELANDIC FARM AND FISHING BUILDINGS

An Architectural History Theme Study

**David Butterfield &
Ed Ledohowski**
Historic Resources Branch

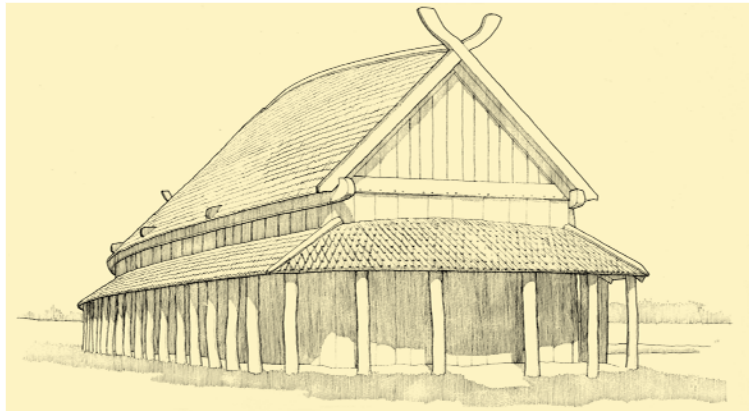
Figure 1
A reconstructed tenth century Viking long house. When the outcasts in Iceland arrived they were able, because of available timber, to construct similar dwellings.

Because Iceland was originally settled by refugees from Norway in the ninth century, Icelandic folk architecture had its roots in Norwegian forms (Figure 1). Individual long houses were used for distinct functions and one house could be for sleeping, one for cooking and one for meetings. When, by the fourteenth century, timber had become scarce in Iceland, and new types of dwellings were built, this separation of functions into isolated buildings was modified. The separate and spacious long houses were replaced by subterranean group houses that brought the individual functions into a smaller unit (Figure 2)

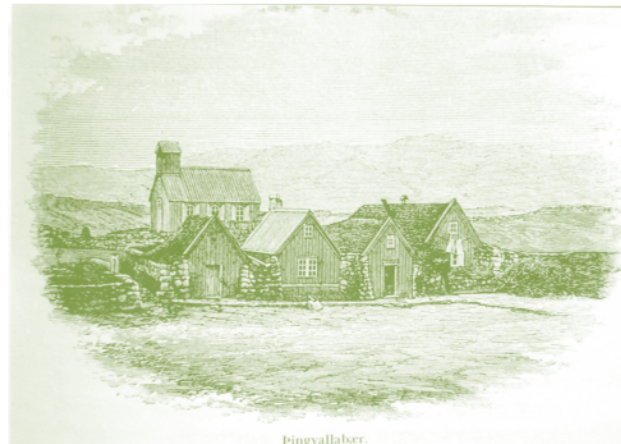
Figure 3

A typical Icelandic farm structure built during the nineteenth century was surrounded by vegetable gardens and hay meadows. Churches, like the one illustrated, were usually found on the yards of larger farmsteads. (Íslandsferd John Coles, Bokafagan Hildur)

Homes built by Icelanders in the eighteenth and nineteenth centuries bore testimony to a growing prosperity and better trade. The buildings still consisted of a series of five or six small grass-roofed structures separated by walls banked with earth or sod (Figure 3).

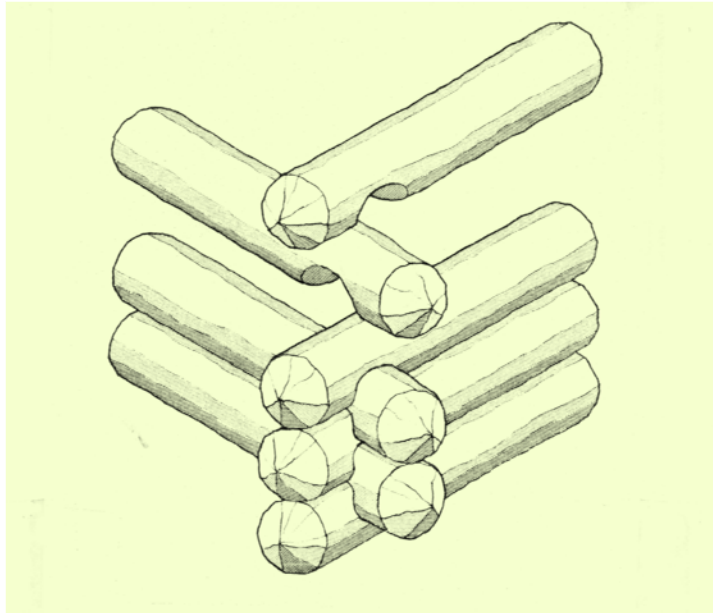
Figure 4

In saddle-notch construction round logs were lapped and, at the corners, curved notches were cut about 300 mm (1') back from the end of the log. The location of the saddle-notch on the bottom of the log was more desirable as it allowed water to drain downwards, reducing the possibility of rain gathering in a top-notch and rotting the joint.

In all, 30 log cabins (the number limited by the number of stoves purchased in Winnipeg) were erected in a joint effort by the settlers. According to Simon Simonson, one of the first settlers, these structures were "12' x 12' in size, man high, of rails which with difficulty we managed to drag to the site." (Simonson, 1946, p. 46). The low walls were surmounted by rafters topped with grass from a nearby low spot. At the corners the walls were connected with a simple grooved or saddle-notched joint (Figure 4).

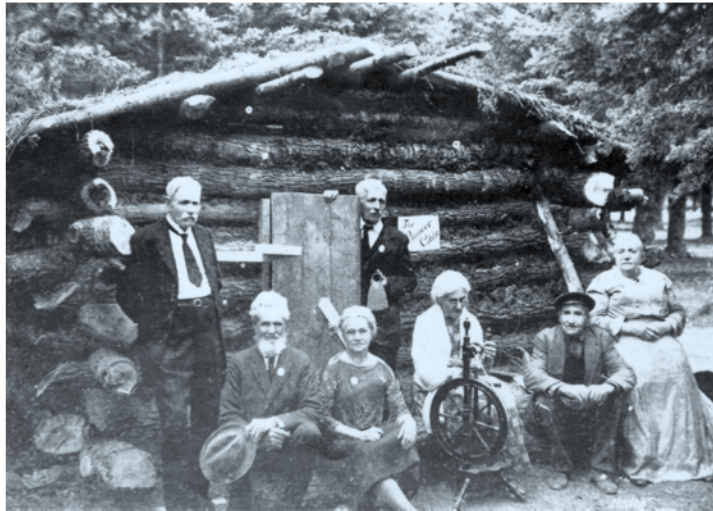
Figure 5

Gimli, 1925. Pioneers of 1875 and 1876 stand before a reconstruction of one of the initial homes on the fiftieth anniversary celebration of New Iceland. Details such as the saddle-notch corners, rails and grass roof, and the crude but Effective door hinge match early descriptions. (Provincial Archives Manitoba)

The doors in some were so low that the occupants had to crawl on their hands and knees to enter. A few had small fixed windows, while others had none. In some cases the wood from the flat boats served as floors for their shelters, but in most cases, the structures were built on flat stones or simply on the hard ground. Each structure not only housed two or three families throughout the first severe winter but also provided shelter for whatever livestock they had brought (Figure 5). None of these crude dwellings have survived to the present.

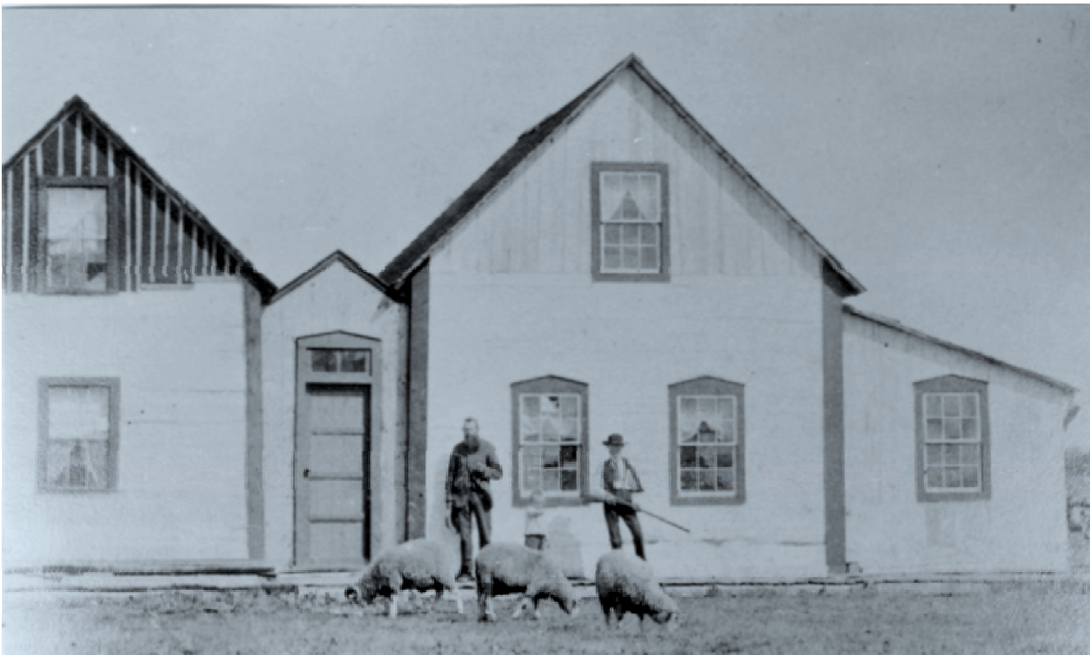
Figure 6
These gable-roofed log houses were joined, like their Icelandic predecessors with a narrow gabled entrance.

The houses constructed by the large Icelandic group that arrived in 1876 were not only slightly better than those built at the Gimli settlement the previous year but also began displaying some traditional Icelandic forms (Figure 6).

John Ramsay, a well known local native, taught many of the newcomers how to improve the cabins. With four or five men at work, a more substantial cabin using hewn logs with dovetailed corners and having windows could be finished in two days. The roofs of some of these cabins were constructed of lumber purchased in Selkirk. The interior arrangements of these one-roomed dwellings were simple: a stove was placed in the middle and beds along the side walls. Some houses had sleeping quarters in a loft above the main floor.

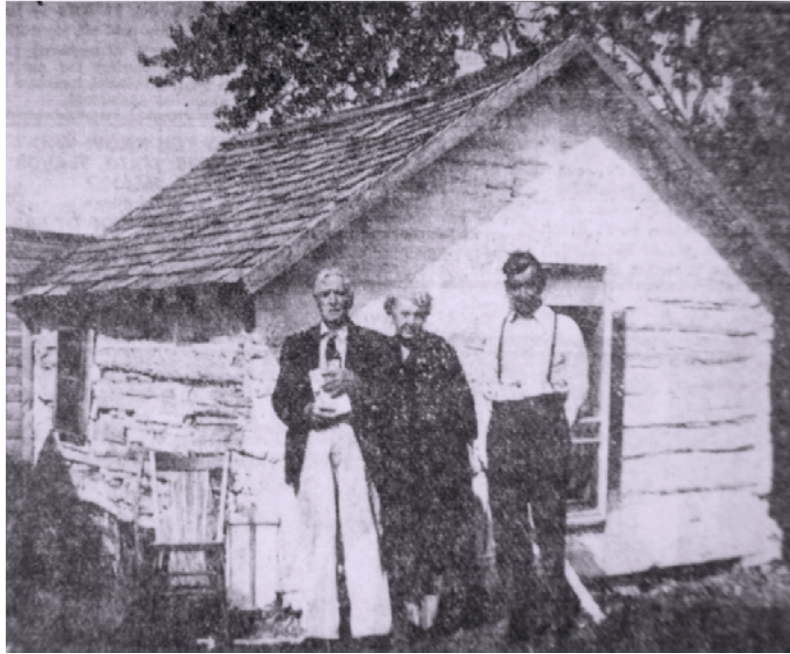
Figure 7
Constructed in 1876 by Fridjon Frederickson, this log cabin held the honour of being the oldest home in Gimli when this photograph appeared in the Winnipeg Free Press in 1950 .(Manitoba Legislative Library)

With the first five years of settlement being very difficult, simple log structures of this type remained the principal form of housing in the colony until the early 1880s. One of these early homes was only recently demolished (Figure 7).

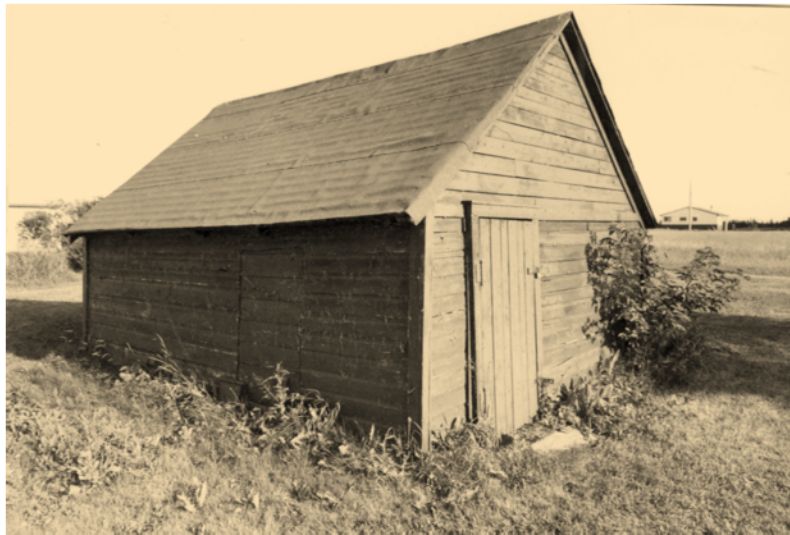
Figure 8
The walls of this pioneer log house were chinked with a sand and lime mortar and then white-washed.

Another structure fitting the descriptions of these early houses is still located near the village of Hnausa (Figure 8). Long time residents of the area recall that the building was used for a time as a house and later as a blacksmith shop.

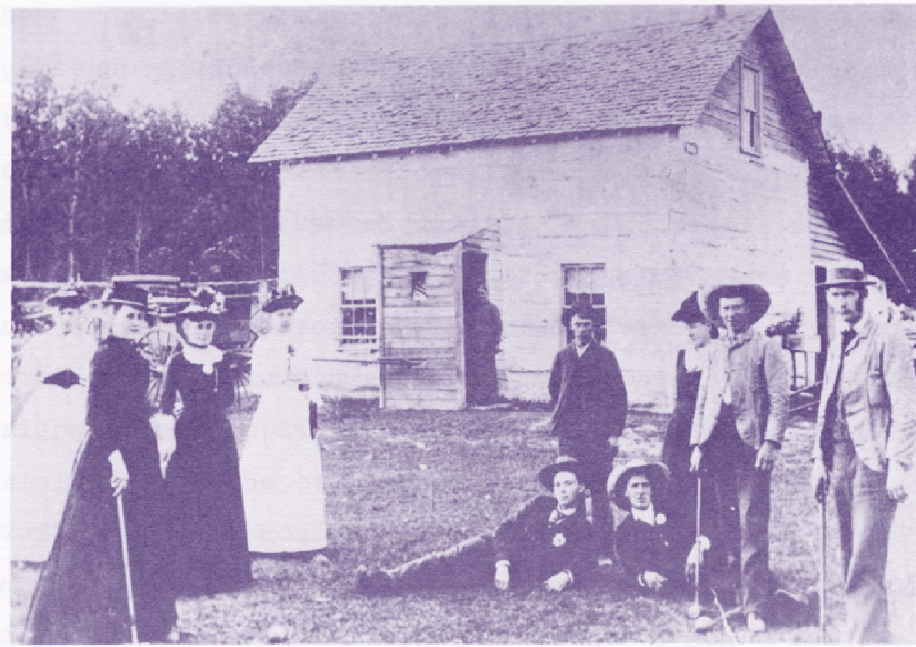
Figure 9

Settlers pose for a photograph in front of a typical circa 1890 house that features dovetailed log construction, whitewashed walls, a single stove-pipe chimney and an attached shed at the back of the house. (Provincial Archives Manitoba)

Most of these structures appear to have been consistent in size and appearance throughout the colony. Generally, 1 1/2 storeys high and gable-roofed, these buildings had up to two rooms, whitewashed walls, and likely an attached storage shed (Figure 9).

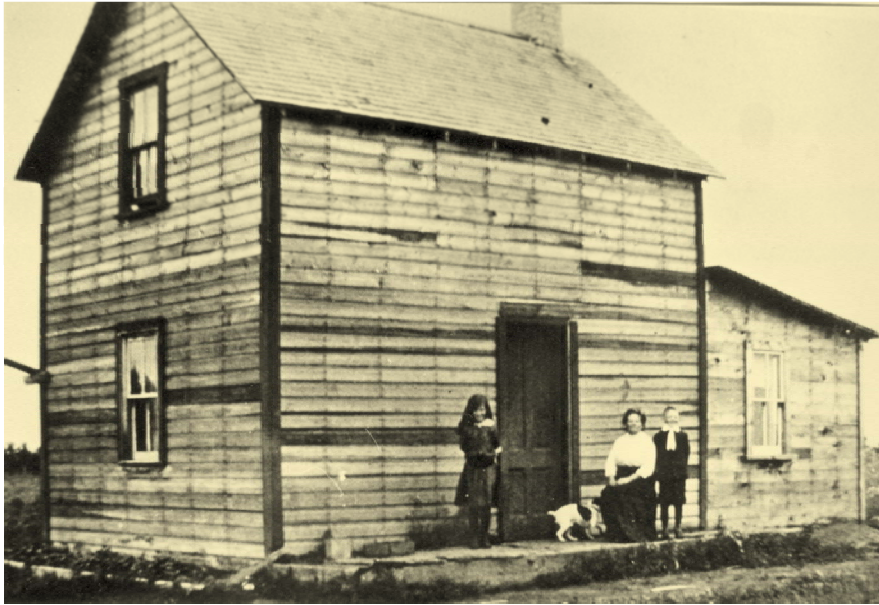
Figure 11

Many of the early Icelandic log homes were improved in later years with wood siding on the exterior walls, brick chimneys, and lean-to kitchen additions (Provincial Archives Manitoba)

Over the years, as their economic situation improved and the size of their families grew, a number of improvements were usually made to the settler's homes. The first of these was the construction of a lean-to addition; initially these were of log but were later more frequently of wood frame (Figure 11).

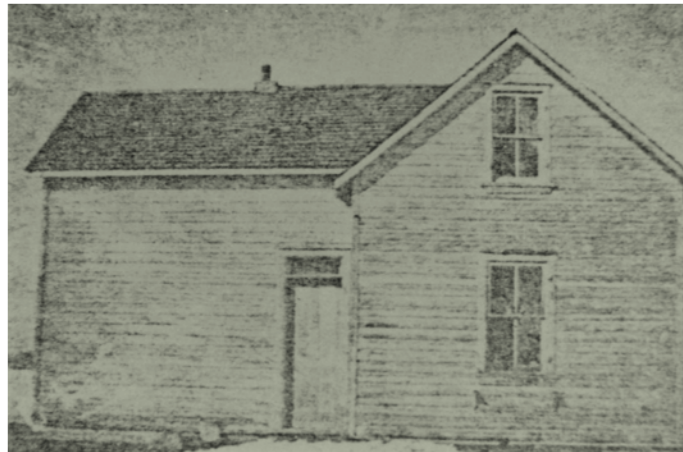
Figure 12

Although the shed-roofed lean-to was the more common addition, some settlers constructed full storey-and-a-half wood frame wings when the original log cabin became too small. (K. Magnusson)

This addition typically became the new kitchen area, freeing the original section to be used as a bedroom or living area. At this time, the cookstove would have been moved into the new kitchen and a brick chimney constructed. In a few cases more substantial additions were made; entire full-sized wings of frame construction were added to the original structure (Figure 12).

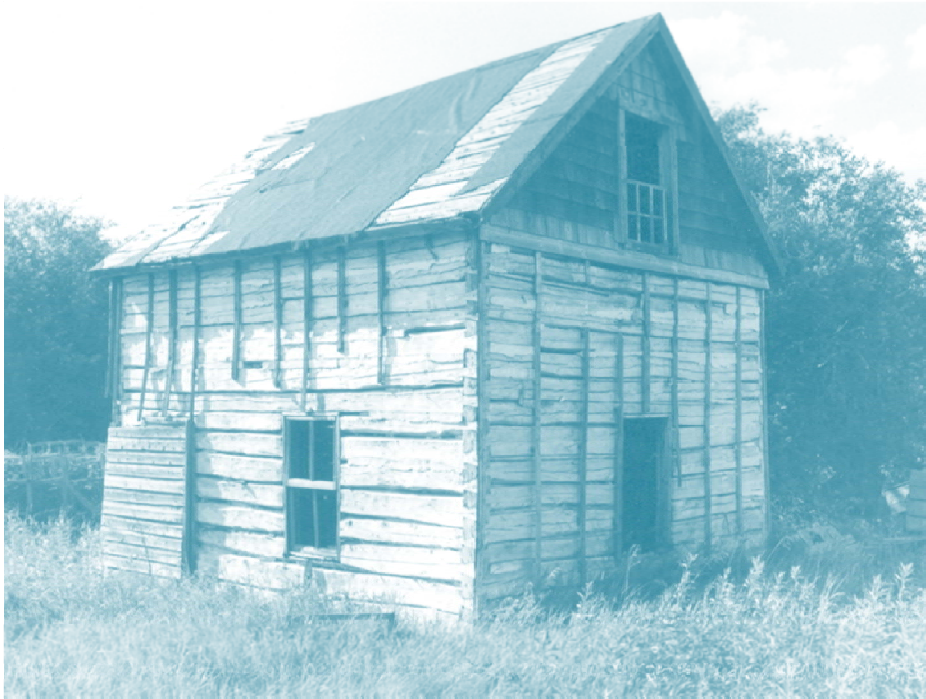
Figure 13

Sniefeld house, SW 17-22-4E, circa 1890. Originally constructed near the lakeshore on SE 8-22-4E, this building was recently moved 1 1/2 miles north where it now stands unused. It is one of only two surviving log homes from the 1883-1903 period of Icelandic settlement.

The logs are roughly squared on four sides and are joined at the corners with well-cut dovetails. The spaces between the logs are filled with a sand and lime mortar, and there are traces of whitewash on both the inside and outside walls. The roof is constructed of rough-cut lumber and the roofing material is rolled asphalt. Sometime after the house was built, a single storey, gable roofed log addition was constructed along the west wall and, in later years, a wood frame extension was added to this. At this same time, the entire structure was sheathed with horizontal drop siding, most of which has since been removed.

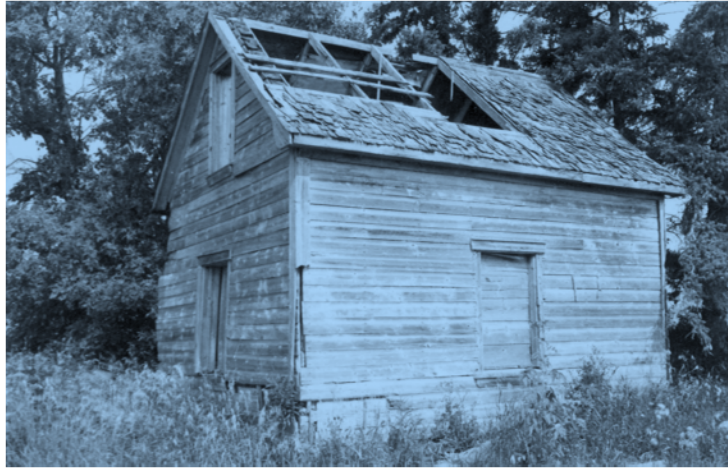
Figure 14
Oddliefson house, SE 19-22-3E, 1890. Later improvements to this log structure included a wood frame shed-roofed kitchen addition, wood siding on the exterior walls, flush board siding on the interior walls and two layers of construction paper on the walls and roof of the upper level.

The one other surviving log house of this type, now found near Arborg, was constructed by Gester Oddliefson in 1890 and originally stood near the banks of the Icelandic River in the old Geysir settlement (Figure 14).

A typical shed-roofed lean-to of frame construction, added to it in later years, was used as the kitchen. This addition has since been removed and stands a short distance north of the building's present location.

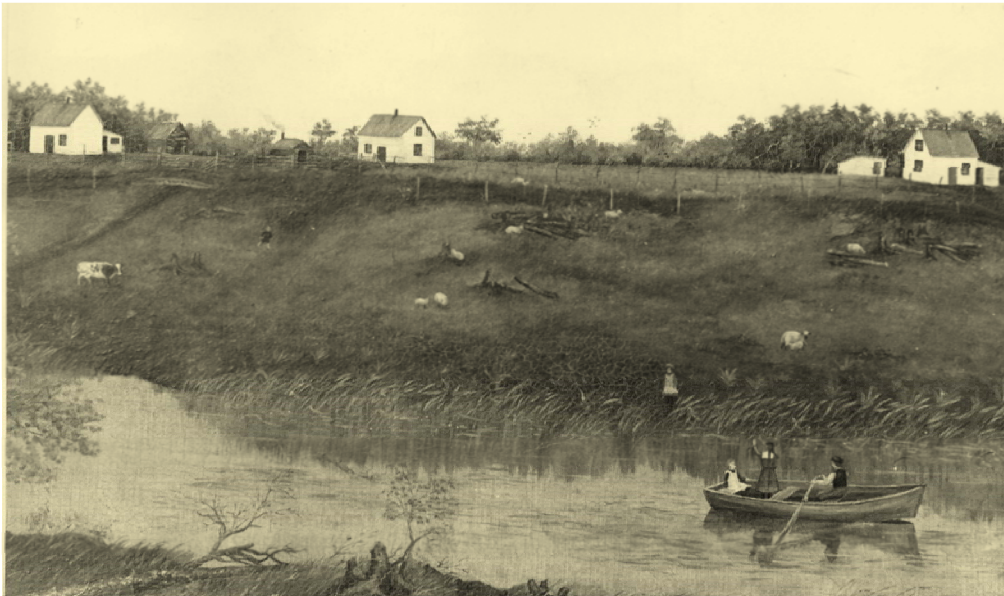
Figure 15
The Borgfjord family homestead in the Geysir settlement, as it appeared around the turn of the century. For 12 years these homes marked the western fringe of settlement along the Icelandic River.

This location was immediately to the east of the Borgford homestead depicted in Figure 15, and had the appearance and situation of the structures in this 1903 painting. Although slightly smaller, it is very similar in form and construction to the Sniefeld house. In this case, however, logs extend up the gable end walls to the peak of the roof, and an earlier type of roofing material, split wood shingles, was used (Figure 16).

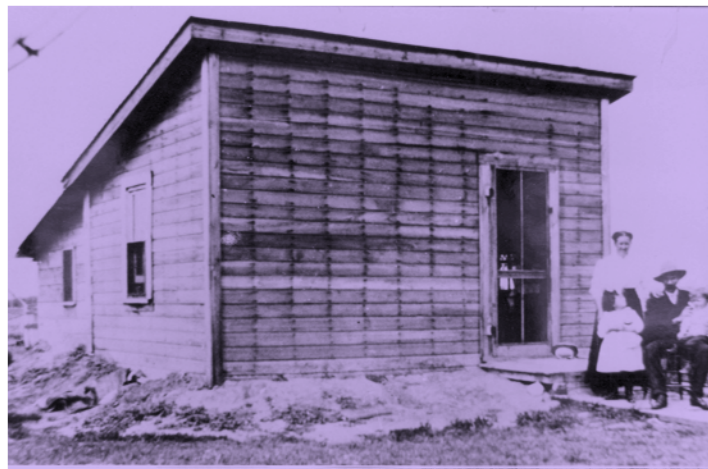
Figure 17

This two roomed shanty, photographed in the Vidir area around 1903 was typical of the period. The absence of siding on the rear portion suggests that it may have been a later addition to the house. (Provincial Archives Manitoba)

Towards the end of the nineteenth century, one storey shed-roofed shanties of frame construction began replacing the early log homes in most areas of Icelandic settlement. Small frame lean-tos had been common additions to the log homes in the early 1890s, but within a short time larger versions of these earlier appendages were completely replacing many of the original log structures (Figure 17).

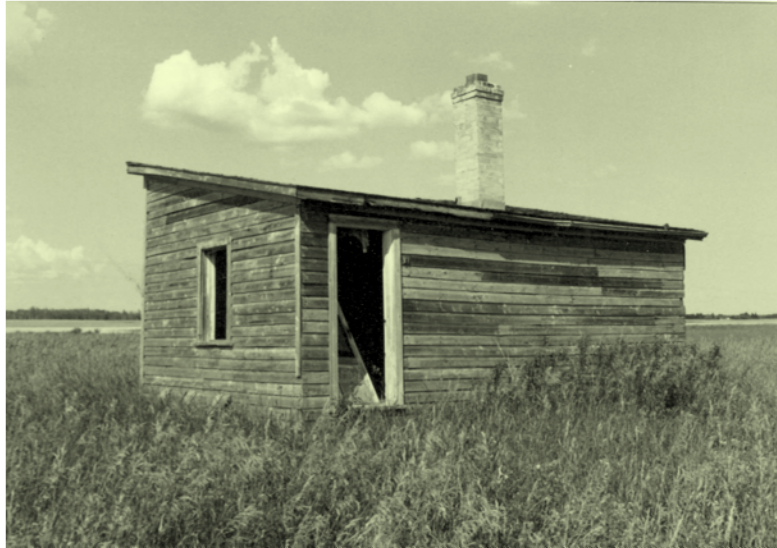
Figure 19

Around the turn of the century, simple shanties, like this one, now abandoned in the Geysir district, were the standard form of housing for many of the Icelandic settlers.

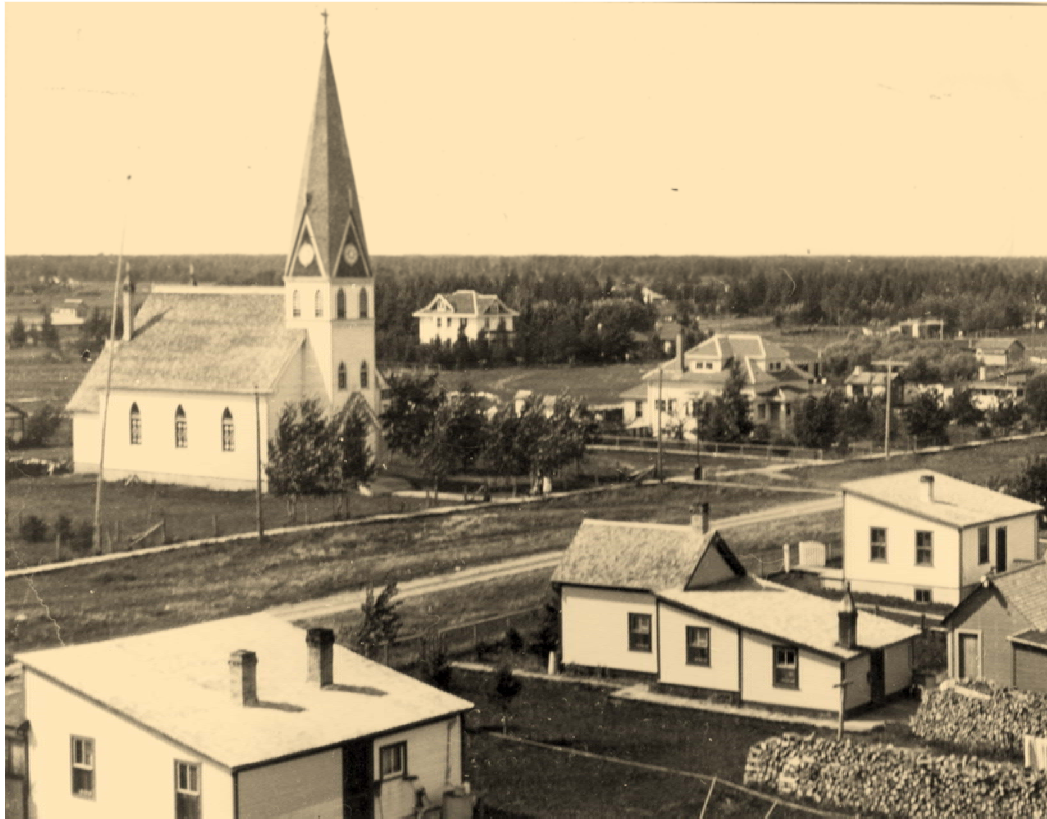
Figure 20

In the foreground of this 1910 photograph of Gimli, which also shows the newly-completed Lutheran Church, are three variations of the shed-roof house.

Small and simple in design, the popularity of the shed-roofed residence was due to the ease and inexpensive with which it could be constructed (Figure 18). A settler did not have to be a skilled carpenter to build such a house and construction took little time. Early photographs and remaining examples indicate that shed-roofed residences varied in size and plan. Some, such as a now-abandoned structure near Hnausa, were simply constructed single-roomed bachelor shacks that rested on a foundation of loose stone (Figure 19). Others, built as more permanent structures, had several rooms and concrete foundations (Figure 20).

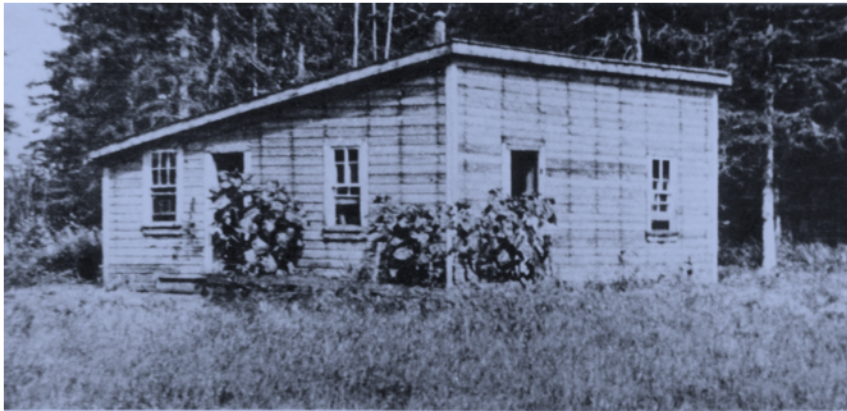
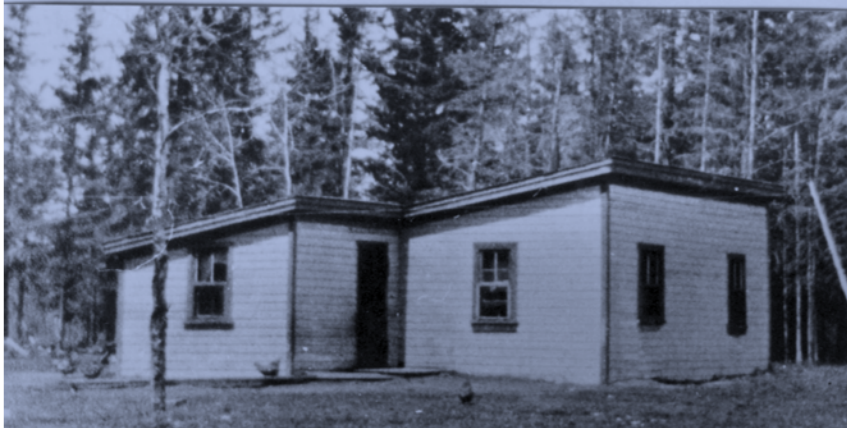
Figure 21

Later additions to the original shed-roofed residences, like this one in the Vidor district, were often shed-roofed as well. (Provincial Archives Manitoba)

A number of improvements were generally made to these early shed-roofed residences within a few years of their construction. These were similar to those made to the log homes during the same period. The earlier metal stovepipe chimney was often replaced with one of the brick, and the interior walls were sheathed with siding or wallpaper. If the original floor was constructed of rough lumber, it was recovered with tongue and groove flooring. The construction of additions was also quite common (Figure 21).

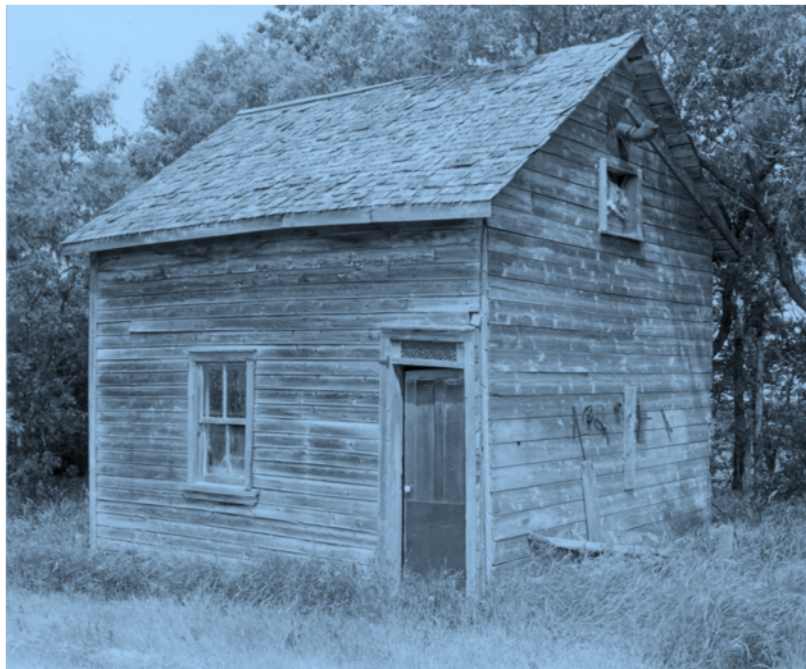
Figure 22
Borgfjord house, SW 19-22-3E, ca. 1895.

According to local residents, it originally stood several miles east of its present location on the banks of the Icelandic River. It is one of the oldest wood frame structures in the entire planning district.

In addition to the shed-roofed frame residences built in New Iceland, a small number of 1 1/2 storey gable-roofed frame houses were constructed prior to the turn of the century. Like the shed-roofed shanties these buildings featured balloon framing construction methods; the basic differences then between the two structures involved the internal planning and the roof shape. A residence, located at SW 19-22-3E, one mile east of Arborg, is the most interesting of the three remaining early gable-roofed examples (Figure 22).

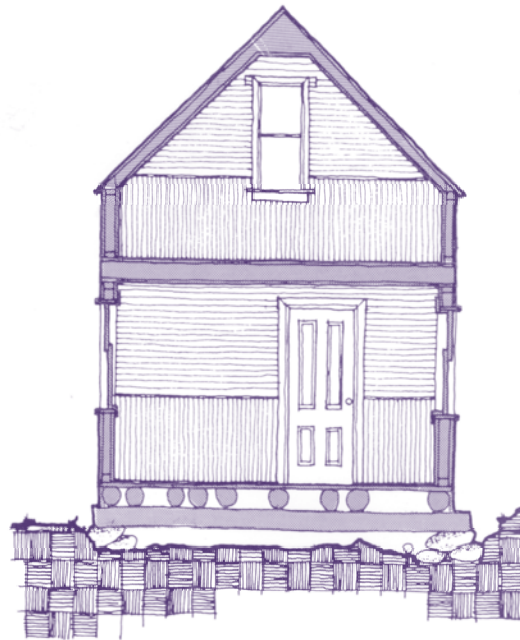
Figure 23
Borgfjord house: floor plans and cross section.

Second
Floor Plan

Ground
Floor Plan

Section A-A

Despite its small size (Figure 23), it is solidly built and exhibits a good deal of workmanship. The interior is nicely finished with wainscoting on the lower half of the walls and on the ceiling. Simple wood mouldings surround all the interior windows, door frames and corner joints. There is no chimney in the structure; holes were simply cut in the ceiling and roof, as they were in log houses of this period, and fitted with stove pipes. The upper level walls and ceiling were finished in a similar manner as the main level. The plain exterior of the buildings has some interesting details. The gable ends were decorated with bargeboards, one of which remains, and a small, coloured glass transom was fitted over the entranceway.

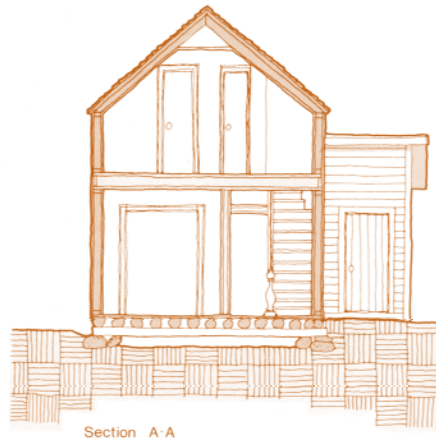
Figure 24
Five-roomed gable roofed house
with shed addition: floor plans and
cross section.

Second Floor Plan

Ground Floor Plan

A typical example consisted of a five or six roomed, 1 1/2 storey gable roofed section, with a single storey shed at the rear. This shed portion invariably extended out about 1000 mm (3') to the right side of the gable portion, just enough to accommodate a front facing door. The main entrance of the building was usually located on the right front of the gable-roofed section. Floor plans varied only slightly in the remaining examples. The larger structures had three bedrooms in the upper level, while two bedrooms were more common in the smaller ones (Figures 24 and 25).

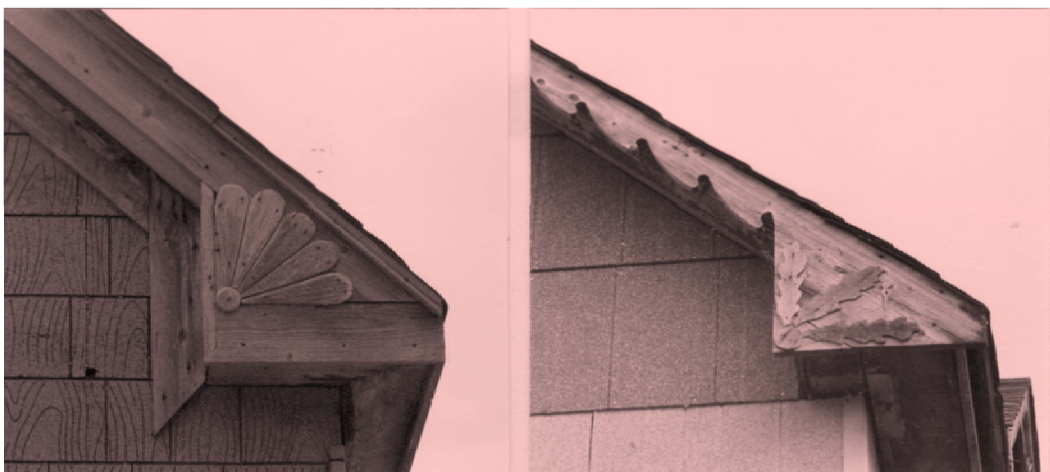
Figure 26

The sunburst pattern was the most common form of decorative trim found on the gable and shed eave returns. Alternatively several featured an oak leaf motif. In this instance the oak leaf motif is accompanied by a decorative bargeboard cut into the shape of cresting waves.

Most of the gable-and-shed residences remaining featured distinctive decorative trim on the gable ends and around the windows. Prominent eave returns were found on virtually all of the buildings; on most this was accompanied by decorative patterns (Figure 26). Decorative wood shingles above the windows on the gable ends were also fairly common, and a few examples with bargeboards were also found.

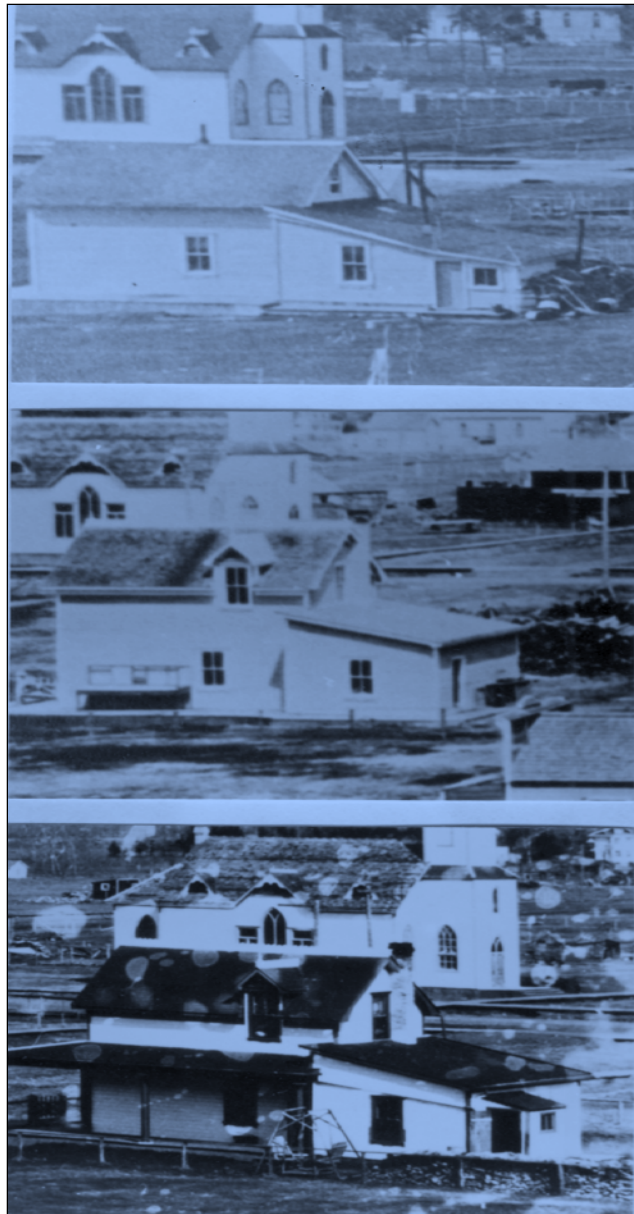
Figure 27

This series of early photographs of Gimli show the succession of changes made to a typical gable roofed house with a shed addition.

Like most early houses in the planning district, a number of changes or additions were often made over the years to the basic gable-and-shed form (Figure 27). The construction of a wraparound verandah was often accompanied by a second storey sun deck.

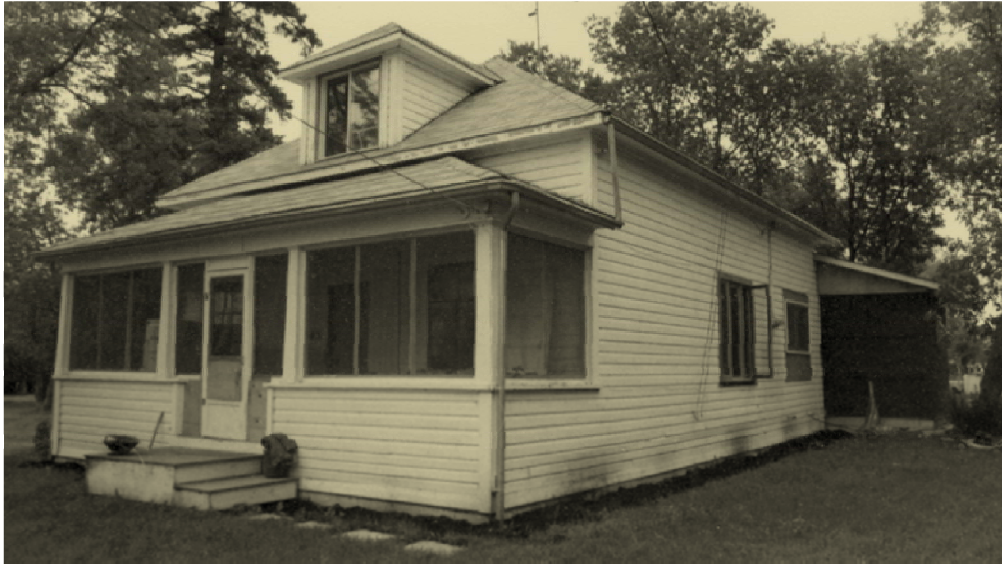
Figure 28
'Cottage-style house, Riverton.

After the First World War the popularity of the gable-and-shed style began to wane, and a new type, known locally as the cottage style, began to appear (Figure 28). During the 1920s and early 1930s, a fairly large number of these homes were constructed, primarily in the district's communities.

In the planning district cottage houses were characterized by a low-pitched pyramid roof with wide overhanging eaves, one and as many as four dormer windows, and usually a front verandah. By the early 1920s concrete was in common use, and many of the cottage homes were built with full basements. The housing examples constructed prior to the 1920s usually had basements added later. Attached kitchen sheds were also fairly common and, as in the case of the earlier gable-and-shed type of home, the shed portion was often the original structure. Decorative elements were rare. Window mouldings and eave returns on the dormers were found on a few examples (Figure 30), while verandahs were occasionally enhanced with carved pillars and balustrades (Figure 31).

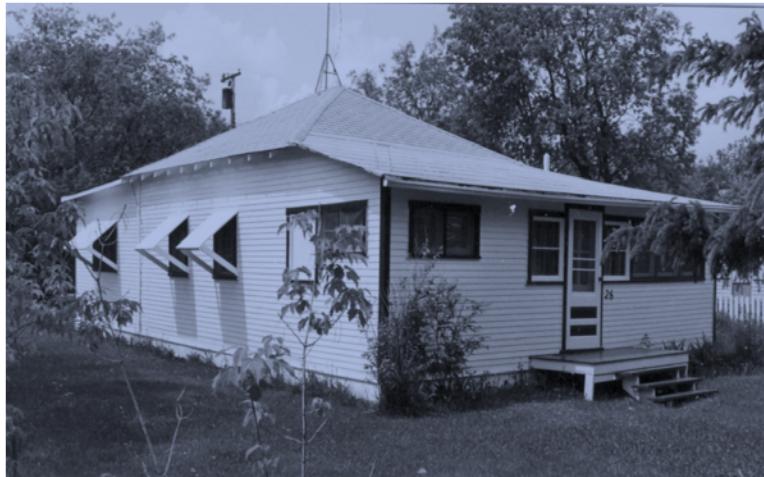
Figure 29
Cottages of this type were being constructed in the Gimli area soon after the railway connection between Winnipeg and the community was completed in 1906.

Due to its local nomenclature, and the fact that this type of residence did not appear in the study area until after the growth of Gimli as a popular summer resort area, it is possible that this house style was influenced by the style of seasonal houses being constructed in Gimli during this period (Figure 29). However, low profile bungalow homes of this type were also popular throughout the province during the 1920s.

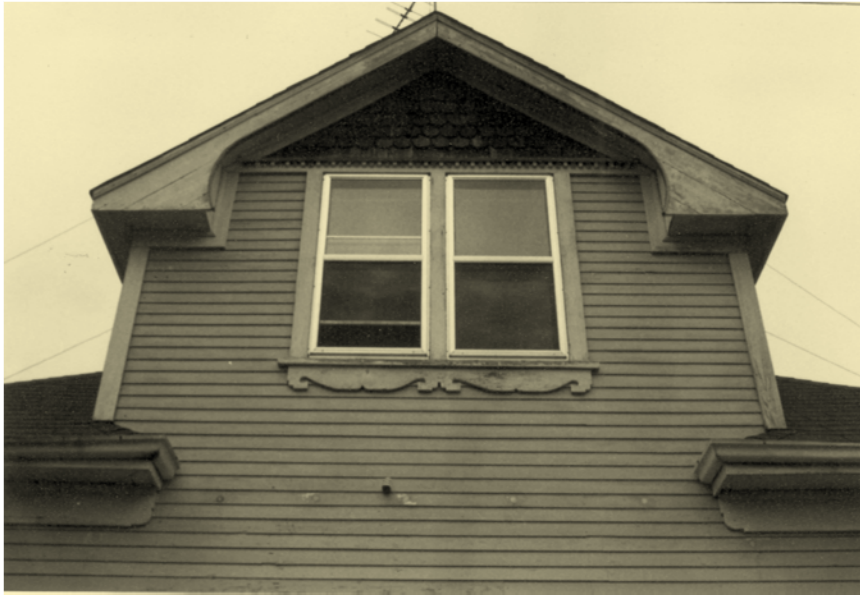
Figure 30
Decorative elements on the cottage residences included window mouldings and eave returns on the dormer windows.

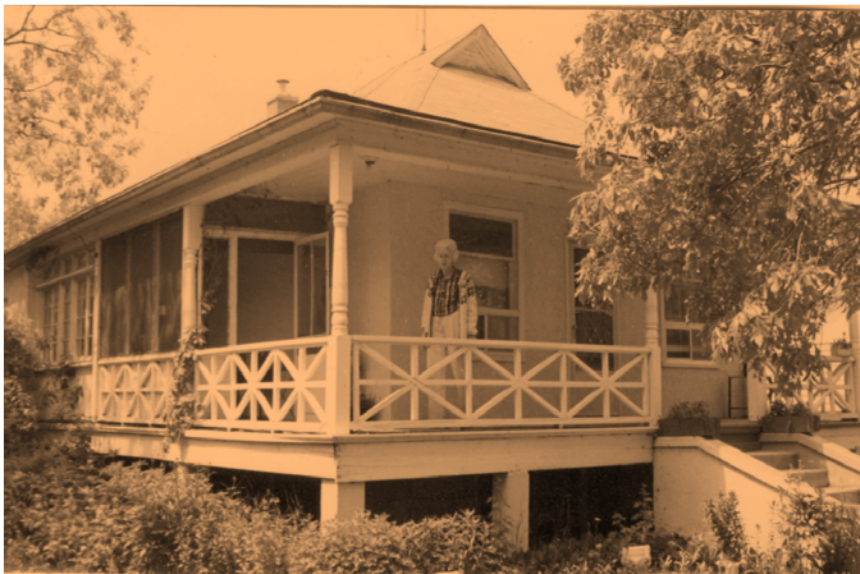
Figure 31
Magnusson house, Gimli.
This cottage house features a small gable, stained glass transoms on the front window and a wraparound verandah.

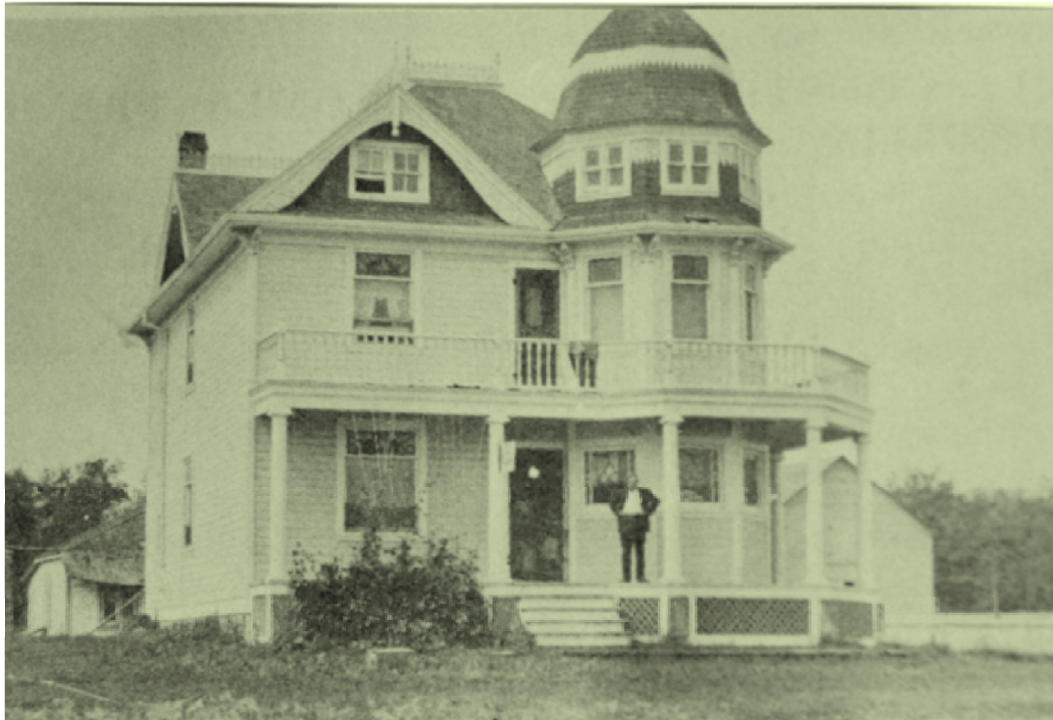
Figure 32

A past landmark in the Hnusa area, "Braedrahofn" (Brother's Haven), was constructed in 1906 by Johannes and Stefan Sigurdson. It had a large turret, bay window, a sundeck and pillars, steam heating and full plumbing. (Provincial Archives Manitoba)

The majority of these larger homes were constructed during the peak period of the district's economic growth and activity, from about 1905 to 1925. They were usually 2 or 2 1/2 storey frame buildings, constructed from plans purchased in Winnipeg or from available publications. A number of these fine homes have been lost over the years, such as the Sigurdson residence in Hnusa which was destroyed by fire in the 1930s (Figure 32). Approximately ten, however, still survive.

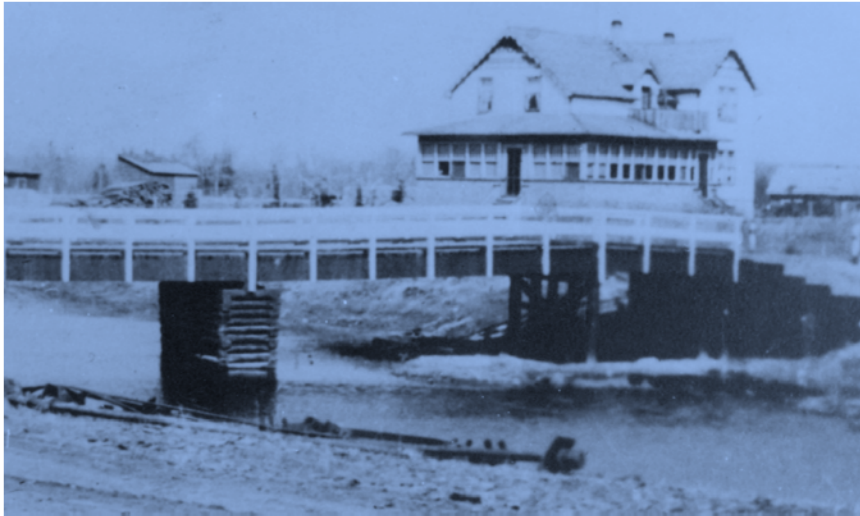
Figure 35
'Vindheimar' (The Windy Home), SW 7-23-4E. This photograph shows the large house as it appeared in 1935. (T. Bjornson Photo.)

One of the most interesting of all the Icelandic residences in the planning district is located about five kilometres southwest of Riverton, also along the banks of the Icelandic River (Figure 35 and 36).

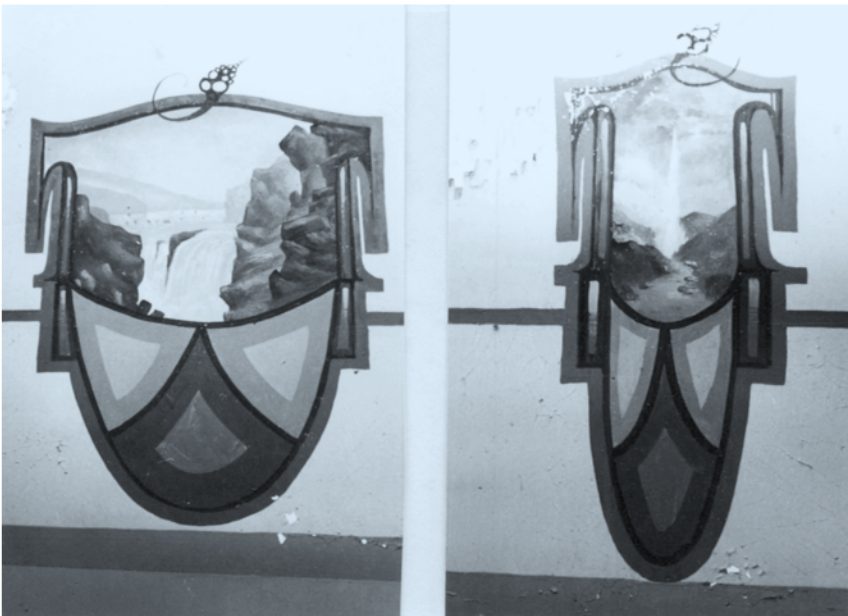
Figure 39
'Vindheimer.' Two of the handpainted frescoes that adorn the dining room walls.

Vindheimar was well known for its Icelandic decorative elements. Stylized wooden dragon heads, like those on early Viking ships, and bargeboards cut in the shape of cresting waves decorated all the gable ends (Figure 38). Of greater interest were the seven hand-painted frescoes which adorned the dining room walls (Figure 39). They were painted directly onto the thick plaster coated walls by an unknown Icelandic artist soon after completion of the house.

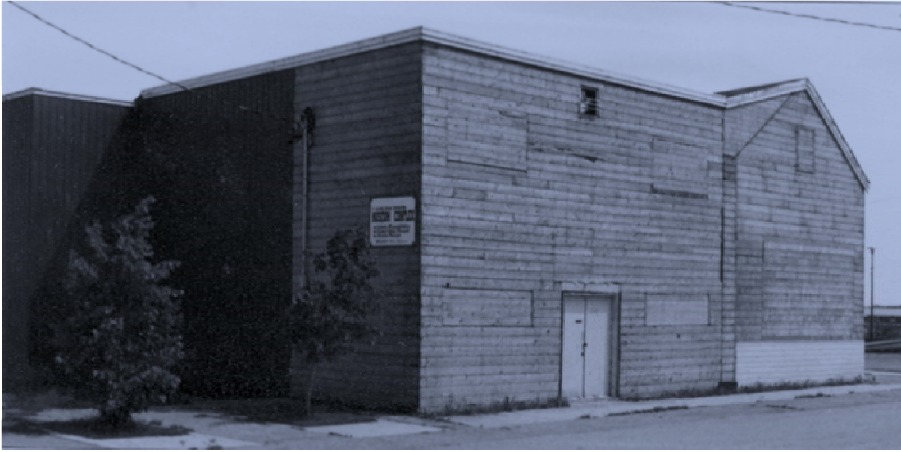
Figure 40

Portions of this structure date back to 1919 when Robbins Incorporated, a Chicago based company, established the first large scale fish processing station in the Eastern Interlake. Since that time the facility has changed hands several times and received a number of additions.

Few of the fish packing stations constructed during the early years of the industry were situated on the shoreline between Gimli and Riverton because of poor natural harbours. Selkirk and several locations on the west shore were the main plan locations. However, after government wharfs were constructed at these locations. The Hanusa facility no longer exists and the one in Gimli is now a local museum (Figure 40).

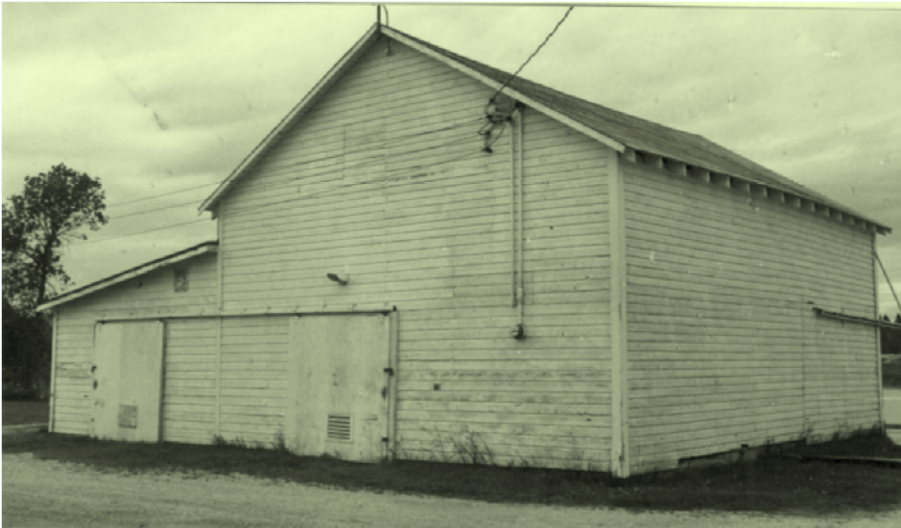
Figure 41

This small fish processing station, located near Arnes, and a similar one near Hnausa, were owned by local Icelandic fishermen, and only recently ceased operations.

Two smaller fish stations were found along the shoreline in the planning district, one at Drunken Point and the other near Arnes (Figure 41). Both appear to be of recent construction, although neither is currently in use.

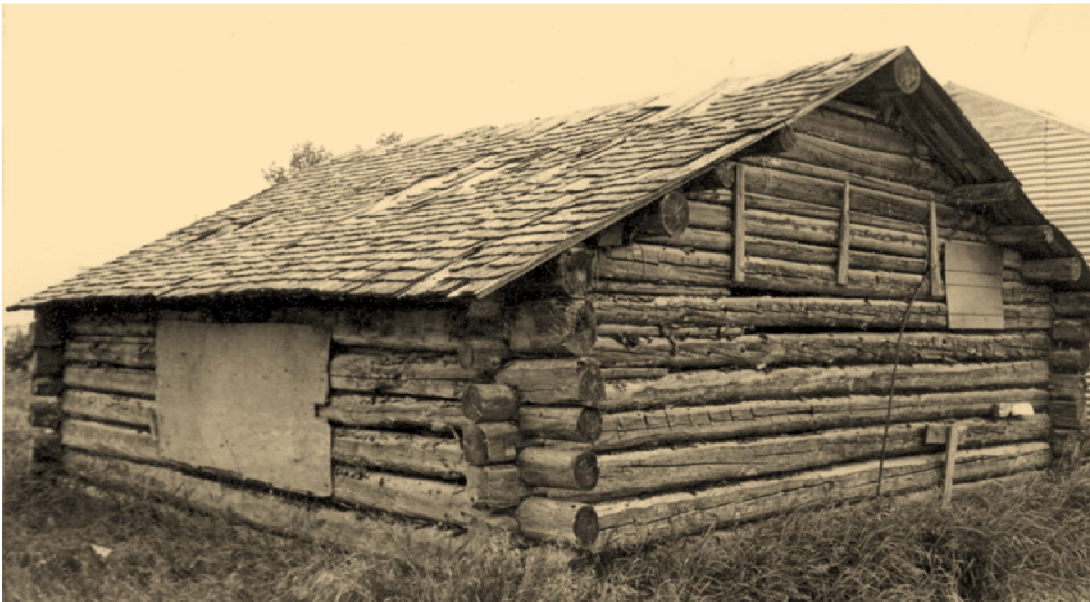
Figure 42
Log building from a former fish camp at
Loon Straits on the northern shores of Lake
Winnipeg.

A number of temporary log fish stations were constructed along the shores of the north basin of Lake Winnipeg and were occupied during the winter fishing season. One such structure from a camp at Loon Straits still stands, now used as a garage and storage shed (Figure 42).

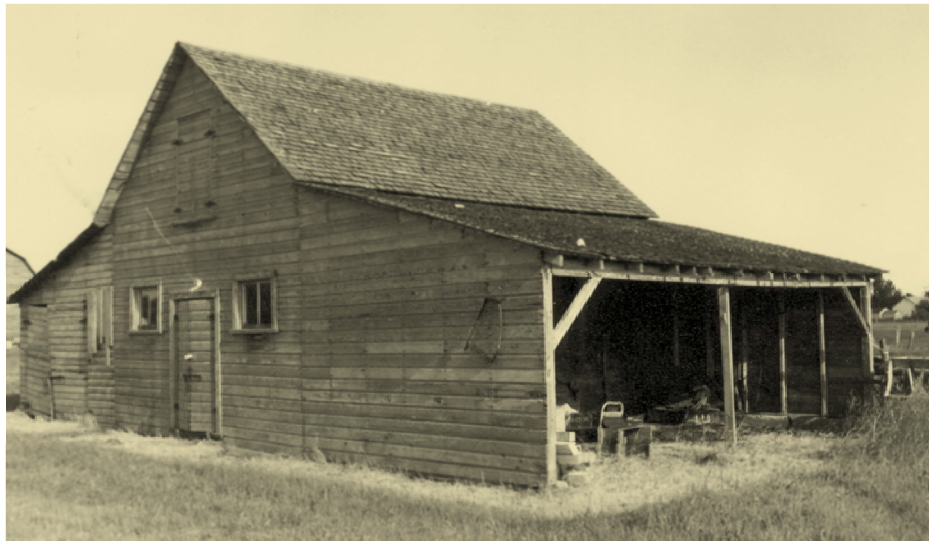
Figure 43
Net and equipment storage shed near
Hnaua.

Many of the local fishermen constructed their own small woodframe, shed-roofed equipment storage sheds, ice and smoke houses. Only a few of these still exist. A building constructed in 1934 for drying and storing nets and other equipment is near Hnaua (Figure 43). Two other small storage structures are located in Riverton (Figure 44). These buildings were apparently constructed prior to the turn of the century and still contain a number of nets and other articles from the early years of fishing on Lake Winnipeg.

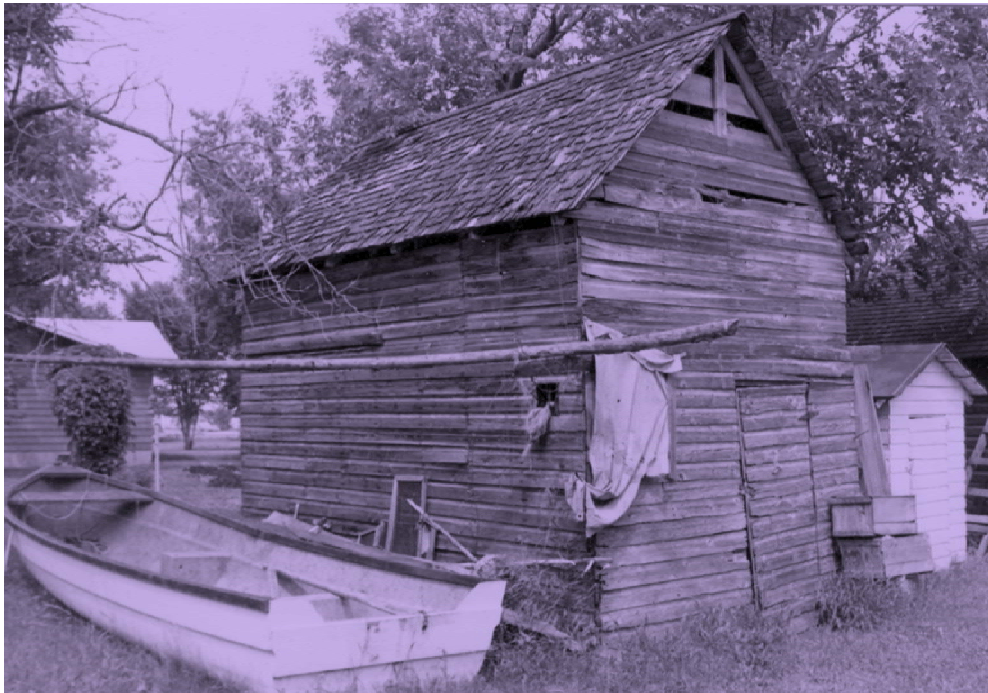
Figure 44

This small storage shed, located in Riverton, is still used for storing nets and equipment after nearly 80 years.
