ICELANDIC FARM AND FISHING BUILDINGS

An Architectural History Theme Study

**David Butterfield &
Ed Ledohowski**
Historic Resources Branch

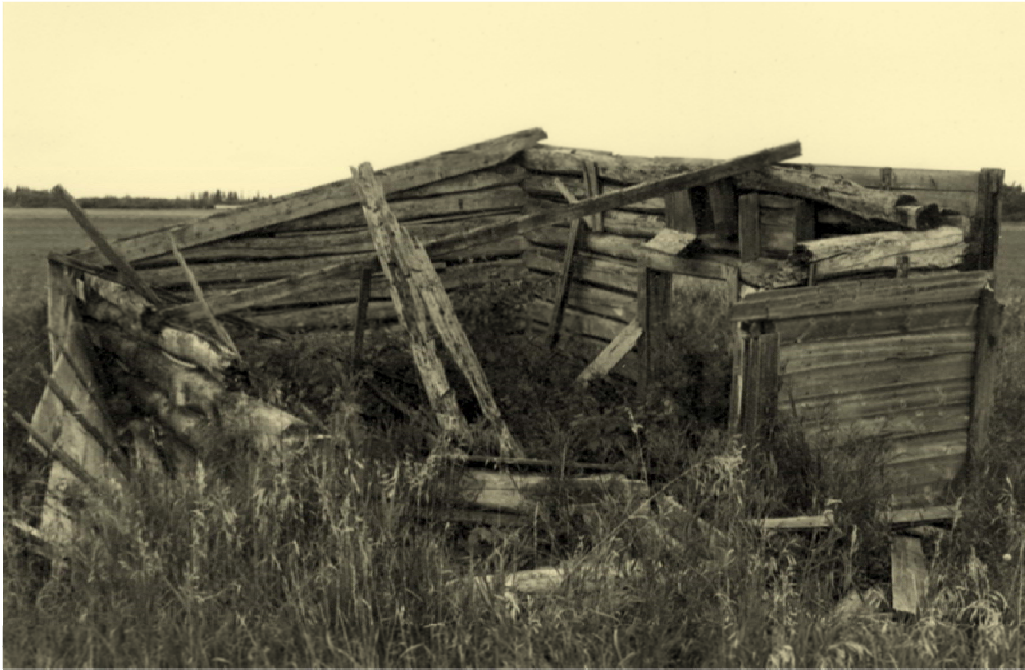
Figure 45

Sniefeld shed, SE 8-22-4E, circa 1895. Small shanty-roofed storage sheds such as this one were among the first farm buildings the Icelandic settlers constructed after staking claim to their homesteads.

Very few pre-1900 farm buildings remain. Only a single building of log construction was found - a shed on the same site as the Sniefeld log house (Figure 45). Small shed-roofed storage structures of this type were often found on the early homesteads.

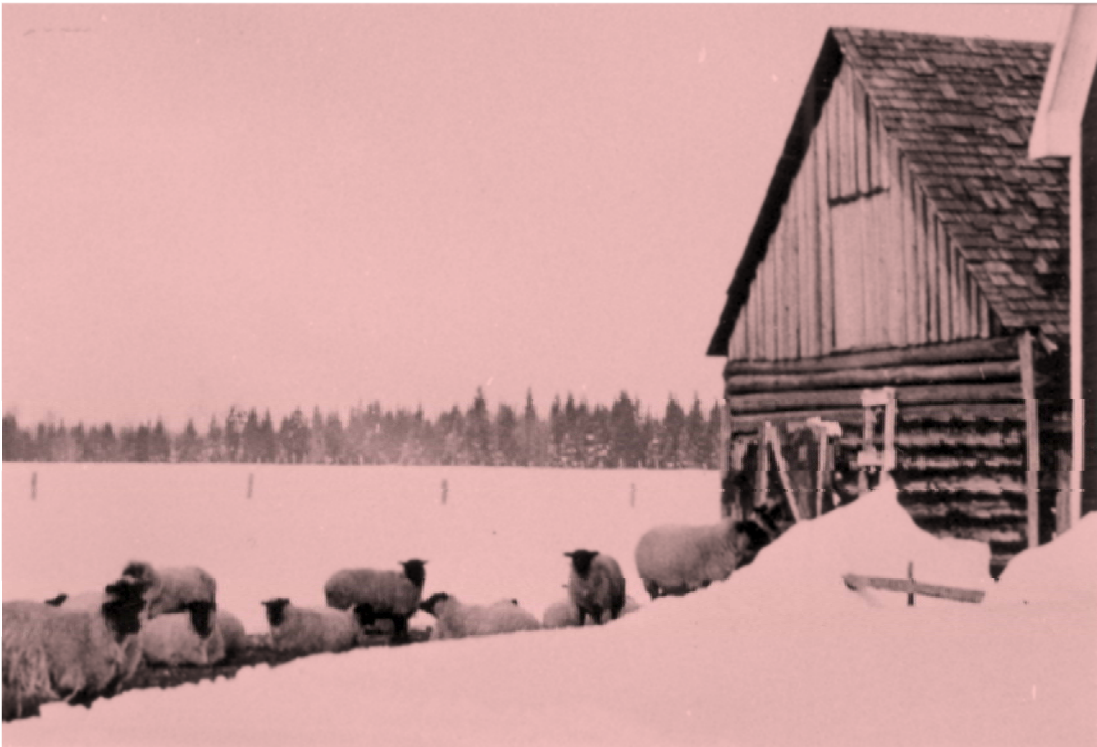
Figure 46

The first barns constructed by the Icelanders were simple gable-roofed log structures. After the turn of the century, when large frame barns were built, these structures were usually demolished. None are known to have survived to the present. (Provincial Archives Manitoba)

Prior to the turn of the century, when livestock numbers were still quite small, simple log stables were used to shelter the animals (Figure 46). The oldest farm building of frame construction is a barn located just south of Riverton on River Lot 8 (Figure 47). The design is not unlike other barns of the period found in most other parts of the province. The simple gable roof was also found on many of the larger barns constructed during this period, of which there are several examples remaining (Figure 48).

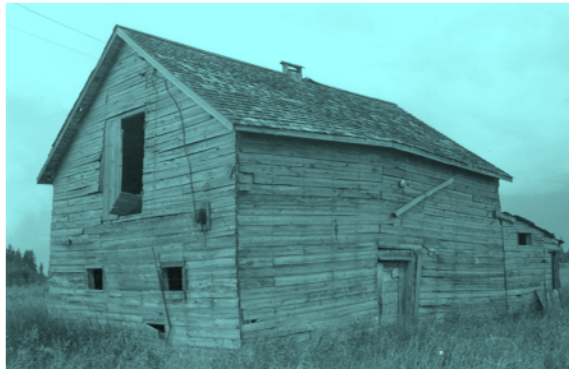
Figure 47

Eyolfson barn, Riverton, 1912. This small frame barn, housed about a dozen head of stock .It had a high walled loft for maximum fee storage capacity, and a lean-to addition for the young animals.

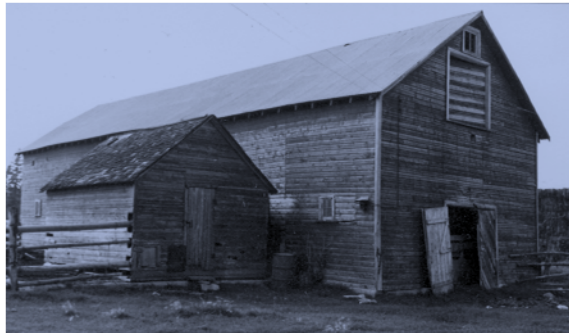
Figure 48

Many of the barns constructed during the 1920s were simply longer versions of the earlier gable-roofed barns, such as this Riverton area example.
