BIPOLE III TRANSMISSION PROJECT

2014 Biophysical Monitoring and Mitigation Report

Report to Manitoba Conservation and Water Stewardship
In Accordance with Manitoba *Environment Act* Licence No. 3055

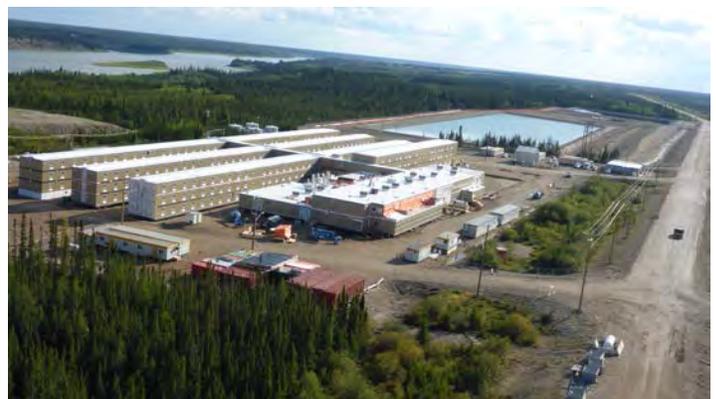
Photo 1: Aerial View of Keewatinohk Work Camp

Construction on the main work camp and supporting facilities occurred in 2014 (Photo 1). One supervisory dorm and one standard dorm were completed and occupied. As of Fall 2014, a temporary kitchen, dining facilities and a 49 person dorm were also installed.

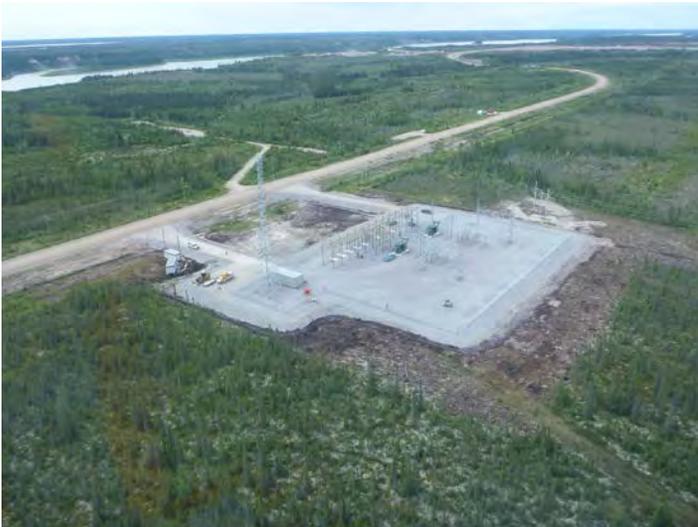
Photo 2: Keewatinohk Construction Power Station

Transmission line construction activities began in mid-December at the Keewatinohk Construction Power Station with the associated construction power line (KN36) (Photo 2). Clearing was completed for the entire 310 metre (m) wide right-of-way (ROW) that will contain the 5 AC collector lines connecting Keewatinohk Converter Station to Henday Converter Station at Limestone (Map 2).

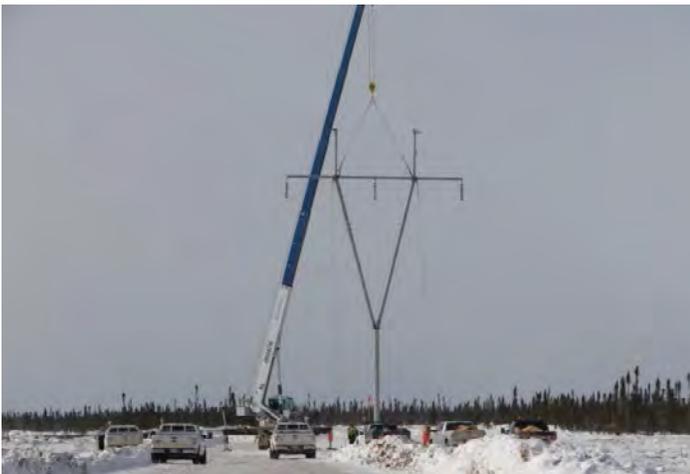
Photo 3: Installation of a Transmission Structure for the Construction Powerline

The construction power line (KN36) is also on this ROW. All 30 km of line KN36 were cleared, towers installed and stringing completed in order to provide construction power to the area (Photo 3). These construction activities were carried out through a joint venture between Fox Lake Cree Nation and Valard Construction.

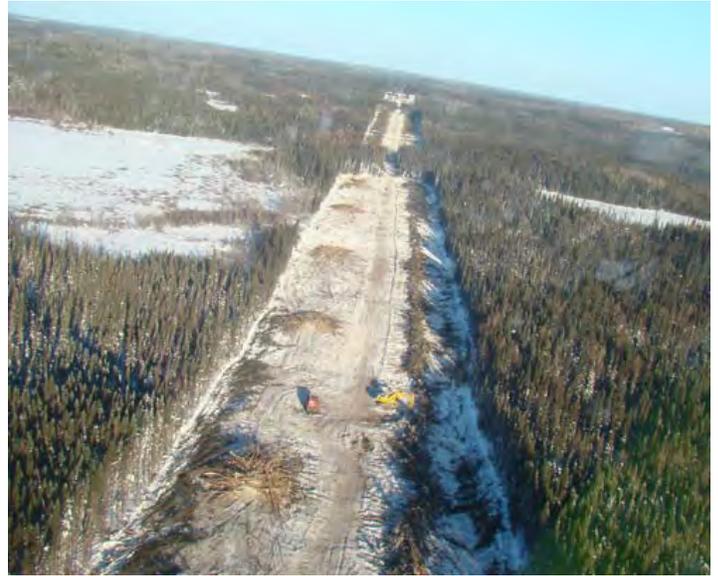
Photo 4: Aerial Shot of Clearing of Bipole III Transmission Line

Transmission line construction activities also began with ROW clearing in sections N2B and N3 in early 2014 through a joint venture between Swampy Cree Tribal Council and Sigfusson Northern (Photo 4).

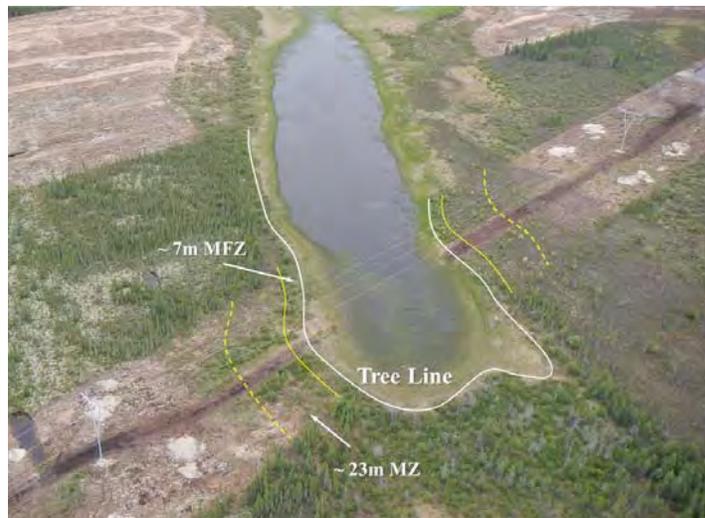
Photo 5: Riparian Zone Measurements

against the list of prescribed mitigation to determine level of compliance as well as recording observations of the conditions of sites. Riparian buffers, vehicle crossings, tower and anchor locations, and rutting and erosion were some of the parameters evaluated.

Of the 29 stream crossings surveyed, all sites were in compliance with 13 of the 21 mitigation measures. Of the 8 mitigation measures in non-compliance, the most common deviations from the prescribed mitigation were slash present below the tree line and minor rutting and stream bank damage. As well permanent structures (tower and/or anchors) for the Construction Power line were situated within the floodplain at five sites, including Goose Creek. During tower spotting it became apparent that previous design decisions and feedback from public engagement regarding minimizing right of way width to 310 metres for the AC Collector and Construction Power lines resulted in towers placed within the floodplain making it impossible to maintain the full riparian buffer of 30 metres at four sites. Manitoba Hydro took special measures during the installation of the towers/anchors under frozen ground conditions to minimize effects to the floodplain. Care was also taken during tower spotting when within the floodplain as to not affect the active channel, so as to not directly impact fish.

Manitoba Hydro went to great efforts in the field to identify and flag appropriate boundaries for riparian zones and buffers under difficult winter conditions in a complex riparian environment. Decisions were made in the field and in conjunction with MCWS to mark buffer zones under deep snow conditions and where there was difficulty in identifying the location of some stream channels. The riparian zones adjacent to most streams were adequately protected based on inspection and MCWS review. All inspection reports indicated that there were no major issues and that the work was in compliance with the applicable approvals and permits.

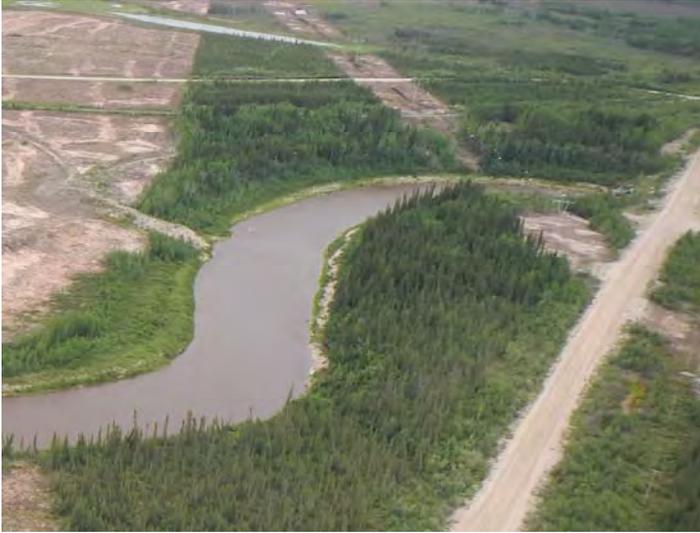
Photo 6: Limestone River crossing

Generally, monitoring activities determined the portion of the buffer closest to stream channels was hand-cleared and machinery was used for selective clearing further from the bank within the riparian buffer zone. At some sites the majority of trees as required for vegetation clearance requirements and shrubs were removed within the buffer, but ground cover remained intact.

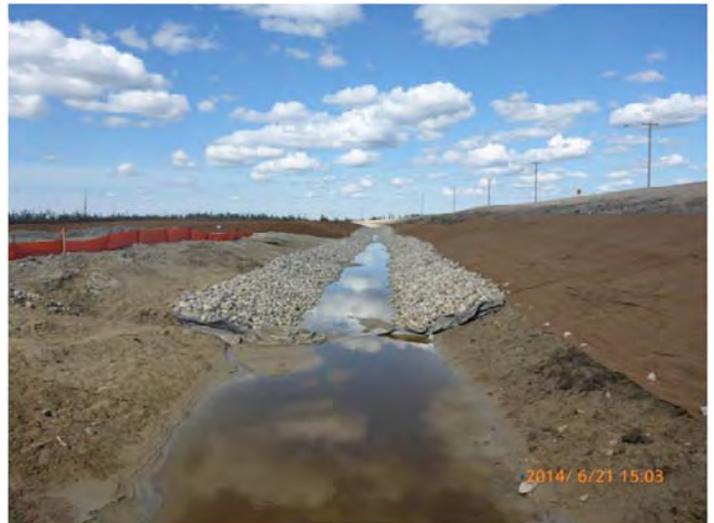
Photo 7: Erosion Control Measures on a Drain Leading to Goose Creek

Rock lining of collector drains, use of rock berms, and natural contouring of landscape were all measures used to keep soil and sediment in place at the Keewatinohk Converter Station site (Photo 7). Silt fencing, coconut fibre mats and permanent geo-textiles were installed in exposed areas to prevent sediment entering channels and streams where it could harm fish habitat in Goose Creek. During construction activities, daily monitoring of water quality was undertaken to ensure measures were effective and that any remedial action could be taken immediately. The suspended load of sediment appeared to be relatively low and sediment control measures effective.

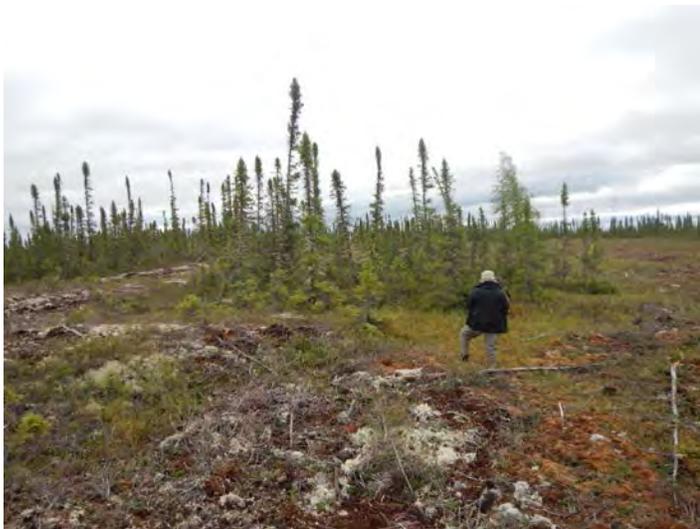
Photo 10: Uncleared Buffer Around Vegetation Species of Conservation Concern

Through fieldwork, it was determined that recommended mitigation was implemented during clearing activities for most sites and effective where implemented (Photo 10). From surveys a further mitigation measure is recommended around the Assiniboine River crossing. Eliminating tree removal by spanning the steep slope or, where possible, reducing clearing at this location is desired to protect populations of several species of conservation concern observed.

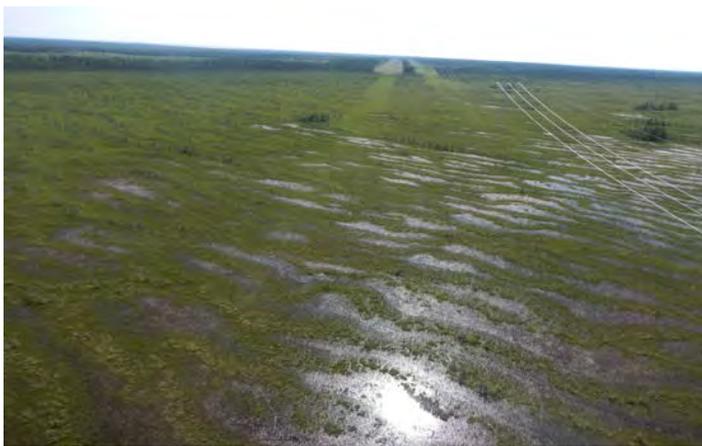
Photo 12: Patterned Fen Wetland Along Bipole III Right-of-Way

Wetlands are valued for their biological diversity and ecological function. The monitoring program for wetlands was aimed at assessing the effect of ROW development on vegetation community health in environmentally sensitive sites (ESS). In the sections cleared in 2014, four patterned fen wetlands sites previously identified in the Project assessment in 2010 were selected for vegetation assessment (Photo 12). Two sites were analyzed for wetland vegetation in paired on ROW and off ROW comparisons. Diversity index, species evenness and species richness had similar ranges in value to the paired survey sites, suggesting that vegetation clearing in these wet sites may not be affecting these vegetation parameters. The only difference was for total percent species cover which was slightly lower on the ROW compared to adjacent to the ROW which was expected immediately following clearing activity and will recover in subsequent growing seasons. For the Project areas cleared during 2013/14, the effect predictions for environmentally sensitive wetland vegetation were accurate with the exception of diversity measures in year one.

Through field work, map review and discussion, it was determined that while some recommended mitigation measures were implemented during clearing activities, others were implemented partially or not at all. Where implemented, mitigation was determined to be effective. In the absence of mitigation, some site disturbance were apparent. All sites appeared to utilize existing access roads and trails, had vehicle traffic confined to established trails, and construction activities were carried out on frozen ground to minimize surface damage. Approximately 42 hectares were disturbed by clearing activities in the environmentally sensitive wetlands and all sites did not retain a 30 m vegetated buffer surrounding the ends of the wetlands. However, no rehabilitation was prescribed as natural revegetation is expected to repair the disturbance caused by construction.

As a result of this information, protection of wetland zones are being reviewed with the Environmental Inspectors for potential improvements in ESS flagging and communication with clearing contractors. Riparian zones were previously noted in the aquatic section and remedial actions described.

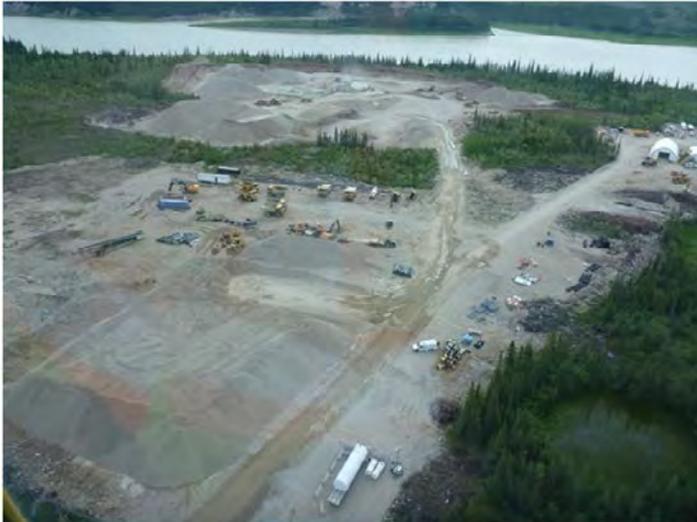
Photo 13: Borrow Pit Requiring Rehabilitation Post Construction

The degree of disturbance was assessed at all sites visited to determine whether natural re-vegetation was feasible (Photo 13). It is recommended the Keewatinohk Construction Camp lagoon, Conawapa Road ditch immediately adjacent to the lagoon and the ditches surrounding the Keewatinohk Converter Station be re-vegetated using native seed.

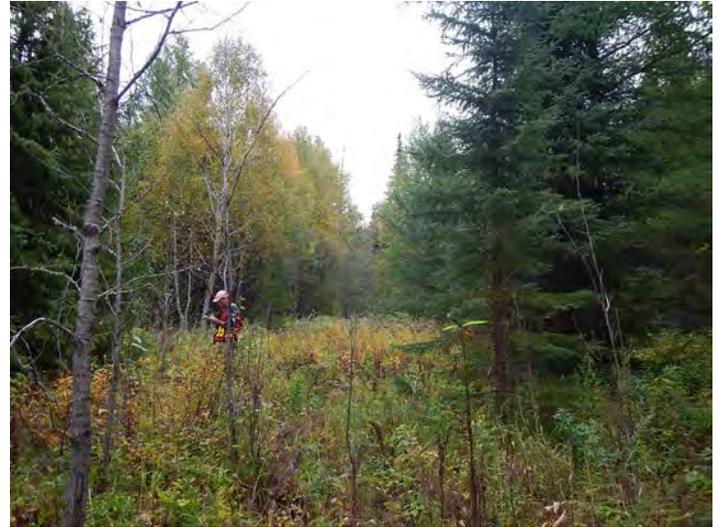
Photo 14: Survey of Planned Tower Sites for Garter Snake Hibernacula

Surveys were conducted for potential red-sided garter snake over-wintering locations or hibernacula. Pedestrian surveys were conducted at 52 Bipole III undeveloped tower sites in September 2014 during the garter snake's fall return migration period. Sites were chosen based on ESS's previously identified in the EIS, additional areas with potential to support garter snake hibernacula, or through Aboriginal Traditional Knowledge (ATK) surveys (Photo 14). Garter snakes or hibernacula were not observed at any of the tower survey locations. Therefore, it is concluded that garter snake hibernacula are not present at or in the immediate vicinity of surveyed tower locations. No further mitigation is recommended at these locations.

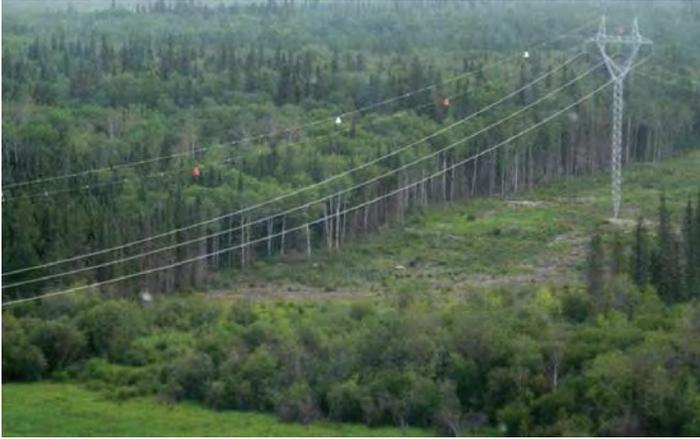
Photo 15: Bird Diverters on a Transmission Line

The 2014 surveys consisted of verification surveys to determine the relative significance of each ESS identified in the EIS based on the density and richness of bird species that have a greater potential for bird-wire collision (e.g., waterfowl, waterbirds, colonial nesting birds). The relative significance of ESS's will allow for a priority assessment for the placement of bird diverters and for bird diverter effectiveness monitoring (Photo 15).

As a result of additional aerial surveys carried out in 2014, a number of the original 144 sites and some new sites have been deemed to be candidate high risk ESS that are recommended for installation of bird diverters when the Bipole III conductors are installed. These sites will be monitored after construction for occurrences of bird-wire collisions in accordance with the BMP. Comparison will be made between high risk sites with bird diverters versus lower risk sites with no diverters.

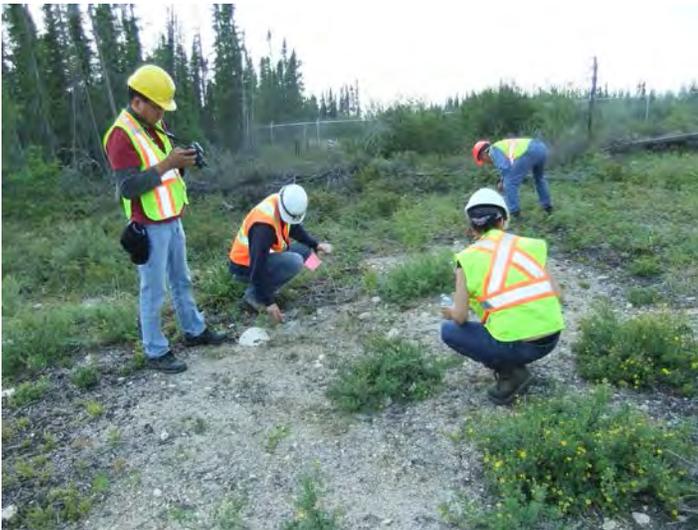
Photo 17: Survey of Heritage Site

In November 2013, one of two known heritage sites was accidentally accessed by snow clearing equipment. The incident was immediately investigated by the Site Environmental Officer and the impact assessed as minimal. The Project Archeologist was notified and visited the site that winter and again in the summer for a full impact assessment. The heritage assessment conducted in July 2014 included a pedestrian survey and GPS documentation of exposed artifacts or any stone features identified (Photo 17). The site assessment included the Project Archeologist, Fox Lake Cree Nation community members and others. Evidence of ground scraping was noted, however, it appeared that only the very top of the organic humus layer was affected and not the substrate below. Both heritage sites are now protected with permanent chain link fencing. In light of the incident steps have been taken to train site contractors to recognize potential heritage resources in the field and how to respond when artifacts are accidentally discovered. This training is now a component of all site orientation.

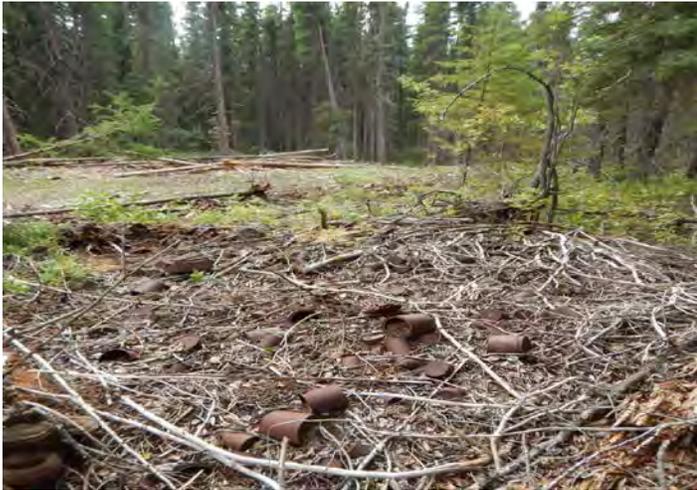
Photo 18: Tin Cans and Refuse Pile Related to Hudson Bay Railway Construction

Three out of four water crossings identified as ESS for heritage were surveyed. At the Saskatchewan River crossing, a historic steam boiler was discovered along the edge of the ROW but was not considered a heritage concern. Two crossings of the Mitishto River were investigated. At one site, tin cans, animal bones and glass bottles were discovered along an access trail (Photo 18).

The material was likely from construction of the Hudson's Bay Railroad in the 1930's and was not of heritage value to warrant designation as an archeological site. In the future, it is recommended Environmental Monitors be on-site to observe all tower footing excavations within 100 metres of heritage environmentally sensitive site locations in case unknown heritage resources are revealed.

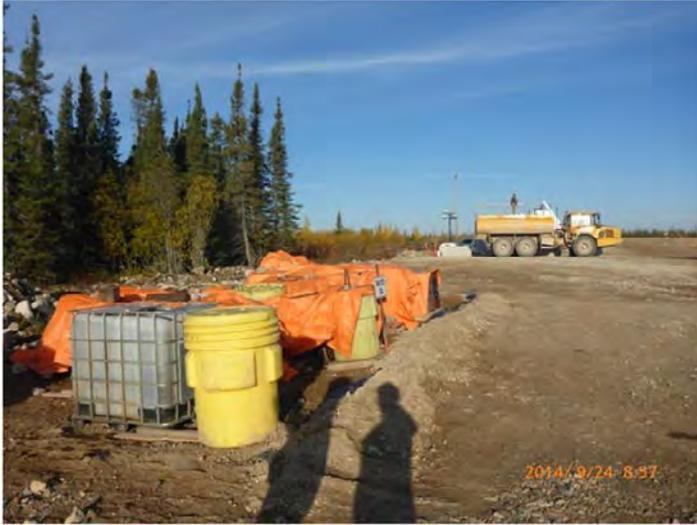
Photo 19: Temporary Hazardous Materials Storage Area at Keewatinohk Converter Station Work Area

Manitoba Hydro requires all contractors to have a spill response plan. All contractor spills, regardless of quantity are reported to Manitoba Hydro. All hazardous materials on Keewatinohk Converter Station site are segregated and stored in lined temporary storage cells (Photo 19).
