Construction Section C1 Environmentally Sensitive Site Locations

Ecosystem Species of Concern Heritage
Heritage, Archaeological **Construction Section C1**

Birds and Habitat Birds and Habitat Wildlife Mammals and Habitat **Construction Environmental Protection Plan Construction Section C1 Environmentally Sensitive Site Locations**

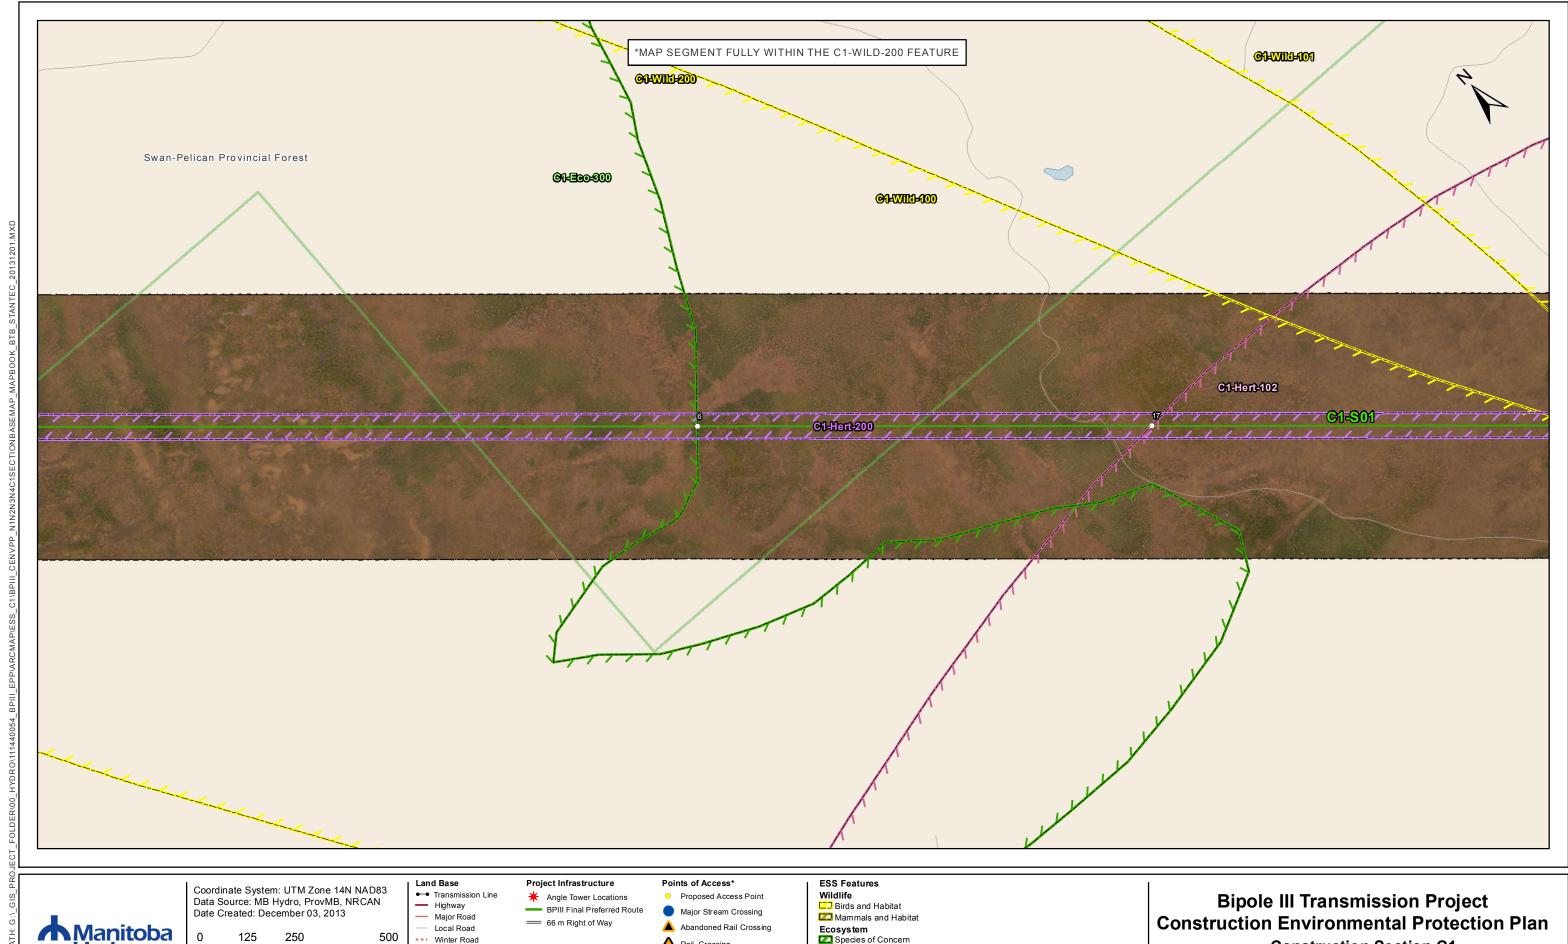
MAP NUMBER: 212 cont'd

Sec-Seg ID	ESS ID	ESS Name	Location	Start	Ston	UTM Zone	Distance
C1-S01		Bird migration route identified by community		E-389871 N-5770447	E-395171 N-5765667	14N	7137 m

Change in bird migration route due to transmission line

Sec-Seg ID	ESS ID	ESS Name	Location	Start	Stop	UTM Zone	Distance
C1-S01	C1-Eco-300	Species of Concern	Site: 5 to 6	E-386187 N-5773771	E-393457 N-5767213	14N	9791 m

Potential loss of previously known plants of conservation concern from clearing, construction, maintenance and decommissioning activities

Sec-Seg ID	ESS ID	ESS Name	Location	Start	Stop	UTM Zone	Distance
C1-S01	C1-Hert-200	Plant Gathering Area	Site: 1 to 2	E-379494 N-5779807	E-396683 N-5764303	14N	23149 m

Sec-Seg ID	ESS ID	ESS Name	Location	Start	Stop	UTM Zone	Distance
C1-S01	C1-Wild-200	Moose Sensitive Area	Site: 13 to 14	E-389782 N-5770528	E-395210 N-5765631	14N	7311 m

Potential disturbance to and loss of sensitive moose habitat

Sec-Seg ID	ESS ID	ESS Name	Location	Start	Stop	UTM Zone	Distance
C1-S01	C1-Hert- 102	Area of Heritage Resource Findings	Site: 17 to 18	N-	E-396683 N- 5764303	14N	3142 m

Loss of heritage resources due to inadvertent disturbance of sites

- Adhere to reduced risk timing windows for protection of birds (August 1- April 30)
- Maintain applicable setback during nesting and breeding timing window
- · Conduct priority assessment for bird diverters and other measures prior to transmission line stringing
- Install bird diverters or other measures at high priority sites

- · Carry out construction activities on frozen or dry ground to minimize surface damage, rutting and erosion
- Use existing access roads and trails to the extent possible
- Remove trees by low-disturbance methods
- Confine vehicle traffic to established trails to the extent possible
- Stabilize sites immediately after construction and re-vegetate disturbed areas in accordance with site Rehabilitation Plan

- Carry out construction activities on frozen or dry ground to minimize surface damage, rutting and erosion
- Minimize surface disturbance around the site to the extent possible
- Remove trees by low-disturbance methods
- No Herbicide to be applied during construction
- Confine vehicle traffic to established trails to the extent possible

- Manitoba Hydro will not support development of designated motorized recreational trail use within areas described above if requested
- No shear blading to clear the ROW in the sensitive range Selective cutting methods to be used leaving low shrub and herb plant communities on the ROW

- Slash piles will be stockpiled every 200m-400m during clearing, adjacent to centerline trail, these piles will be placed on centerline trail post construction

- Annual ground inspection of towers to occur late in winter season to avoid creating packed snow trails that facilitate predator use of the ROW
- Selective cutting to remove danger trees only on portions of the ROW to reduce line of site for hunters and predators and facilitate wildlife movement across the ROW

- Any access trails used to access the ROW for construction that will not be needed for future maintenance will be
 decommissioned on completion of construction Any culverts or road improvements will be removed and the first 100
 m from of the trail dug up to the extent possible Available slash < 1 m in height will also be evenly distributed over
 the access trail to reduce the possibility of use be ATV traffic

- Carry out construction activities on frozen or dry ground to minimize surface damage, rutting and erosion
- Identify and flag prior to start of work
- Conduct site investigation with Archaeologist post clearing and prior to construction
- Minimize surface disturbance around the site to the extent possible
