SAFE WORK

No. 245
March 2006

Vermiculite Insulation - Asbestos Contamination

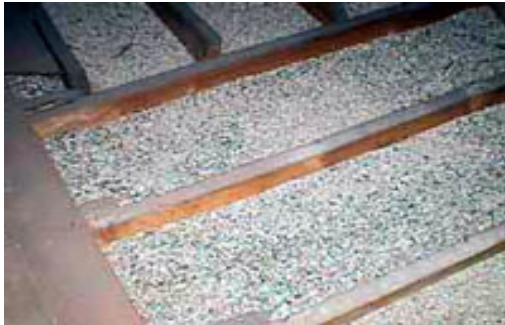
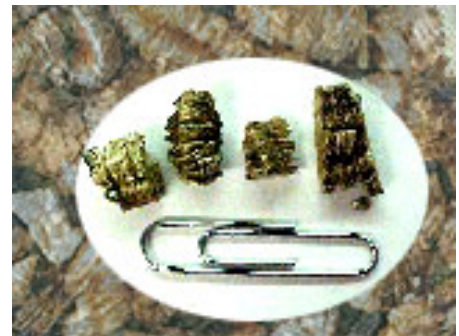
(Source of photos: EPA)

Vermiculite is a mica-like mineral mined around the world. Vermiculite is light, has good insulation properties, and is also fire resistant. Vermiculite insulation in the loose form is light brown/grey/gold in color and is a pebble-like material ranging in size from 2 – 10 millimeters in diameter.
