APPENDIX 5

Photo Library

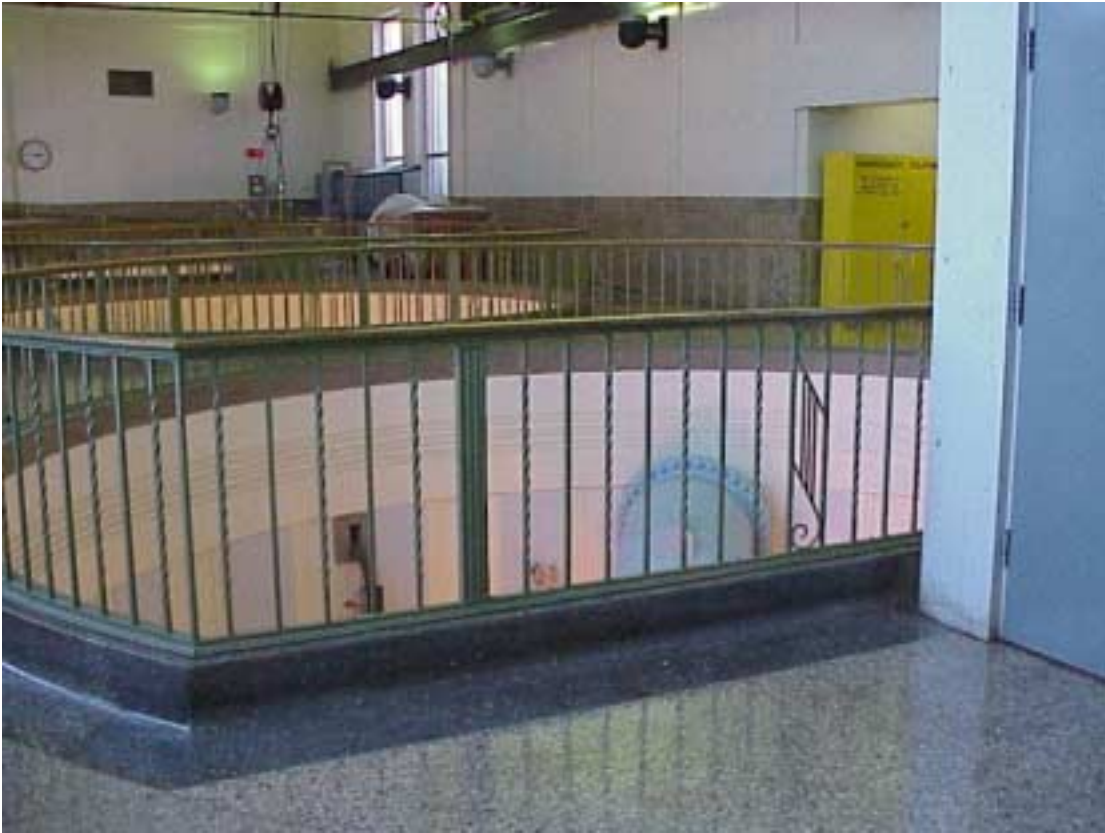
Three dry wells.

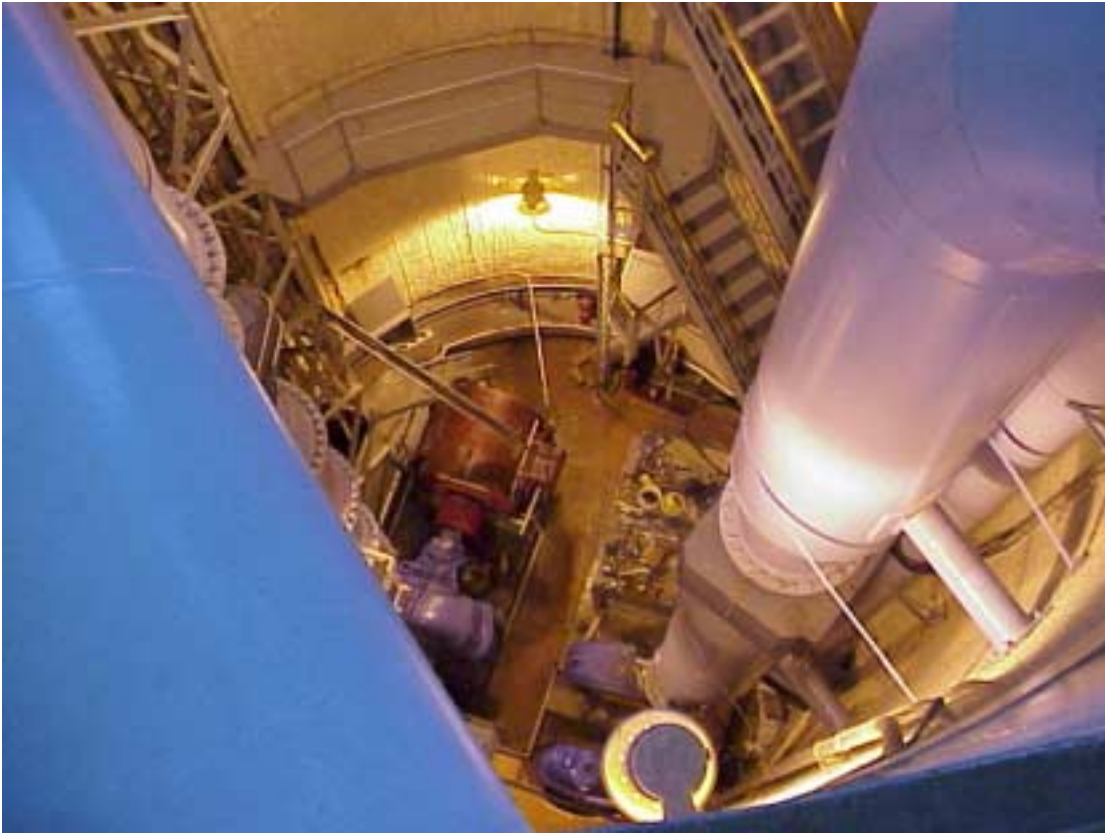
Viewing down into dry well, shows valve, reducer, pump attached to white discharge header on right side of photo.

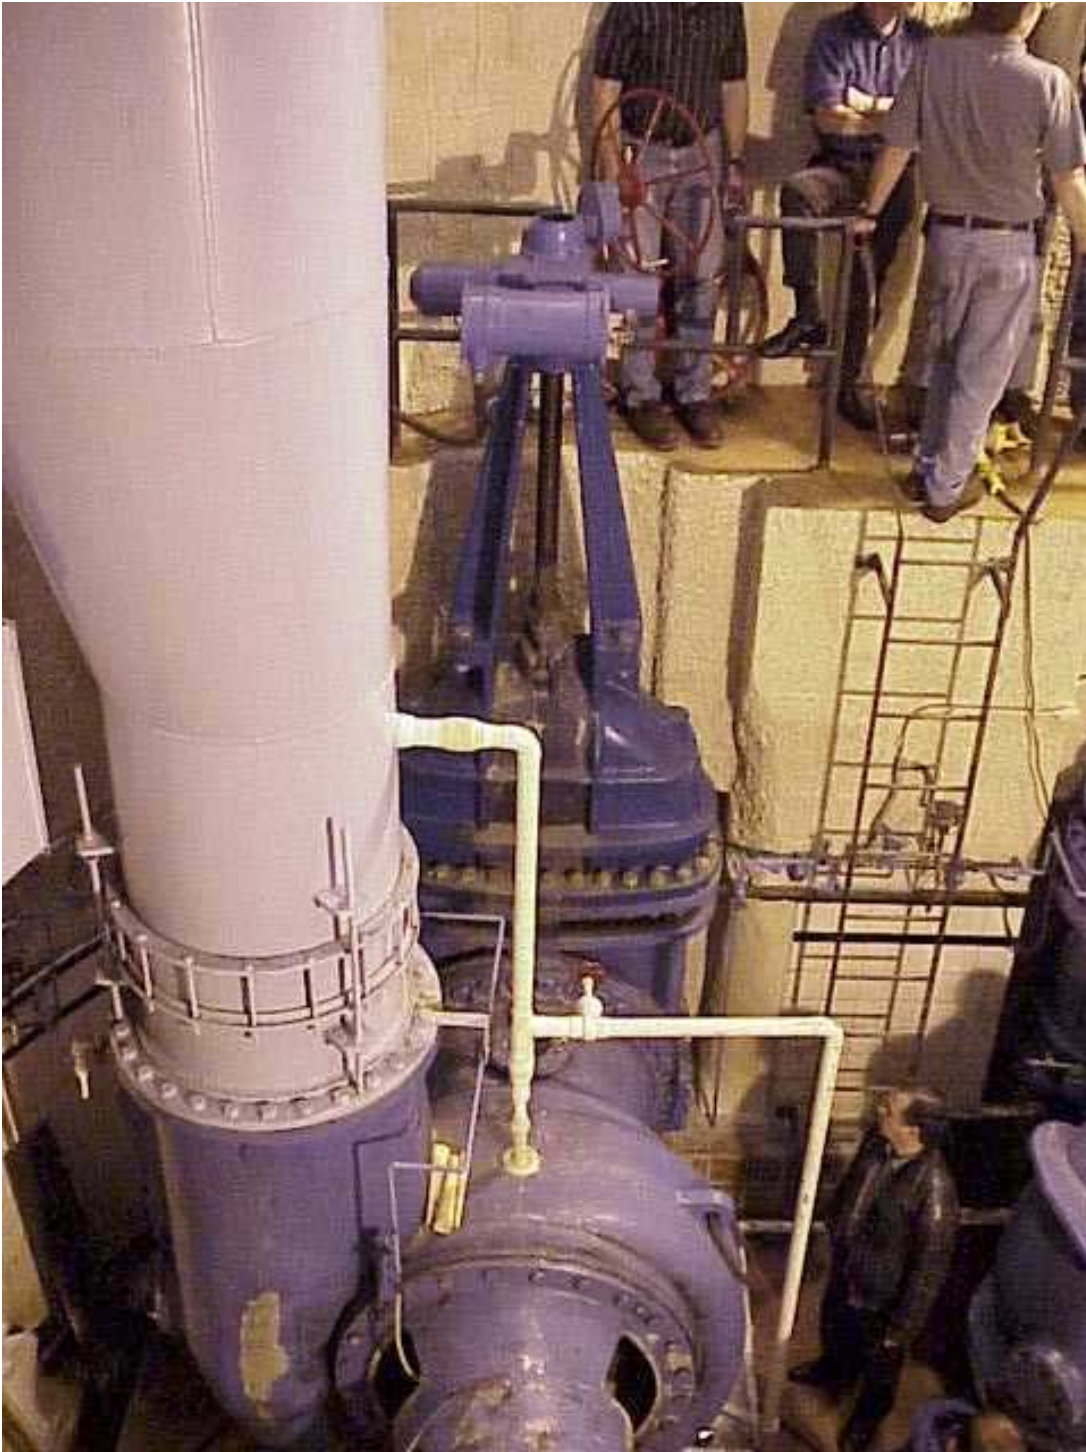
Photo shows suction gate valve in back and pump MP5 in foreground. Small diameter white pipe is the system drainage piping. The large white pipe on the left side of the photo is the discharge header. Inspection plate is located on the left side of the pump below the discharge header.

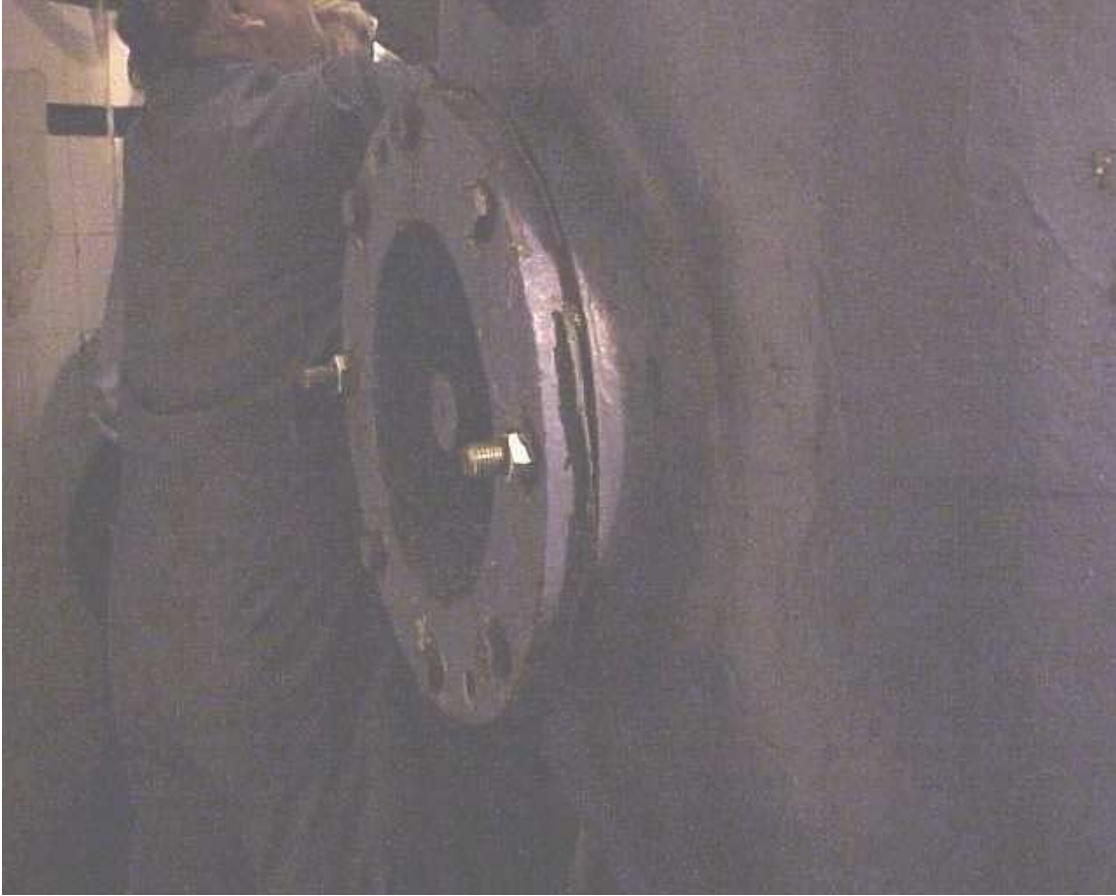
Inspection plate on the side of pump MP5.

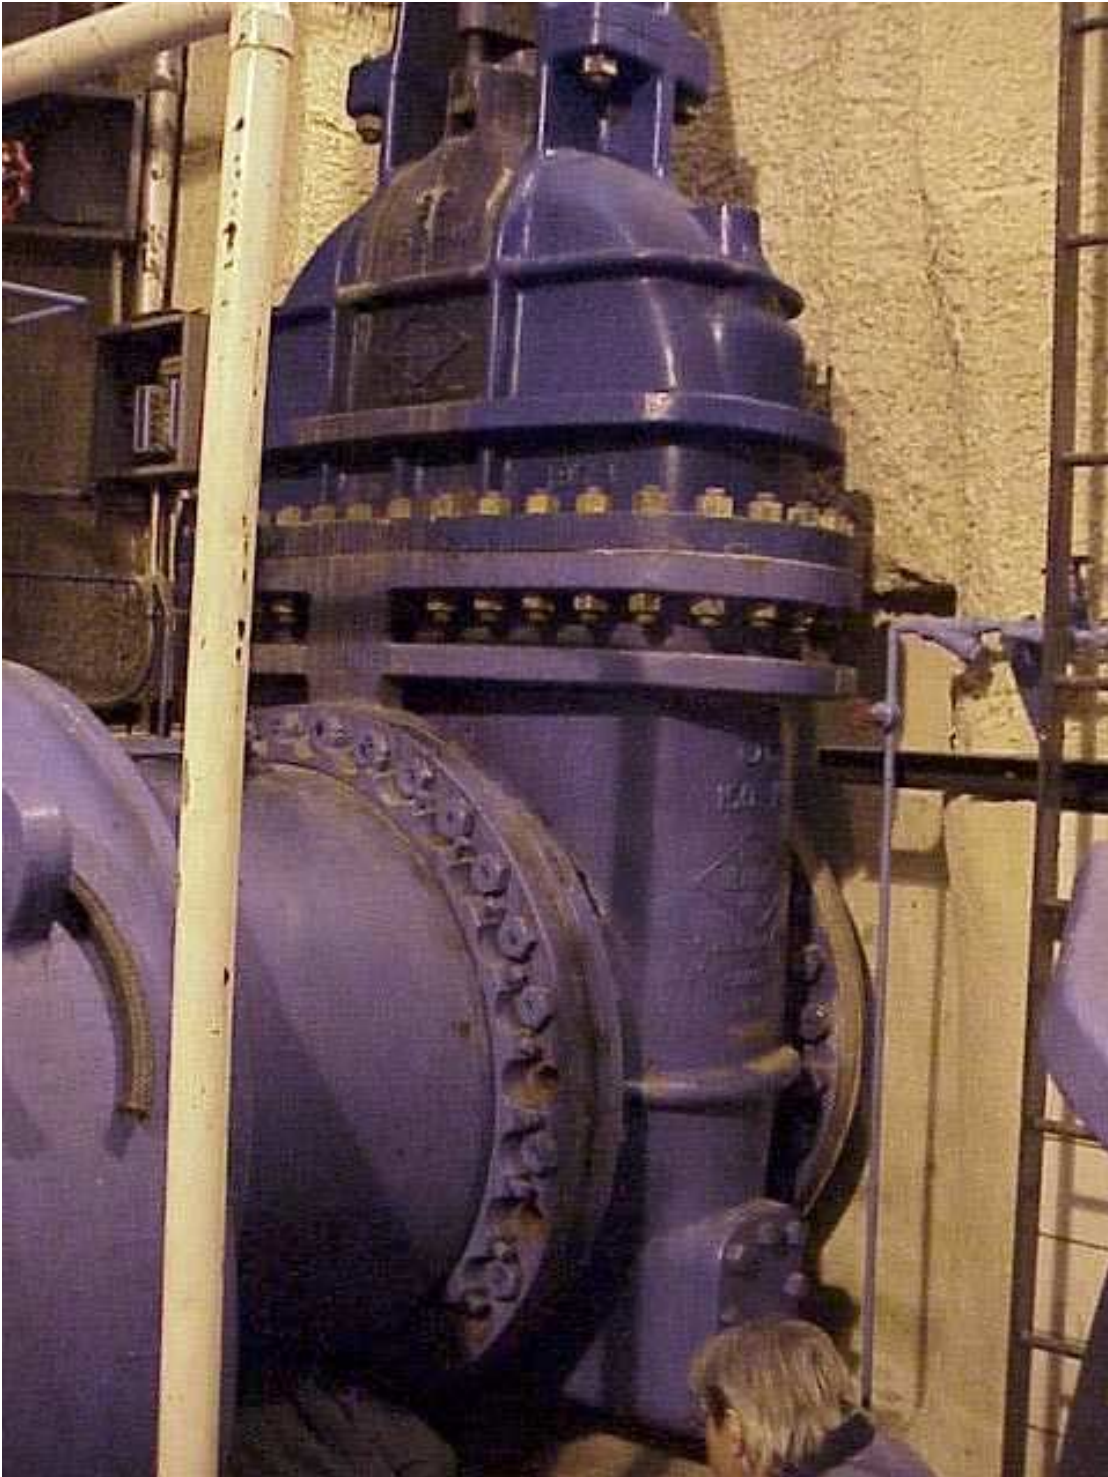
Suction gate valve and reducer - white pipe is designed to drain wastewater located between the discharge side of the suction gate valve and the discharge header.

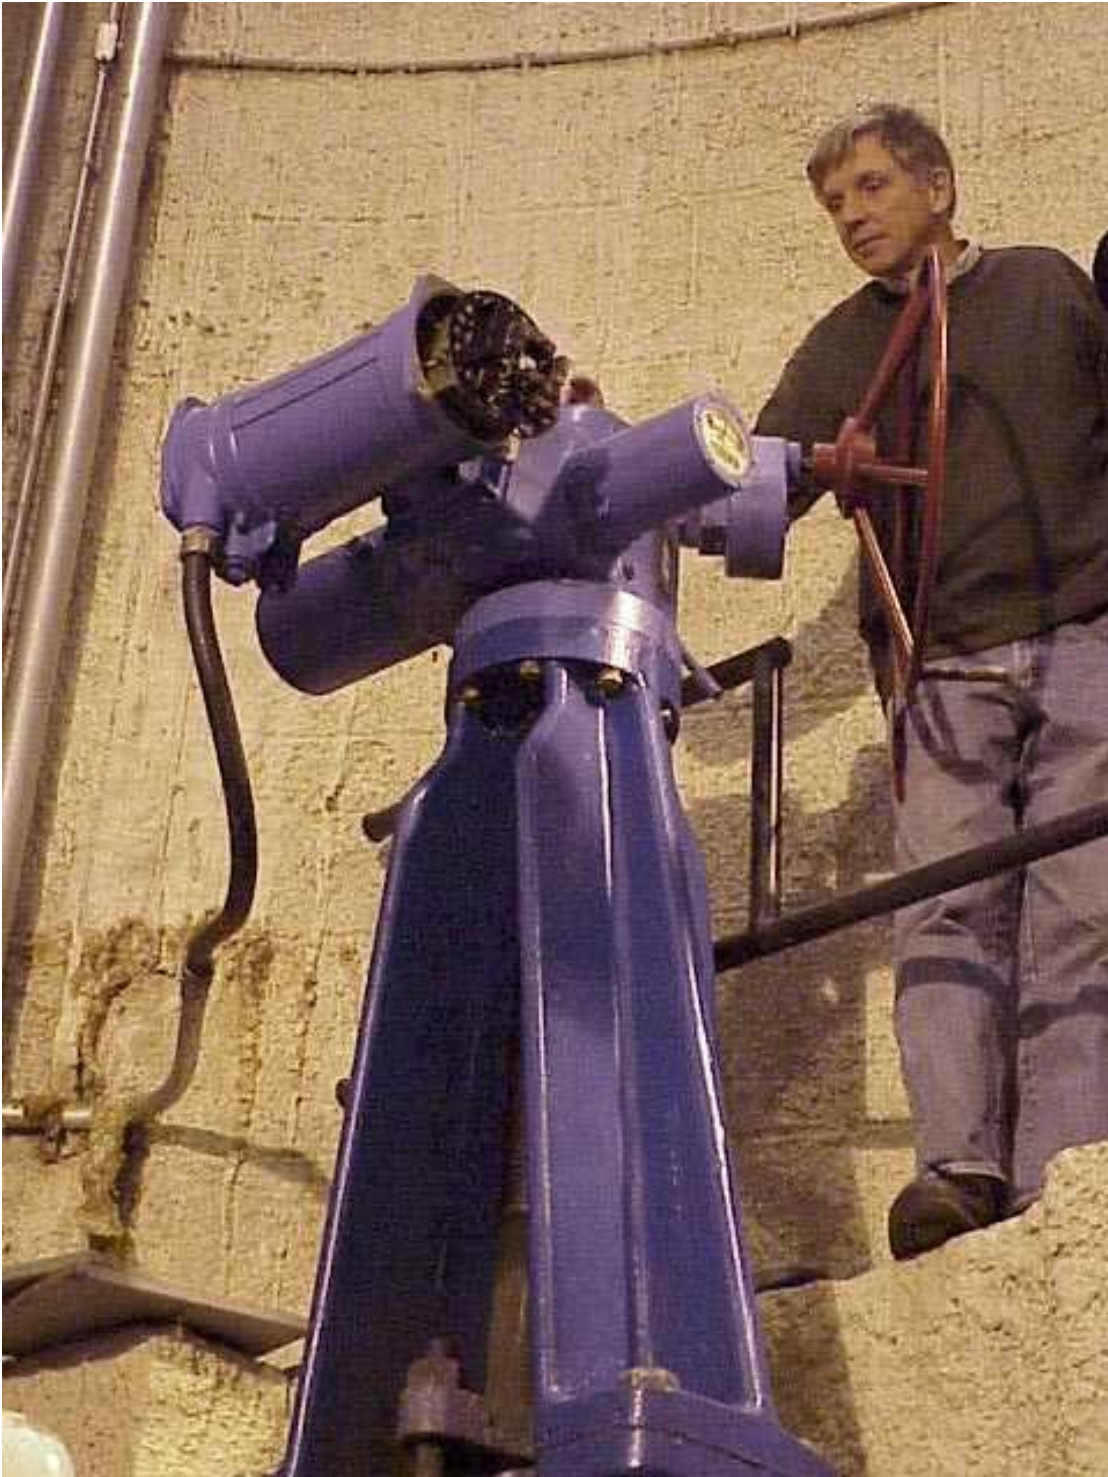
Rotork valve actuator and manual wheel located on top of valve stem guide assembly.

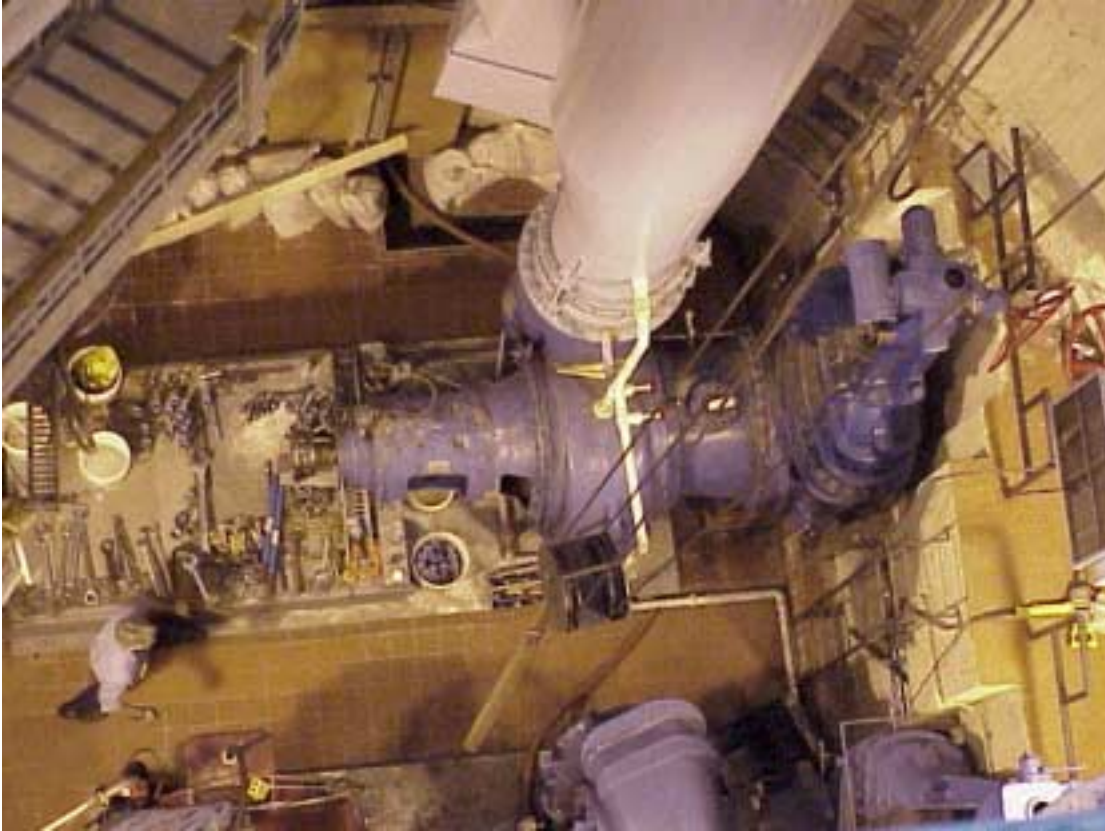
Right side of photo shows suction gate valve, reducer, MP5 pump and white discharge header at bottom of dry well. MP5 pump motor has been removed for servicing. Small diameter white pipe is designed to drain the system when the suction gate valve has been closed. This pipe was prone to continual plugging and was ineffective, as a result the maintenance crew resorted to using the pump inspection plate.

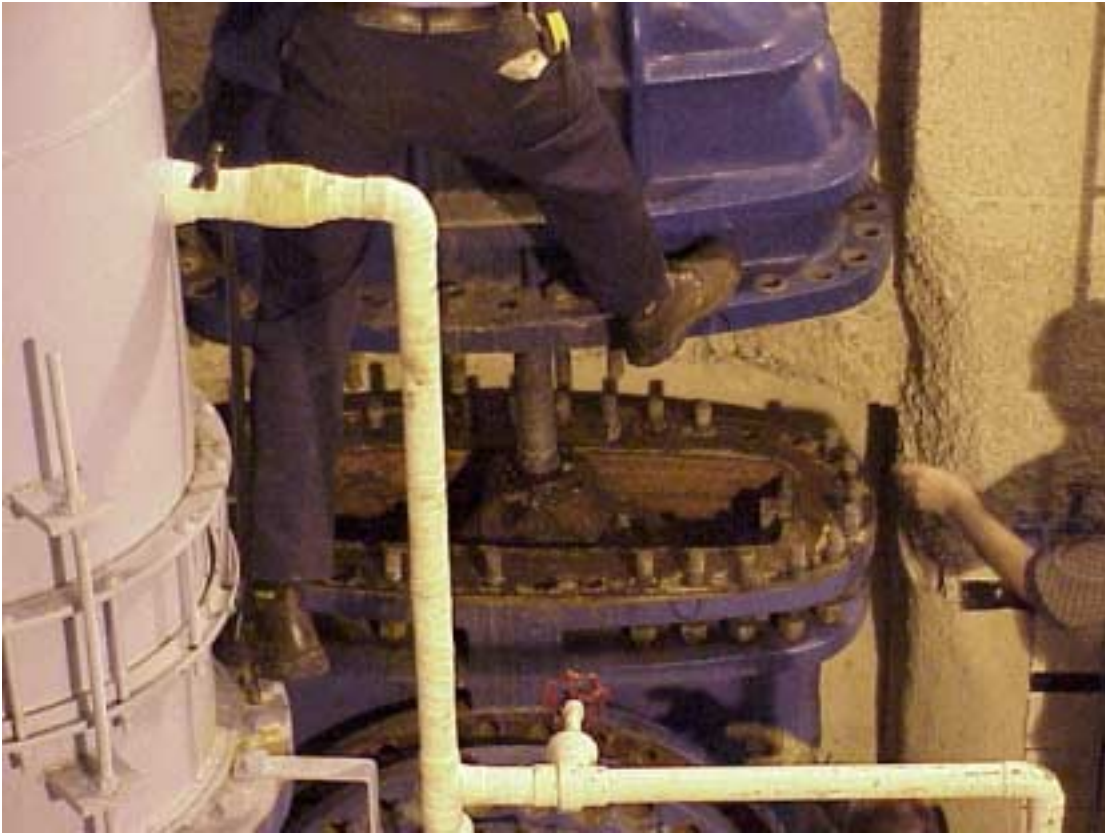
Removal of the valve bonnet - photo shows location of valve plate and attached valve stem.

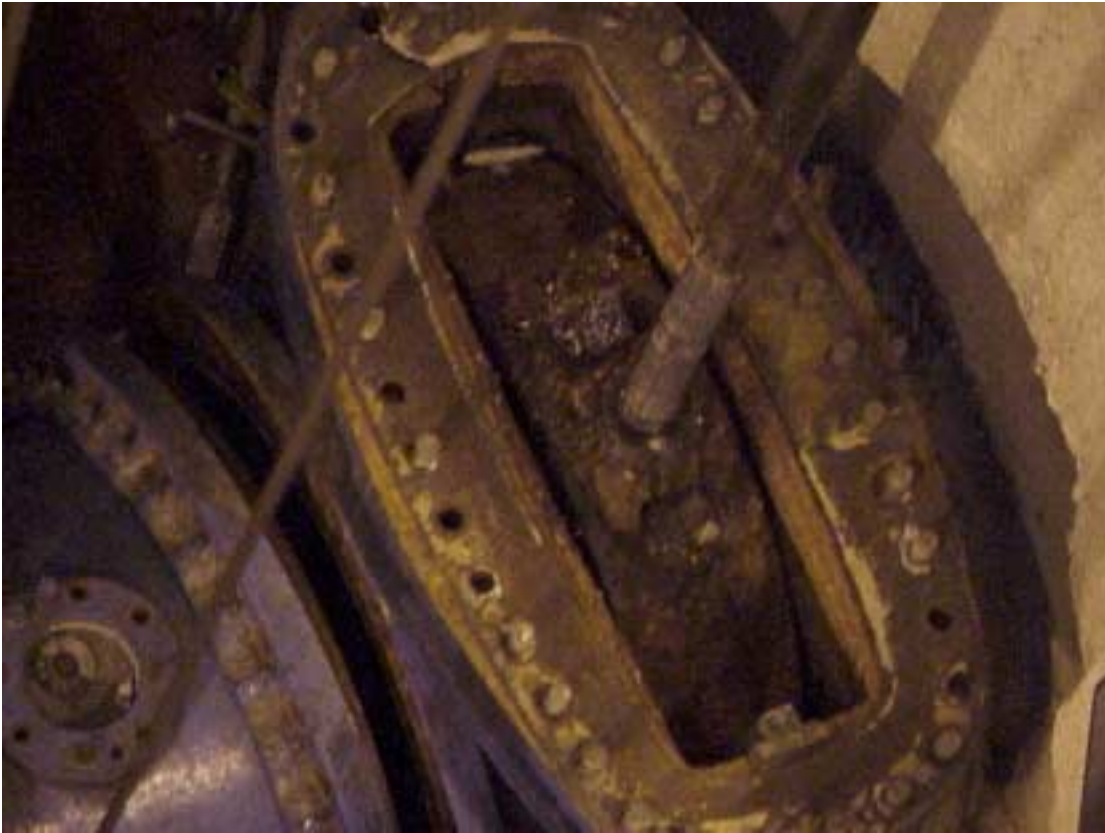
Top view of valve plate and valve stem. Valve had been blocked by the diver to prevent the altering of the location of the valve plate during the dismantling of the valve. The valve could not be removed without partial disassembly.

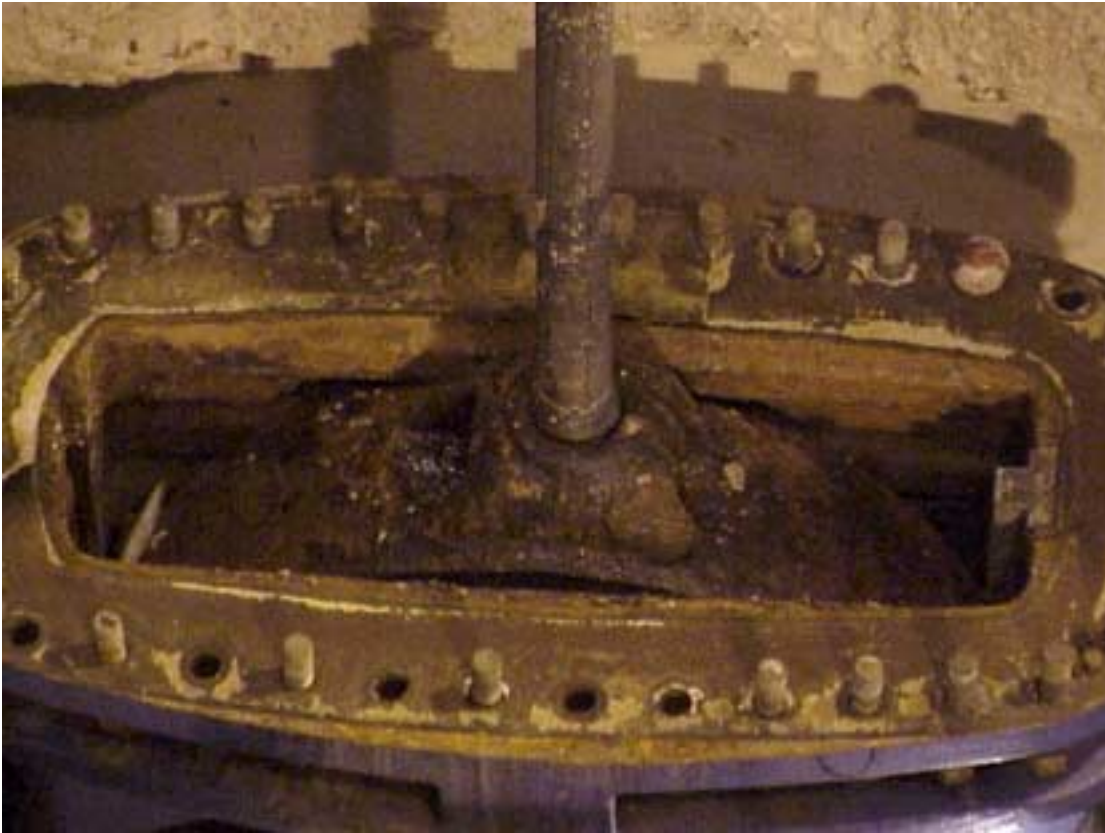
Viewing into the lower portion of suction gate valve.

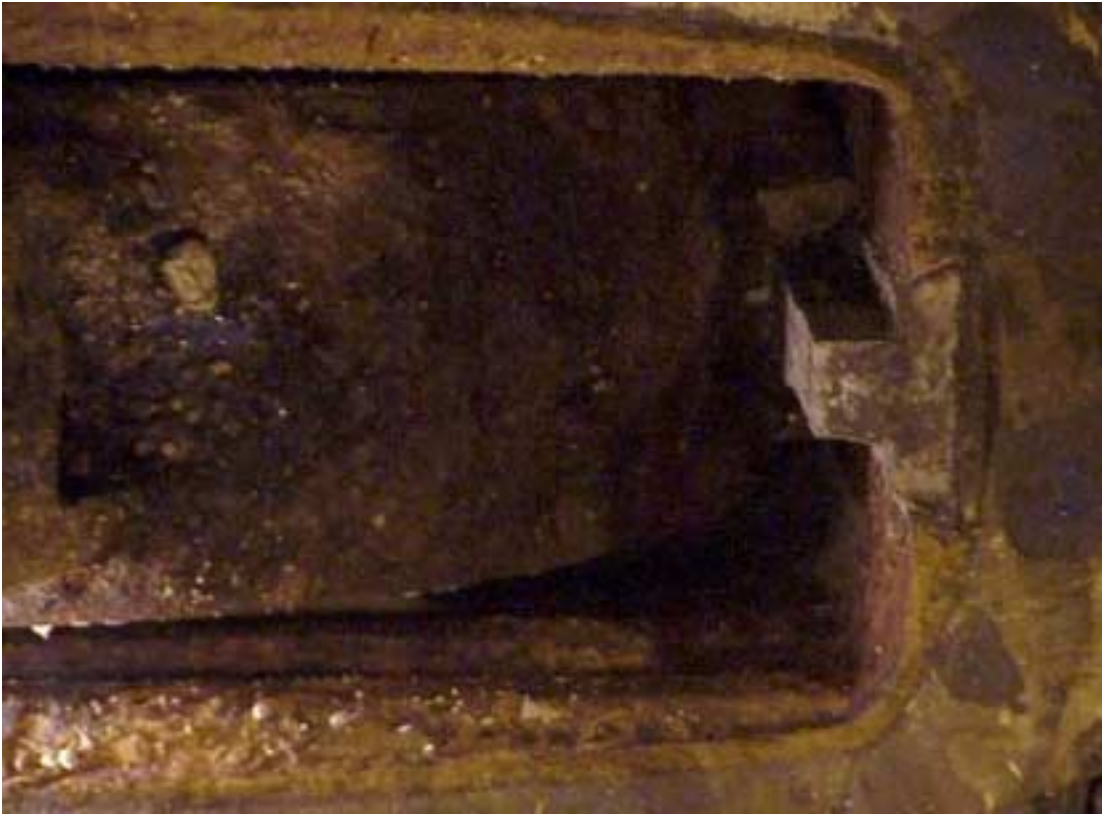
Photo shows valve guide in place on the lower portion of the valve body.

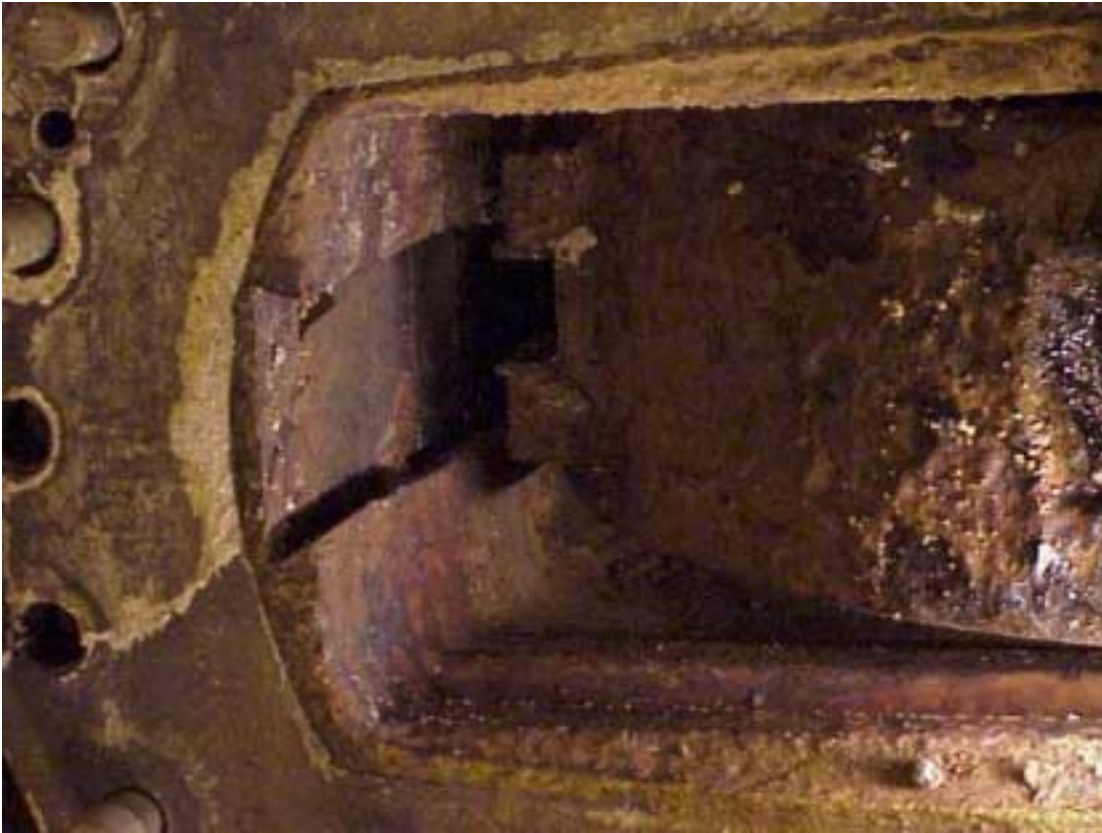
Photo shows valve guide missing from valve body.

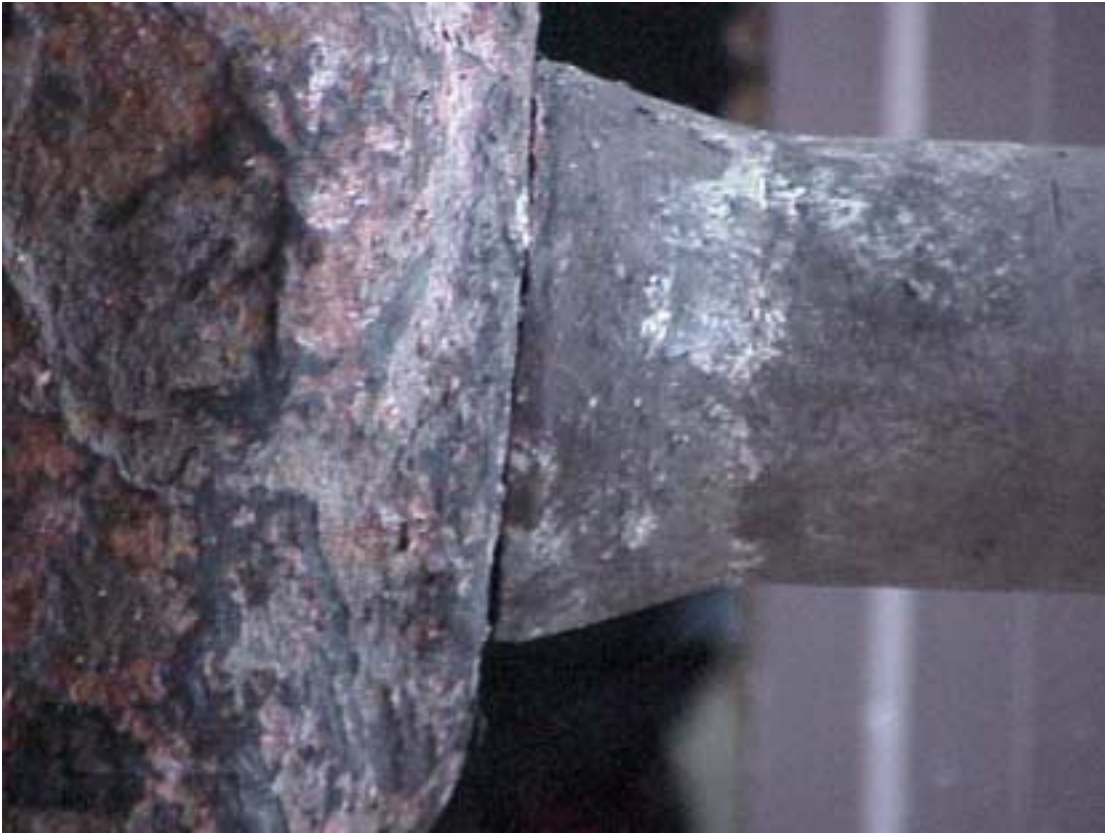
Valve stem attached to valve plate.

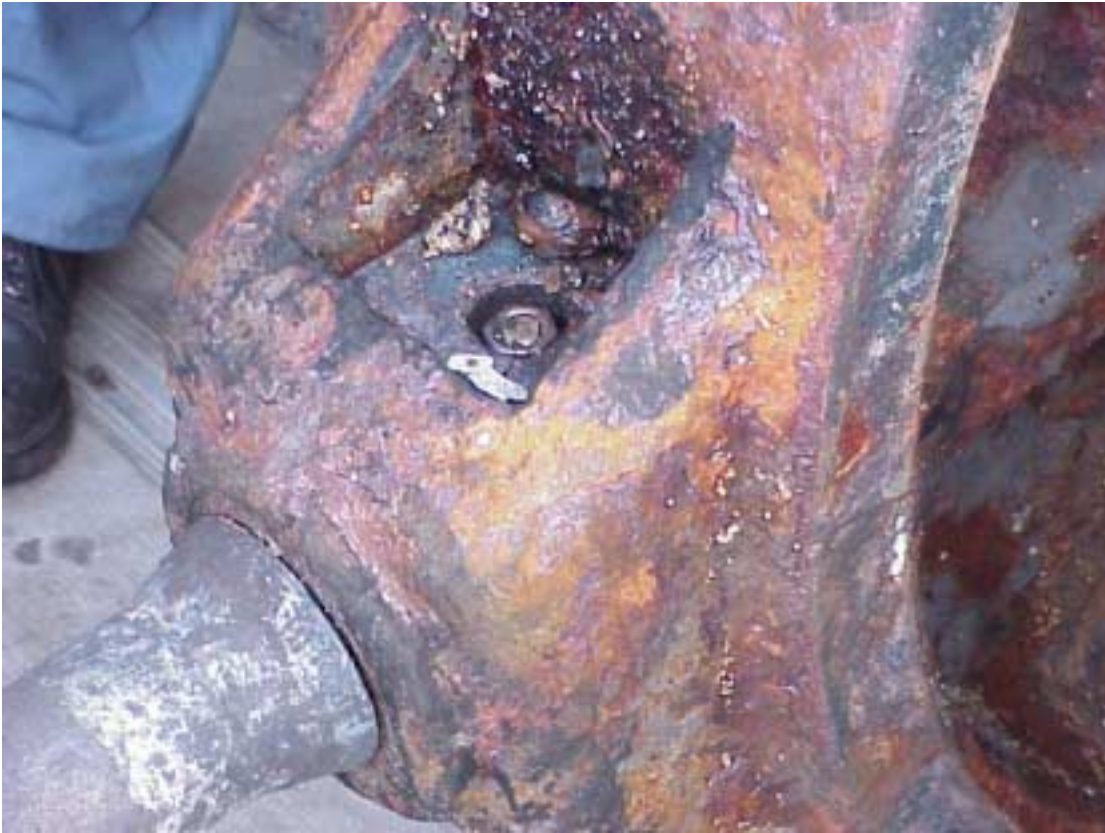
Valve stem attached to valve plate and connecting pins in place.

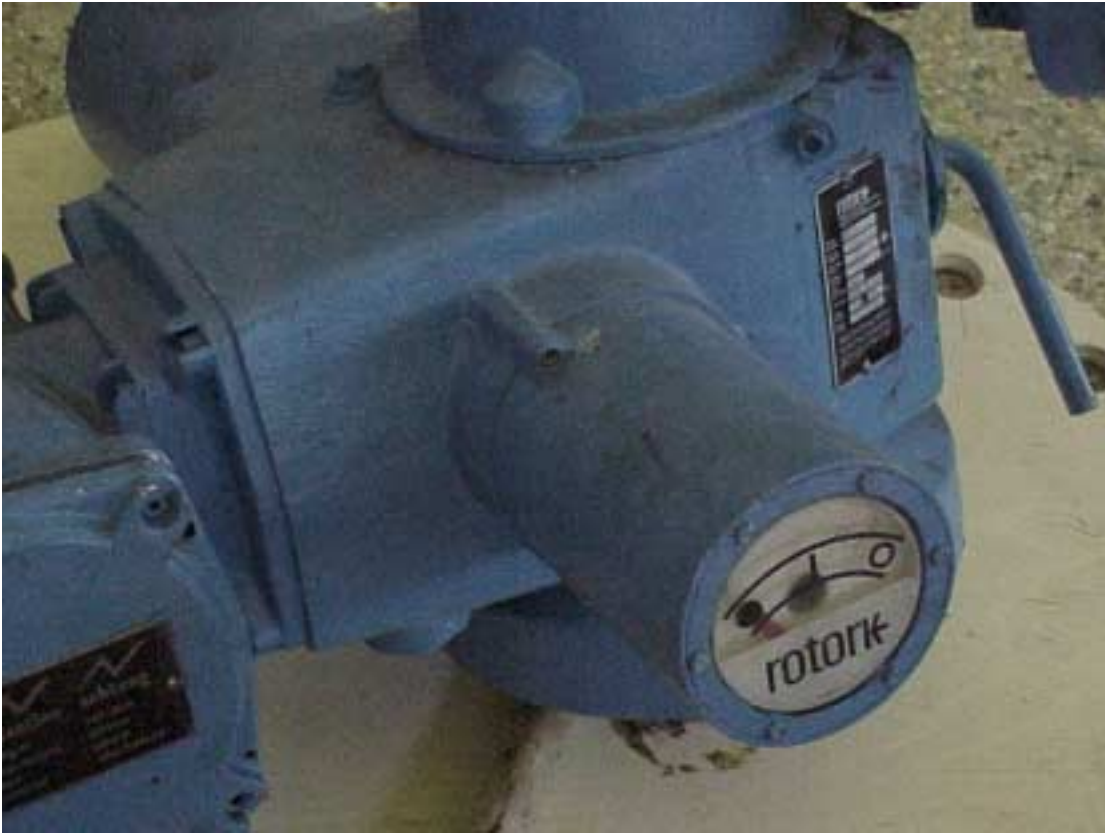
Rotork Actuator and valve position gauge.

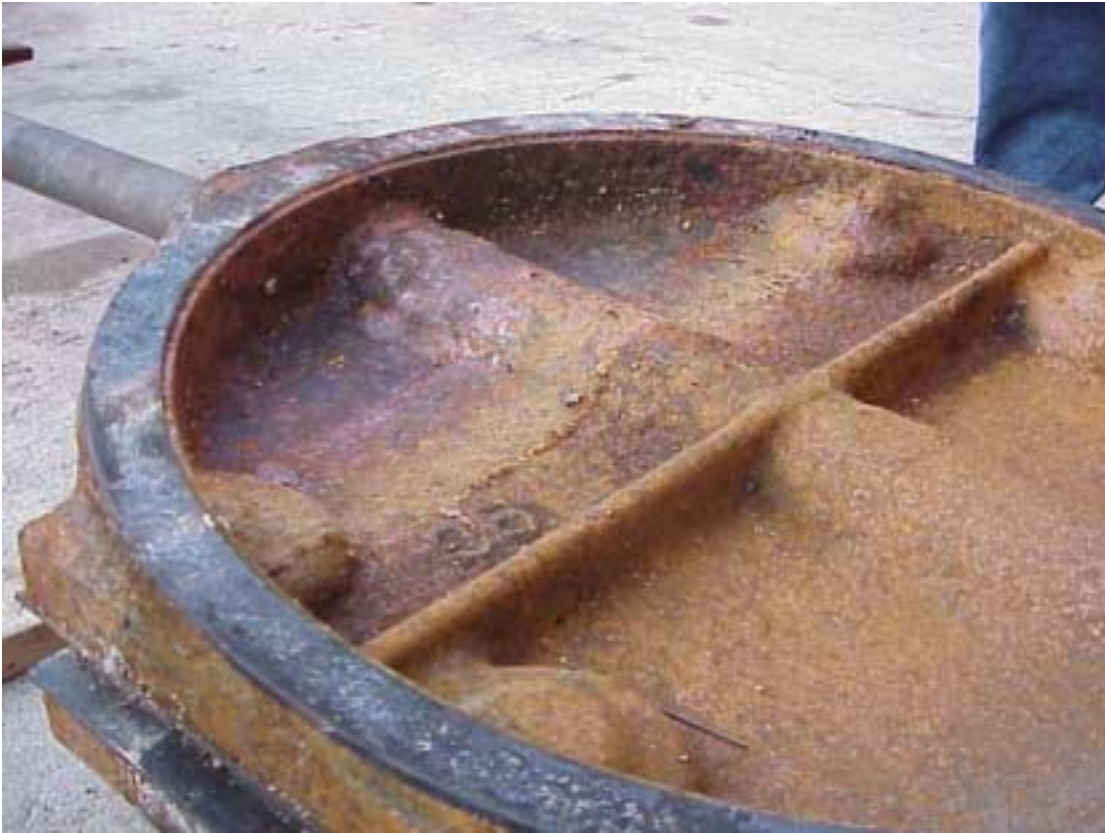
Valve plate and guide channel of side of valve.

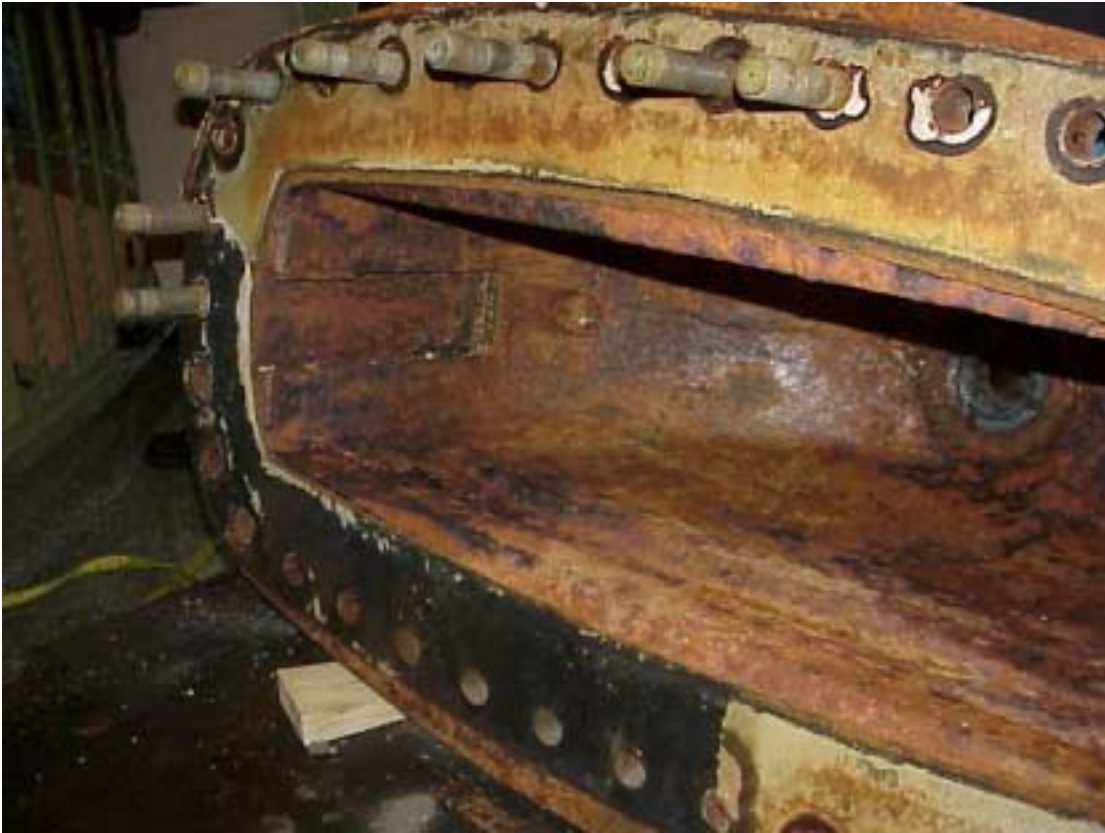
Interior view of valve bonnet showing location of where valve guide bar is missing from.

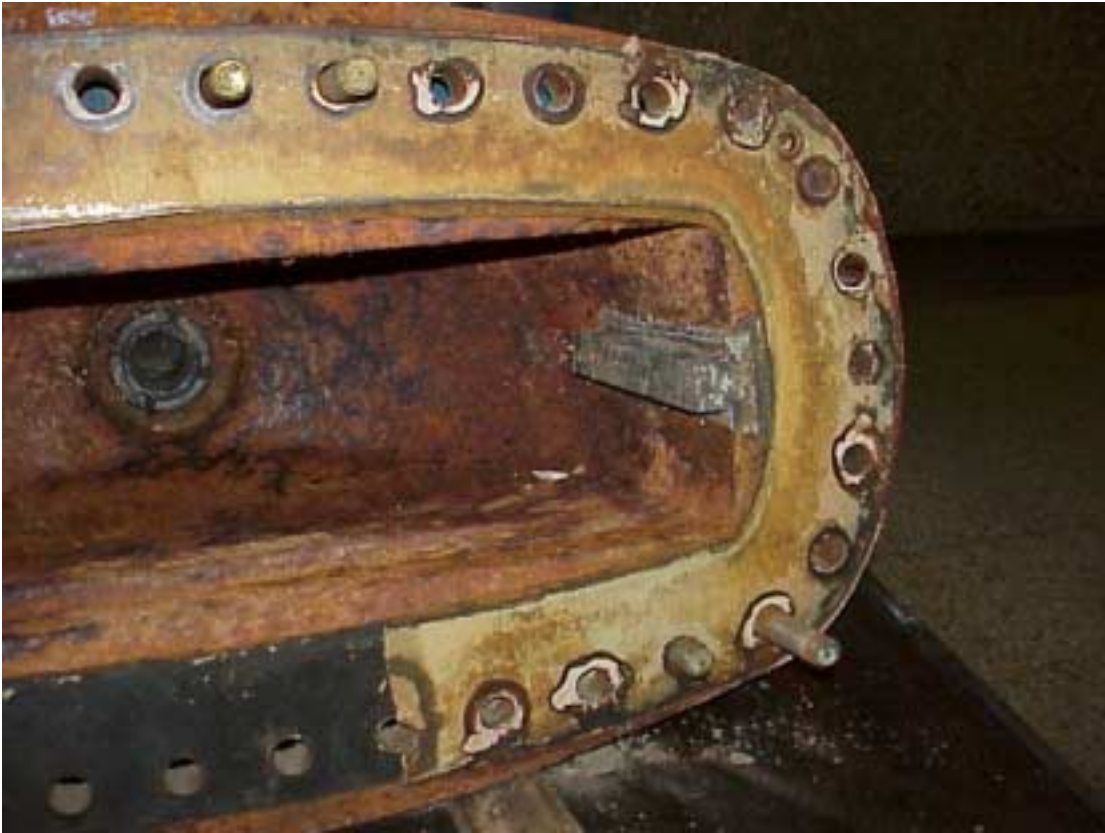
Opposite side of valve bonnet with valve guide bar in place.

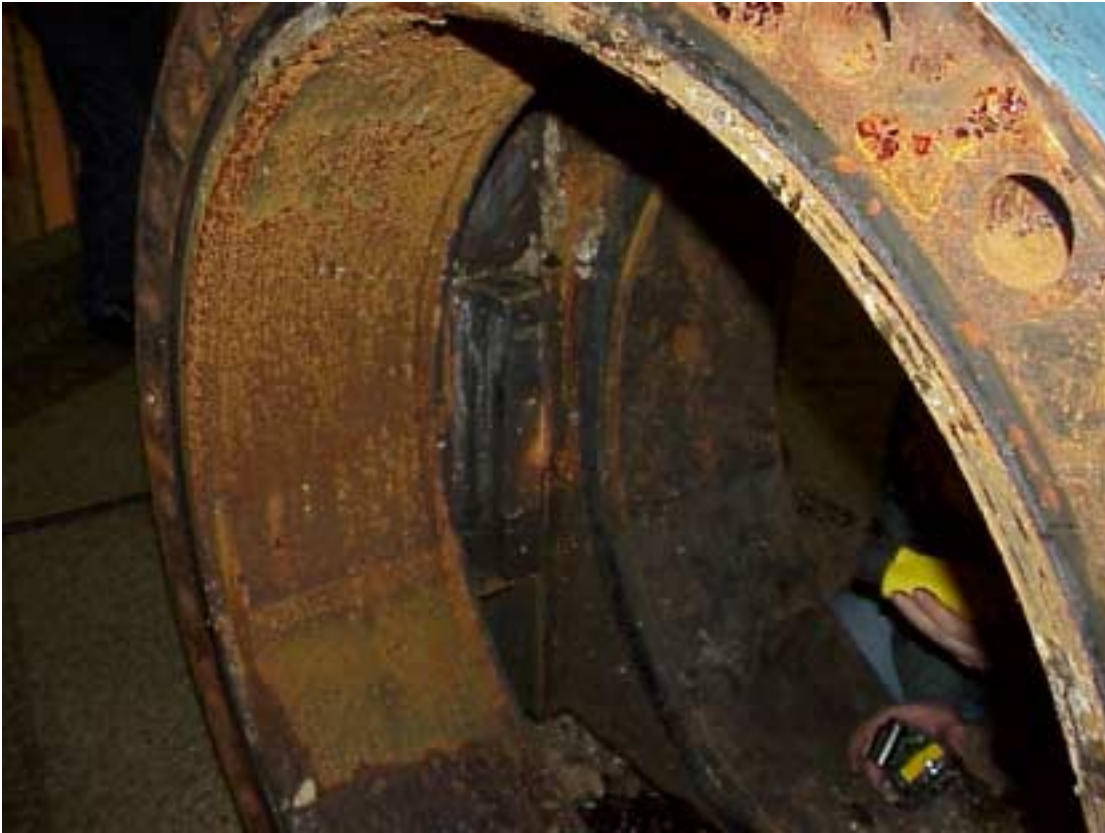
Valve body showing upper valve guide from bonnet now located in lower portion of valve body.

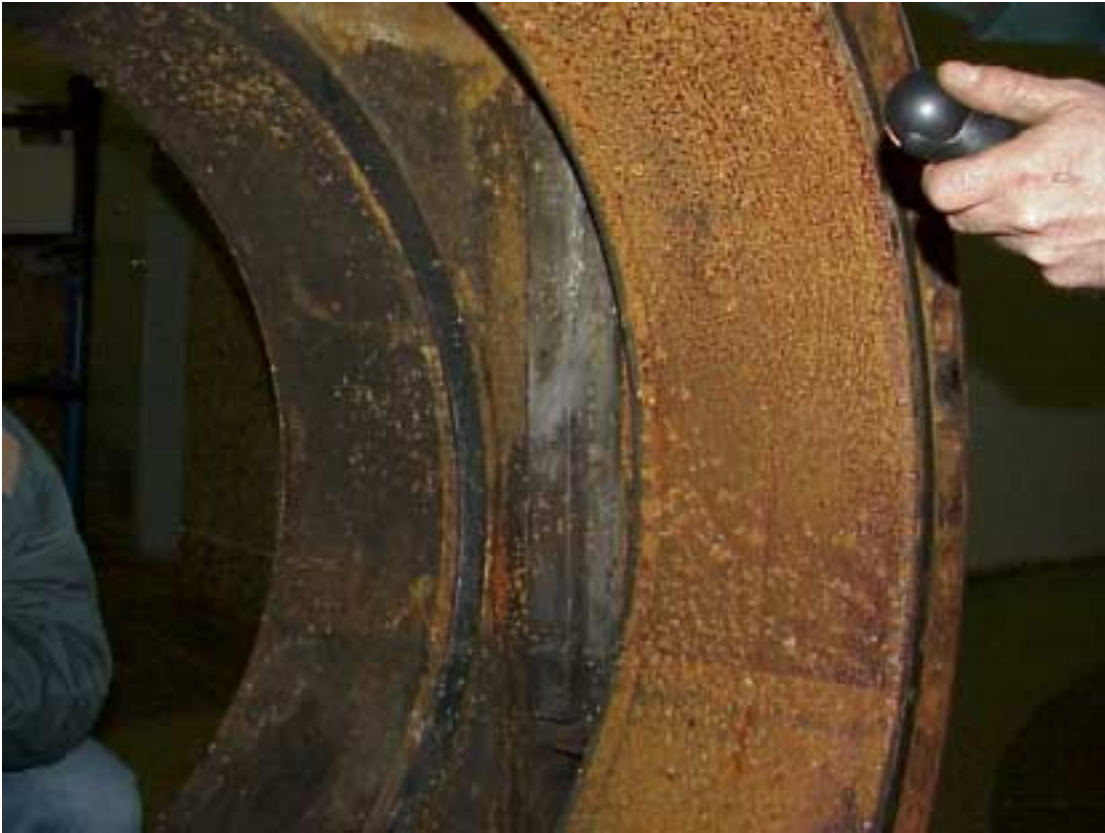
Valve guide bar in place on opposite side of valve body of suction gate valve.

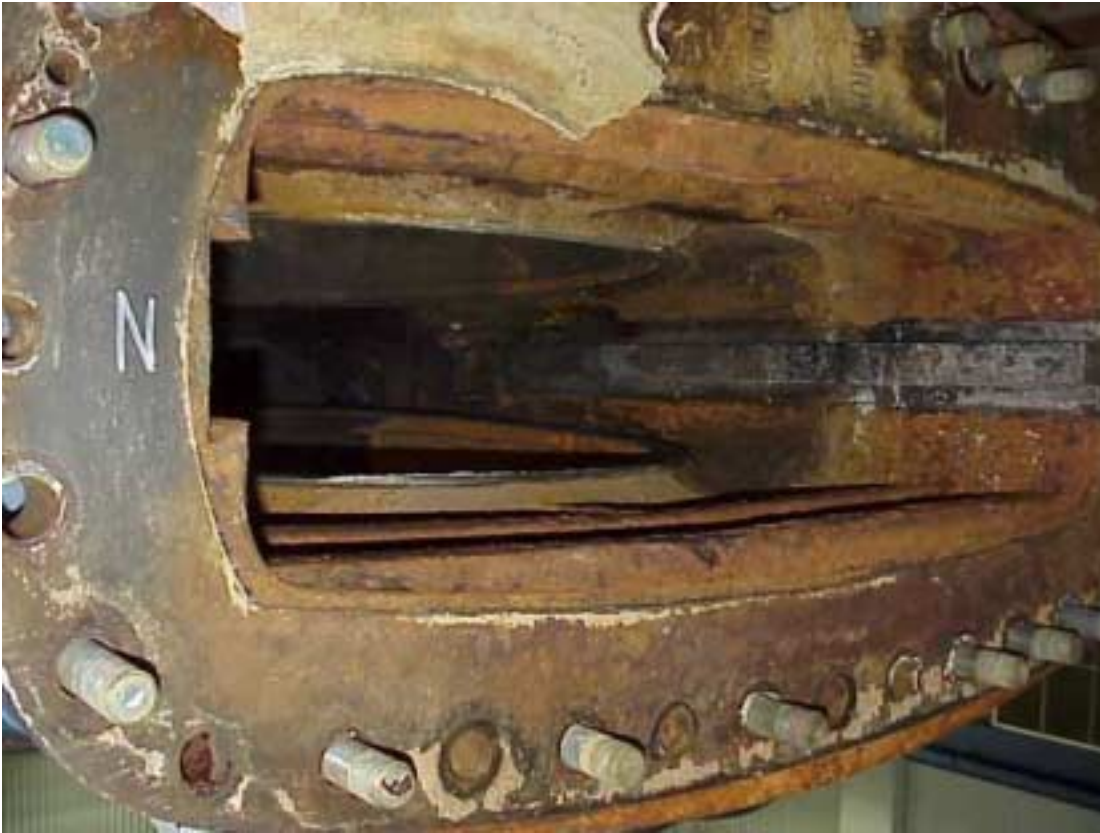
Lower portion of suction gate valve showing valve guide bar in place on right side of photo and missing on the left side of the photo. Guide bar would be located in the dovetail shaped channel.

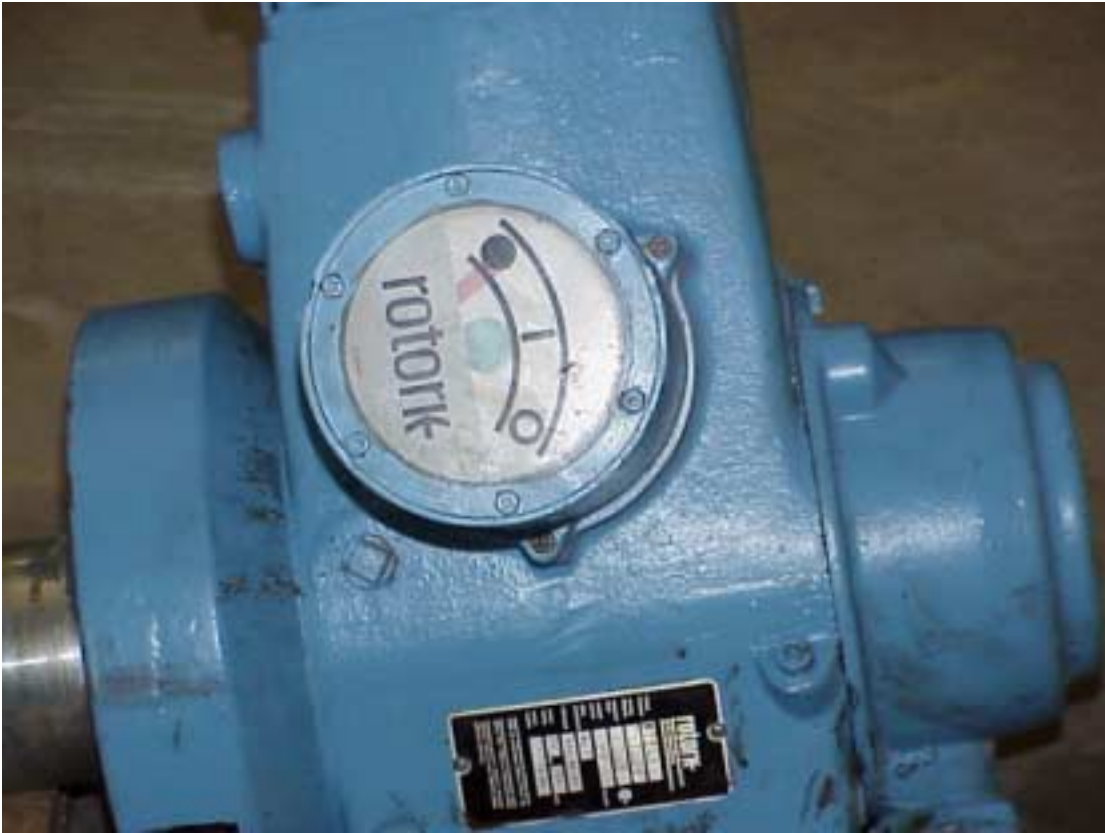
Close up view of valve position gauge on Rotork.
