APPENDIX 5

Photo Library

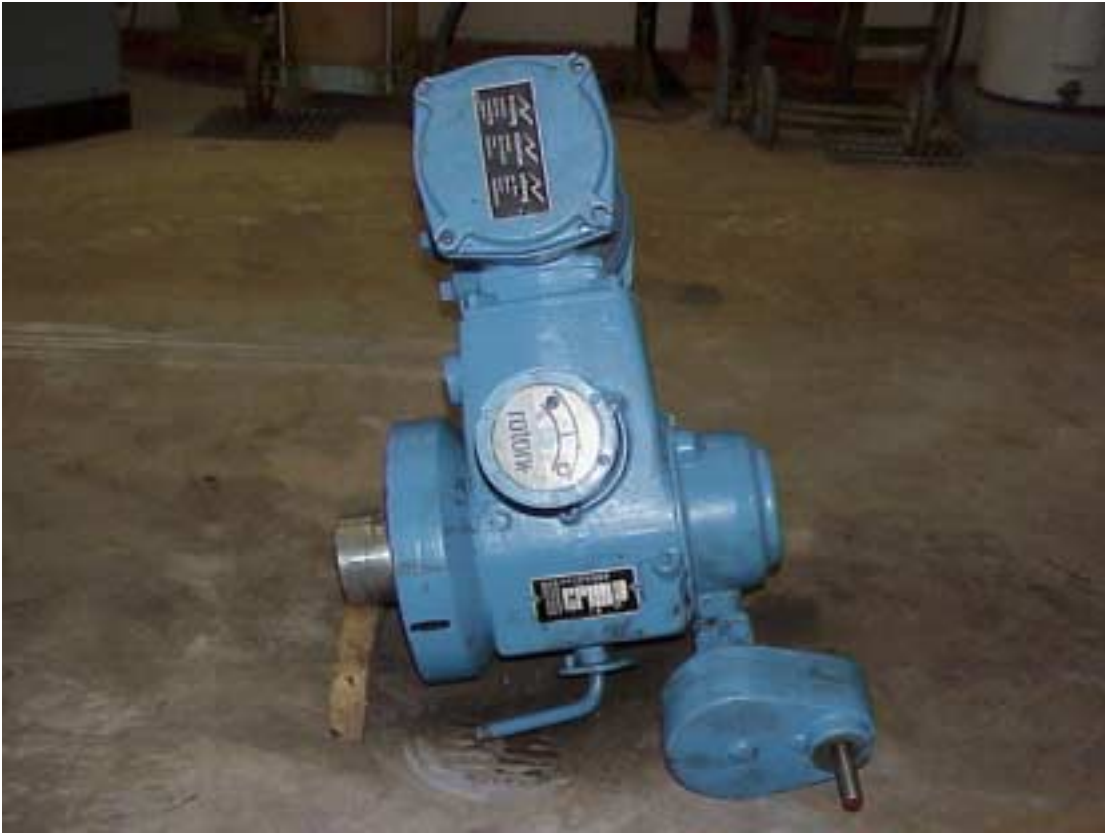
Photo shows Rotork actuator - manual crank wheel would be attached to right side of the unit.

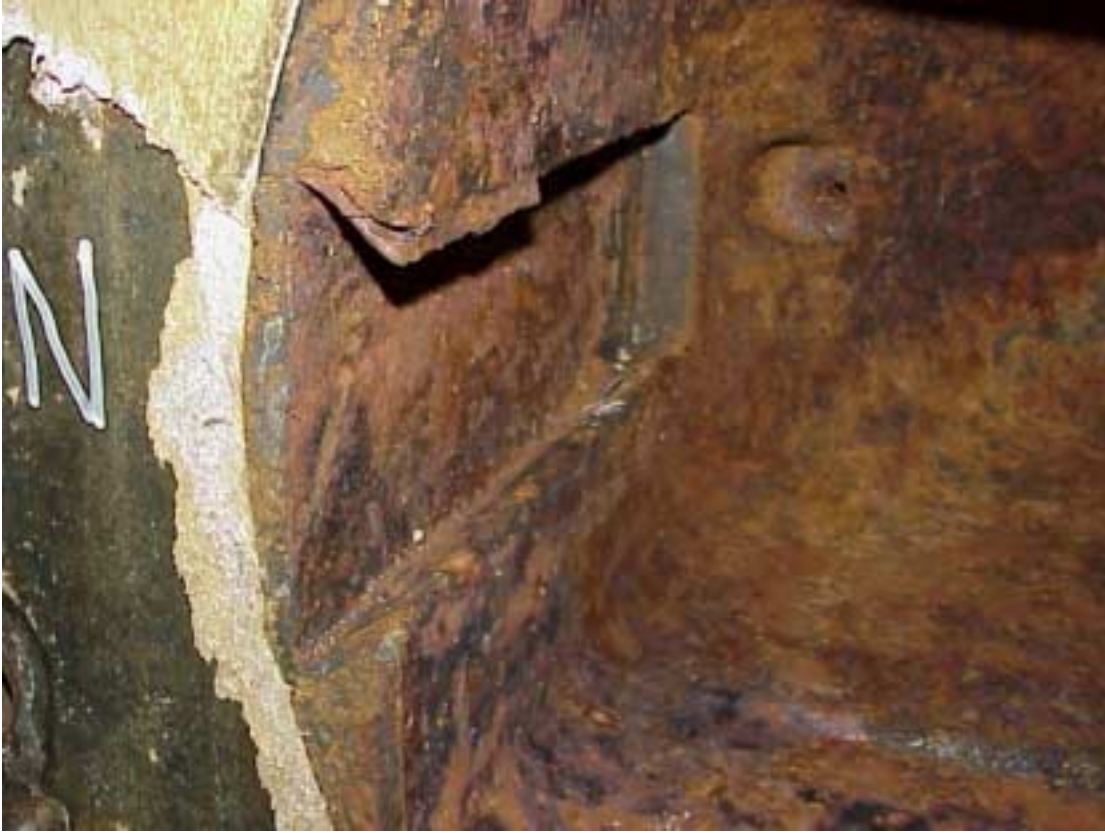
Close up view of valve bonnet showing channel where guide bar would be located.

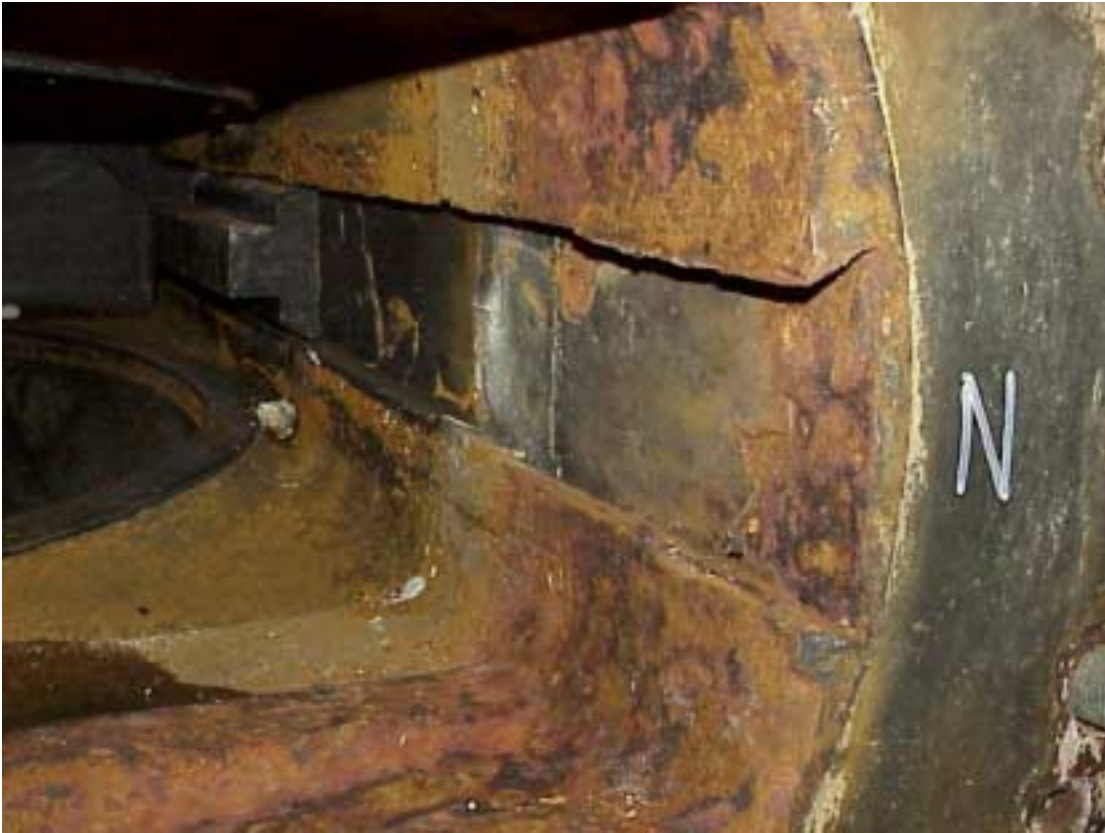
Photo of lower valve body - guide bar from the bonnet is shown located in the lower portion of the valve body.

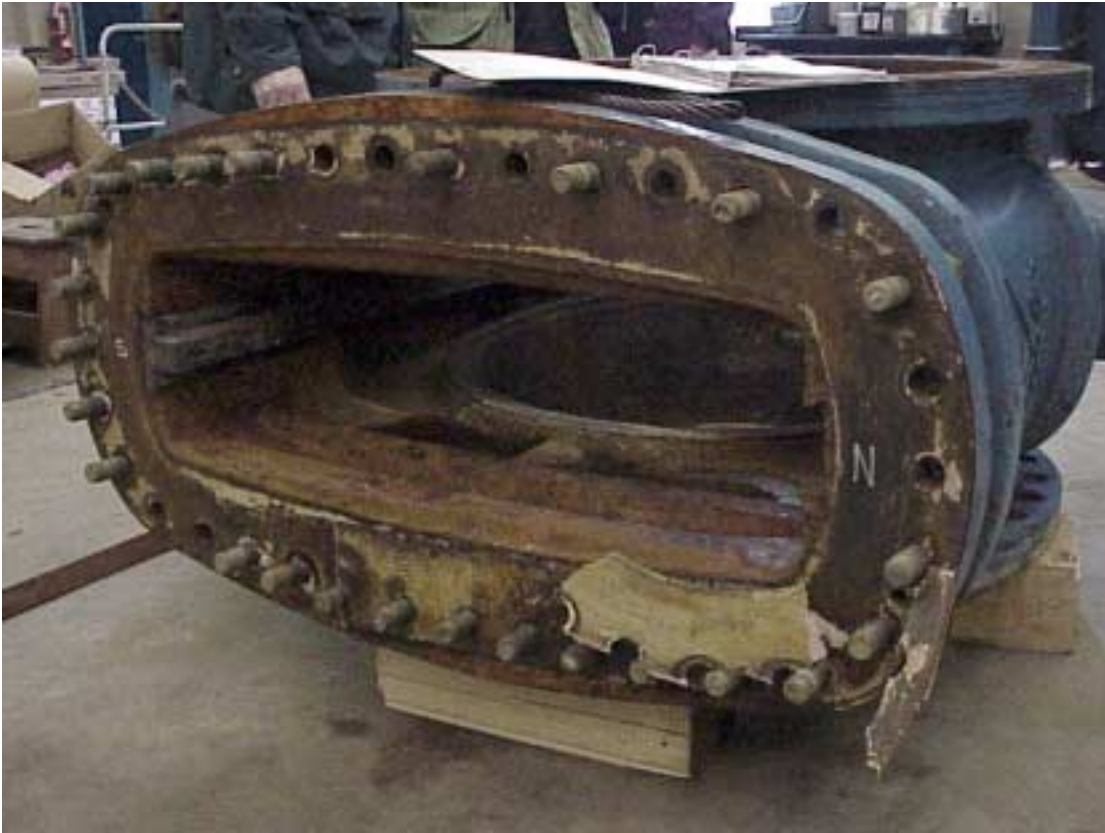
Photo of lower portion of suction gate valve body.

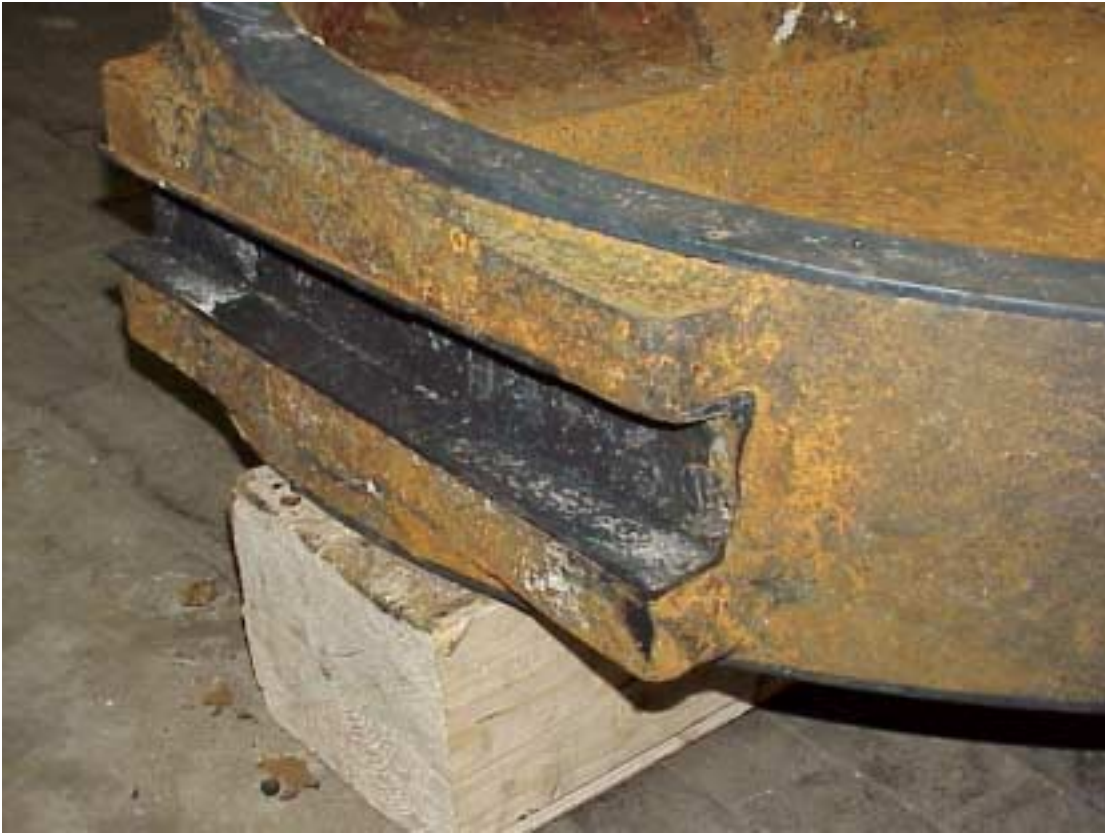
Guide channel on valve plate.

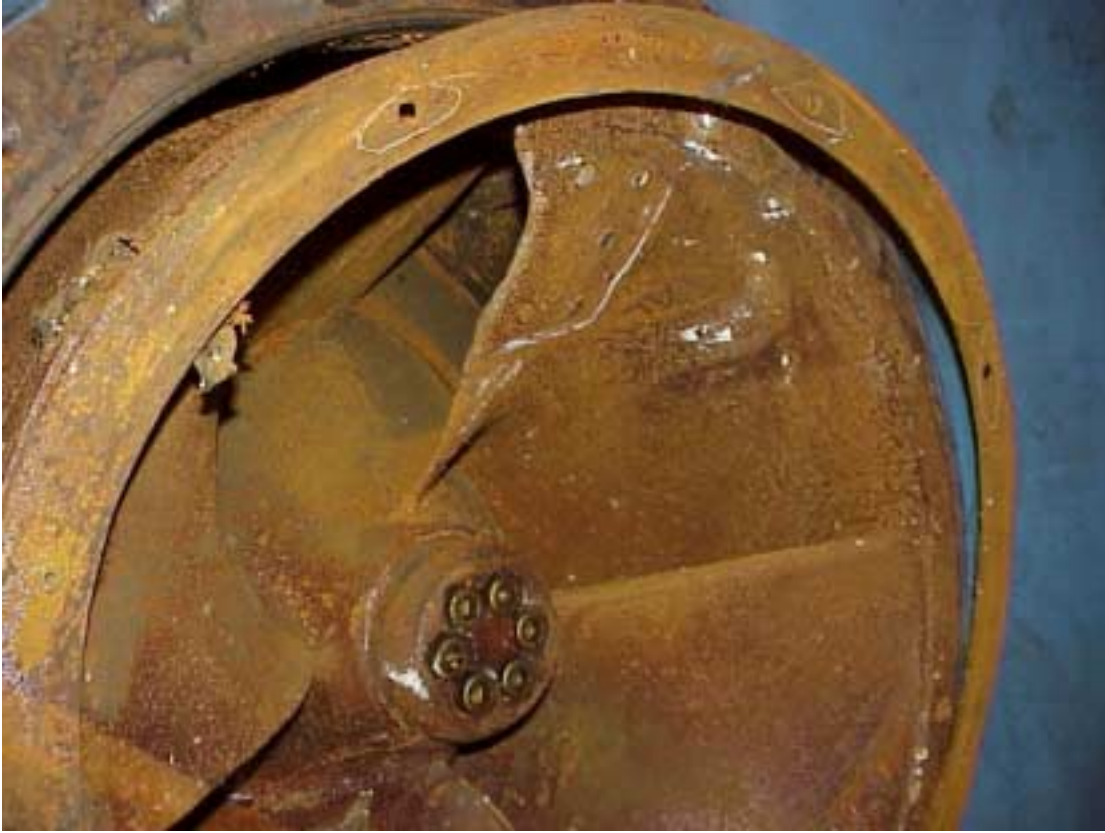
Top of photo shows a piece of metal missing from the pump impeller.

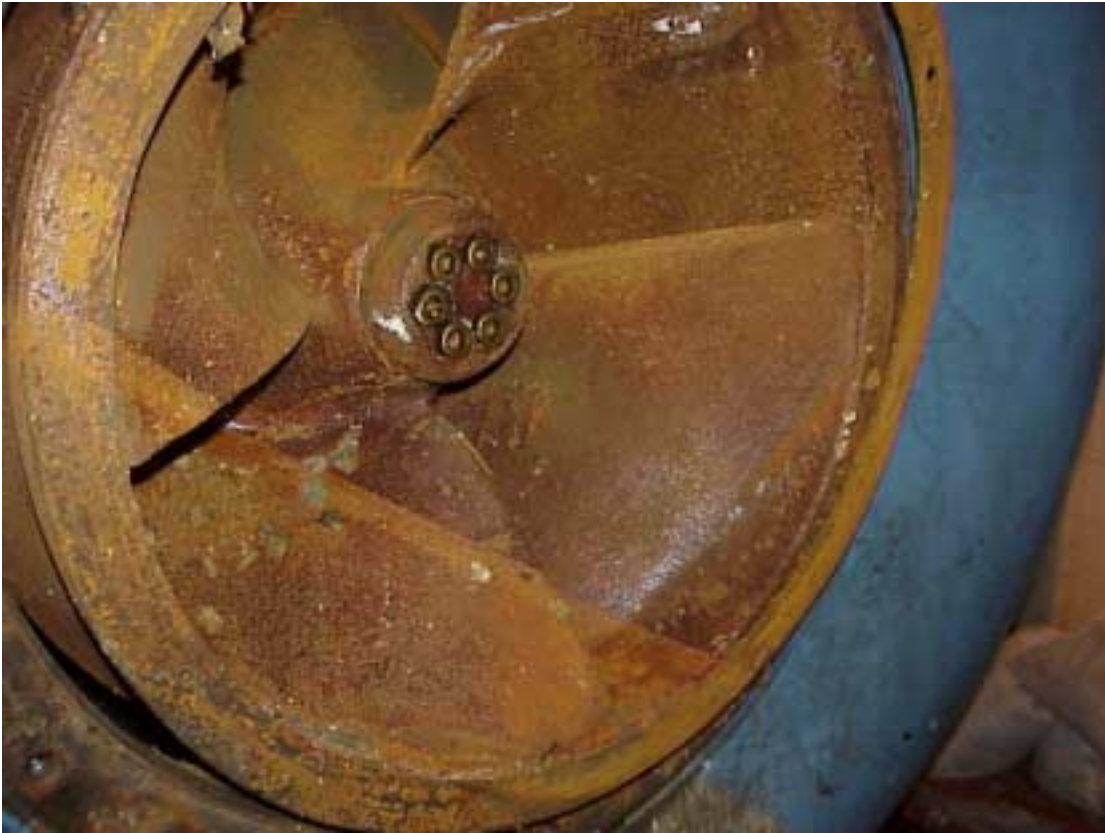
Lower photo of pump impeller - photo shows no damage to impeller.
