MANITOBA ENVIRONMENT ACT PROPOSAL

Lake St. Martin Flood Relief Channel: Interim Operating Licence

Manitoba Infrastructure

December 2016

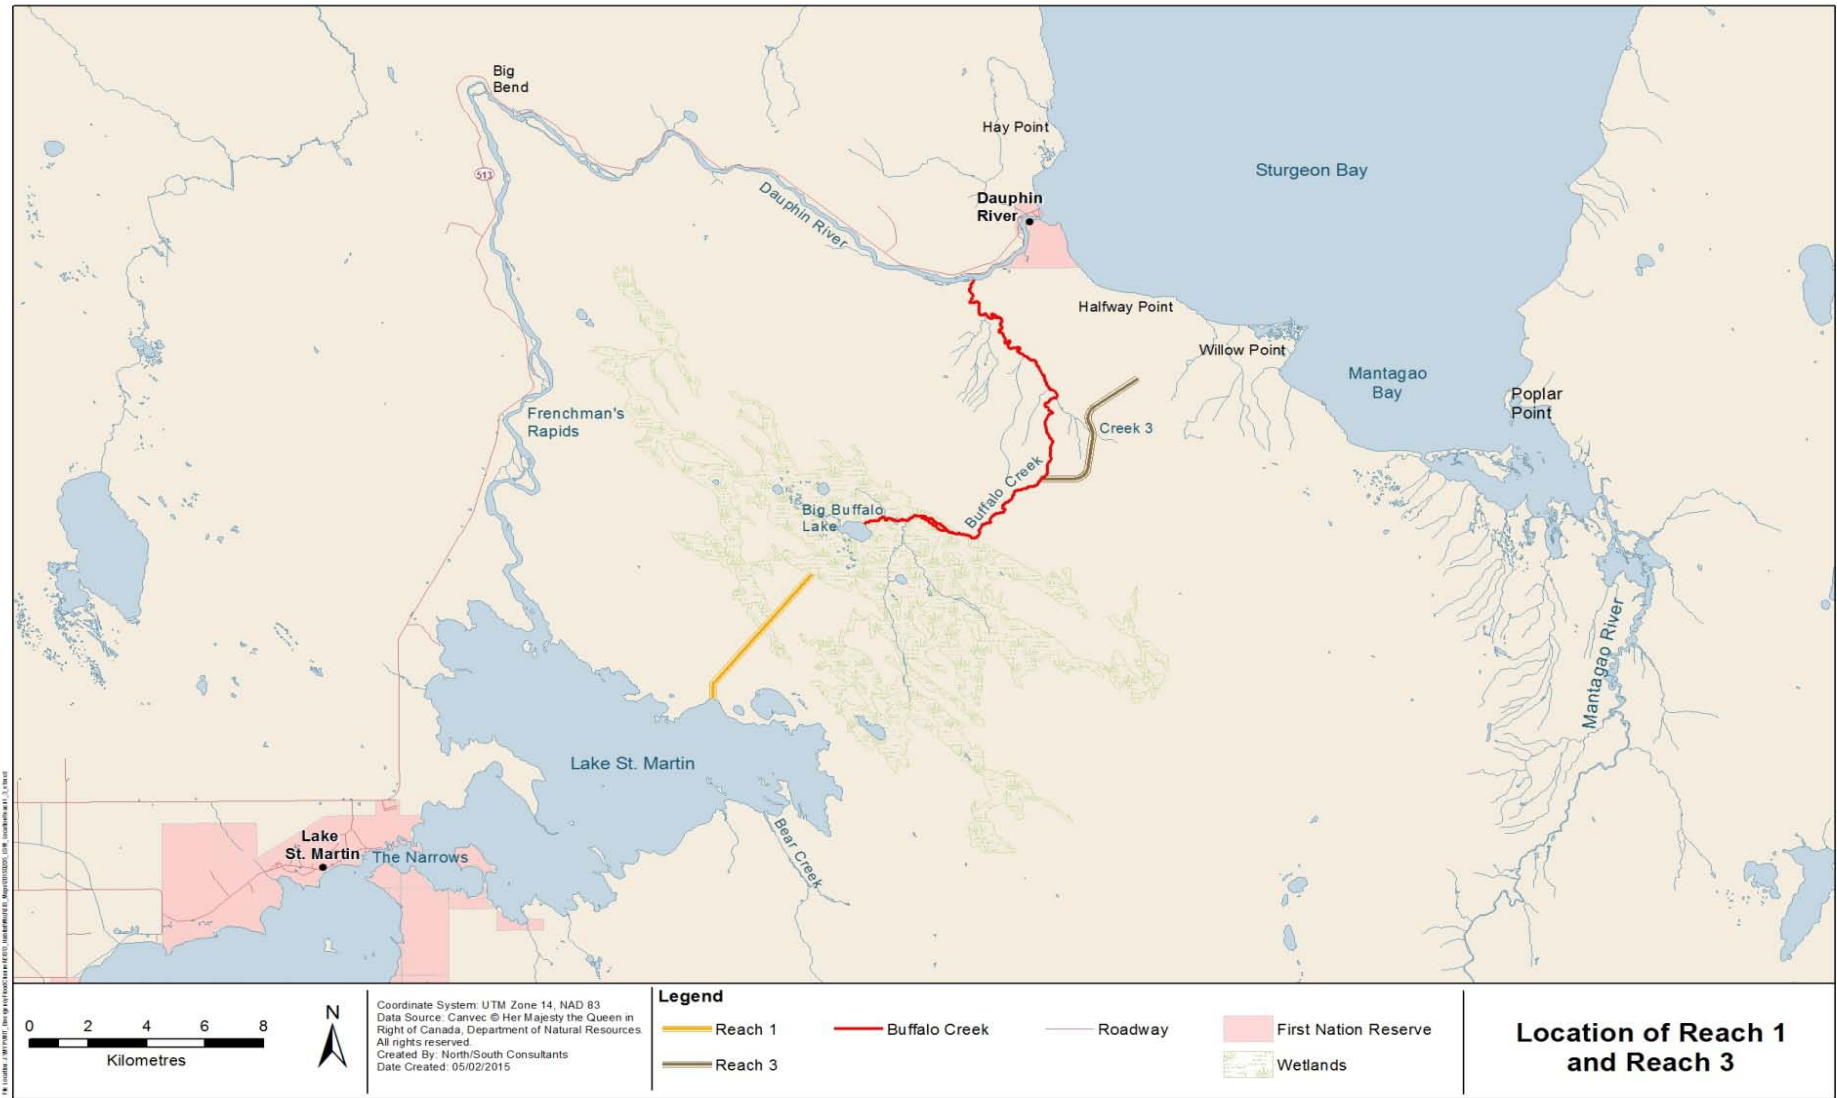
Figure 1 Location of Reach 1 and Reach 3

Reach 1 begins at the northeast shore in the north basin of Lake St. Martin and extends approximately 6 km to a bog complex that is the headwaters for Buffalo Creek, a small tributary that drains into the lower Dauphin River approximately 4 km upstream of Sturgeon Bay on Lake Winnipeg (Figure 1). Water from Reach 1 inundates the bog area and then flows into Buffalo Creek, the lower Dauphin River and, ultimately; into Sturgeon Bay (North/South 2015).

Reach 3 originates at Buffalo Creek and is approximately 6 km in length, it terminates in a low-land area 3.5 km inland of Sturgeon Bay (Figure 1). Substrate within the channel is mostly clayey till but an area of bedrock occurs just upstream of the channel outlet. The channel base is 21 m wide in areas where the substrate is comprised of fines but it expands to a width of 28 m within the bedrock section.

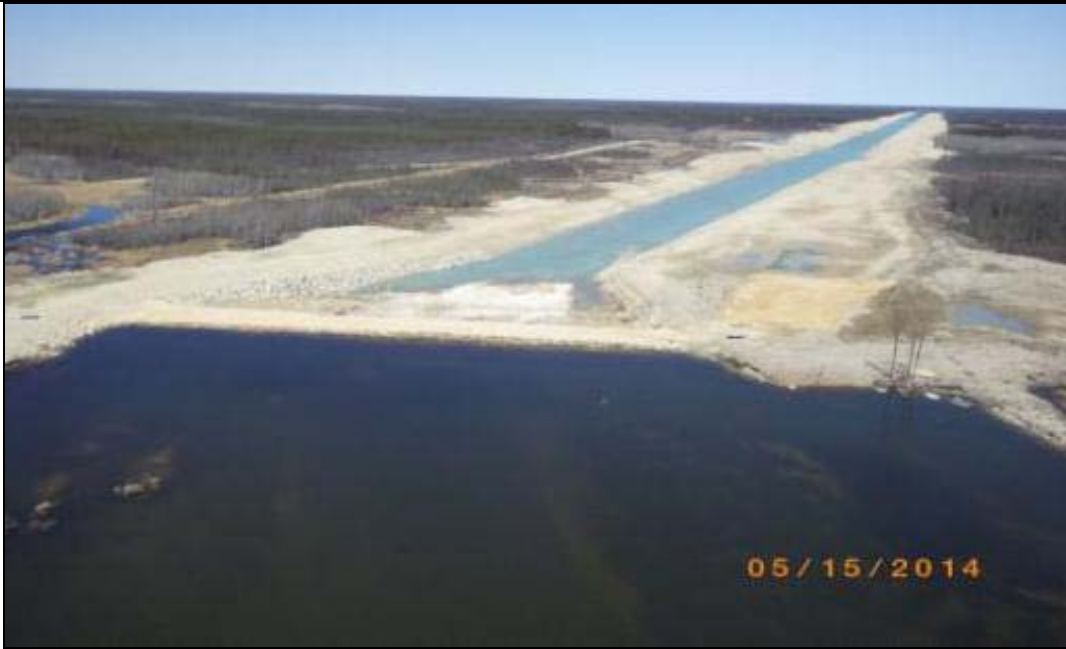
Figure 15 Reach 1 Inlet at Lake St. Martin

In order to facilitate the construction of the Reaches 1 and 3, the existing vegetation/organic matter along the channel alignments was cleared and stripped (trees, peat, organic materials etc.). The current condition of the Reach 1 & 3 Channels can generally be characterized as devoid of vegetation although some limited natural re-growth was observed along the periphery of the Reach 1 Channel. Figures 12, 13, and 14 below show the Reach 1 Channel and limited natural re-growth occurring along the periphery. Figures 15, 16, and 17 show the major components of the Reach 3 Channel. At the time the photographs were taken it appears that limited natural re-growth was occurring along the Reach 3 Channel. It is expected that some limited natural re-growth will occur over time along the periphery of the Reach 3 Channel similar to what is occurring along the Reach 1 Channel.

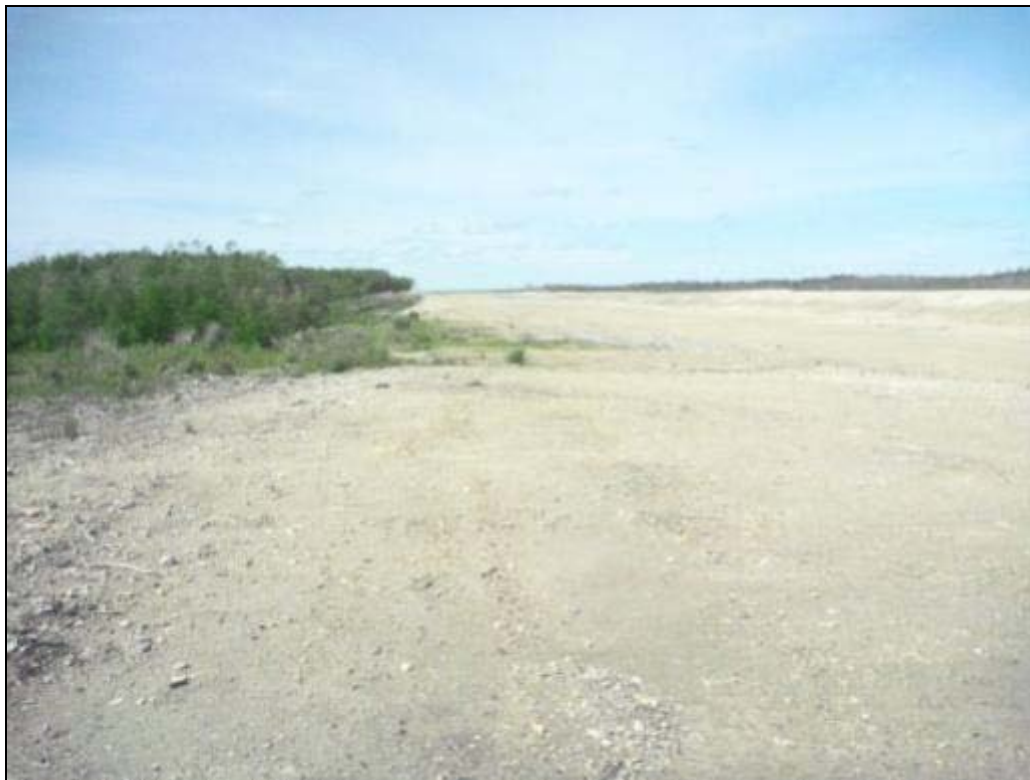
Figure 16 Looking along Reach 1 showing limited vegetation growth

A general lack of natural vegetation re-growth along the Reach 1 & 3 Channels can generally be attributed to the disturbed nature of the conditions at these sites. Scatliff, Miller & Murray (2013) indicate that conditions inhibiting the natural regeneration of vegetation along the Reach 1 & 3 Channels include:

- Ground compaction stemming from initial Channel construction activities and settlement of materials over time;
- Large tracts of exposed glacial tills/base material along the extent of the Reach 1 & 3 Channels. Base materials do not serve as a good growth medium and tend to be slightly alkaline, low in salinity, as well as deficient in organic matter and major nutrients;
- Presence of heavy rill erosion along the Reach 1 & 3 Channels; and
- Low to marginal soil organics and fertility.

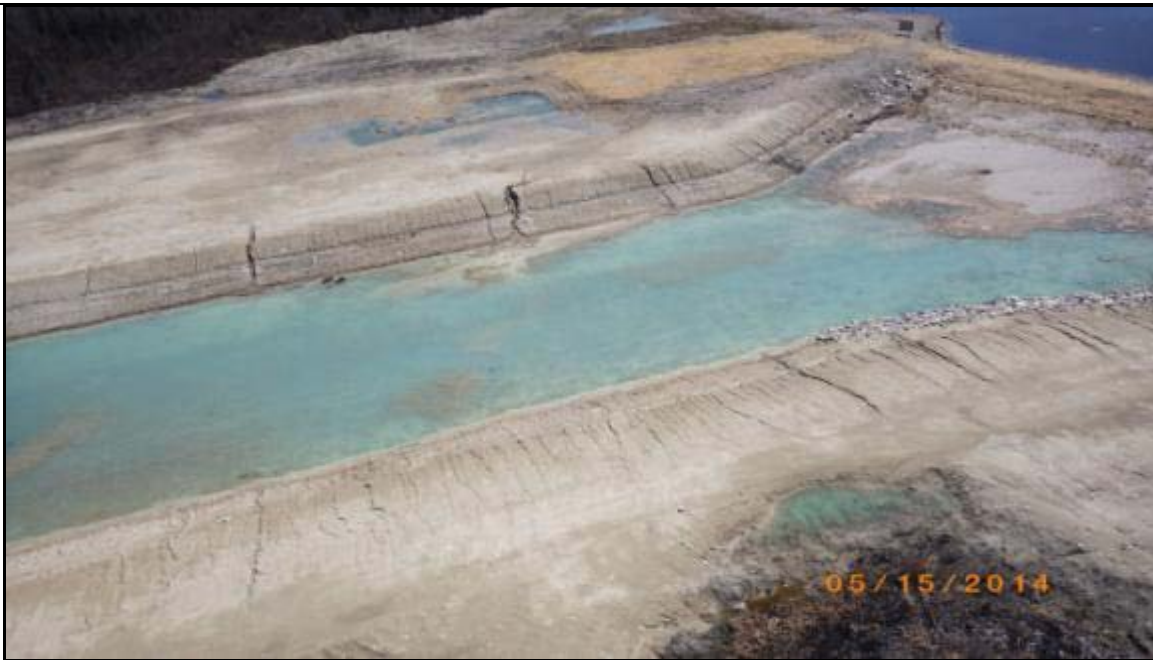
Figure 17 Erosion along Reach 1

Erosion along the primary components of the LSMEOC also occurs under non-operating conditions. Sources of erosion during non-operation are attributable to the lack of vegetation or other protective cover in combination with natural forces such as wind, rain, run-off, and seepage/infiltration of groundwater.

Despite the inclusion of design mitigation measures, erosion, sedimentation, and bank destabilization are ongoing (both under operation and non-operating conditions) and expected to continue in the near future as part of the interim operation of the LSMEOC. The mobilization of sediments due to erosion and scour is limited and does not extend beyond the primary components of the LSMEOC. At some point in the future, it is anticipated that the self armoring of the Reach 1 will occur and no further erosion and destabilization of the channel side slopes will take place.

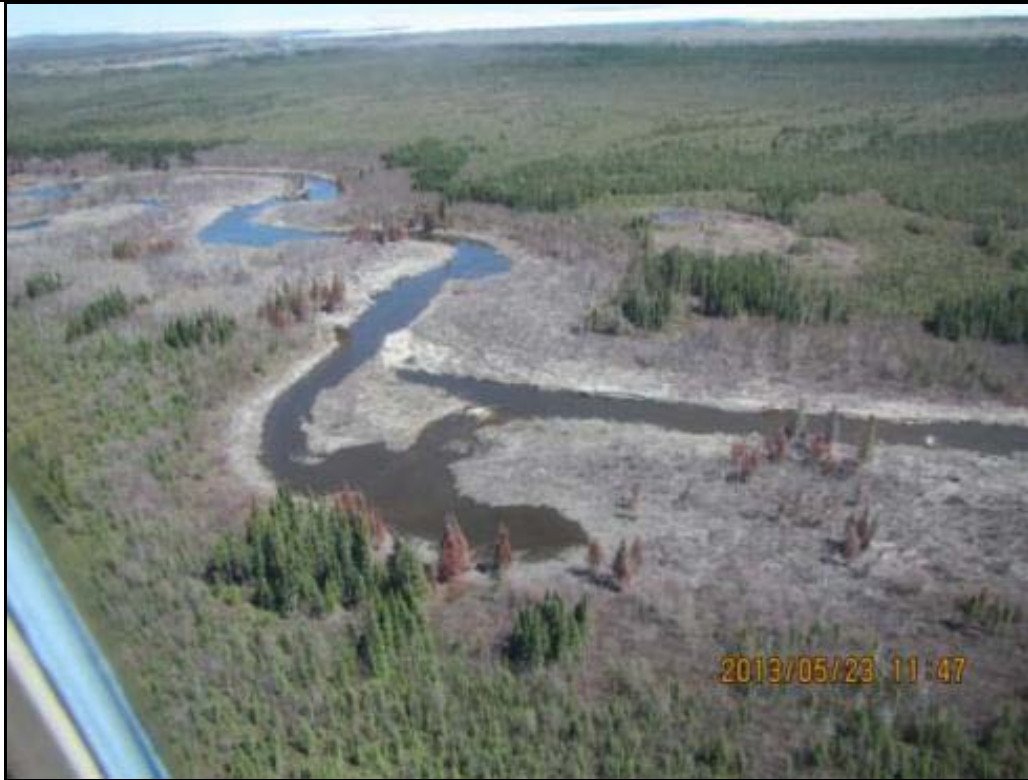
Figure 18 Vegetation die off from Flooding along Buffalo Creek

In addition to the Reach 1, Buffalo Creek also serves as an important component of the LSMEOC that serves to convey diverted flows into the Dauphin River. Vegetation cover along Buffalo Creek was surveyed as part of the sediment erosion monitoring program in order to better determine the creeks resiliency and/or susceptibility to erosion. It is generally accepted that the increased flows and subsequent flooding along the Buffalo Creek Channel stemming from the Project operation has led to the mortality of vegetation along the banks of the Buffalo Creek Channel. Figures 19 and 20 below show an example of erosion and vegetation mortality along Buffalo Creek delineating the zone of inundation due to the operation of Reach 1.

Under non-operational periods, Buffalo Creek may experience some additional loss of riparian vegetation due to ongoing erosion and bank destabilization processes. Loss of riparian vegetation along Buffalo Creek under non-operating conditions is expected to be minor. No other effects on vegetation are expected to occur under non-operating conditions associated with the LSMEOC.

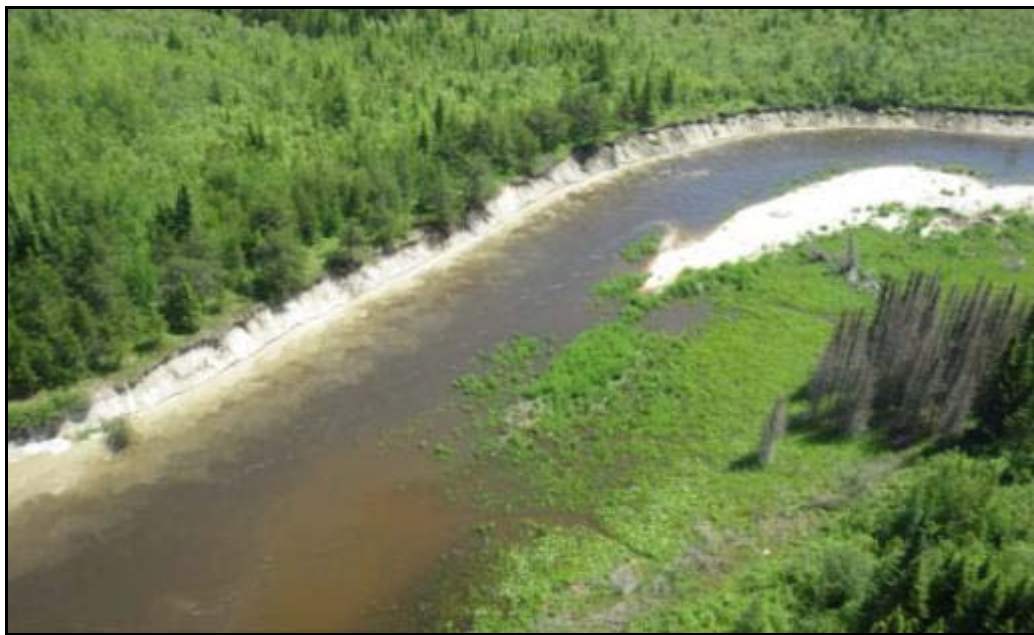
Figure 19 Bank Erosion along Buffalo Creek (2014)

The LSMEOC will result in the temporary loss of some riparian habitat due to erosion and bank destabilization taking place along Buffalo Creek. Temporary habitat loss is expected to occur over the short-term under both operating and non-operating conditions. Causes of habitat loss during operation include inundation, erosion, and bank destabilization. Similarly, erosion and bank destabilization processes leading to some continued habitat loss is likely to occur to a lesser degree under non-operation. The temporary loss of riparian habitat is expected to continue at a declining rate during the short-term until Buffalo Creek stabilizes, vegetation cover returns, and riparian areas reestablish. No mitigation measures will be employed to offset potential effects associated with the temporary loss of riparian habitat along Buffalo Creek.

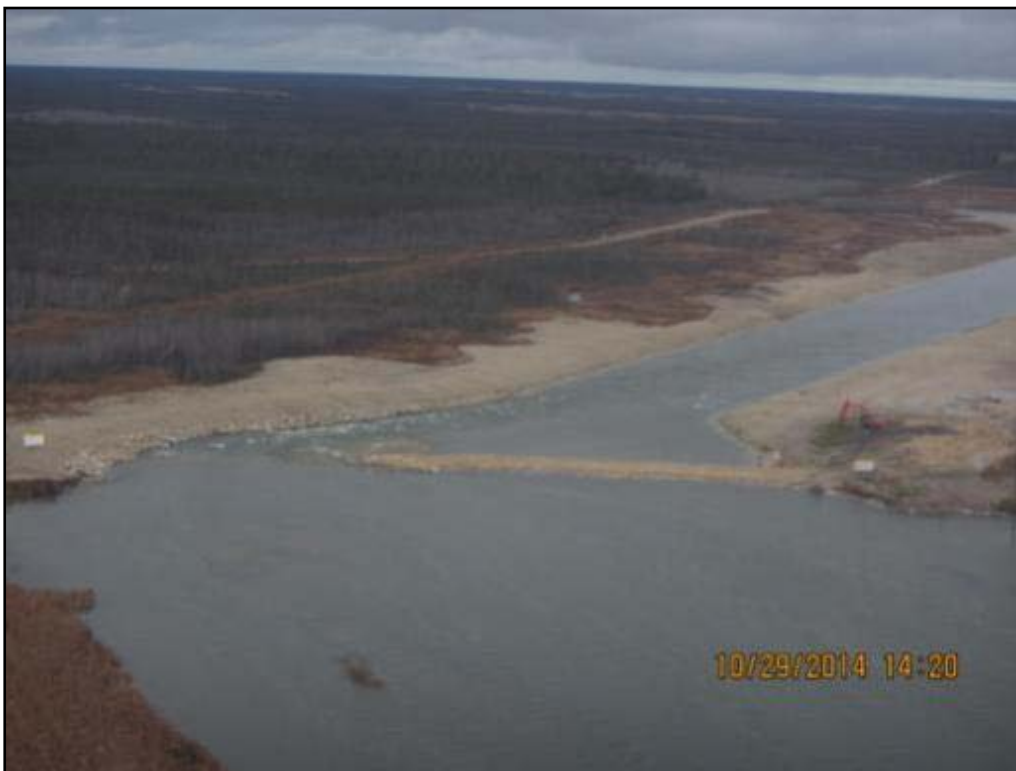
Figure 20 Signage at Reach 1 Inlet on Lake St. Martin

The LSMEOC is located in a relatively remote and isolated area. The Reach 1 and 3 channels are not currently road accessible. The inlet for the Reach 1 Channel on Lake St. Martin may be approached by boat during the summer months. The Reach 1 channel inlet does present a potential public safety concern for boaters if operation occurs under open water conditions on Lake St. Martin. Recognizing the potential safety concern at this location, MI has installed permanent signage and maintains warning buoys during open water conditions at the location of the Reach 1 inlet. The installation of signage and maintenance of warning buoys were approved by Transport Canada's Navigation Protection Program (Approval no. 8200-2011-600278). Figures 21 and 22 respectively show the signage and buoys installed at the Reach 1 inlet location.
