# Lake St. Martin Emergency Relief Channel Monitoring and Development of Habitat Compensation Volume 3 - Water Quality

Volume 3 – Water Quality

A Draft Report Prepared for  
Manitoba Infrastructure and Transportation

February 2016

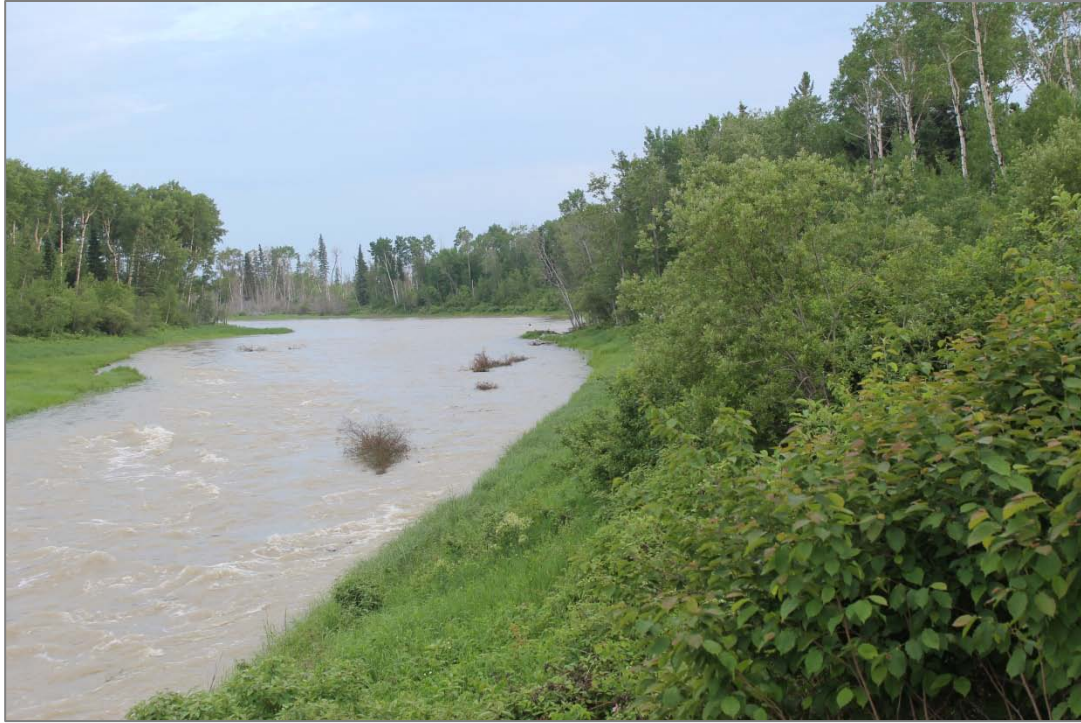
Figure 20. Time-lapse photograph from camera DR-1 showing large tree debris flowing downstream in Buffalo Creek.

The type of debris generally ranged from small sticks and branches, to larger logs, to entire trees (Figures 20 and 21; Appendix E). Most debris (approximately 65-70%) was observed along the right-hand bank (looking upstream) of Buffalo Creek. Water velocity in this stretch of Buffalo Creek was higher along the right-hand bank. Additionally, the cameras were installed on the right-hand shoreline, so debris on the left-hand bank was farther away in the images and may have been more difficult to observe.

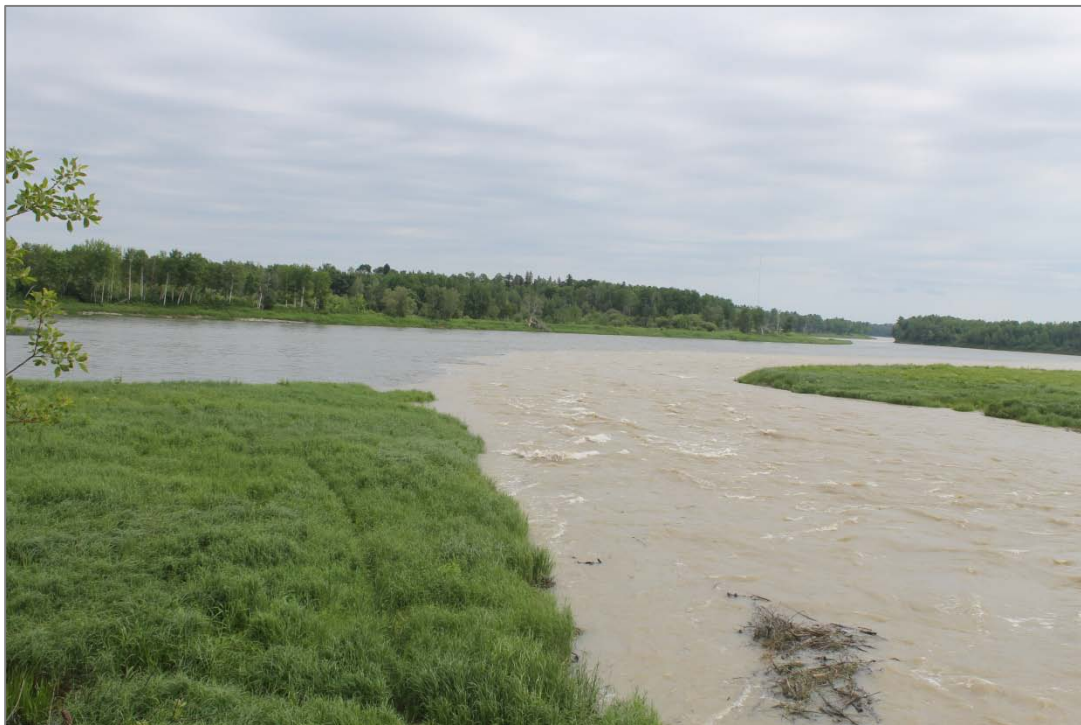
Figure 21. Time-lapse photograph from camera DR-2 showing small sticks and branches flowing downstream towards the Dauphin River.

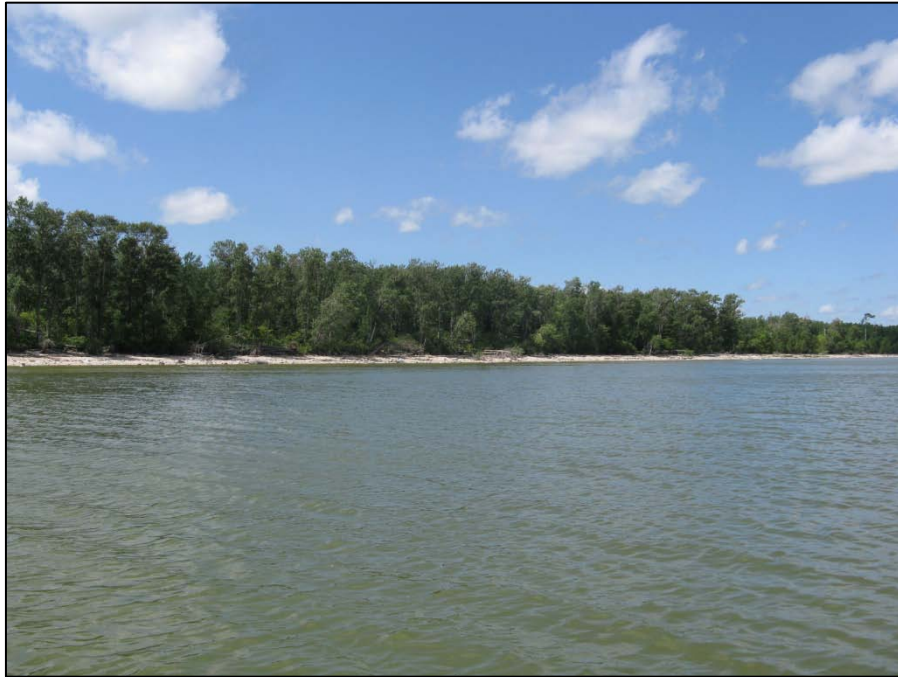
Figure F-2. Example of fallen trees and old, rafted debris along the shoreline from the Dauphin River to Halfway Point, summer 2012.

Woody debris was abundant along the shoreline in this section, but most appeared to be locally fallen trees or old rafted debris deposited at the existing tree line along the beach ridge (Figure F-2). At least one large spruce was observed on the beach near Halfway Point (at point # 2741 in Figure F-1) and had been more recently deposited. This tree may have originated from the Buffalo Creek watershed (Figure F-3). Although fresh peat deposits were observed at the water's edge along this reach of shoreline during spring, none remained at the time of this survey. Old, anthropogenic debris in the form of fish tubs and nets were observed along the tree line and an old dock had washed ashore (at point # 2746 in Figure F-1), but no recently deposited anthropogenic debris was observed.

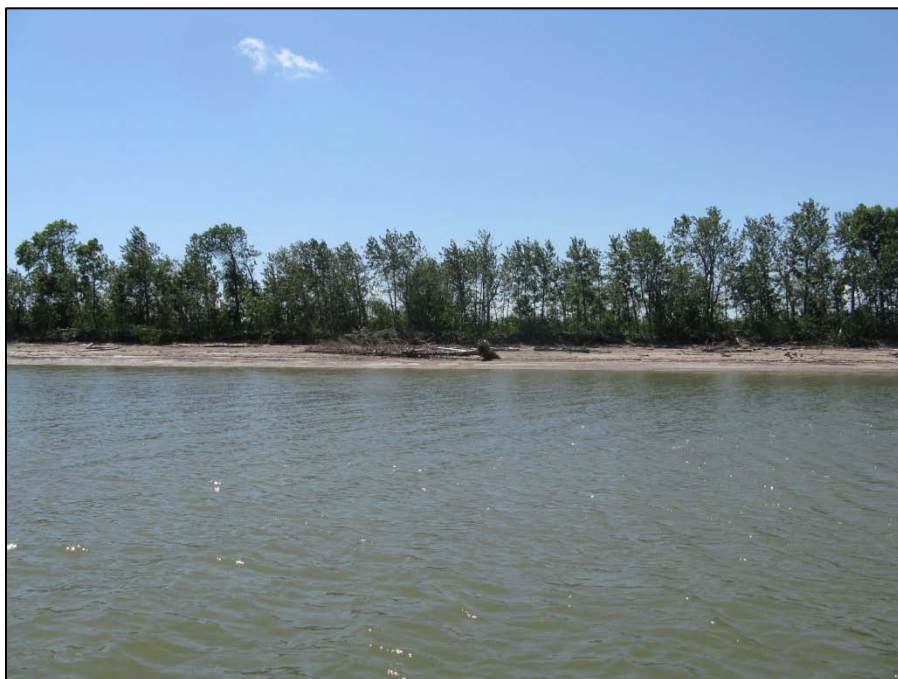
Figure F-3. A spruce deposited along the shoreline from the Dauphin River to Halfway Point, summer 2012. This tree may have originated in Buffalo Creek.

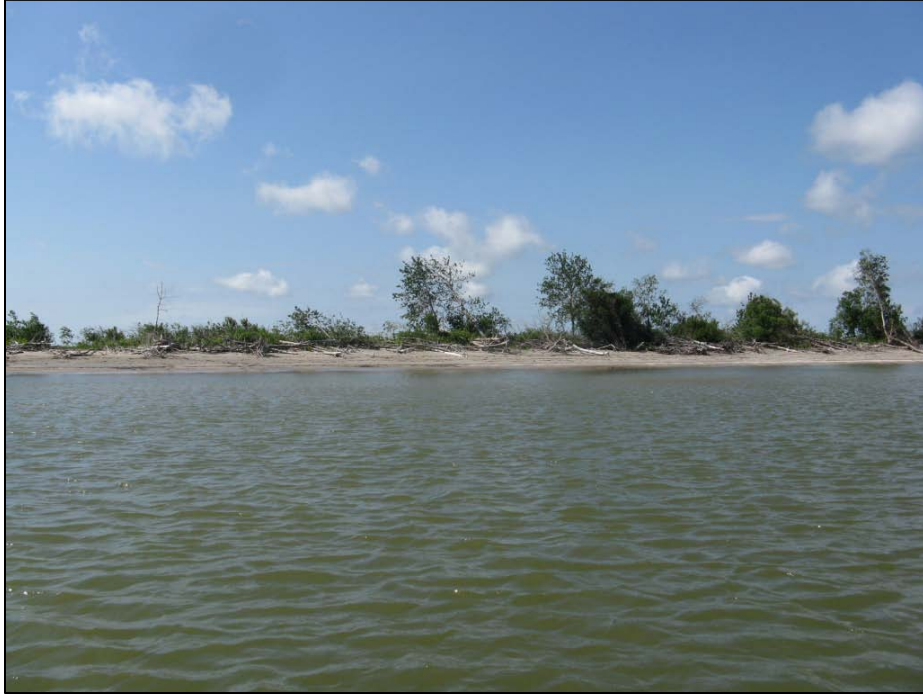
Figure F-4. Example of fallen trees and old, rafted debris along the shoreline from Halfway Point to Willow Point, summer 2012.

As between the Dauphin River and Halfway Point, woody debris was abundant along the shoreline between Halfway Point and Willow Beach, but consisted of local trees knocked over by the wind or old, rafted material (Figure F-4). Fresh peat deposits were observed in this section during spring, in smaller quantities than the section closer to the Dauphin River mouth, but were not evident during this survey. Old fish tubs and nets were observed along the tree line, but there was no evidence of any recently deposited anthropogenic debris.

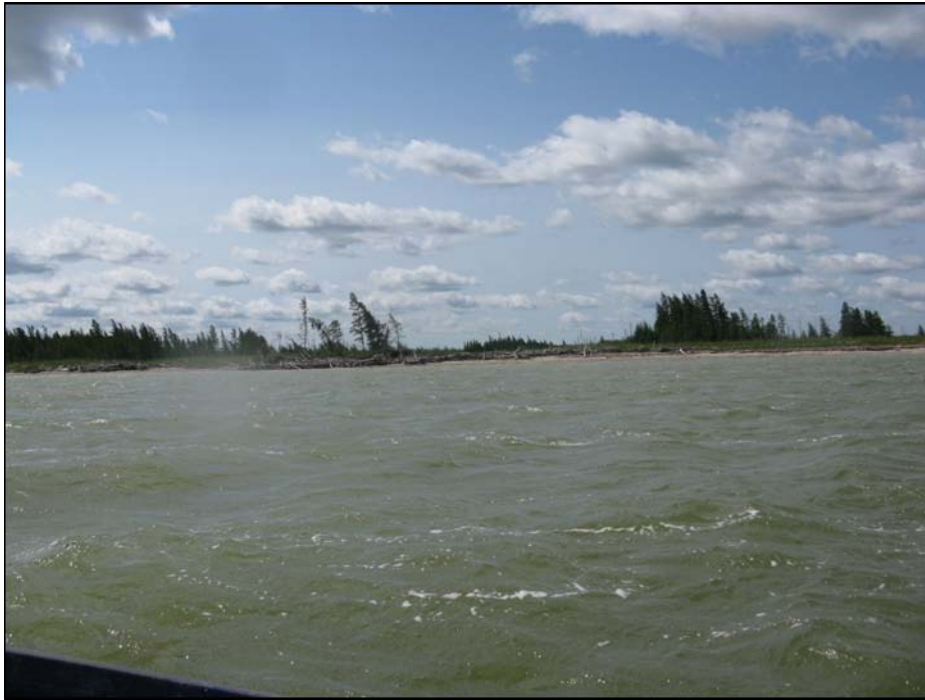
Figure F-5. Example of fallen trees and old, rafted debris along the shoreline of Mantagao Bay, summer 2012.

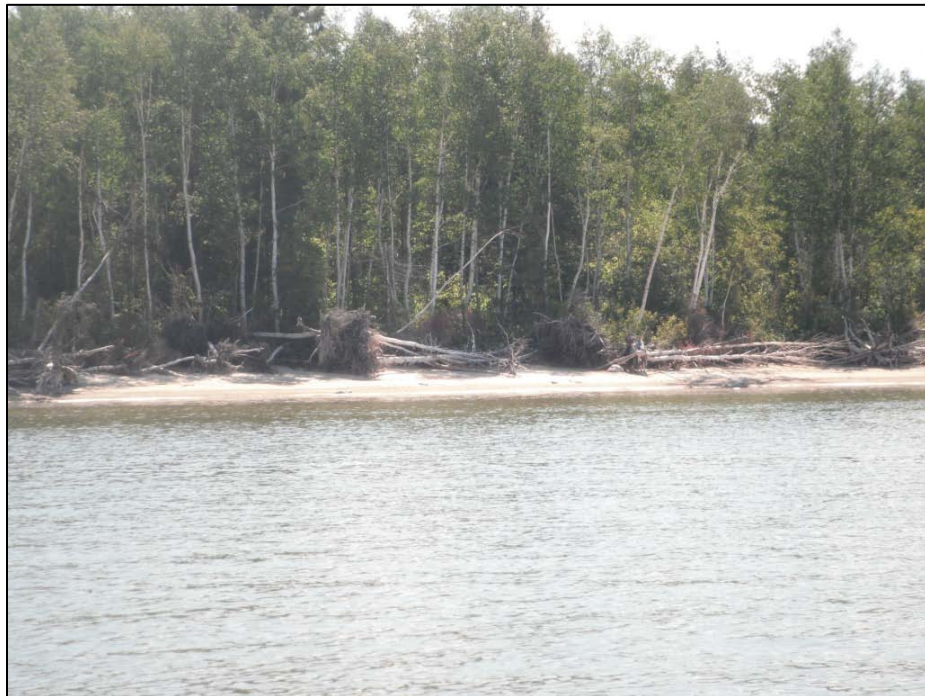
Figure F-6. Example of fallen trees and old, rafted debris along the eastern shoreline of Sturgeon Bay, summer 2012.

Old downed trees and rafted debris characterized the eastern shoreline of Sturgeon Bay (Figure F-6); however, there was no evidence of recently deposited debris. Small amounts of old, anthropogenic debris were washed ashore just north of Mantagao Bay.
