RECONNAISSANCE

SHORE-FAST ICE

FORT CHURCHILL TO CAPE TATNAM

HUDSON BAY

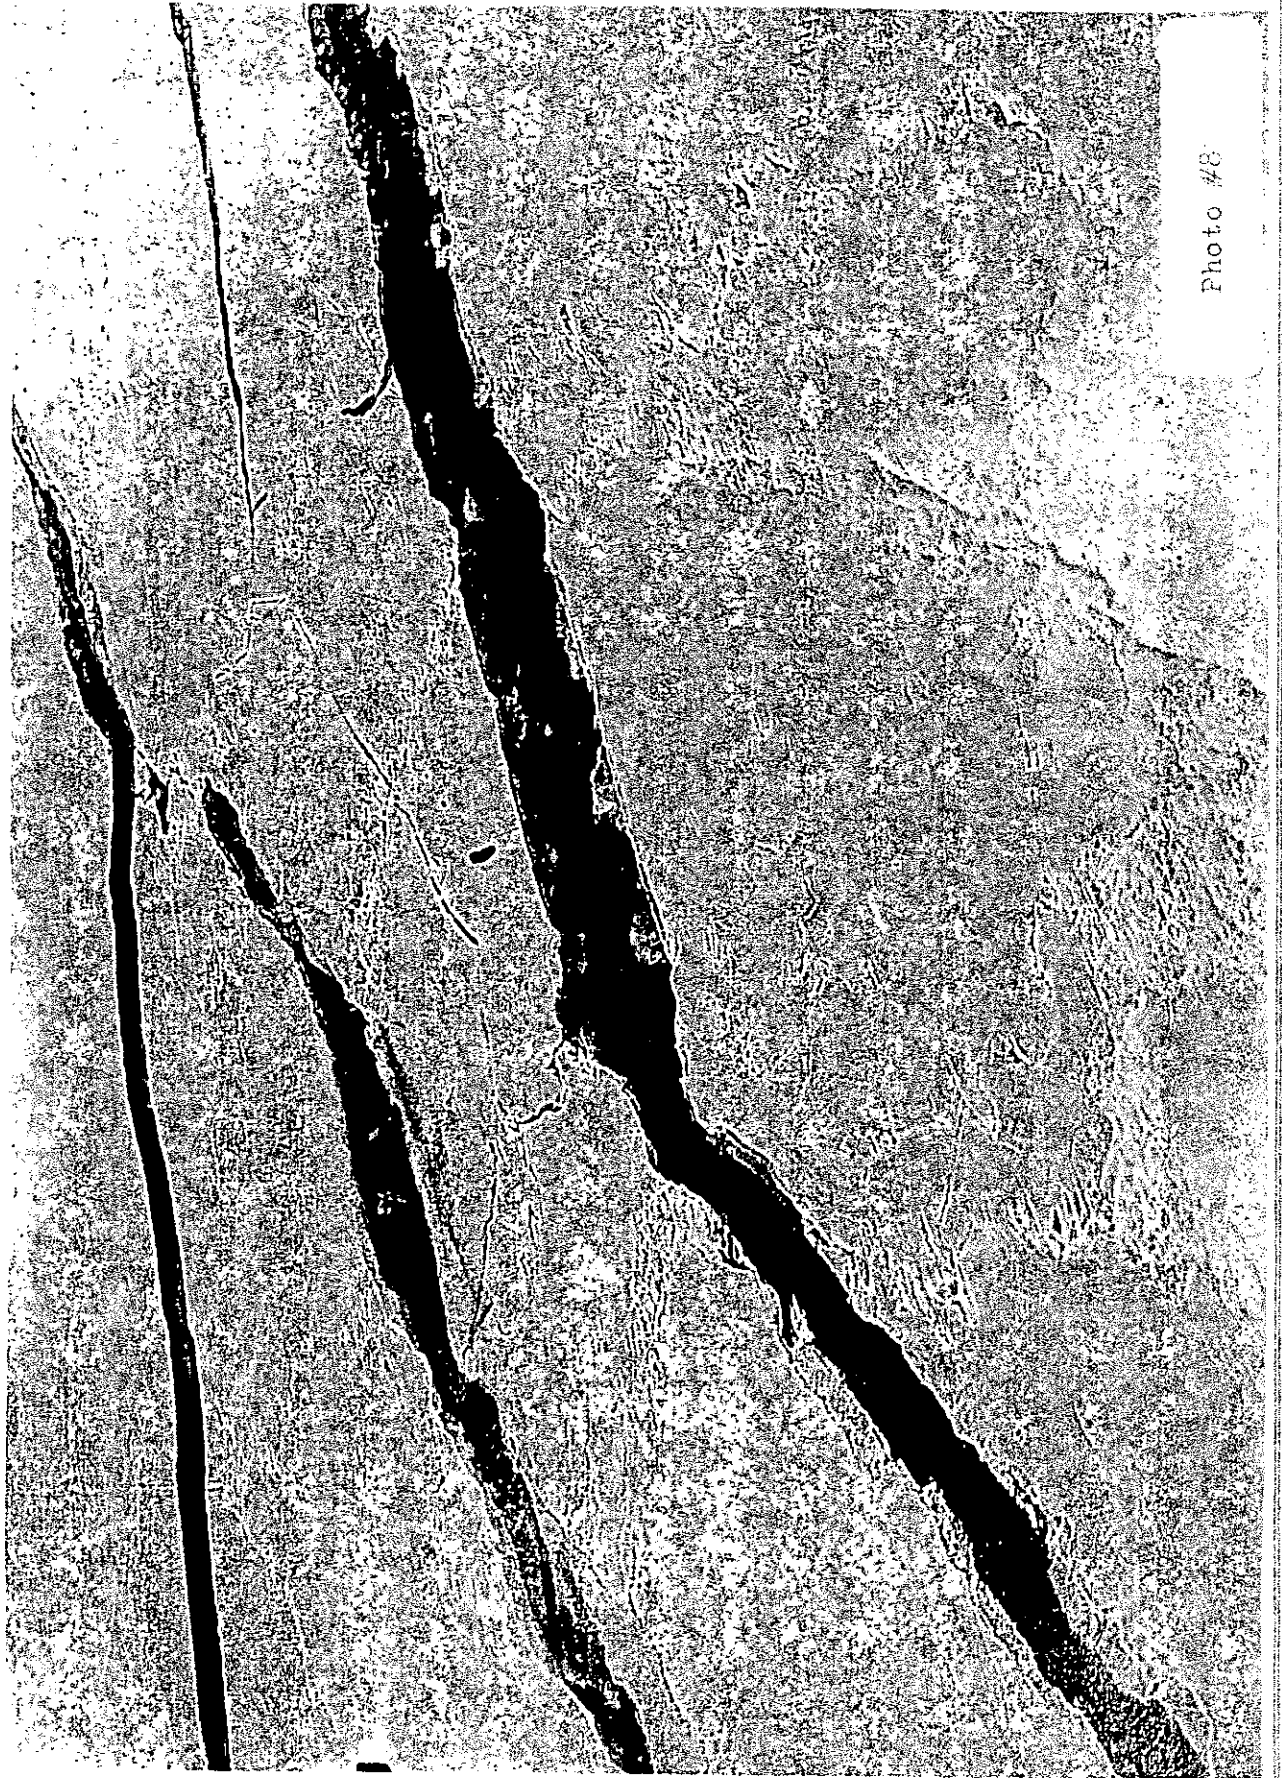
Photo #8

PHOTO #8

An oblique R.C.A.F. photo (not to be reproduced) taken in the mid-bay area between Cape Hopewell and Chesterfield Inlet in the early mid-winter period. The ice is fairly smooth but interrupted by numerous pressure ridge systems. Note the leads are largely healed with thin ice.

The open shore lead can vary from a few yards to a reported twenty or thirty miles in width. The bay ice is reportedly composed of large pans with pressure ridges and open leads are common (Photo #8). Ice thickness reportedly varies from three to six feet depending on the relationship of snow and minimum temperatures. The ice becomes unsafe by "rotting" while near maximum thickness, rather than by reduced thickness through melting.
