**PHASE I ENVIRONMENTAL SITE ASSESSMENT
RESIDENTIAL PROPERTY
45124 ROAD 164N (CARNE RIDGE ROAD)
RM OF GRAHAMDALE**

**Prepared for:
Manitoba Transportation and Infrastructure
1520-215 Garry Street
Winnipeg, Manitoba R3C 3P3**

**Parsons Inc.
7 Terracon Place
Winnipeg, Manitoba R2J 4B3
Phone: (204) 489-2964**

December 16, 2024

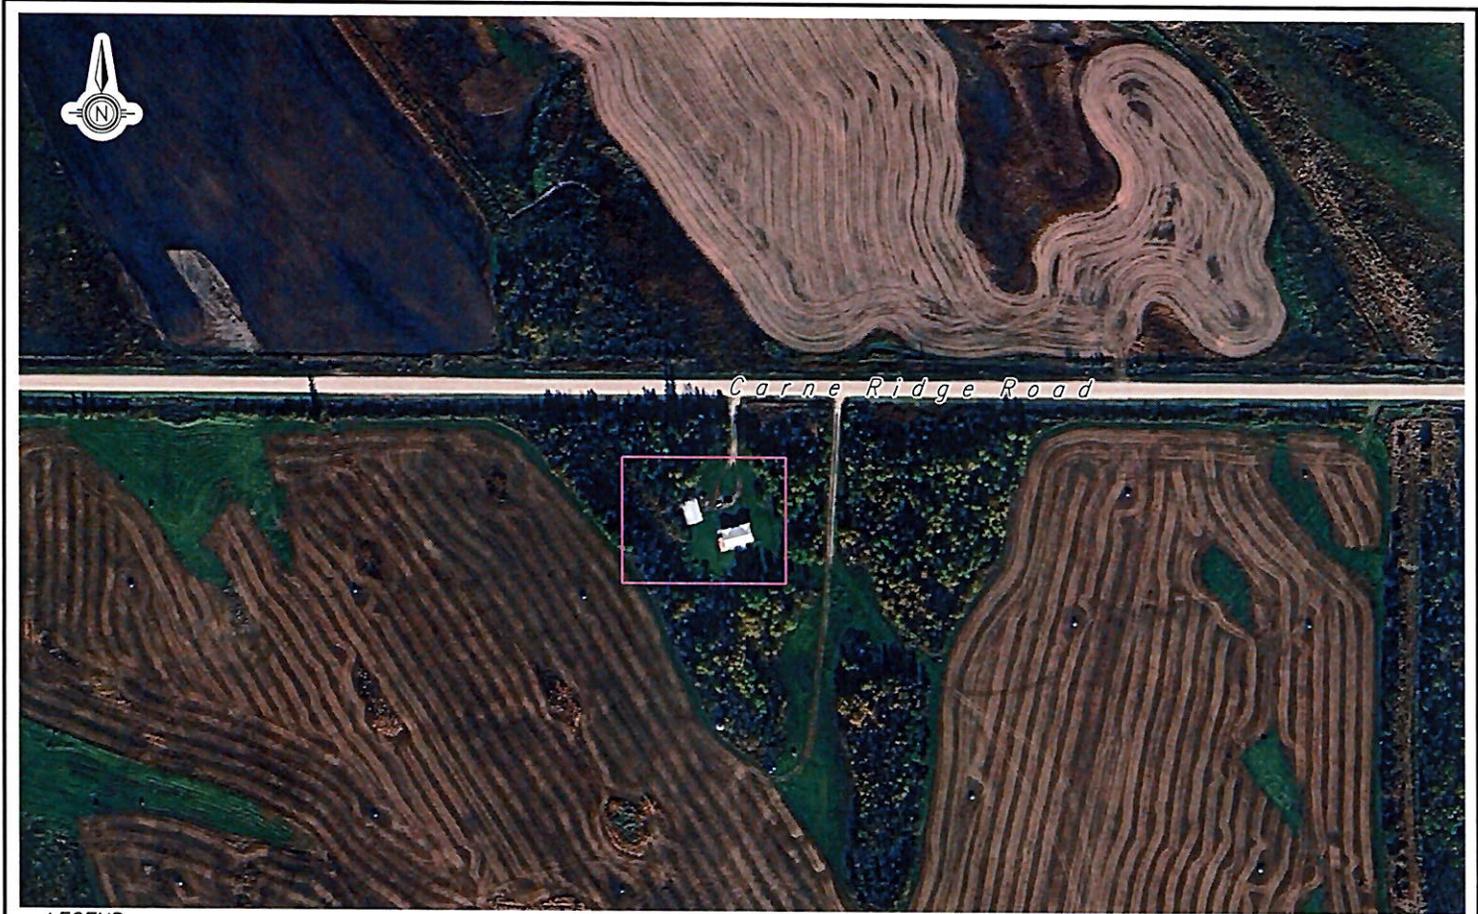
Drawn: VJH	Page Size: 8.5 X 11 in	Ref.: 10-13288
Reviewed: CS	File: 13288S002	Date: 2024/12/05
PARSONS		Drawing: 2

The present Site configuration is shown on Drawing No. 2. Annotated photographs of the Site and structure/features noted above and within are presented in Appendix A.

*Drawing No. 2 is presented on a 2024 Google Earth image and represents the current Site configuration.

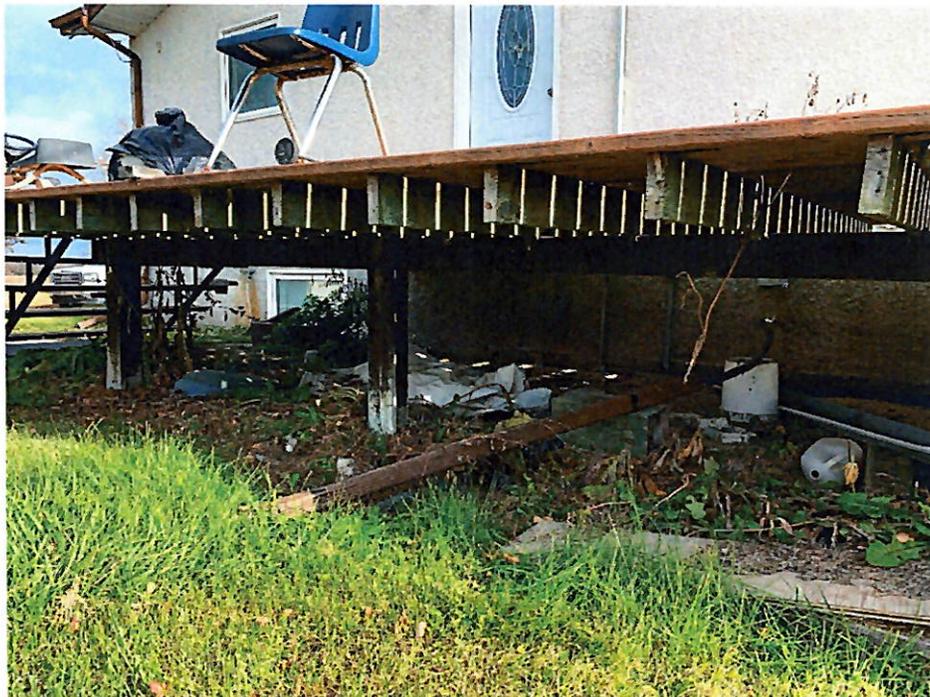
A water well is present at the Site that supplies water to the residential dwelling. The water well is located on the west side of the residential dwelling and water enters the dwelling via piping in the basement foundation into the utility room. A water filtration and softener system were observed in the utility room.

A.6. Water well and piping entering basement – exterior west side of dwelling

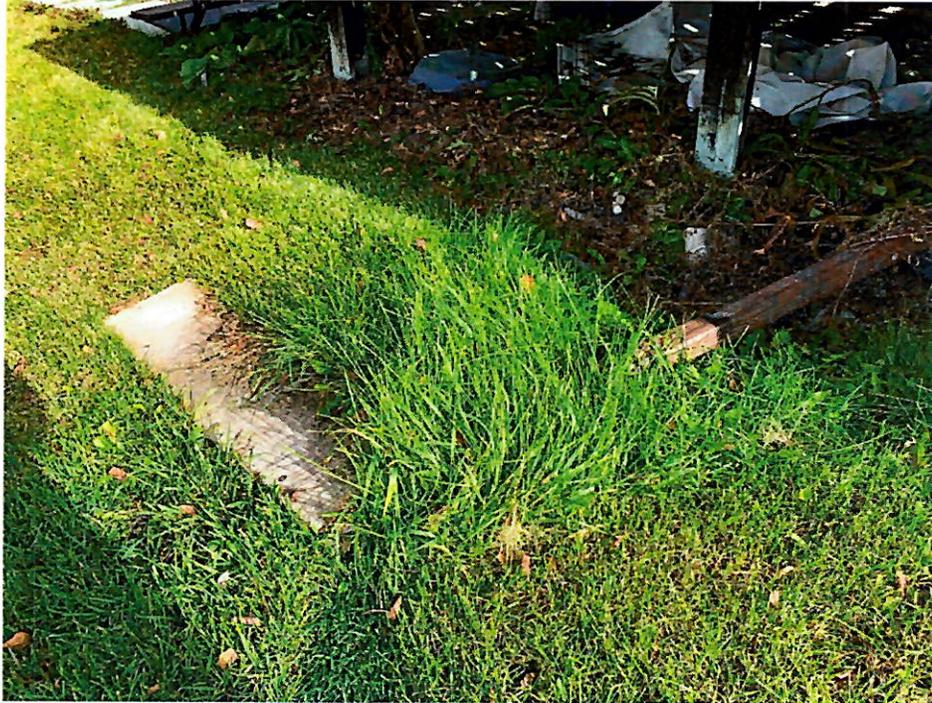
A water well was observed on the property.

A.7. Water well location – exterior west side of dwelling

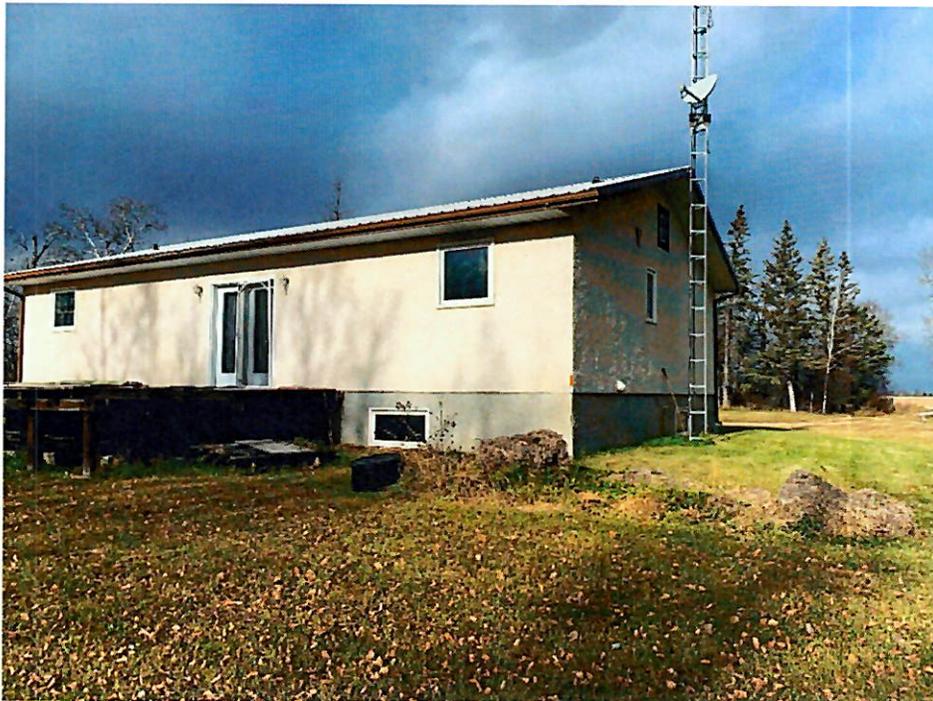
A septic tank is located near the southeast corner of the residential dwelling. The size of tank and current status of contents is unknown.

A.8. Septic tank/field – exterior southeast side of dwelling

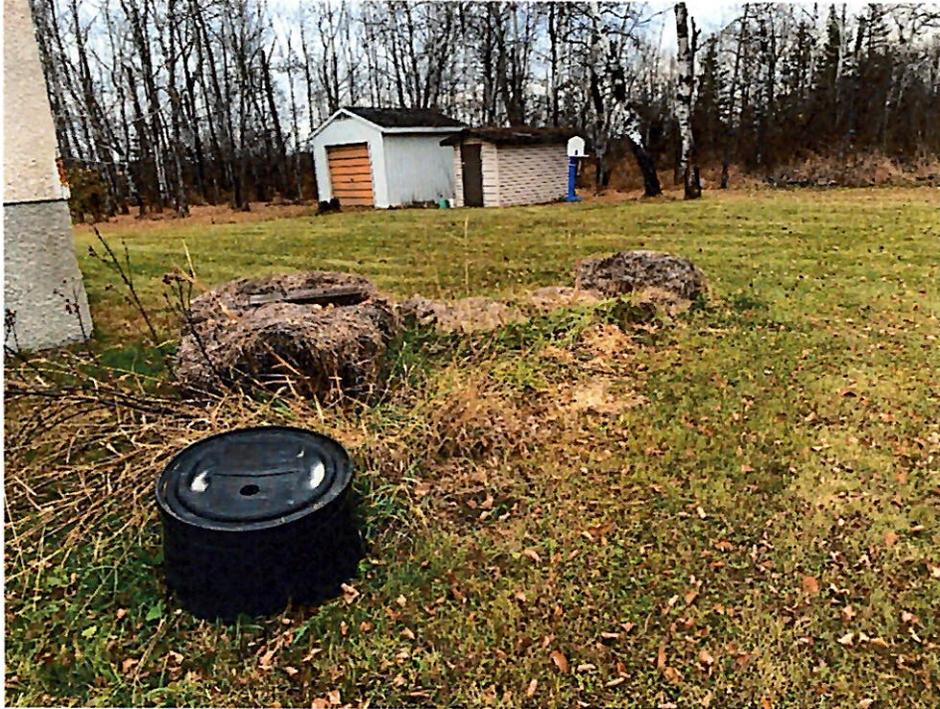
A.9. Septic tank/field – exterior southeast side of dwelling

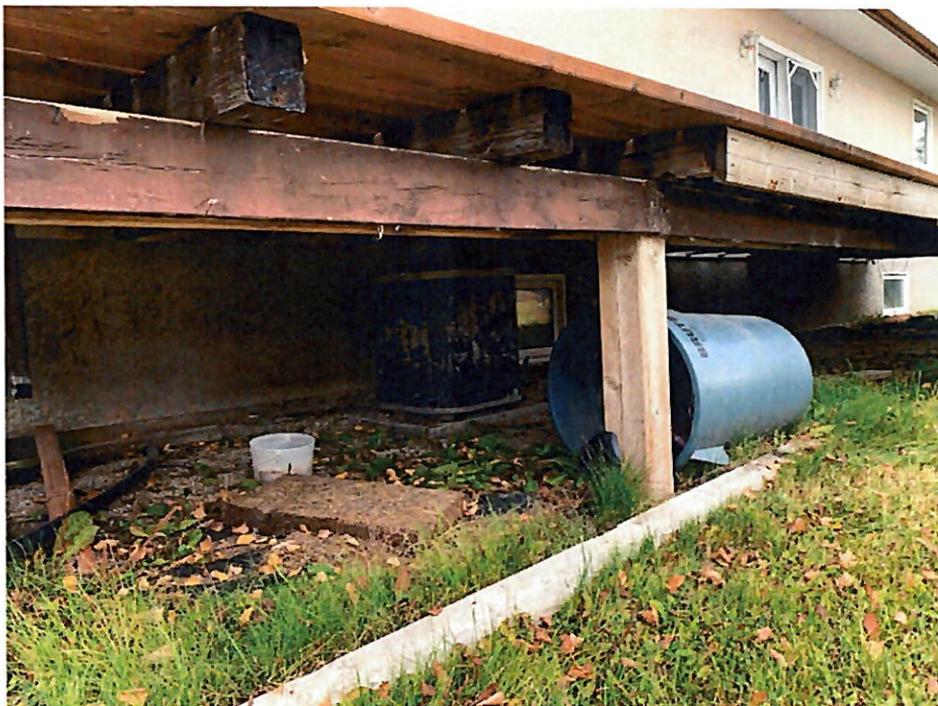
A.10. Air conditioning unit under deck on south side of dwelling

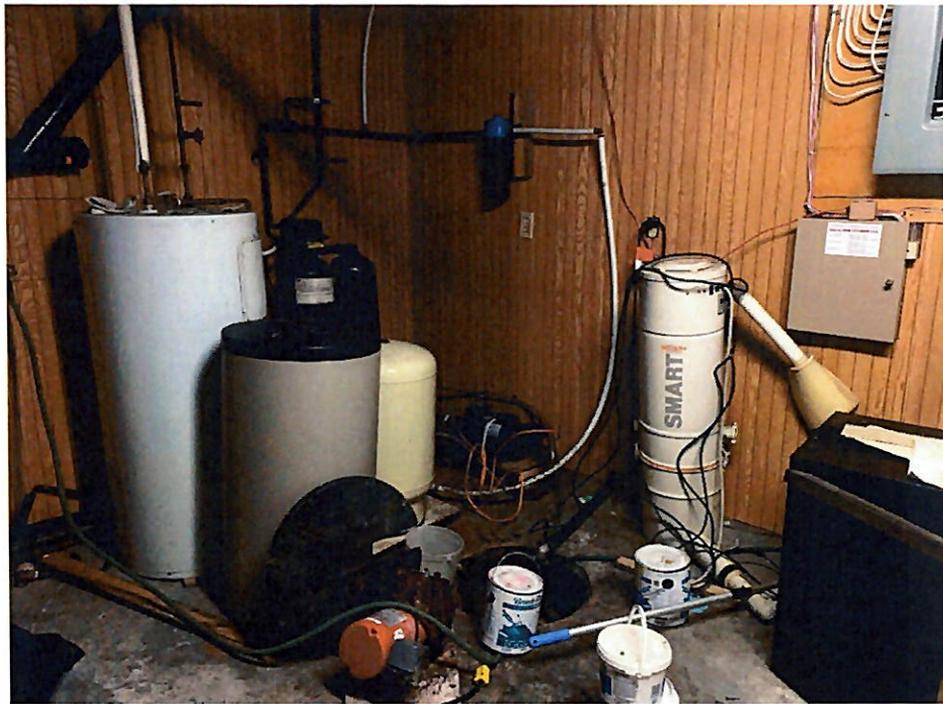
Two sumps were observed in the residential dwelling basement (utility room and storage closet). In addition, a drain was observed in the center of the concrete floor of the garage (discharge point is unknown).

A.18. Utility room – basement of dwelling

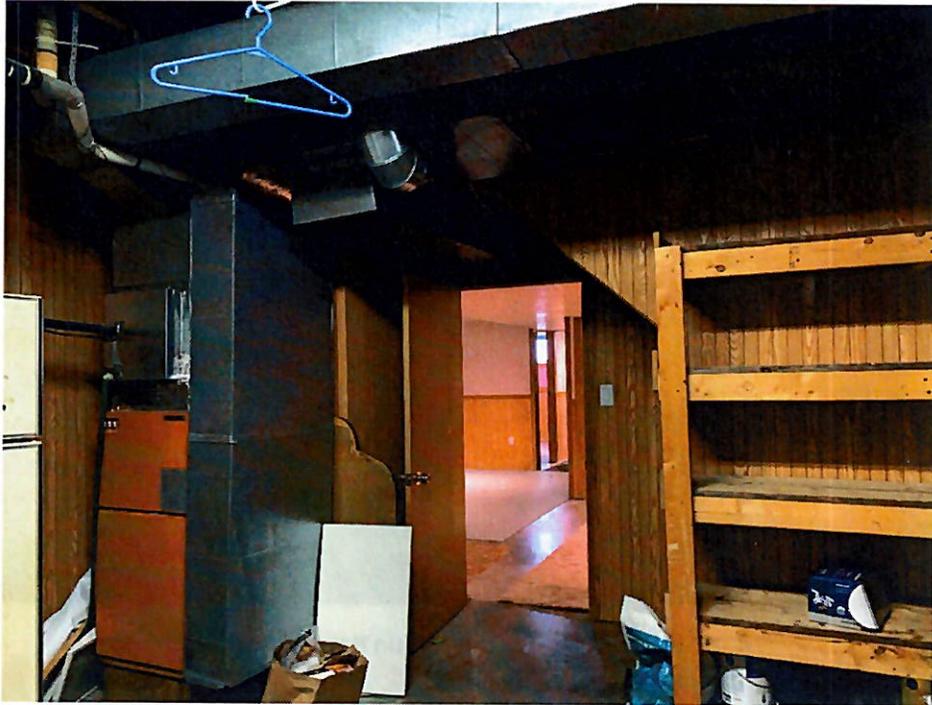
A.19. Utility room – basement of dwelling

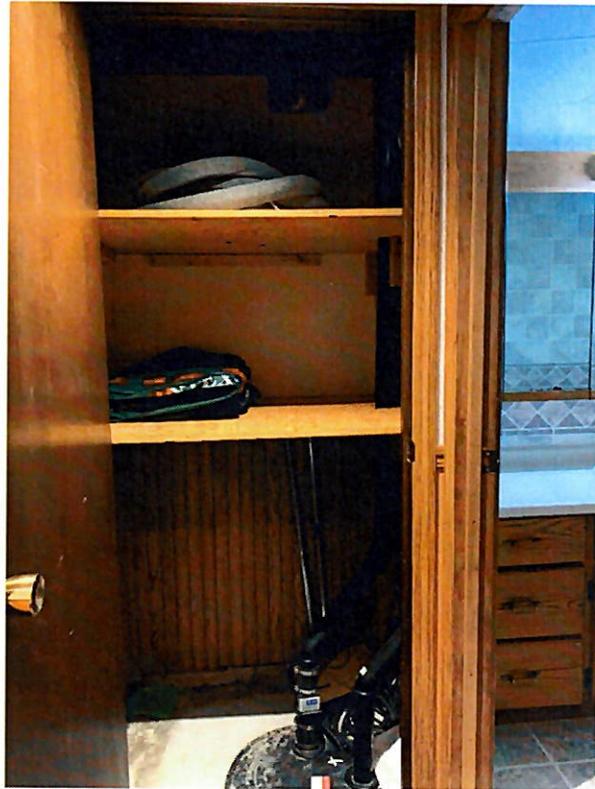
A.20. Sump in storage closet – basement of dwelling

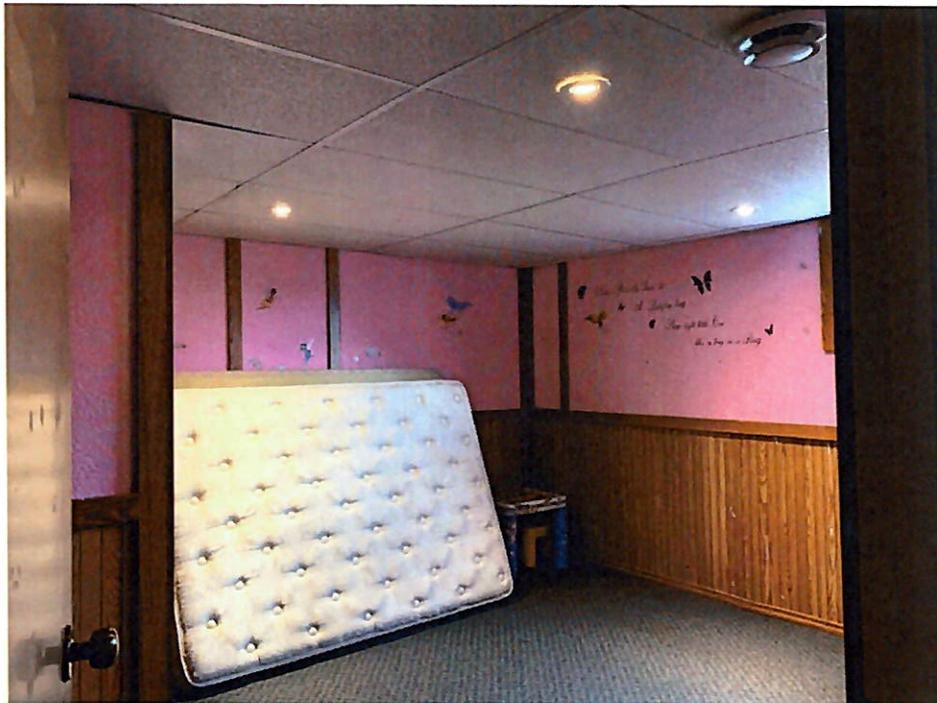
- In April 2024, during a site visit, Ms. Hickman noted the carpet in one of the basement bedrooms was wet. It was determined that an outdoor tap (located on the west side of the house) caused water to leak into the basement bedroom. MTI personnel removed all of the carpet from the bedroom.

A.22. Bedroom – basement of dwelling

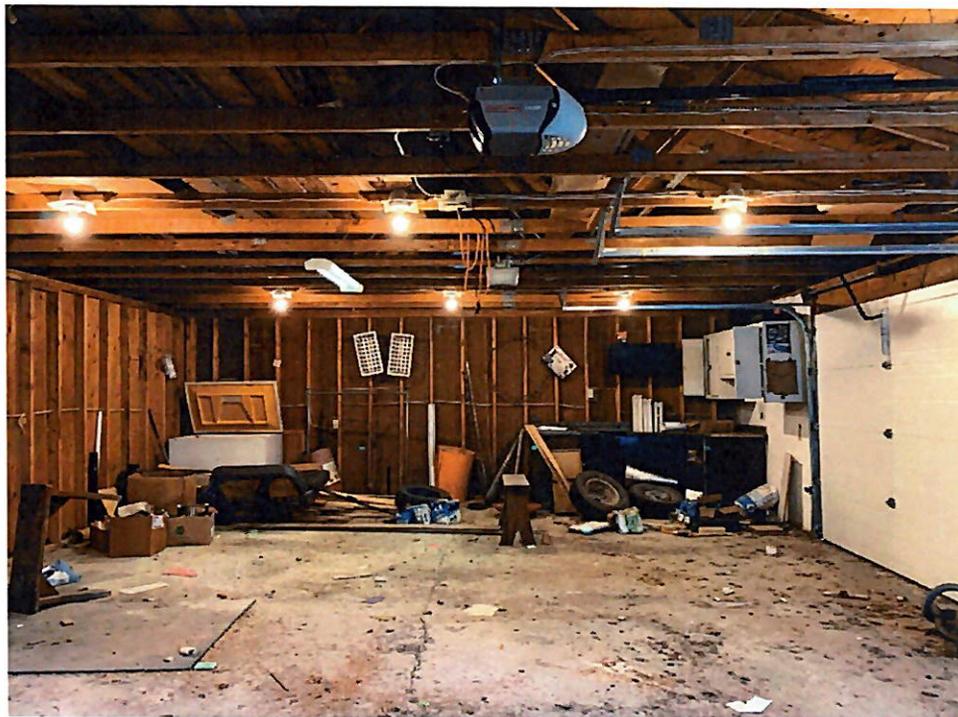
A variety of household and vehicle maintenance materials and chemicals were observed in and around the residential dwelling and garage. In addition, mouse droppings were observed in the garage.

A.30. Garage – interior looking north

- Investigation and/or sampling of the potential mould noted in the residential dwelling;
- Removal of mouse droppings and installation of preventative measures to deter rodents from entering the dwelling and garage;
- Installation of secure lid on the septic tank to address potential safety concerns; and,
- Removal of household and vehicle maintenance materials and associated chemicals observed in and around the residential dwelling and garage.

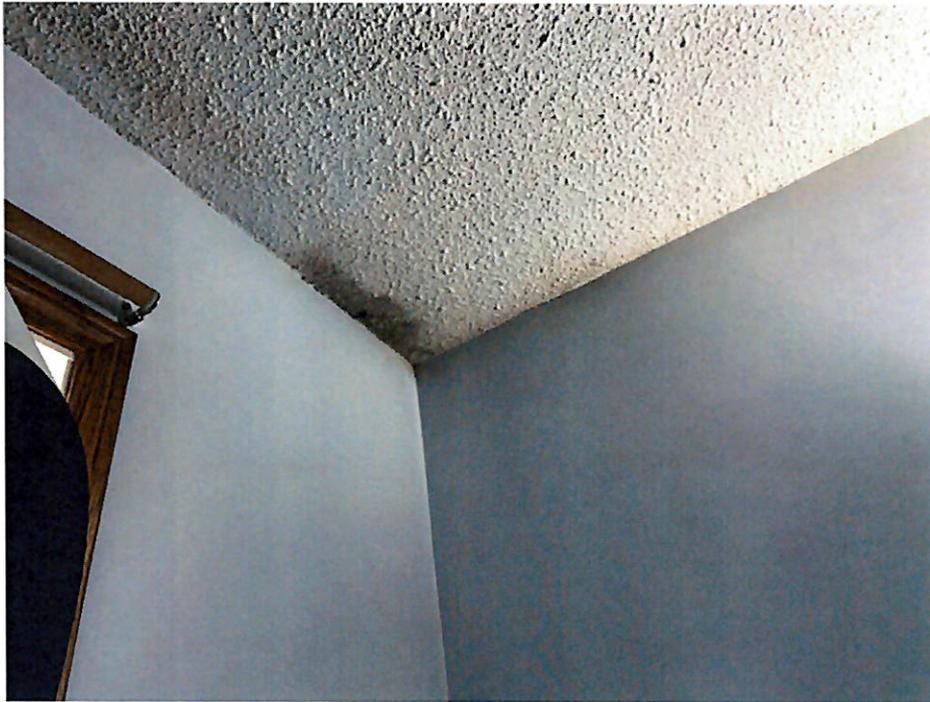
Staining and potential mould was observed on the kitchen and primary bedroom ceilings of the residential dwelling.

A.37. Potential mold on ceiling in primary bedroom

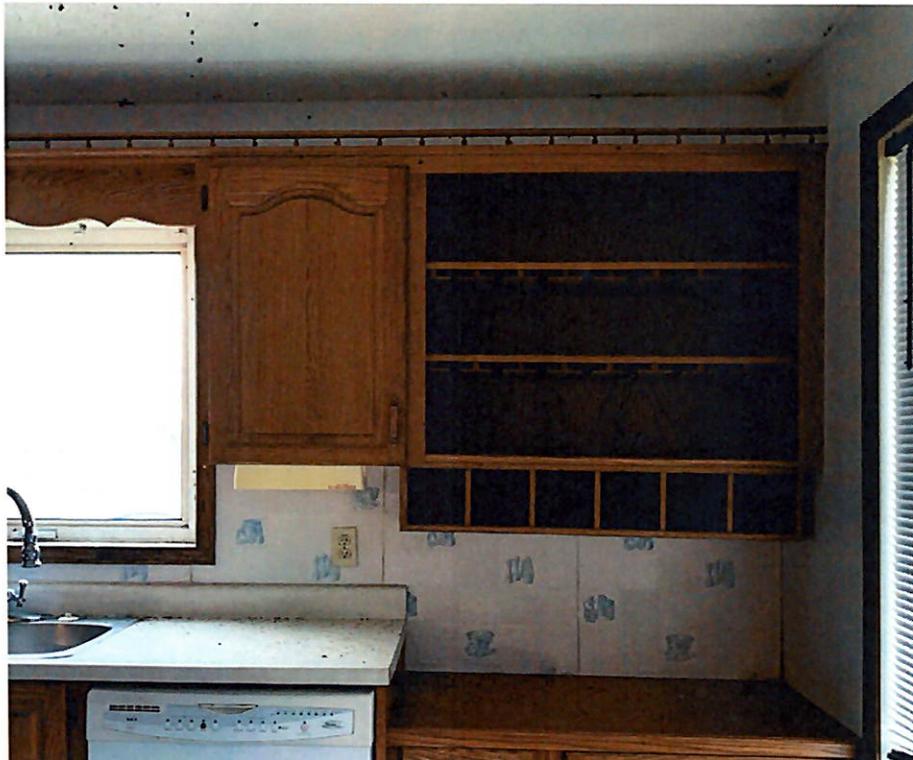
A.38. Potential mold on ceiling in kitchen
