Economic History Theme Study

A HISTORY OF GRAIN ELEVATORS IN MANITOBA

PART 3: A SELECTED INVENTORY

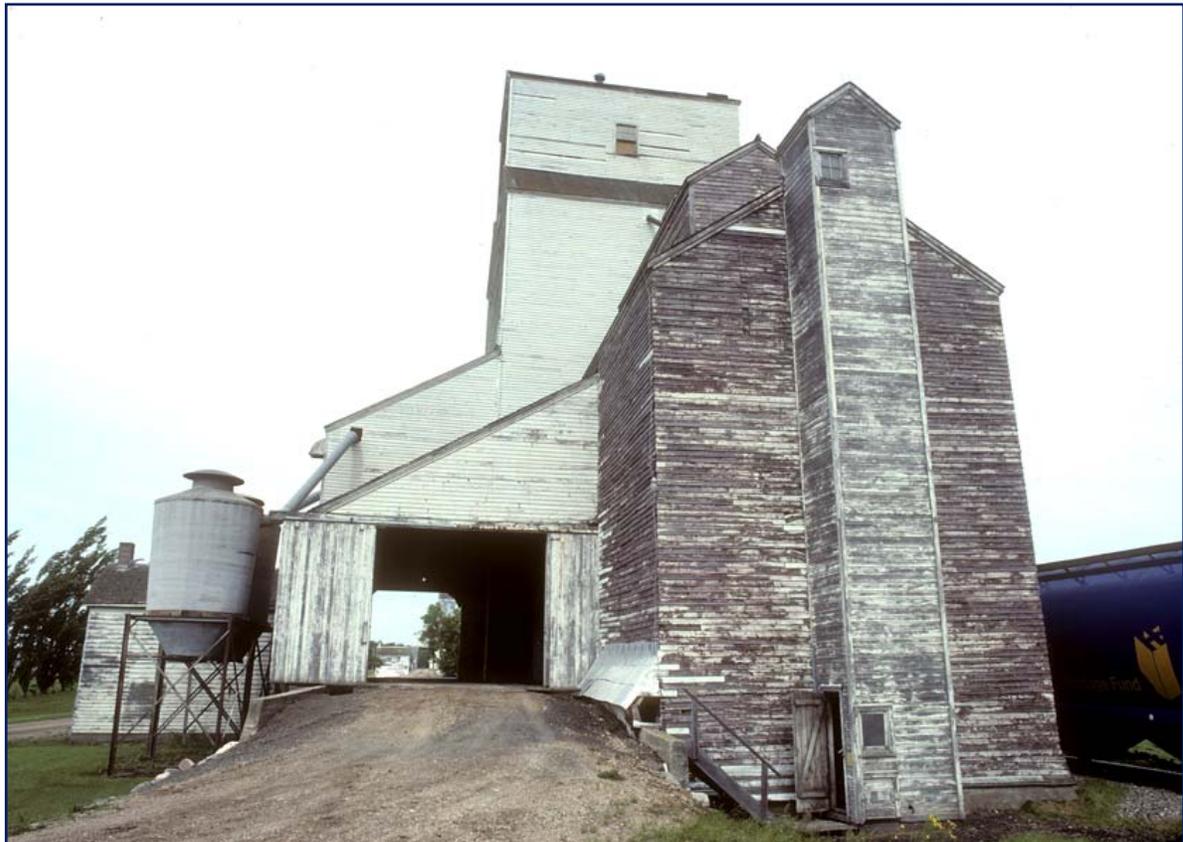
**Altamont
United Grain Growers, 6.L.2**

This elevator is not in particularly good condition. The wood siding has deteriorated in numerous places and there are gaping holes in the driveway roof and walls. However it seems the UGG is currently undertaking some stop-gap repairs.

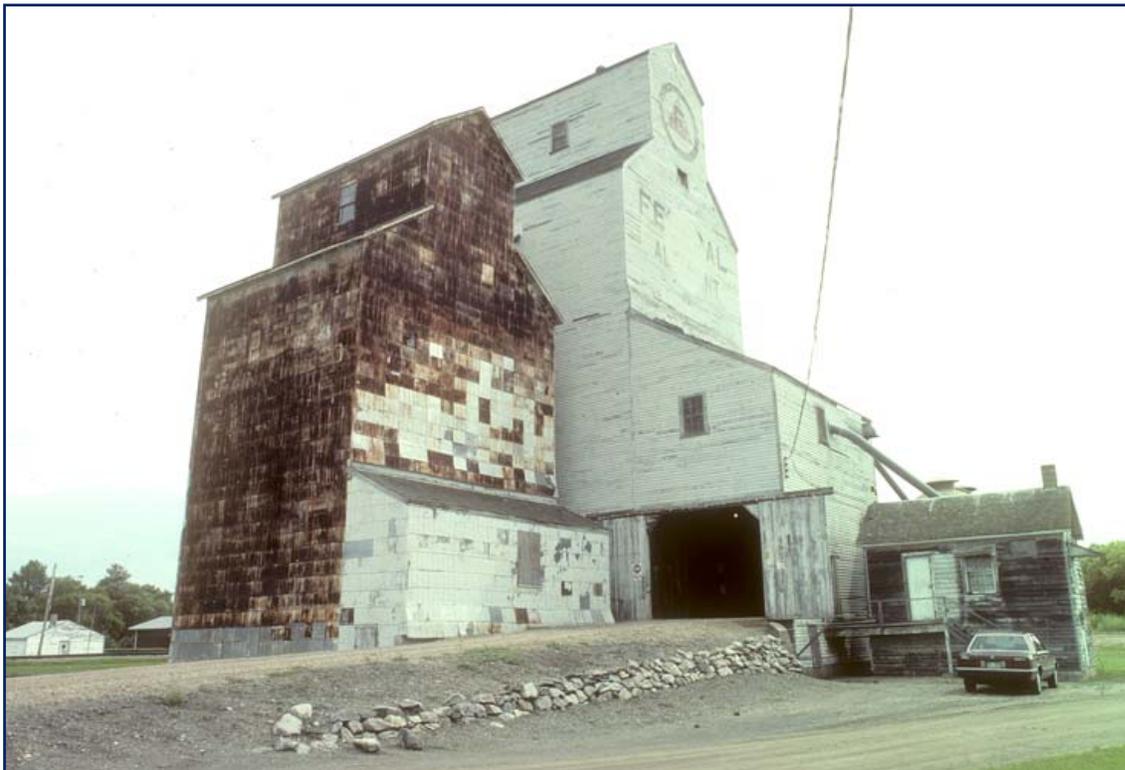
Ashville
United Grain Growers, 20.L.1

This elevator is in good condition owing to its continued use by a major grain company.

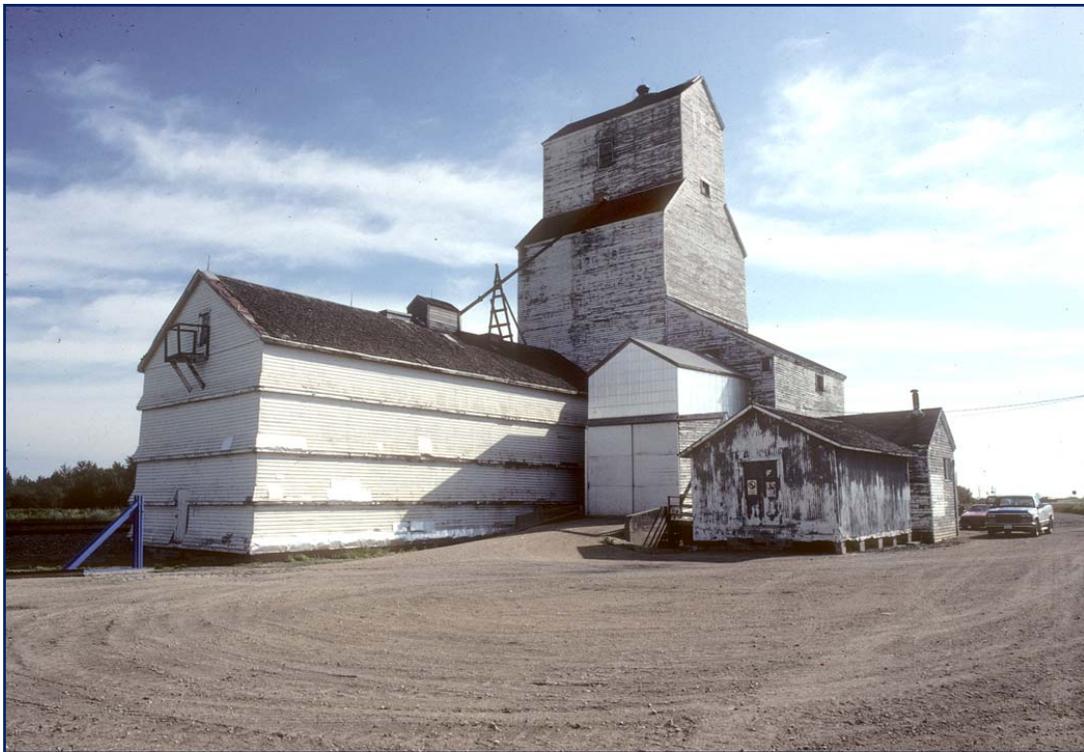
Austin Manitoba Agricultural Museum 25.L.2

This elevator is well maintained by the museum staff and is in excellent condition. It is not kept in working order but every indication is that it could be. It is covered in tin siding that has probably been put on since 1976.

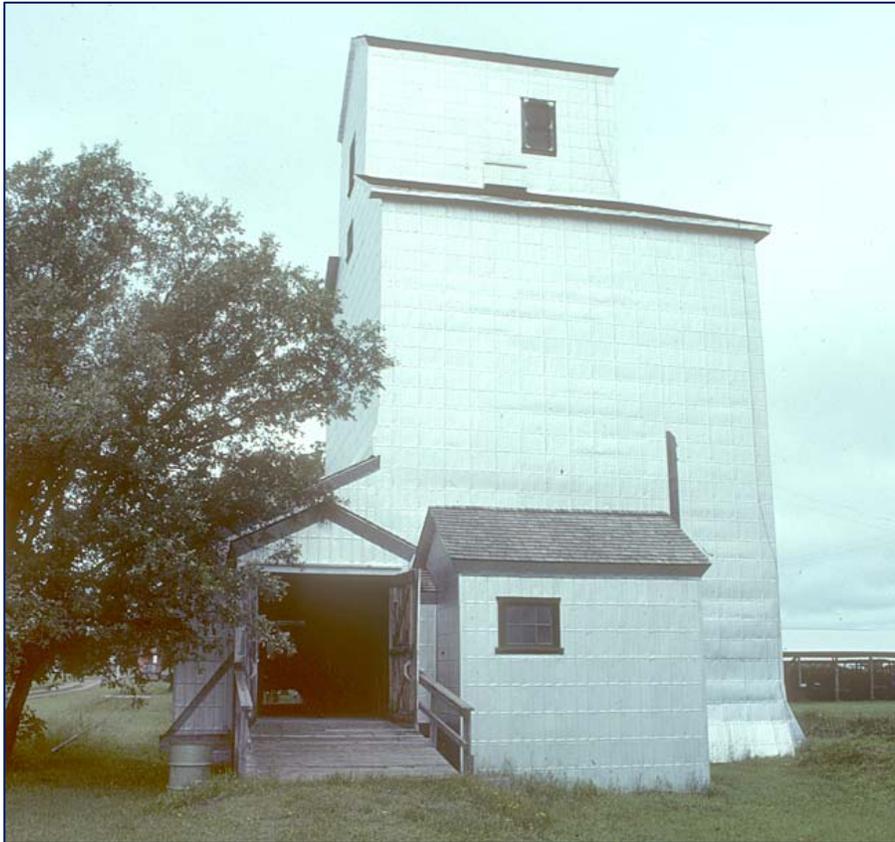
Barnsley 726.L.2

The exterior of the elevator is covered with tin siding which has provided good protection against the elements. However, in a couple of areas where the siding is not present, rotting of the structure has begun. This is particularly true in the north-east corner of the elevator. The foundation appears sound, as do the main structural supports of the driveway. The condition of the interior floors, walls, and ceilings is good, but most windows have been broken or are in serious disrepair. One end of the driveway is without a door. This combined with the animal infestation that has occurred, means that the interior is not very clean. The elevator has not been used in at least a decade. Therefore the exact state of its mechanical workings is difficult to determine. However, the major components appear to be in good condition and probably could be returned to working order with a minimum of maintenance.

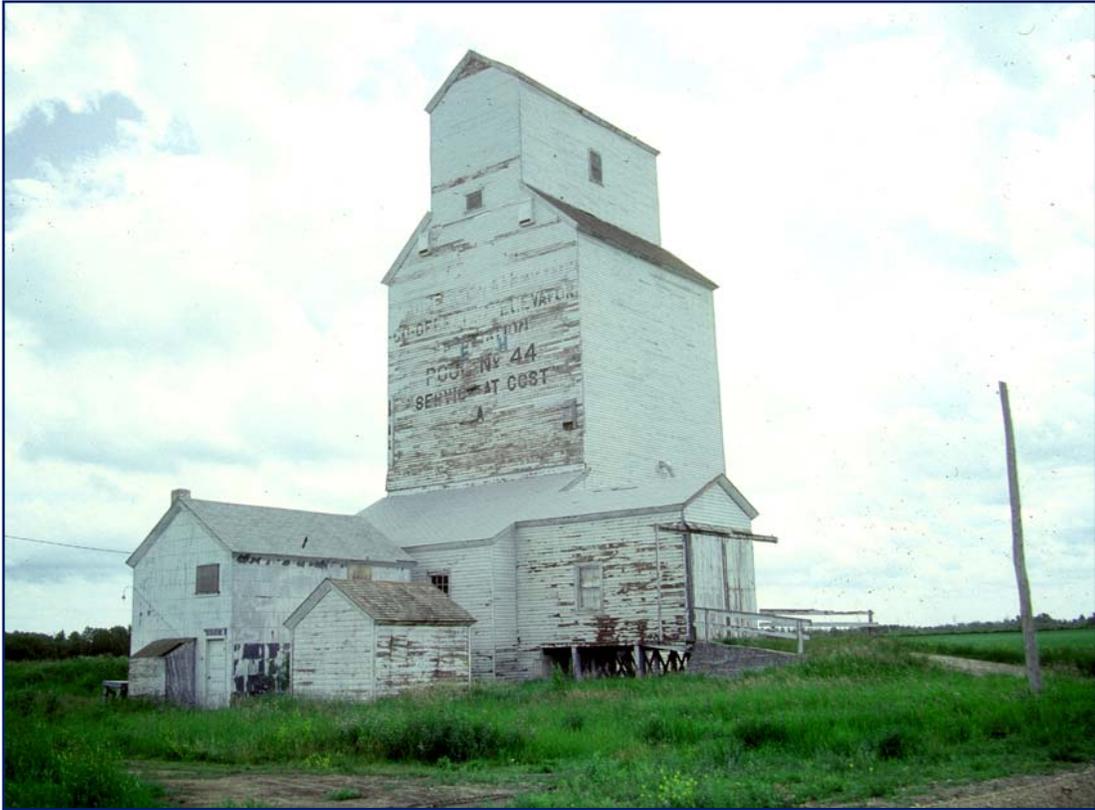
Beulah
Beulah Farmers' CO-Operative, 45.L.1

The elevator has suffered from a general deterioration of those areas exposed to the elements, including the wood siding and shingles. Structurally it appears to be sound.

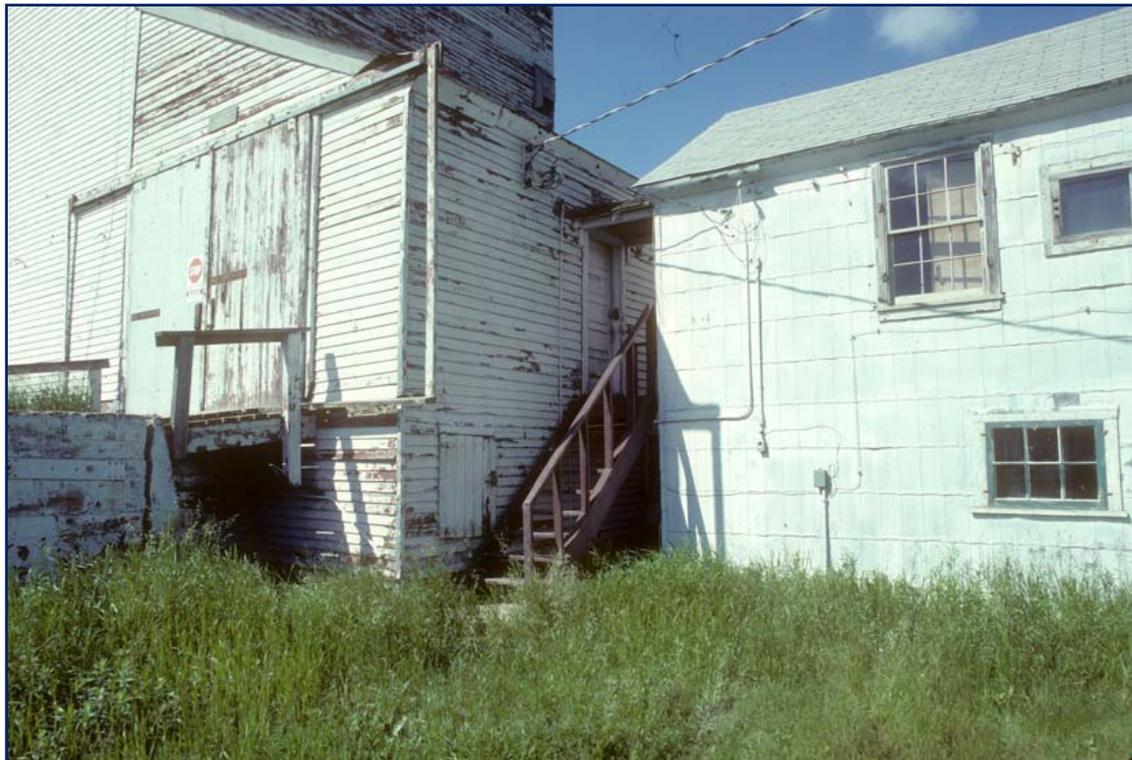
**Birdtail
Private Farmer, 51.L.1**

The elevator is in slightly below average condition with some of the wood siding in need of repair or replacement and the cribbed walls have begun to rot in several areas.

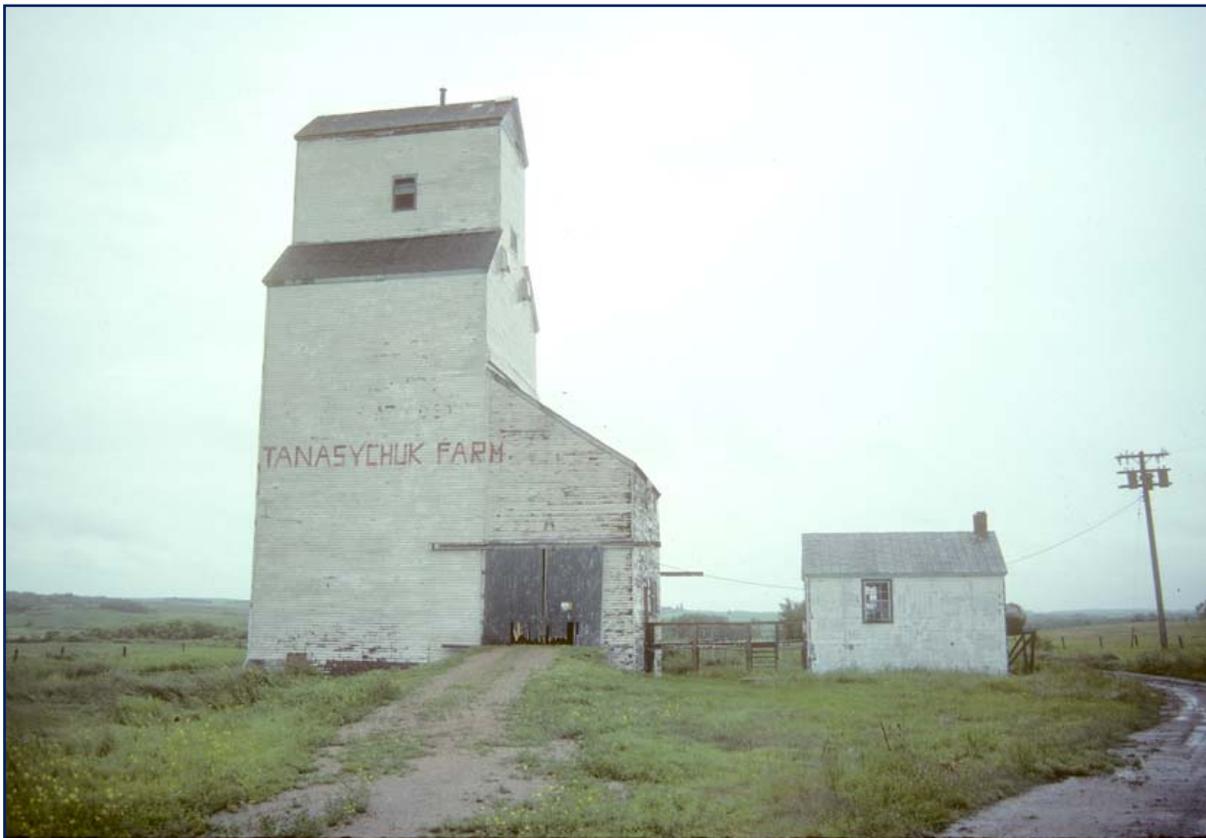
**Bradwardine
Private Owner, 59.L.1**

The elevator is in good physical condition. The 'red pool' paint scheme has survived very well.

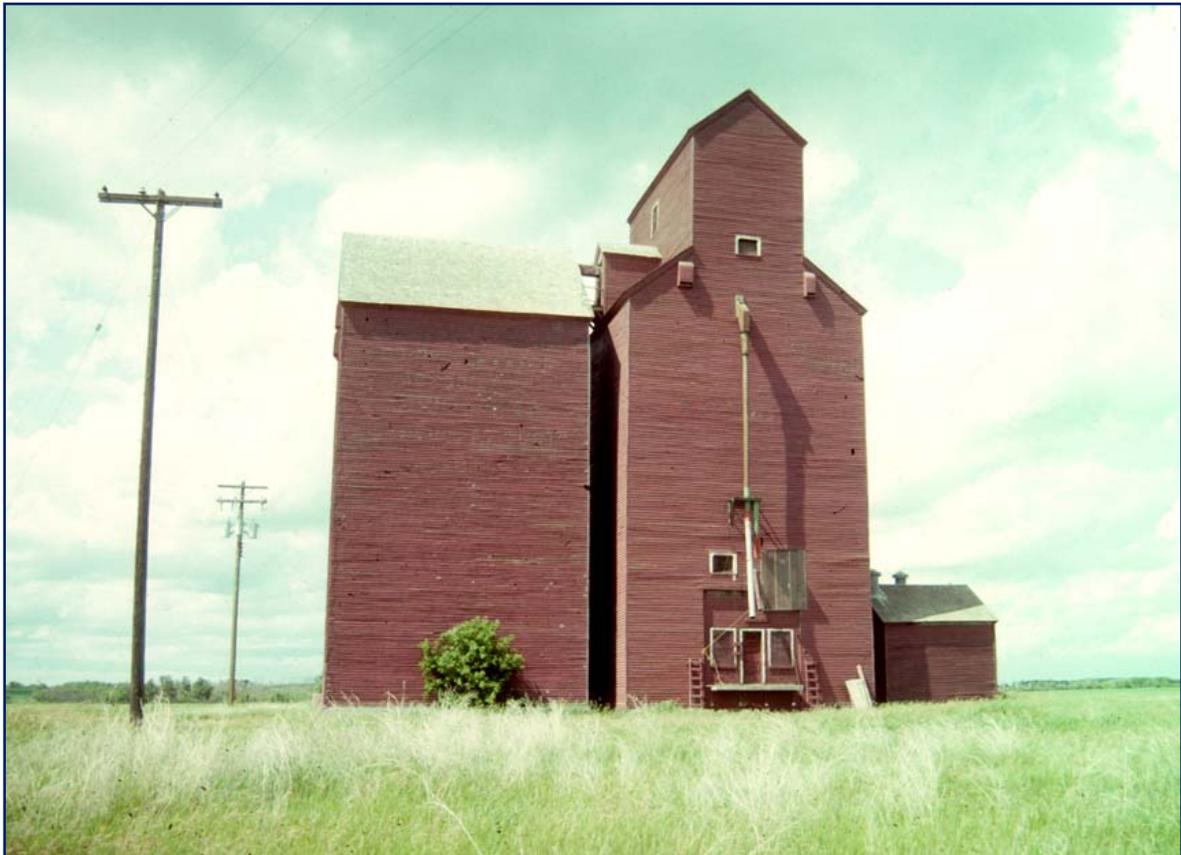
Brookdale 65.L.1

Structurally the elevator appears sound but both the shingles and wood siding are generally poor condition and need repair or replacement.

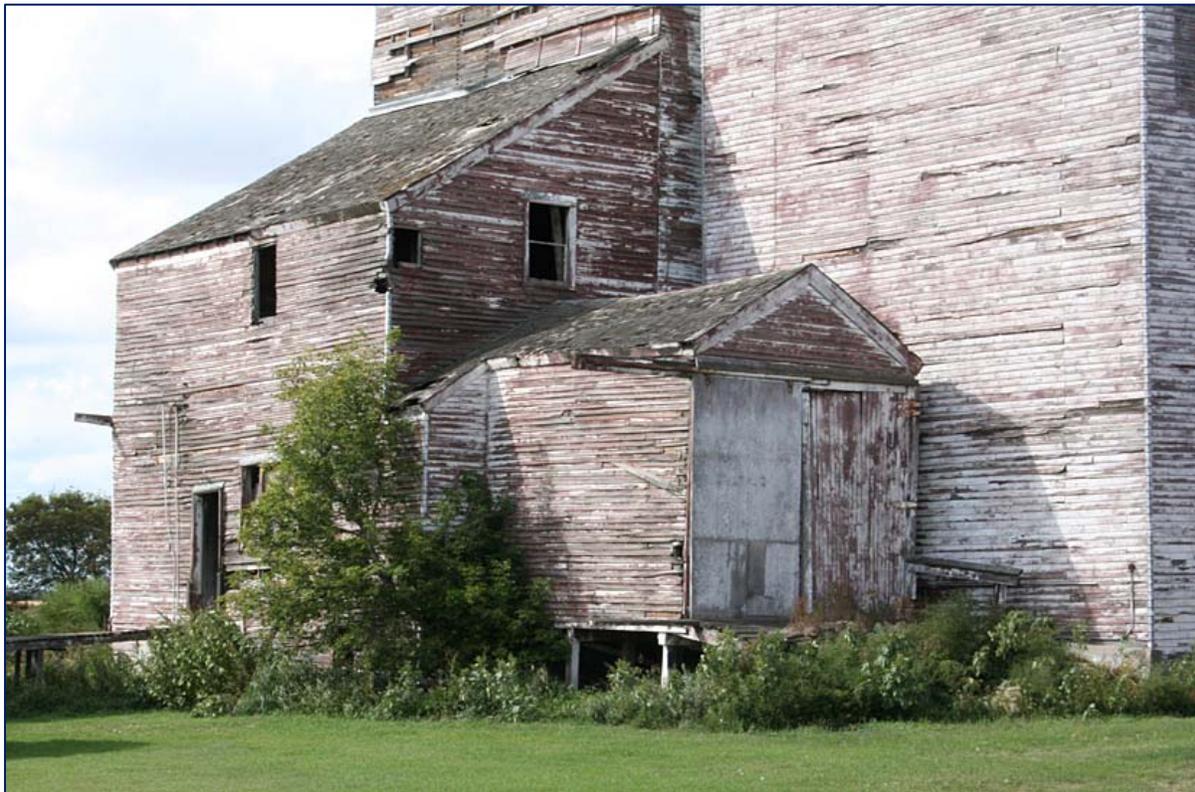
Brookdale (Private Owner) 65.L.2

This elevator has been extensively repaired, including the installation of new t5in sidings, since entering private hands. It is in good condition.

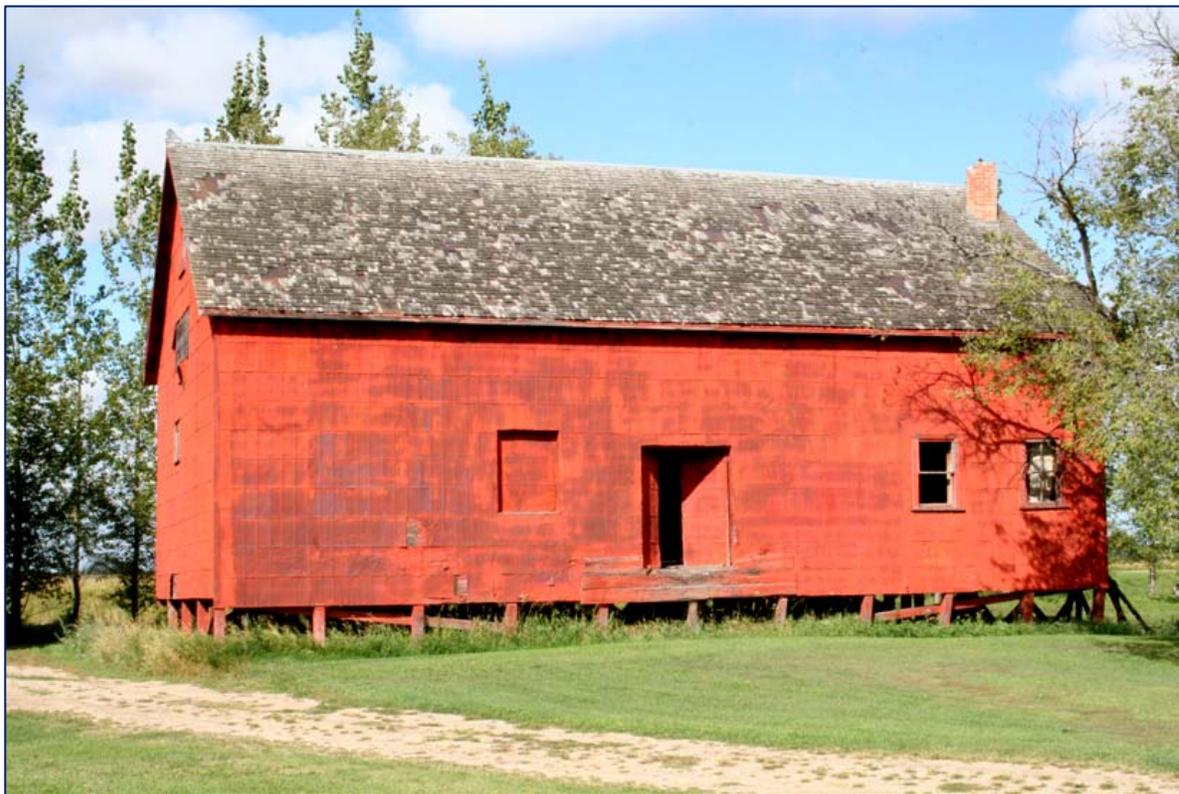
Brookdale 65.L.3

Structurally the warehouse appears sound, but both is in need of general repair and maintenance.

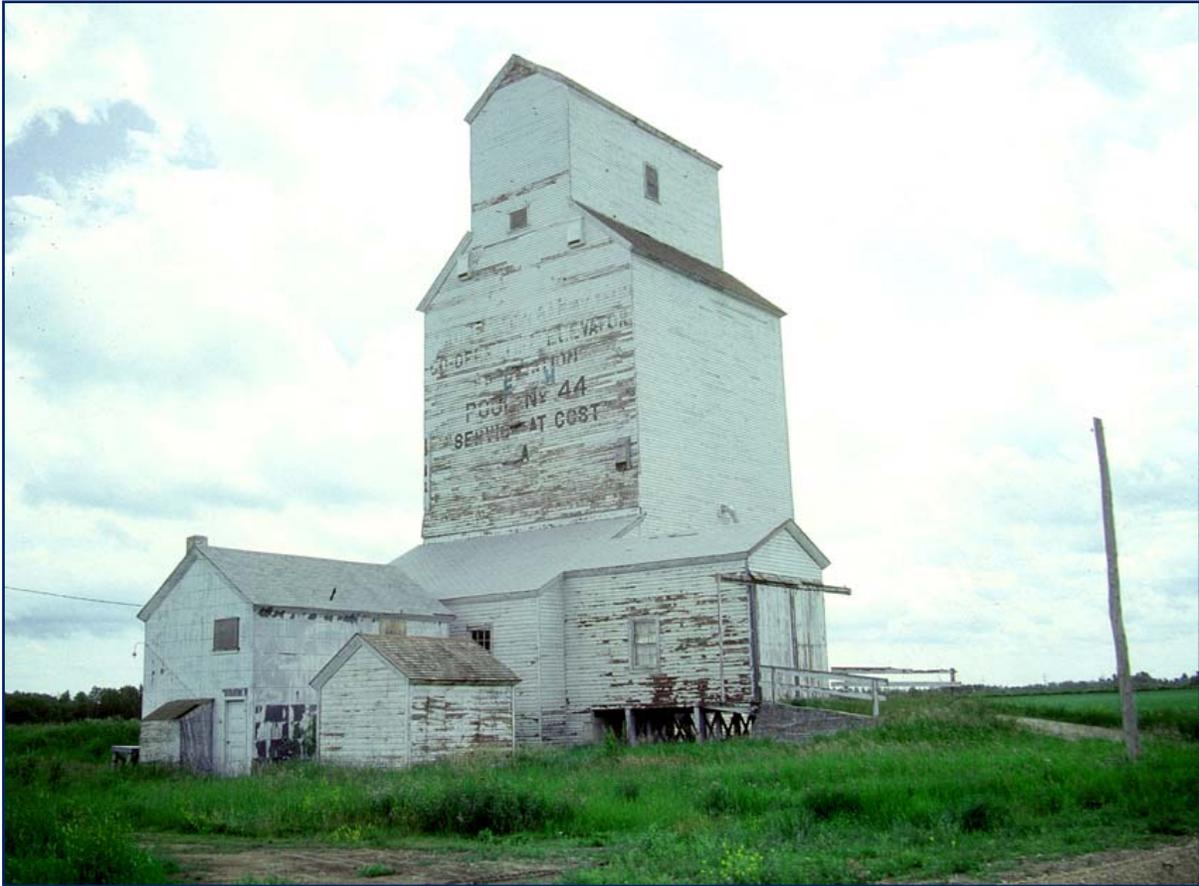
Beulah
Beulah Farmers' Co-operative, 45.L.1

The elevator has suffered from a general deterioration of those areas exposed to the elements, including the wood siding and shingles. Structurally it appears to be sound.

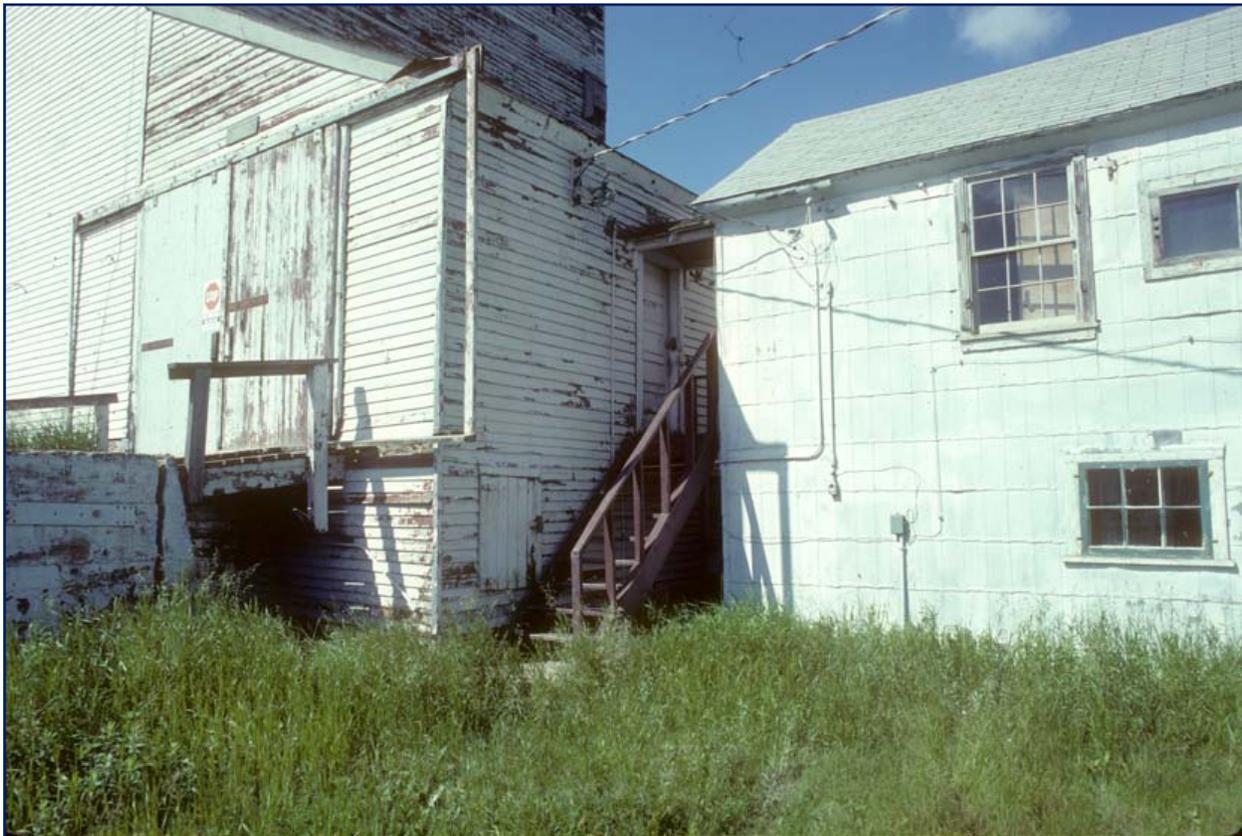
**Bryd
N.M. Paterson & Sons, 800.L.1**

This elevator is in good condition, typical of corporate elevators that are in regular use.

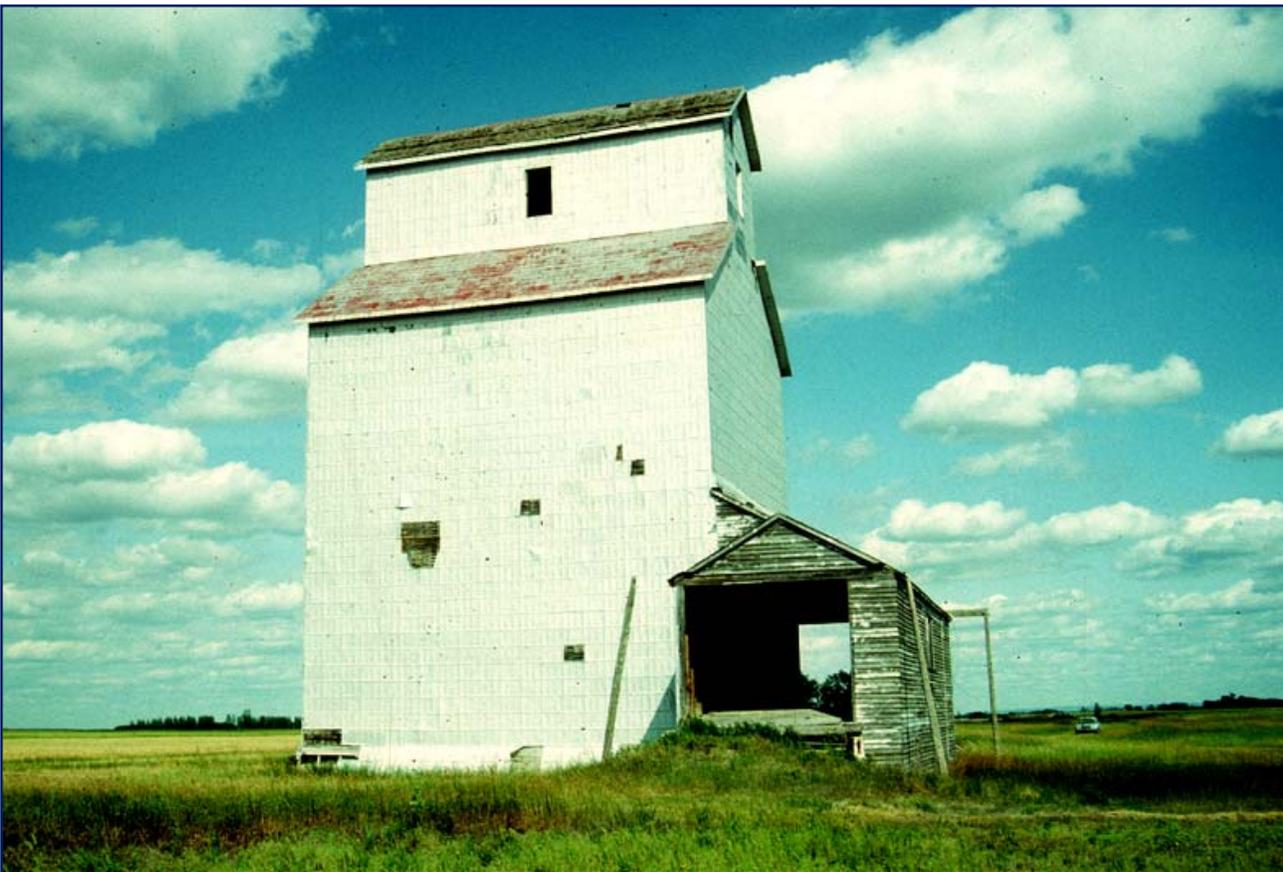
Dufrost
N.M. Paterson & Sons, 133.L.2

The elevator is still in use and therefore is well maintained. It is mechanically sound except for the grain cleaner which requires constant maintenance of its many belts. The exterior is covered in wood siding which provides good protection. A new foundation was poured in the mid-1970s and the elevator is structurally very sound.

Annex: There are two annexes on the site. One is a temporary balloon type built during World War II. It is in very poor condition with extreme structural deflection. The other annex is of permanent cribbed vertical type. It was built in 1950. It is in good condition. Both annexes are in regular use.

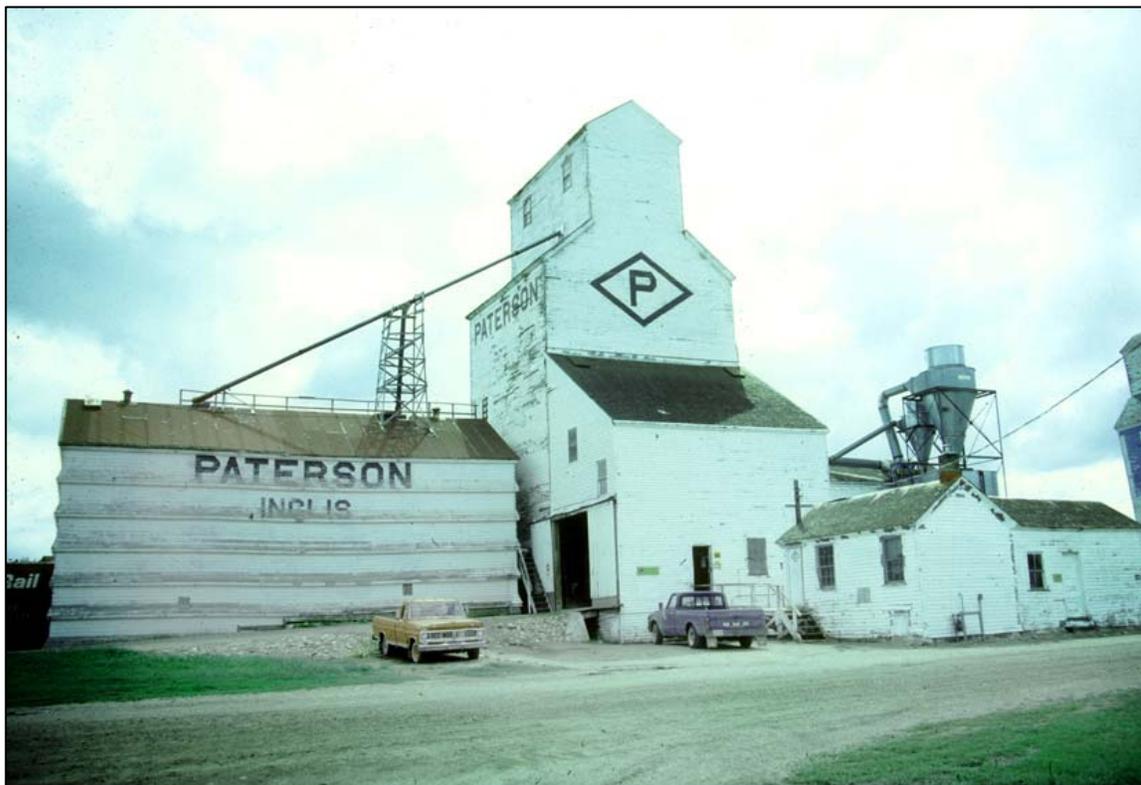
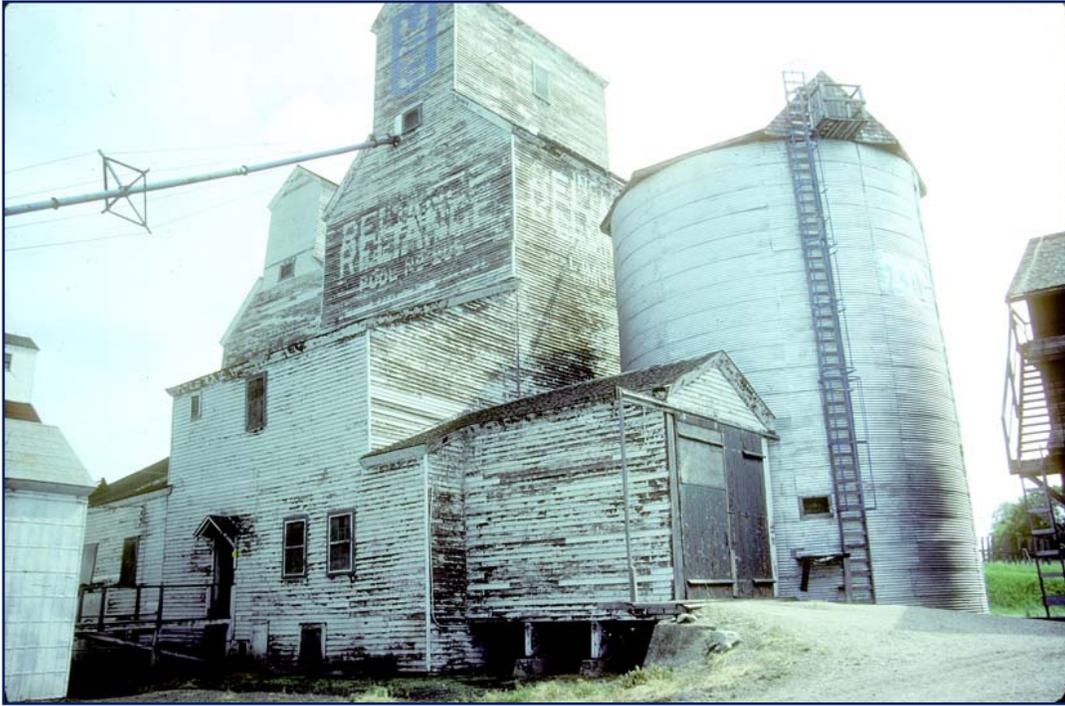
Inglis 245.L.2

The interior of the driveway is in good condition as is the structure of the 'A' elevator. The 'A' elevator is still in use and is mechanically sound. The 'B' elevator is no longer used as the structure is leaning quite severely. It's hopper and leg have also been partly dismantled. Only the main scale is still used in the 'B' elevator. The cause of the lean is a crumbling foundation and the exterior walls suffer from rot in several places.

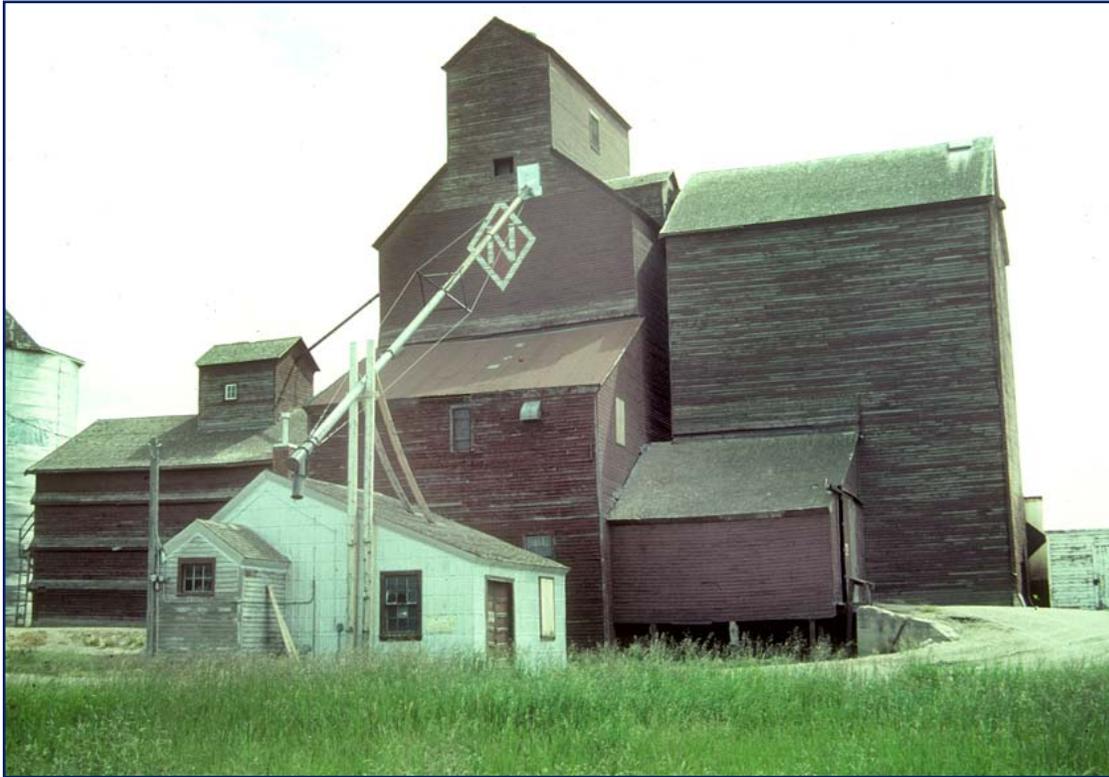
Inglis 245.L.3

The elevator is not in the best of condition. The shingles and wood siding are in need of repair and the elevator appears to have a slight lean. It has not been painted in at least twenty years, as it still has its National colors and logo. Because of its frequent use, the elevator's interior has received regular maintenance and is in generally good condition. Mechanically the elevator is sound.

Annexes: There are two annexes; one is a temporary balloon type while the other is of the permanent vertical cribbed type. Both are currently in use, though they both suffer from general exterior and structural deterioration.

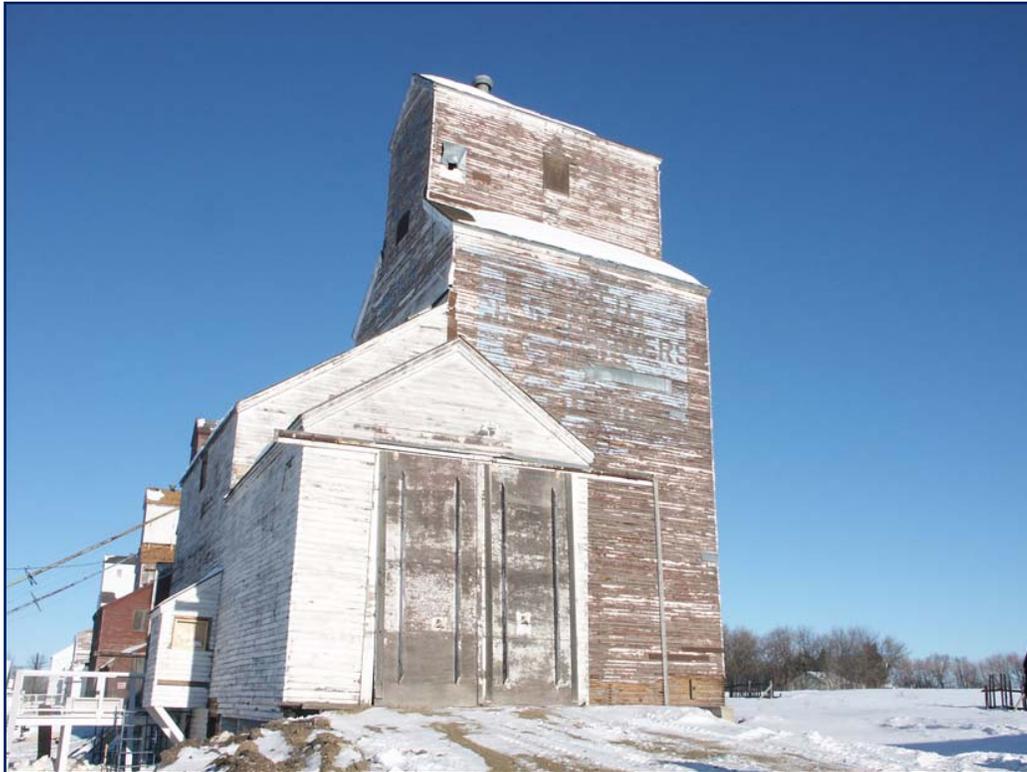
Inglis 245.L.4

The elevator is in good condition inside and out, but there are some areas of concern, in particular the shingles. All mechanical elements of the elevator are in good working condition. The structure of the elevator is solid, as are the ramps. The elevator is in need of a coat of paint.

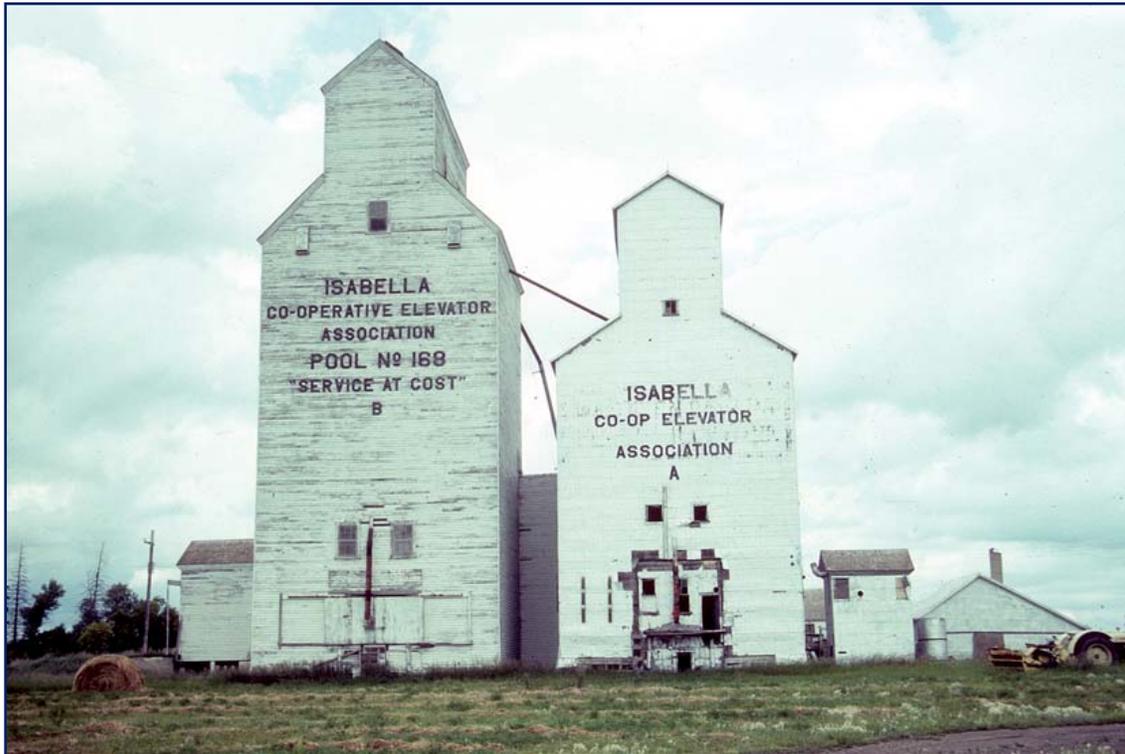
Isabella
Private Owner, 247.L.1

The elevator is in poor condition inside and out. The wood sidings and shingles are in need of repair. Some of the grain spouts have been removed from the Traditional Tall elevator and it is not in working order. Animal infestation has occurred.

Office: There are two offices on the elevator site. The first is the Traditional Tall elevator's original office. It stands beside the elevator and is not attached by a walkway. It is in poor condition. The second office is connected to the driveway and was built in 1970. It is in good condition.

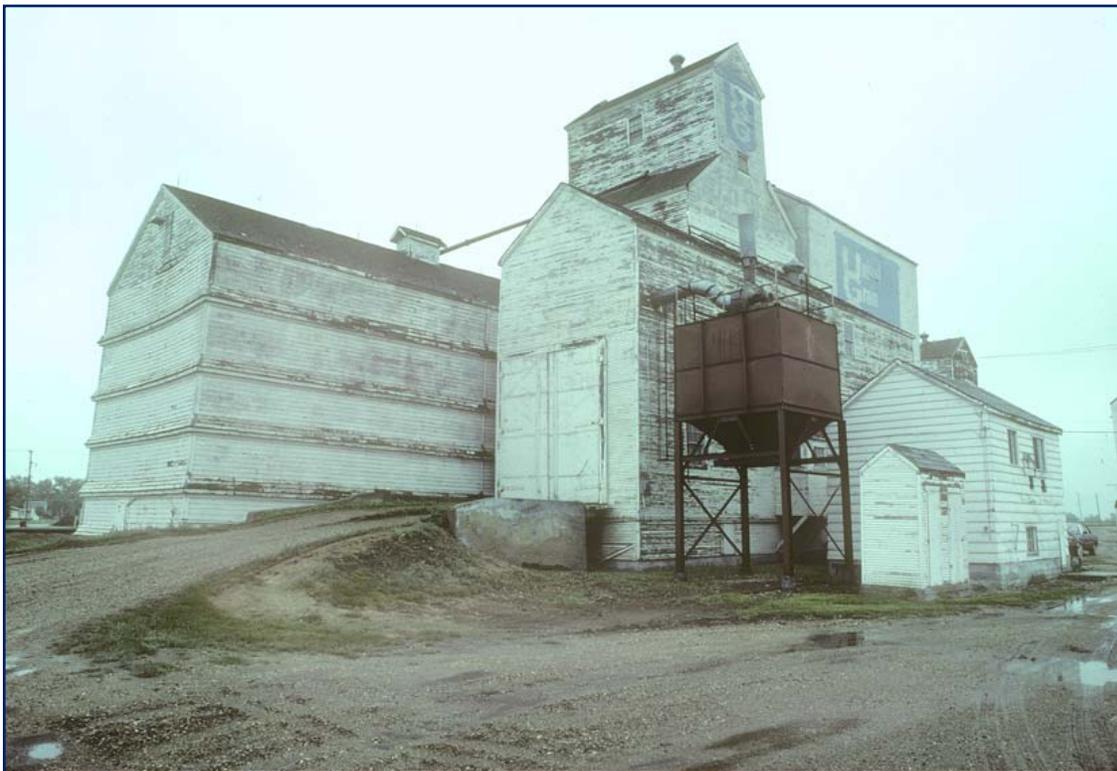
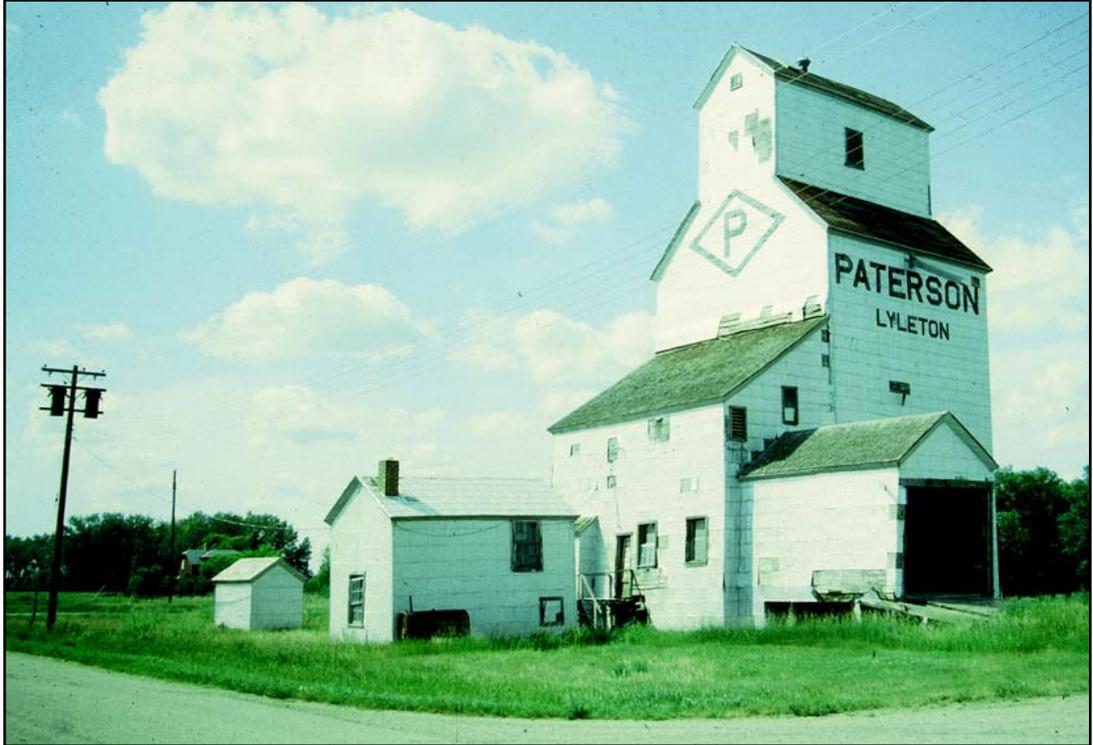
**Lyleton
Private Owner, 301.L.1**

This elevator has a slight lean and its shingles and wood siding are in need of repair. One of the driveway doors is missing.

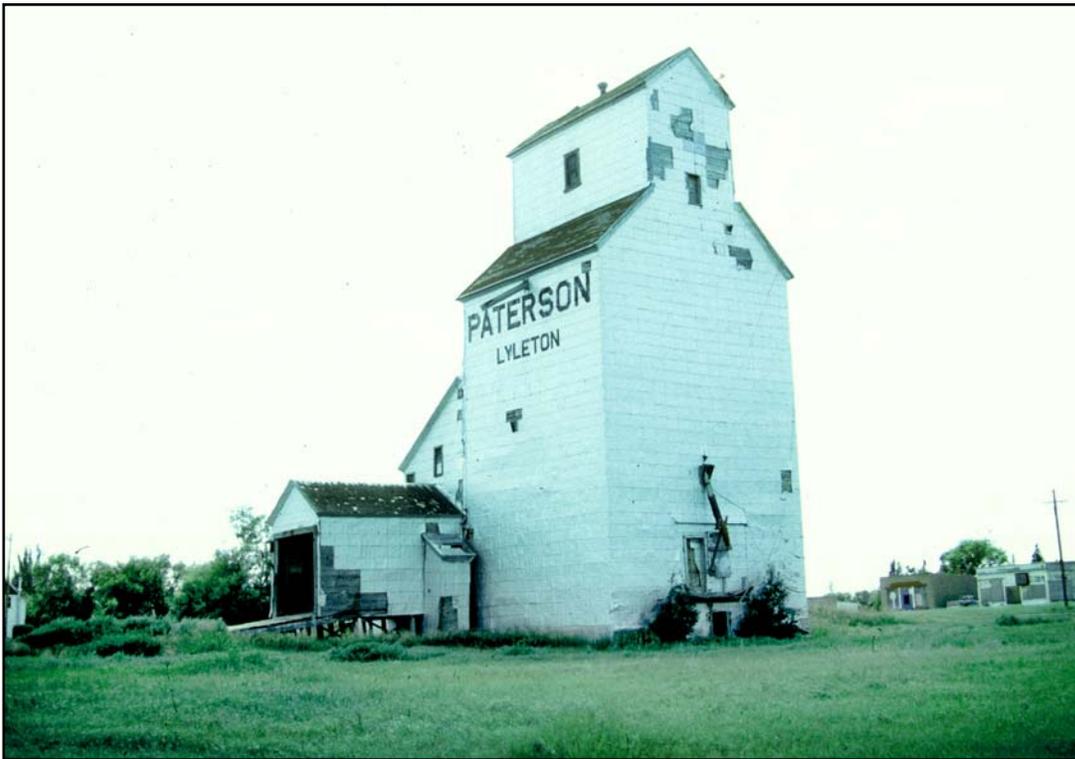
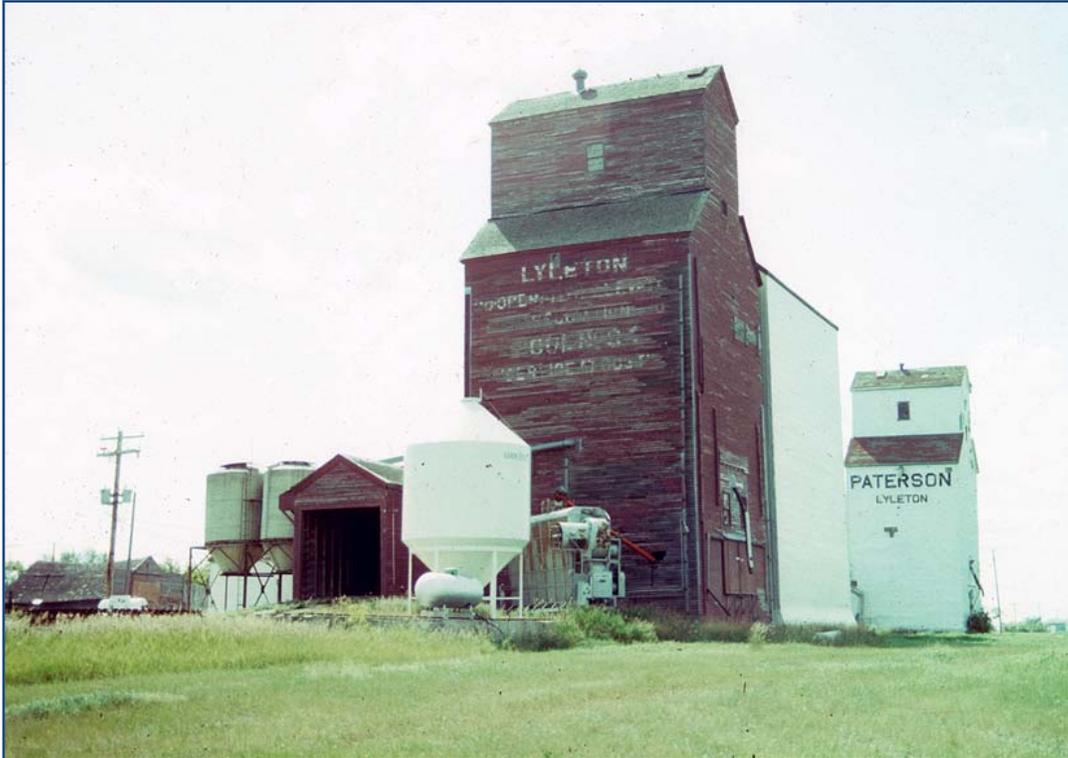
**Lyleton
Private Owner, 301.L.2**

The elevator is in generally good condition except for the wood siding which has begun to rot in several places. The 'red pool' paint scheme has survived quite well.

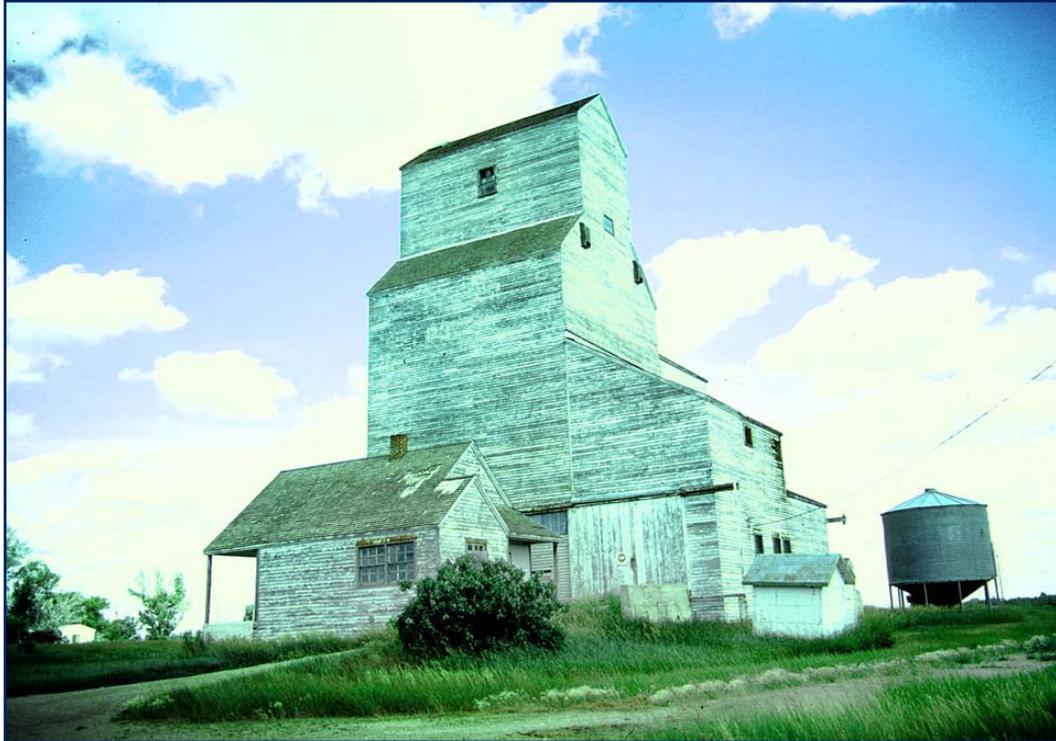
Tilston
Private owner, 556.L.2

The elevator's wood siding and shingles are not in very good condition. The elevator seems to have a slight lean.

Annex: The elevator has one Overgaard annex built c. 1950. It is in good condition.
