Economic History Theme Study

A HISTORY OF GRAIN ELEVATORS IN MANITOBA

PART 3: A SELECTED INVENTORY

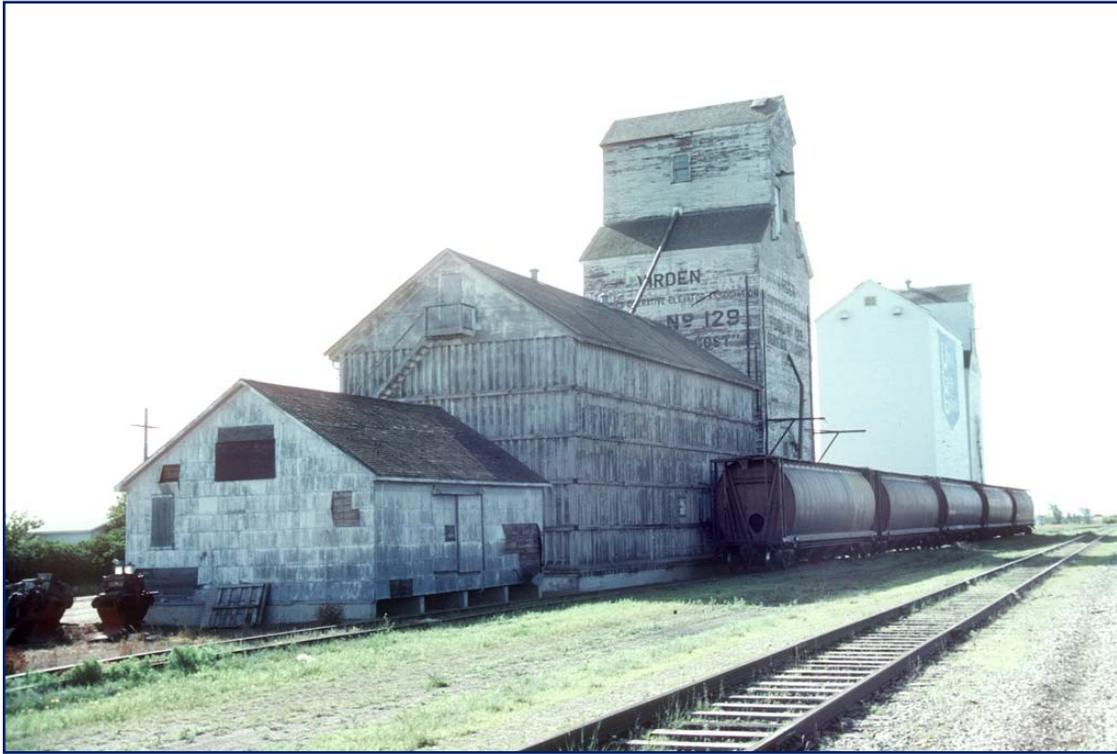
Virден Kent Flour Mills, 574.L.2

Mechanically the elevator is in good condition and it is used regularly. However, the shingles and wood siding are in need of repair or replacement. The elevator has a noticeable lean, although it is not severe enough to affect the performance of the leg. Some Pool colors are visible through the weathered paint scheme.

Office: The office is of the large attached type and was built in the 1960s or 1970s it is in good condition, but it detracts from the elevator's structural integrity.

Annex: The elevator's annex is of the Overgaard type and was probably built c.1950. it is in good mechanical condition but it has had all of its metal siding removed.
