# **MANITOBA–MINNESOTA TRANSMISSION PROJECT Environmental Monitoring Plan**

## **SHARP-TAILED GROUSE MONITORING REPORT 2021**

Prepared for  
Manitoba Hydro

By  
Wildlife Resource Consulting Services MB Inc.

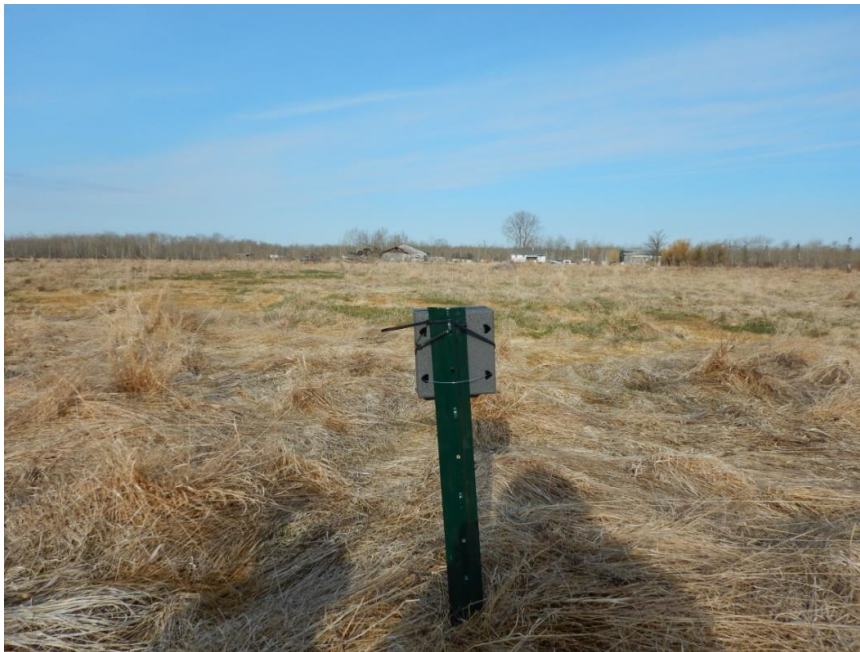
**Photo 1: Trail camera at a sharp-tailed grouse lek**

Sustainable Development (B. Kiss 2017, pers. comm.). Two Reconyx™ PM35C31 trail cameras, one facing north and the other west, were set up to photograph sharp-tailed grouse activity (Photo 1). Short metal stakes were driven into the ground, to which trail cameras were fastened with zip ties. Cameras were programmed to take a series of 30 rapid-fire photos every five minutes from 4:00 a.m. until 8:00 a.m.

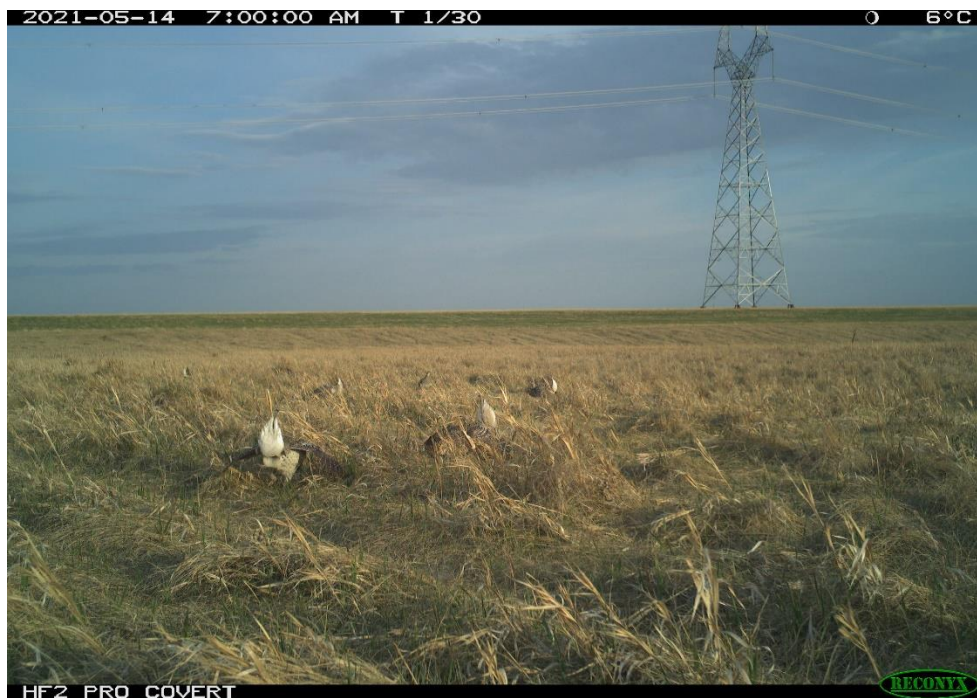
**Photo 2: Dancing sharp-tailed grouse at lek 495L May 14, 2021, with MMTP in background**

In 2021, the greatest proportion of grouse activity photographed was loafing/feeding at nine of 10 leks (Table 6). Reproductive behaviour (Photo 2), which was observed as early as 5:00 a.m. and generally continued until the end of the programmed photo period at 8:00 a.m., was photographed at all 10 leks and was the second-most frequent activity at all but one. Flush and alert behaviours were observed at all leks but there was typically little of each. Flush and alert behaviours were greatest at reference sites 263L and 461L, respectively (Figure 1). When only known behaviours were considered, there was no significant difference between the mean proportion of

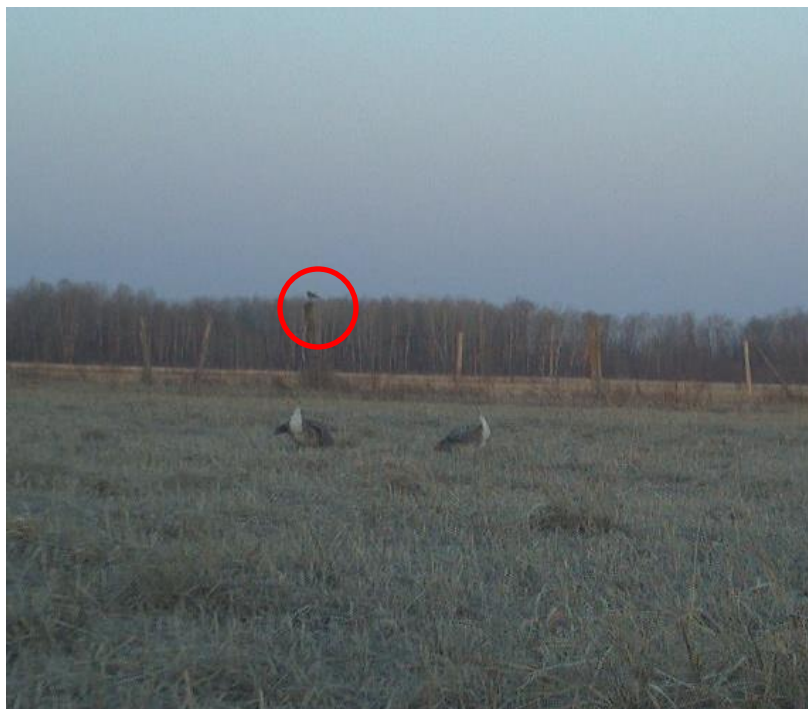
**Photo 4: Unknown large bird (circled) perched on fence post near dancing sharp-tailed grouse at lek 263L April 22, 2021**

sequence exhibited alert behaviour for a few seconds and then returned to loafing; no grouse were flushed when it appeared. Three males began to dance while the large bird was present (Photo 4). In this single instance where an avian predator was potentially photographed with sharp-tailed grouse in 2021, its presence had no apparent effect on grouse behaviour.
