STRUCTURE CONTOUR & ISOPACH MAP
 DEVONIAN – ASHERN
 FORMATION

Revised: January, 1980/H.R.McCabe
December, 1991/C.D.Martiniuk
Reissued: R.K.Bezys/1998

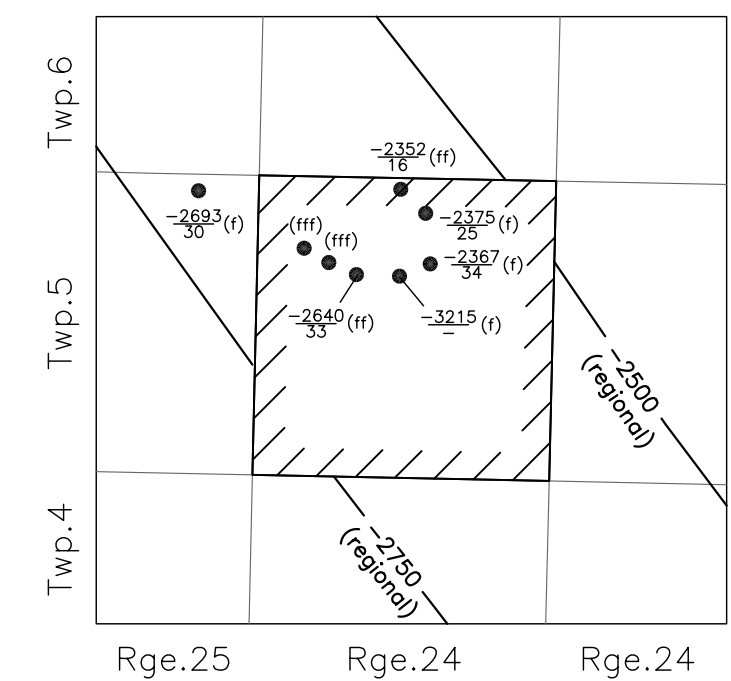
HARTNEY AREA

Contours not indicated in Twp. 5, Rge. 24
Structurally complex area; probable crater structure.
(f)—some faulting noted, or significant isopach anomaly.
(ff)—highly faulted, no correlation possible.

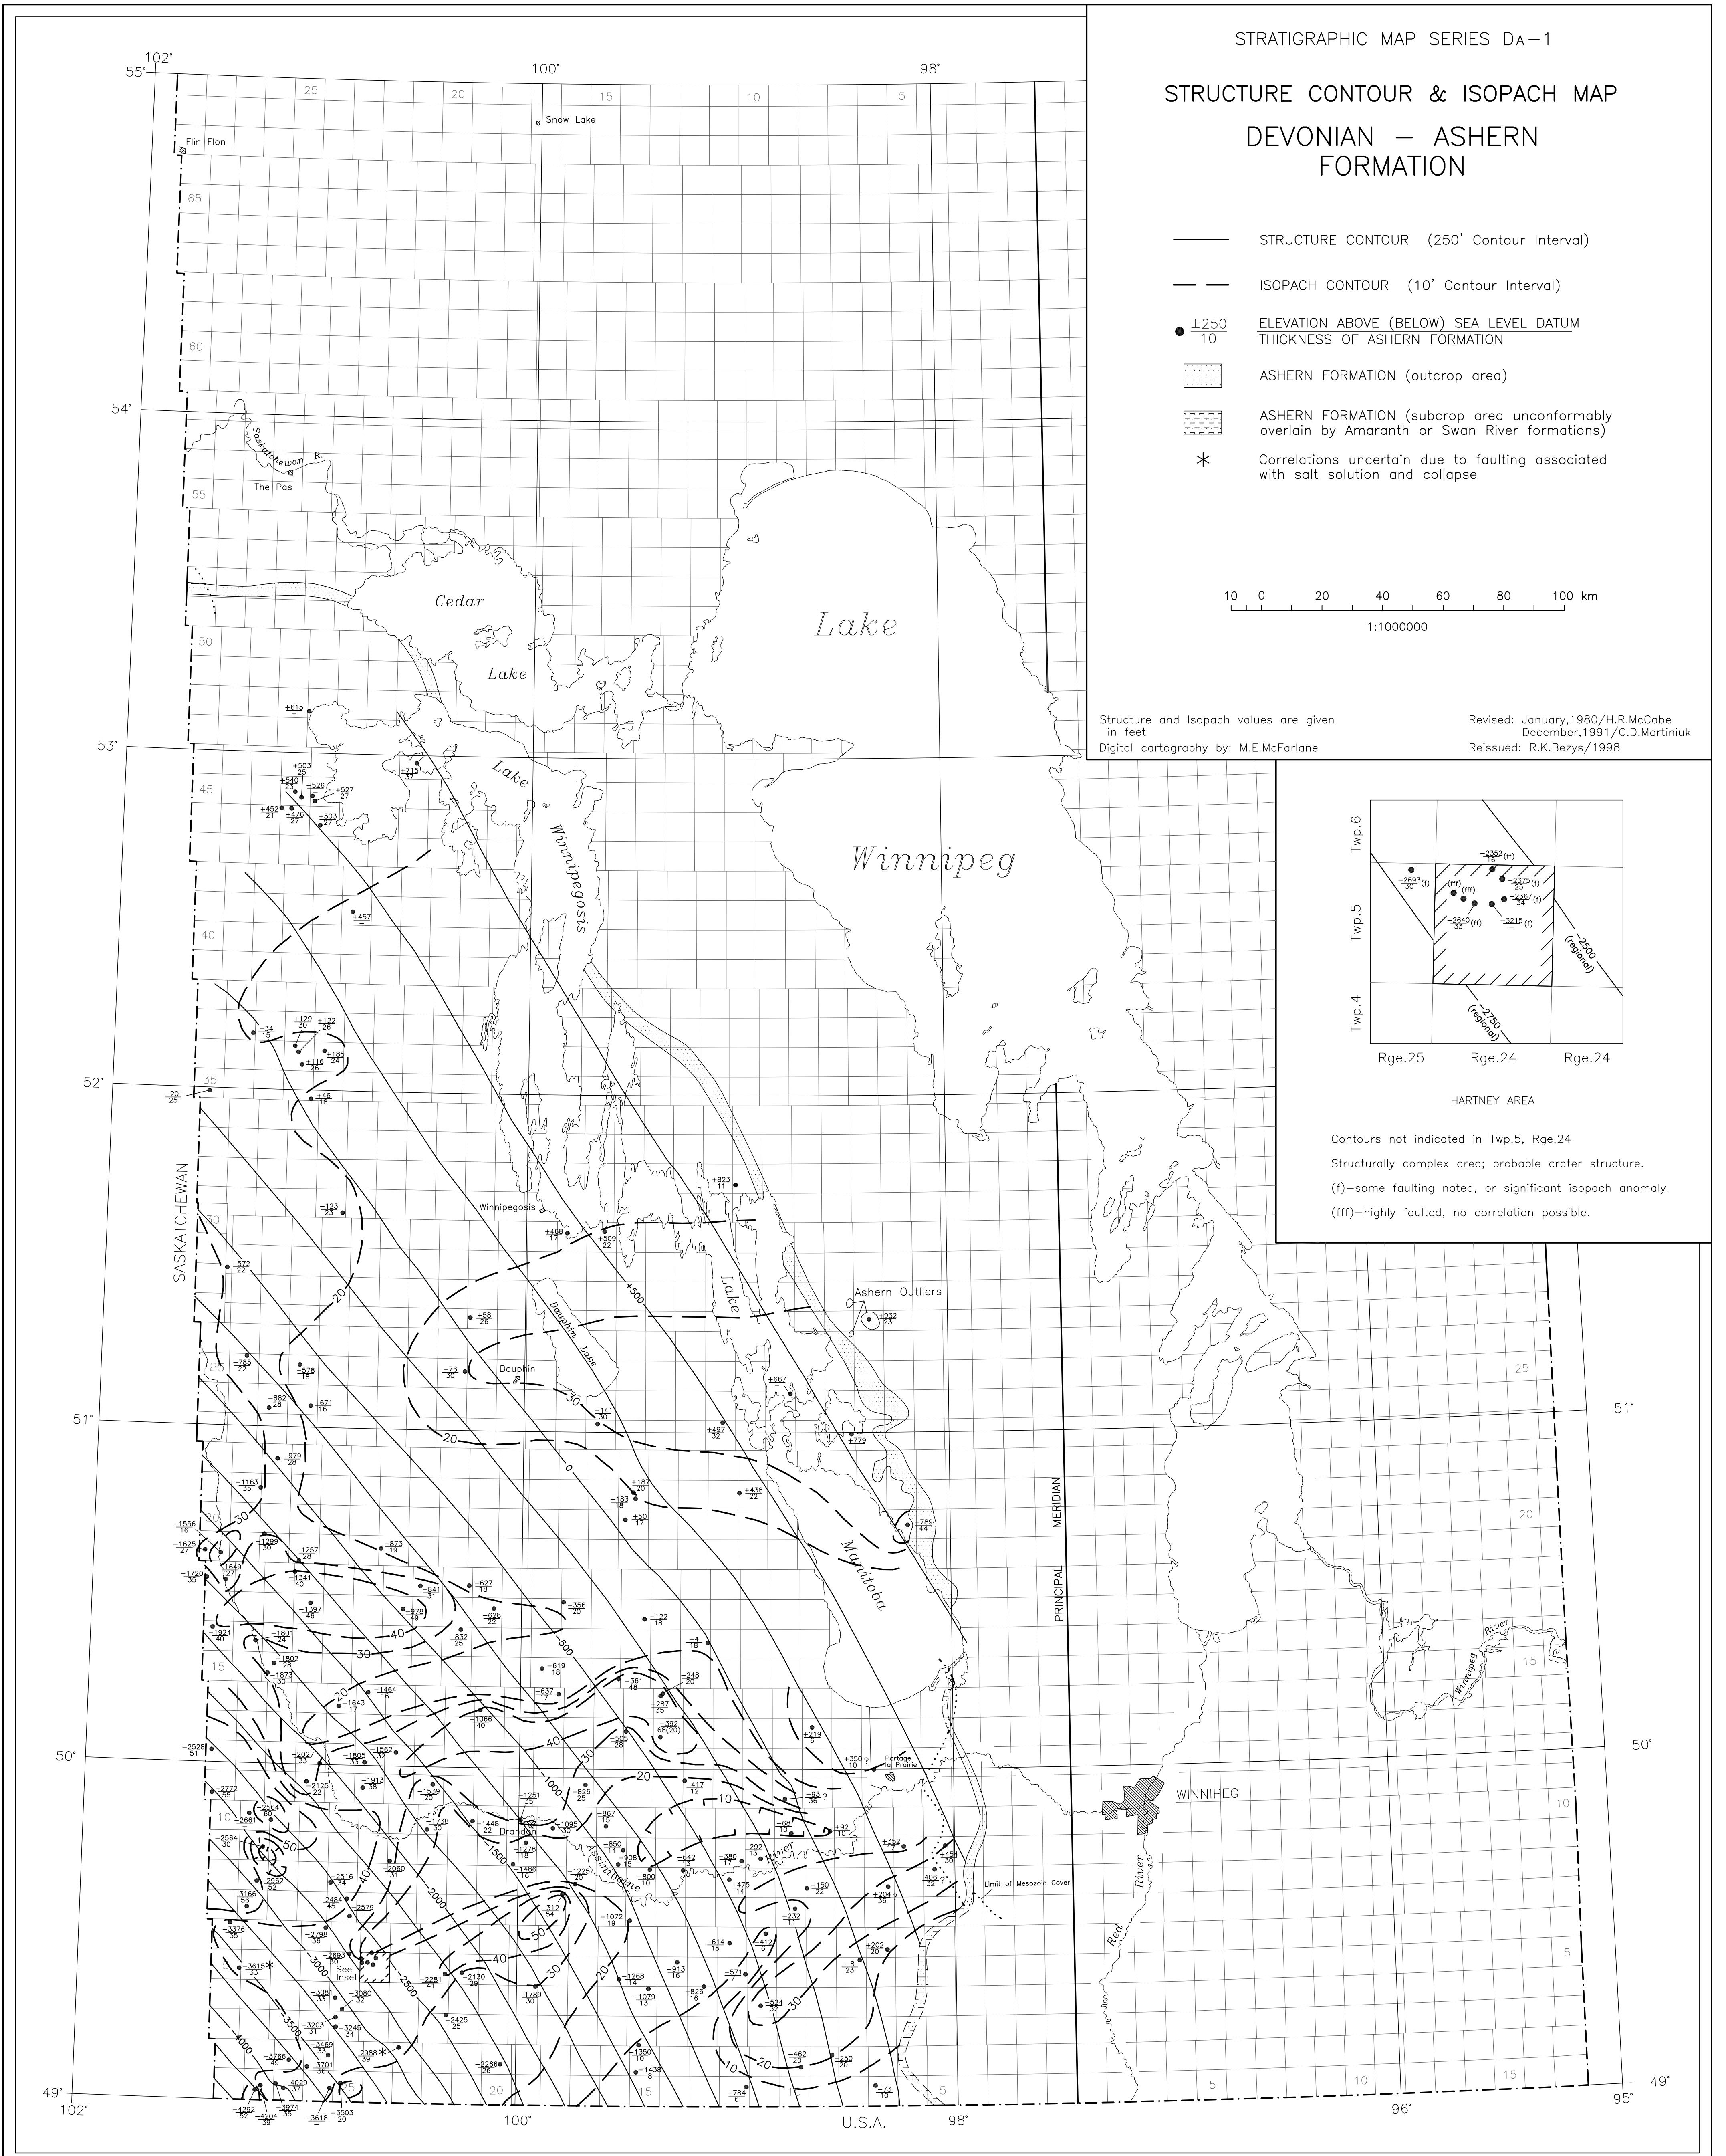
Structure and Isopach values are given
in feet
Digital cartography by: M.E.McFarlane
