PTH 1 AND PTH 5 ROAD SAFETY STRATEGY

January 2024

Manitoba Transportation and Infrastructure (MTI) developed a road safety strategy led by a safety strategy team to identify potential improvements and to focus on engineering and road safety characteristics of the PTH 1 and PTH 5 intersection.

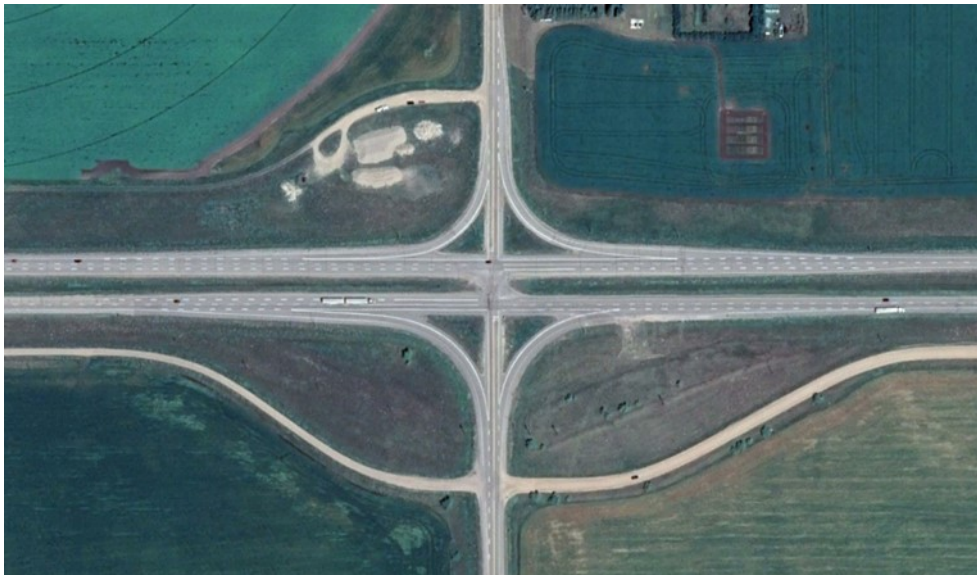
This information bulletin only provides information related exclusively to the PTH 1 and PTH 5 intersection as shown below.

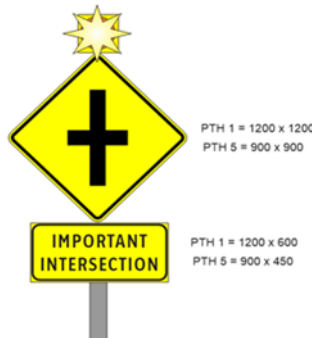
- Installation of "Important Intersection" signs.
- On August 18, 2023, MTI installed signs with a flashing amber light on PTH 1 and PTH 5 ahead of the intersection.

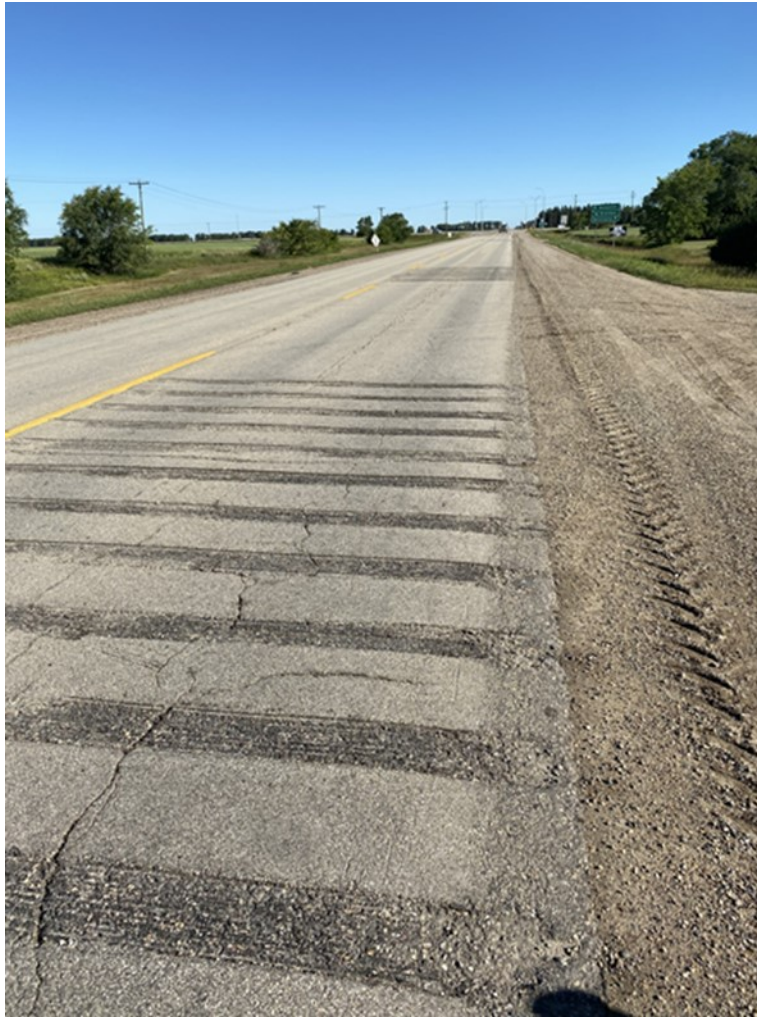
- Installation of additional speed limit signs.
 - The department installed these signs to reinforce the 100 kilometres per hour (km/h) speed limit on PTH 1 in the vicinity of the intersection.
- Refurbished the existing transverse rumble strips on PTH 5.
 - MTI refurbished the rumble strips on PTH 5 north and south of PTH 1.

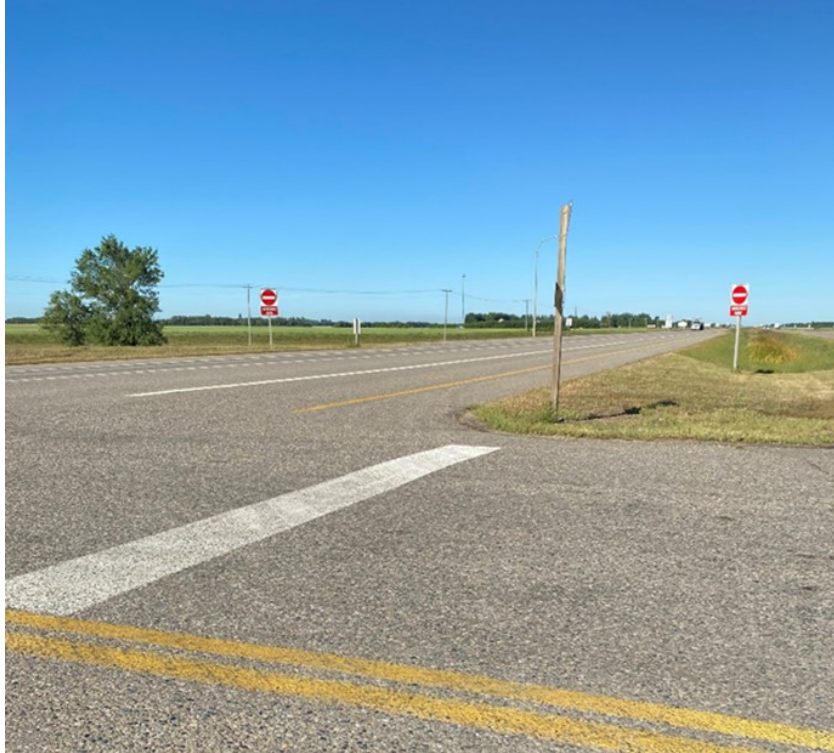
- The department refurbished the pavement markings at the intersection.
