2.4. Water Crossings

2.4.1. *Water Crossing Locations*

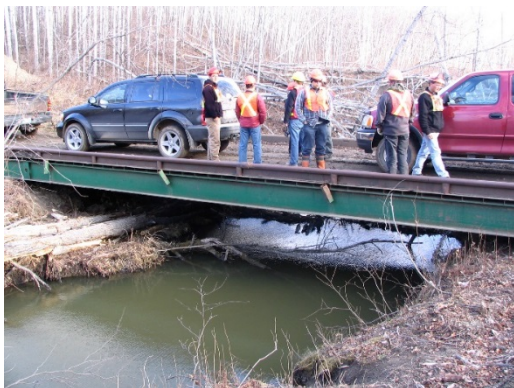
2.4.3.1. Bridges

Bridge crossings often prescribed are engineered portable structures that can be installed with relative ease. Typical construction considerations for forest road bridges are described as follows:

- Bridge footings will be constructed out of stable material to prevent sedimentation. Logs, timbers, and soil wrapped in geotextile are some examples of appropriate footings.
- Wing walls will be constructed on all bridge installations and will remain in place during unfrozen conditions (spring, summer, and fall).
- Disturbance to the existing streamside vegetation will be minimized during construction. This will ensure natural re-vegetation after decommissioning as well as stabilization while the structure is active.

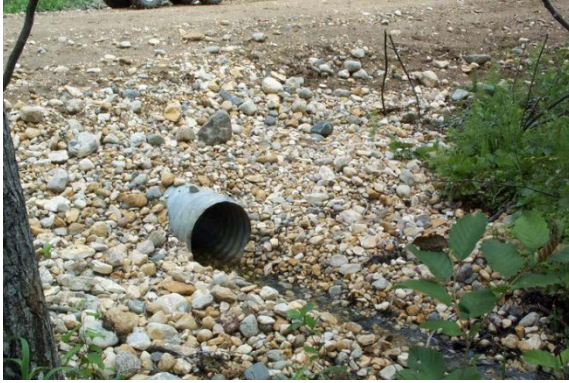
Culverts

Culvert crossings were typically installed during dry conditions in the spring, summer and autumn months. In some cases, small PVC culverts were used to assist continuous flow during winter months within a winter snow and ice crossing. The following general procedures and considerations were used for culvert installations:

- were designed to support a Q100 flood event.
- Were planned for periods of low flow; if the watercourse is flowing, the flow was blocked temporarily to enable dry installation.
- Large boulders or rocks were removed from streambed in order to prevent culvert damage.
- While maintaining the original slope of the watercourse, the culvert was embedded approximately 10% of its diameter.
- Geotextile may be laid underneath culvert if suitable base material was not present.
- Suitable backfill material was then placed around culvert and compacted to ensure culvert stability.
- The inlets and outlets were rip rapped or re-vegetated if conditions warrant (slope, flow, channel width *etc.*).

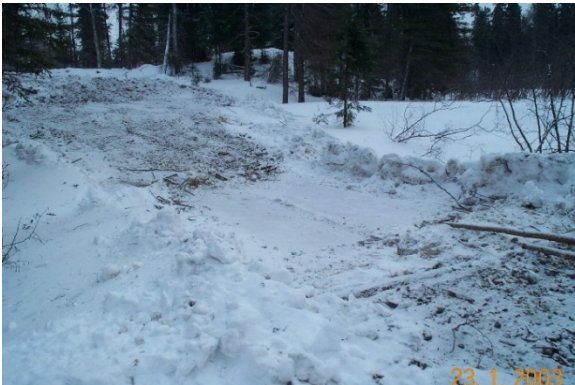
Snow and Ice

Temporary snow and ice crossings were common structures constructed during winter operations. The following guidelines were implemented during the construction of snow and ice crossings:

- Construction of snow and ice crossings occurred during freezing temperatures for water.
- Snow pushed into watercourse was free from dirt and or logging debris.
- Clean snow may be hauled in from an outside location if not present on site.
- Water was pumped onto snow to strengthen and stabilize crossing.
- During deactivation a trench was constructed in order to allow for unobstructed flow during the spring melt.

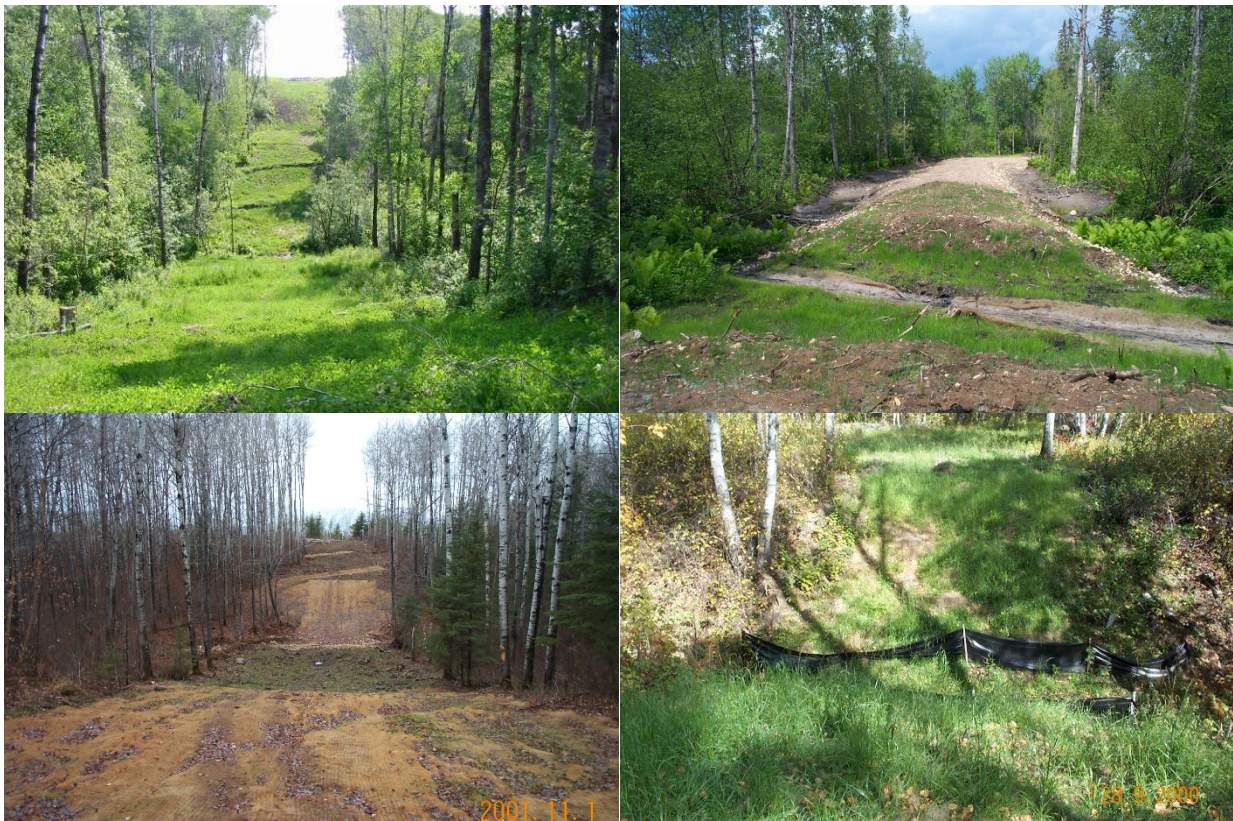
Figure 2.10 Water crossing decommissioning examples.

Temporary water crossing decommissioning involves removing the structure (*e.g.* culvert), sloping the roadbed away from the watercourse, track-walking the slopes, installing cross

Permanent decommissioning involves removing the structure, sloping the road fill material away from the watercourse to near natural conditions prior to construction, track-walking the slopes, and installing cross ditches to divert runoff water from the roadbed into standing vegetation (Figure 2.10) The exposed soil was then seeded and covered with either erosion matting or straw mulch.

Snow and Ice crossings were decommissioned by digging a shallow trench in the ice to prevent runoff from backing up and scouring the banks on flowing streams. The snow and ice crossing then melts naturally.

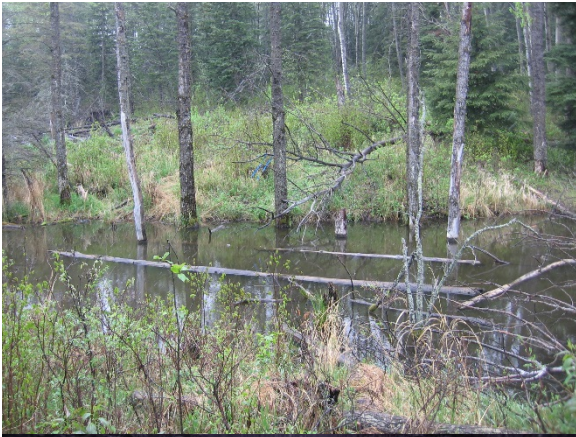
Proposed crossing MGL-C16 (across) was submitted in the 2012 operating plan. The water crossing prescription had a preferred structure of a portable bridge.

Water crossing MGL-C16 is an example of a successful water crossing decommissioning. The crossing was first proposed in 2012, a steel bridge installed in 2012, decommissioned in 2013, and monitored until fall 2014. MGL-C16 was deemed successful, and no longer needed to be monitored after the fall of 2014.

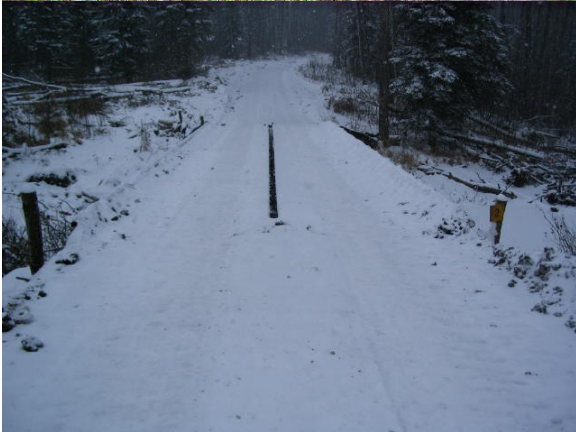
A steel bridge was installed in 2012 (winter picture). The site was monitored, checklist completed, and photographed.

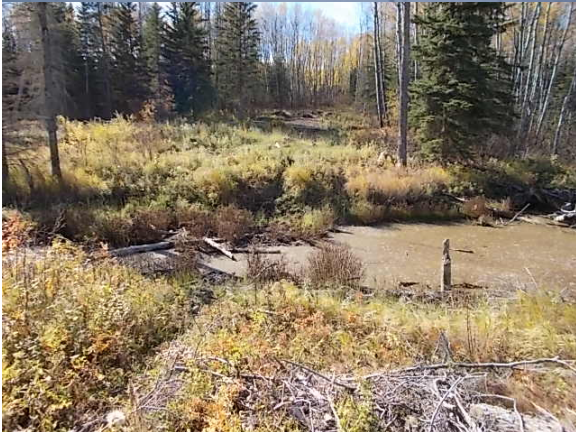
Once operations were complete, the steel bridge was removed. The decommissioned site was monitored, checklist completed, and photographed in fall 2013.

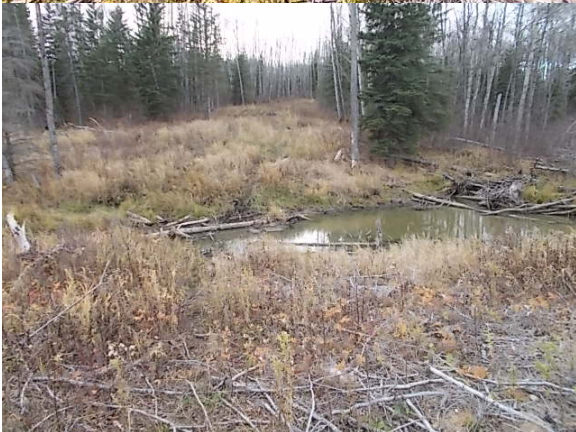
The decommissioned site was monitored a second year, checklist completed, and photographed in fall 2014. Water crossing MGL-C16 was deemed successfully decommissioned.

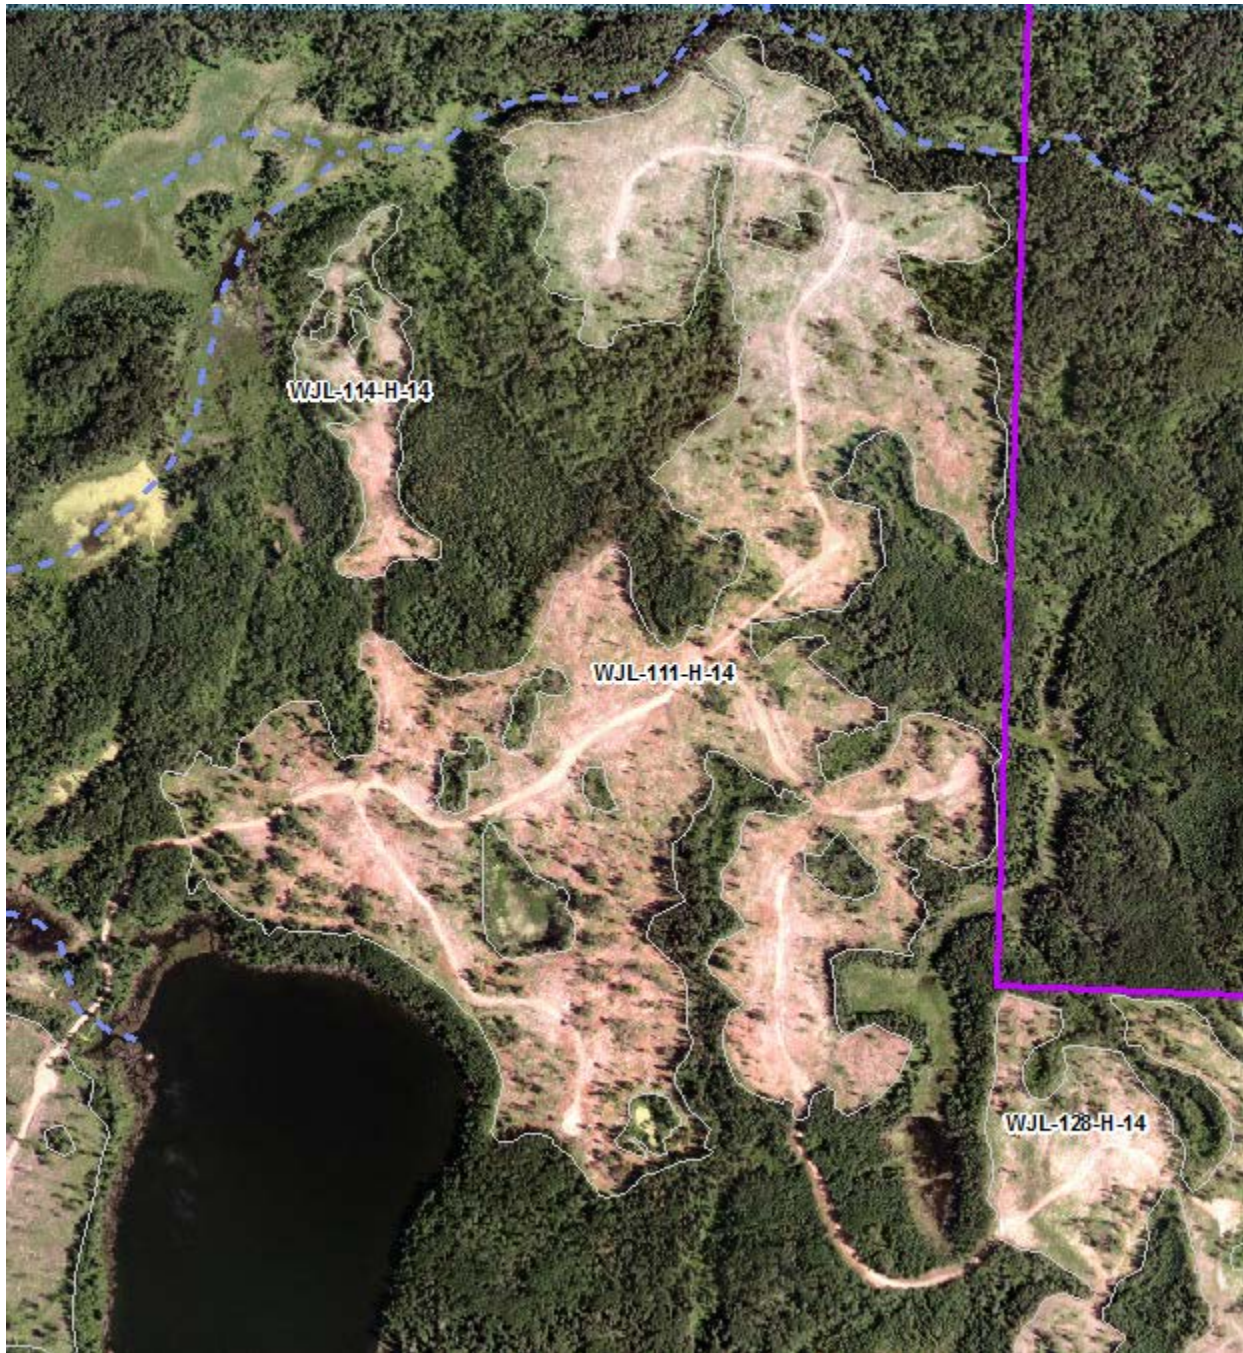
Figure 2.11 Harvest block that shows harvest shape, leave areas, riparian zones, and buffers.

Harvest block boundaries were designed to follow natural boundaries (Figure 2.11). The harvest block shape is affected by planning for water features, wetlands, wildlife features, topography, and riparian habitat.

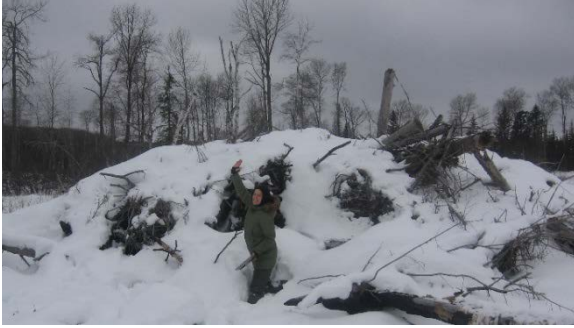
Wildlife Debris Piles

In designated harvest blocks, wildlife debris piles have been constructed to promote small mammal habitat. Based on concerns expressed during discussions with local trappers, debris piles were created in harvest areas in the Duck Mountains. These piles were constructed within 100 m of the block boundary and riparian features to encourage use of the harvest area by marten and other small mammals. The debris piles provided cover between residual patches, which helped to

Wildlife debris piles (WDPs) were constructed from logging slash, tops, limbs, and larger logs. Piles were located approximately 50 to 100 m from block or riparian edges to facilitate immediate use by marten and other animal species. Proximity to residual tree patches within harvested areas was considered prior to establishment. WDPs provided cover habitat between residual patches, which helps establish travel corridors through harvested areas. When piles were constructed, large elevated pieces of coarse woody debris or 'stringers' were placed connecting the pile to the adjacent forest. This provided access to WDPs in the winter through openings created between the snow and stringer and in summer along the logs.

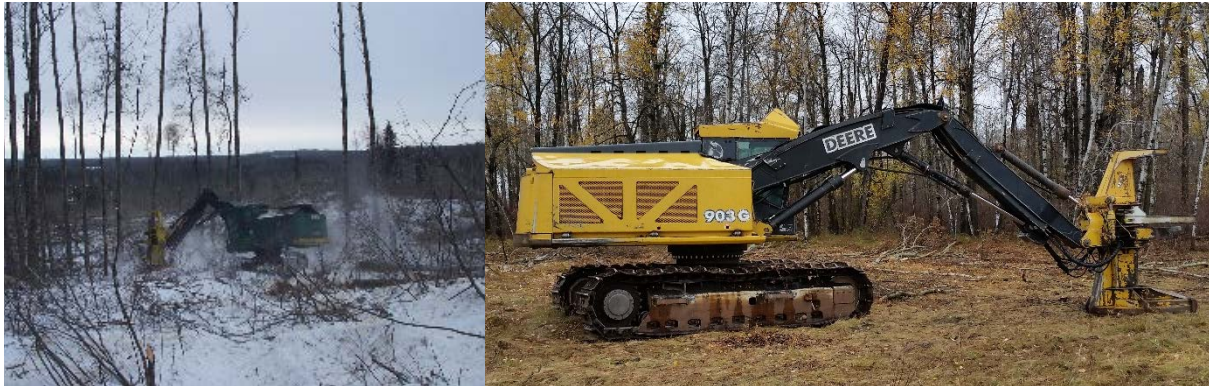
Felling – Feller bunchers were used to cut standing trees. A saw cuts each tree, while the accumulator arms allow for several trees to be held and form a ‘bunch’. The bunch of whole trees is then laid on the forest floor.

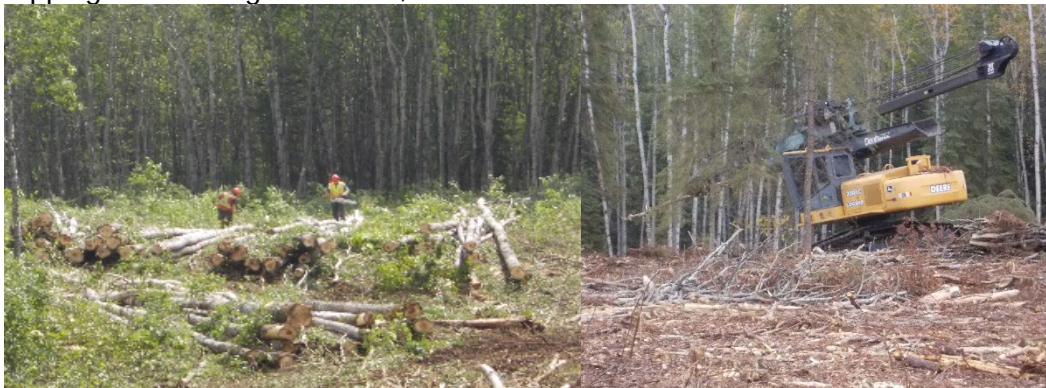
Topping and limbing – Power saws or stroke delimiters were commonly used to delimiting the branches off the stem, and to cut the top off. Power saws were more commonly used for topping and limbing hardwood, while softwoods were often stroke delimited.

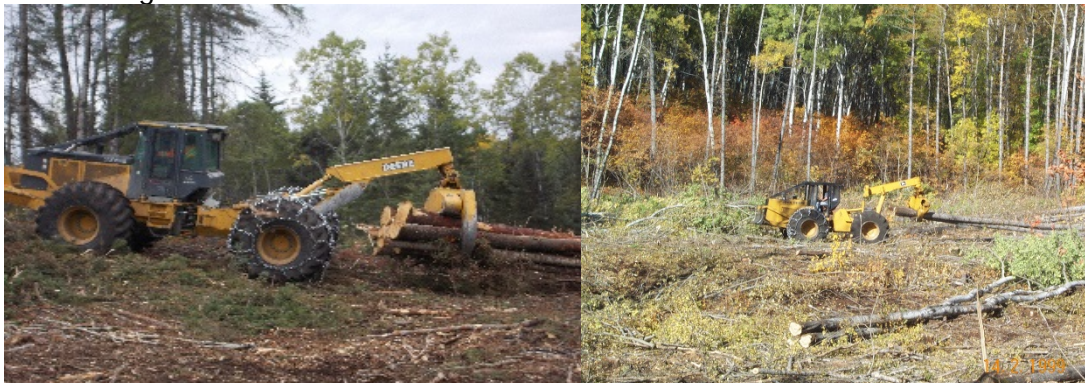
Skidding – A grapple skidder was used to move bunched tree stems to roadside for processing and hauling.

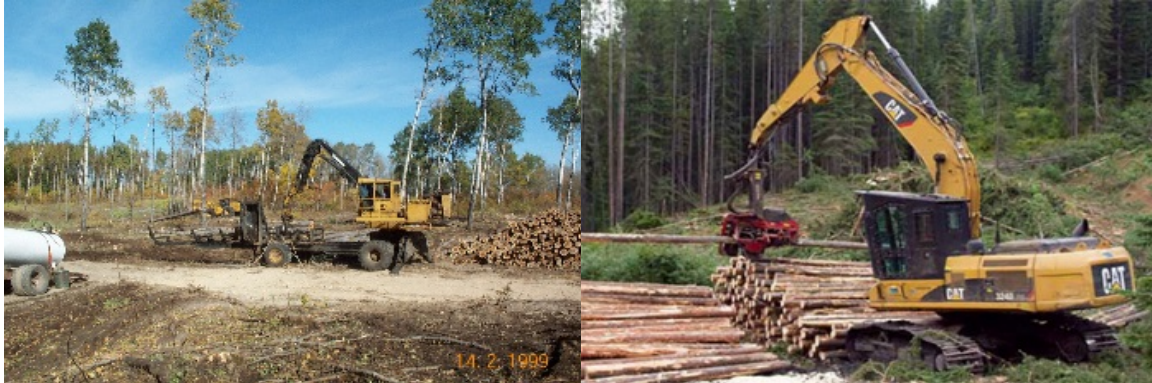
Slashing – A slasher or processor head on an excavator processed tree-length stems at roadside. Hardwood tree-lengths were processed into 2.54 m (8 foot) lengths. Softwood tree-lengths that are sawlogs were processed into 5.1 m (16 foot), 3.8 m (12 foot), or 3.2 m (10 foot) lengths. Softwood chipperwood had variable lengths.

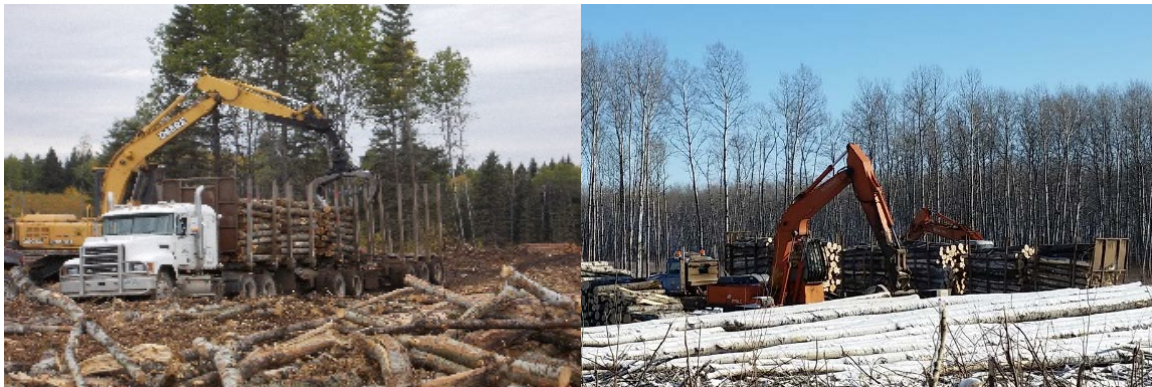
Loading- A swing loader on a tracked excavator was used to load processed logs onto a haul truck.

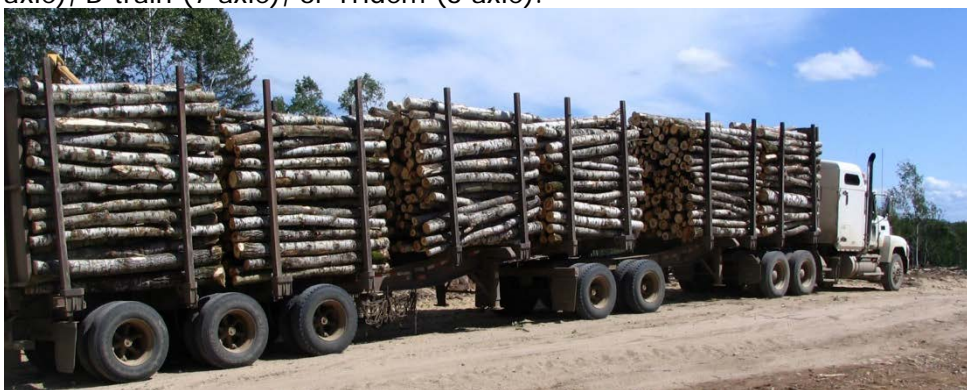
Hauling – The wood was then hauled to a mill. Trailer configurations included Super B (8 axle), B-train (7 axle), or Tridem (6 axle).

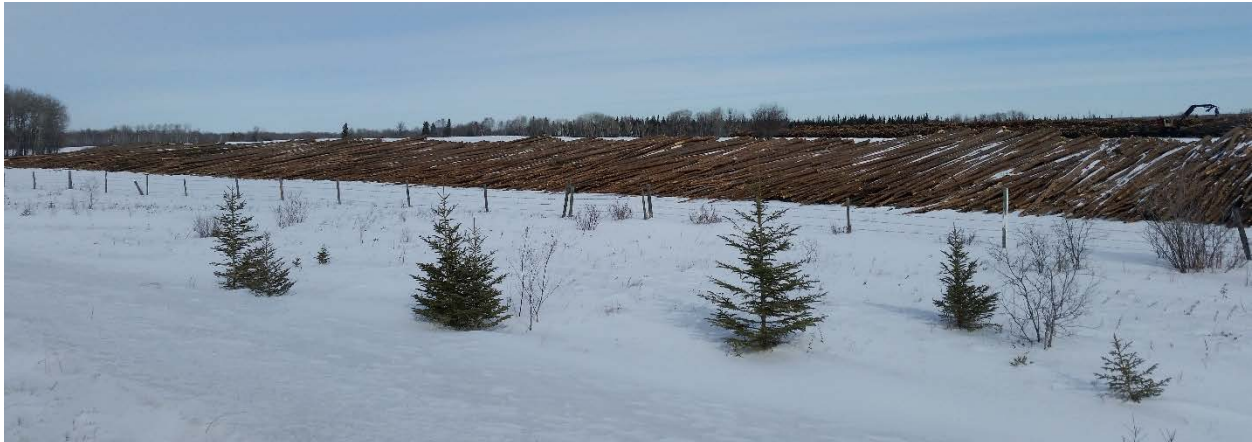
Figure 2.26 Softwood stockpile site.

Softwood storage sites (Figure 2.26) were established throughout FML # 3 on a yearly basis. Some wood was skidded to roadside within the cut block for further processing or chipping with a portable chipper at a later time. In other instances, wood was forwarded, or moved off-site, to a location that provided all weather access roads to the wood for processing or chipping. There was typically a small amount of incidental hardwood that was forwarded to these sites as well.

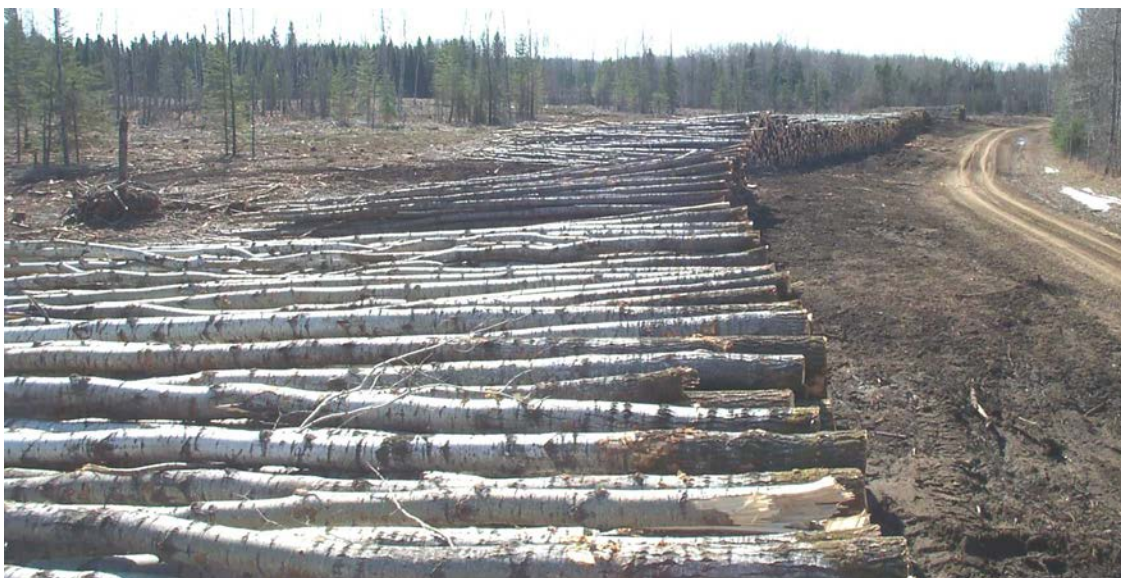
Figure 2.27 Hardwood stockpile site at block JFL-010

Hardwood storage sites (Figure 2.27) have been far less common in FML #3 than softwood storage sites. Hardwood storage sites have been established within cut blocks that have all weather access with wood being skidded to roadside and processed later. In some cases, processed wood has been left within the cut block as a result of early thaws causing roads to deteriorate and trucks being unable to haul the wood.
