RE: Leachate Storage/Evaporation Ponds Notice of Alteration – R.M. of St. Clements – Libau Landfill

File No. 16-0607-003

2.0 LEACHATE STORAGE/EVAPORATION POND DESIGN

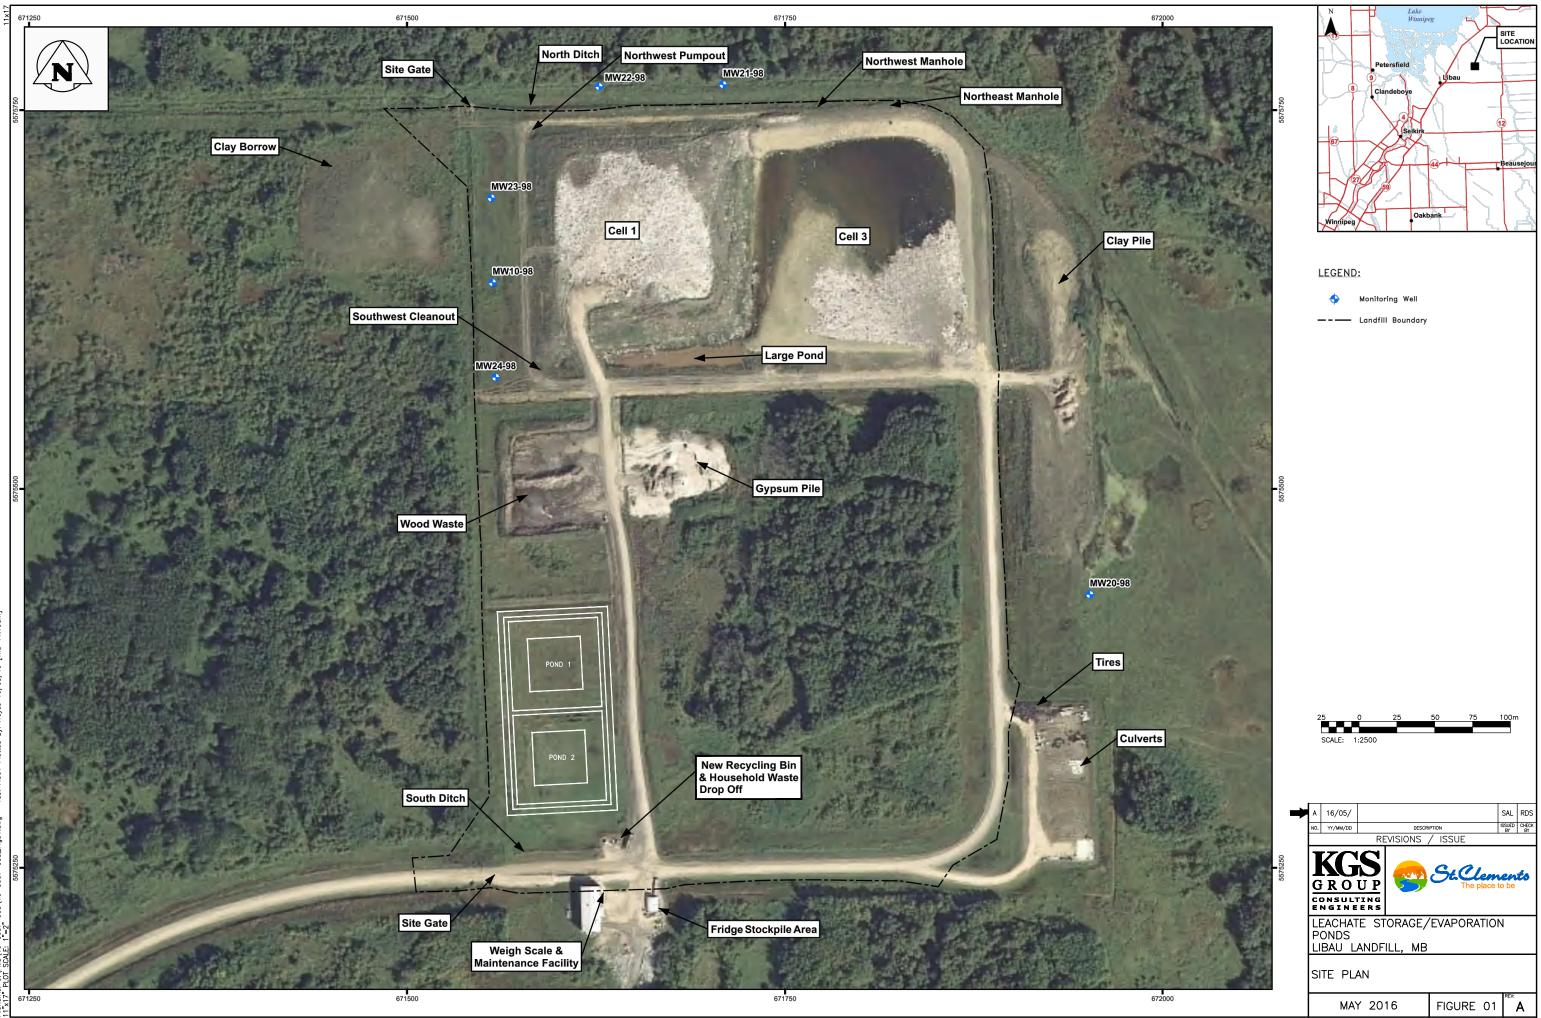
lieName: U:\FMS\16-0607-003\16-0607-003_Fig01.dwg - Tab: FIG01 Plotted By: rreyes 16/05/19 [Thu 11:19am] 1*x17" Pl 01 5rAl F: 1*=2"

- 1. **Geotechnical Investigations** Figure 1 shows the area where the leachate ponds would be constructed. KGS Group (2000) monitoring report indicates thin layers of peat (0.3 m) and sand (0.5 m), over approximately 8 m of silty clay. The clay is suitable for a compacted clay liner. Based on subsurface investigations and soil tests data confirm the quality/suitability as good liner material. This work involved a survey of the proposed area, and test pits for soil sampling and laboratory, and focused analysis on the upper 3 m of the soil profile.

KGS Group staff visited the Libau Landfill on May 20th of 2016, excavating 9 test pits where the location of the evaporation ponds have been proposed, as indicated in Figures 01 and 04. The drilling logs from the test pits have been included in Appendix B, and soil testing results for Atterberg Limits, maximum dry density and hydraulic conductivity have been included in Appendix C.

The pond operation is described as follows. Once the leachate ponds are constructed, leachate from the northwest and northeast manholes in Cell 3 (See Figure 1) and the existing large pond south of Cell 1 will be pumped to one of the leachate ponds. Leachate/impacted water will be discharged to the rip rap aprons in the ponds to prevent scouring. From Cell 3, leachate will be pumped out at low flow rates to prevent clogging of the collection system and impairing its long term performance.

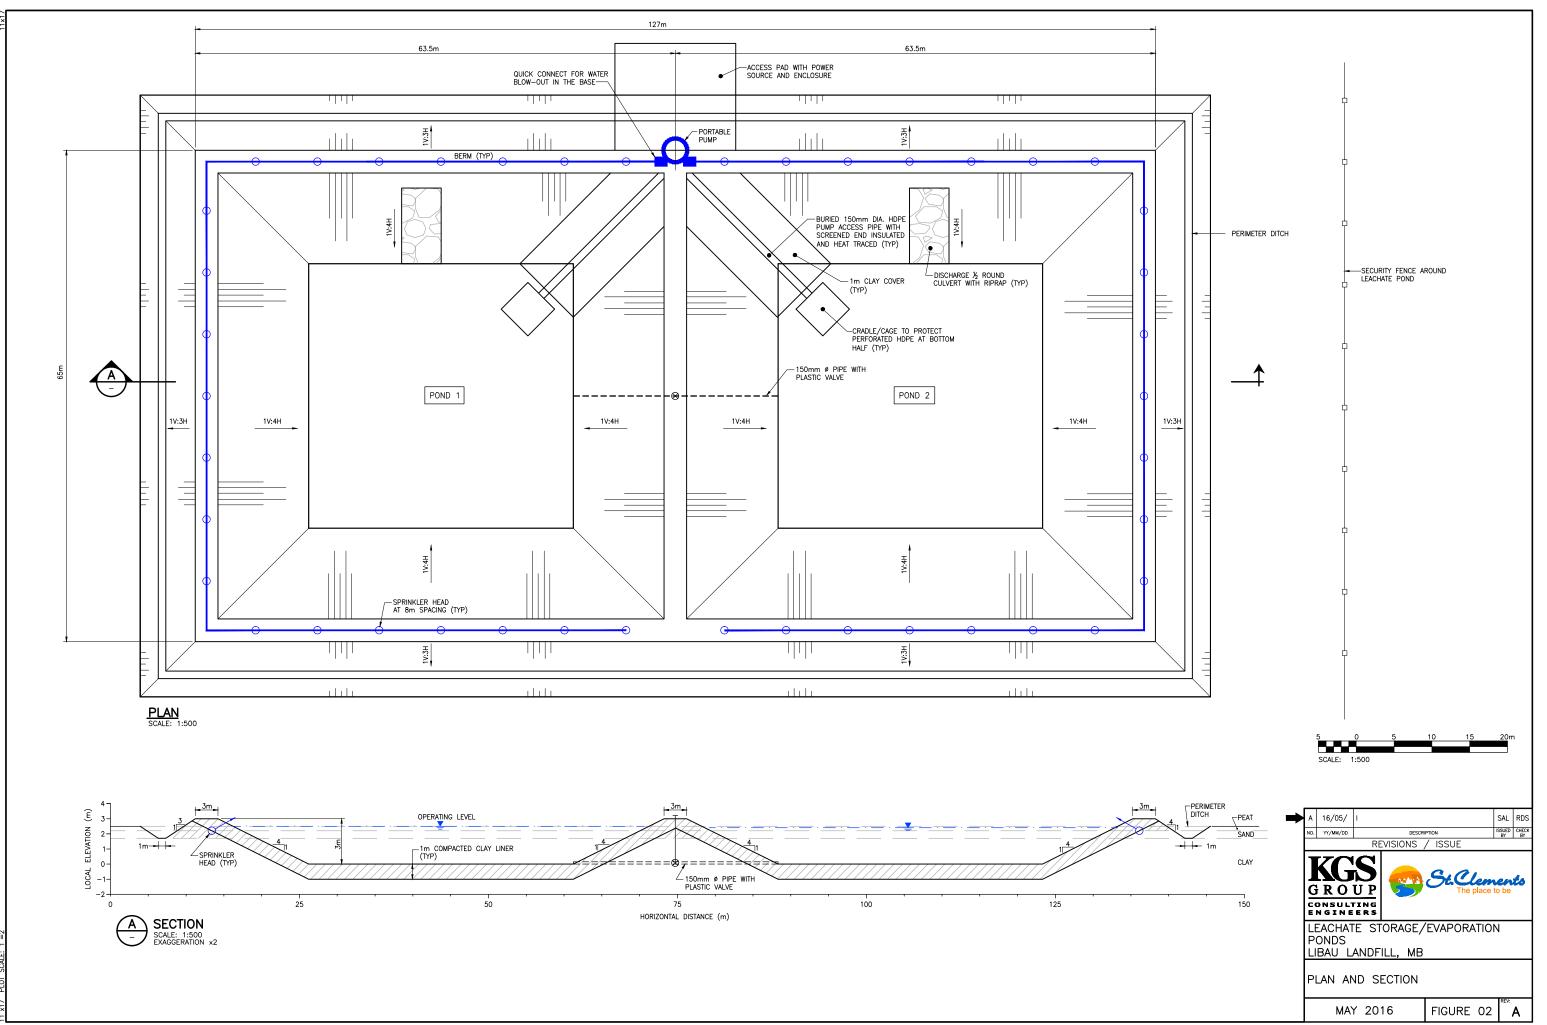
Figure 2 shows the design of the leachate ponds, each measuring 65 m x 63.5 m, with a 1 m compacted clay liner meeting $1x10^{-7}$ cm/sec permeability requirements and the soil sampling and soil laboratory data confirms the hydraulic conductivity is approximately $1x10^{-8}$ cm/sec and likely much lower (See Section 5). The design utilizes an inside slope of 4 to 1, with a berm width of 3 m for vehicle access, and a perimeter ditch with 3 to 1 slopes and a 1 m base. The maximum design leachate level is 2.5 m above the clay liner, with 0.5 m of freeboard, as shown in Figure 2.

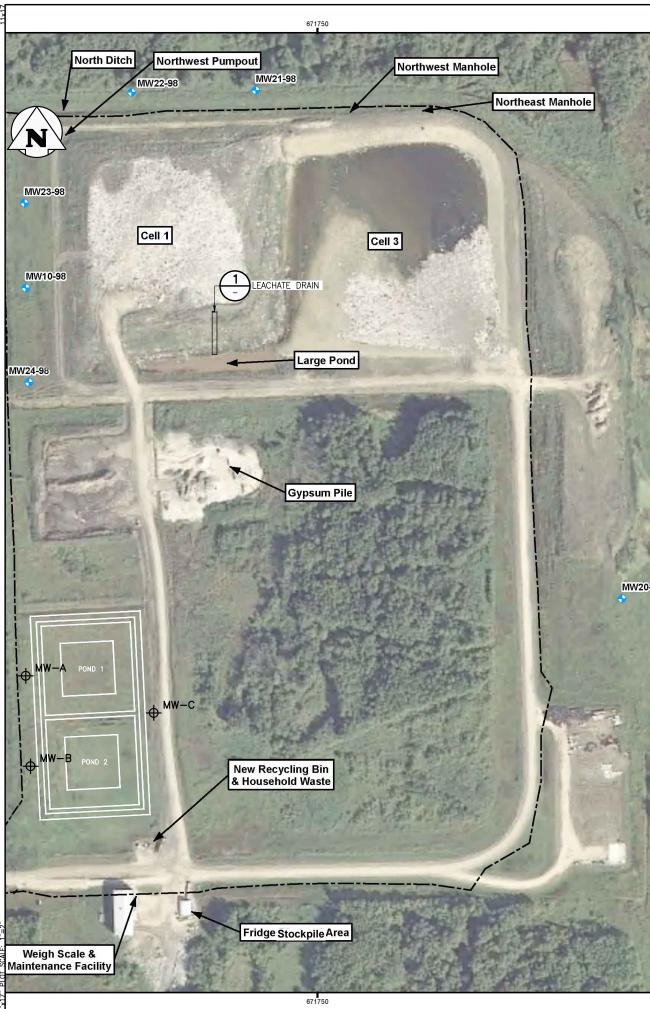
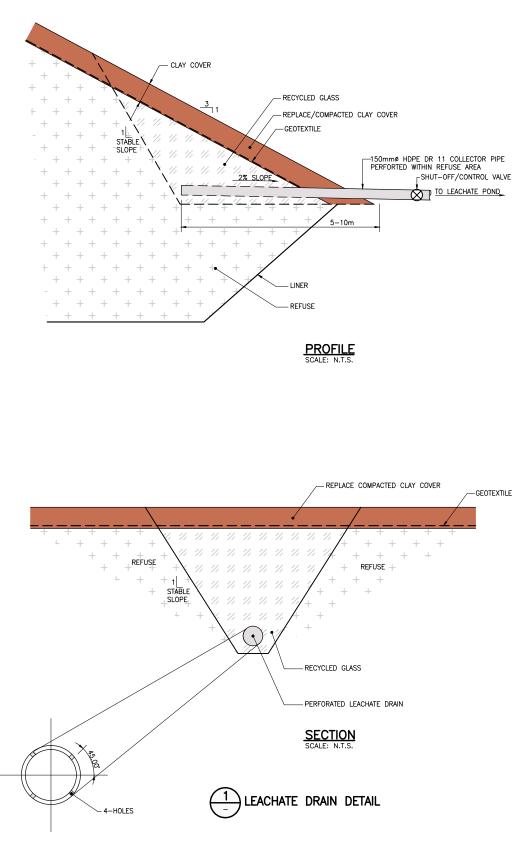
The proposed Retrofitted Leachate Collection System (RLCS) consists of a 0.15 m diameter HDPE DR 11 perforated pipe of 5 to 10 m of length, embedded in recycled glass with a shut-off/control valve at the pipe-end for leachate flow control, as shown in Figure 03. After using a backhoe to dig up a 5 to 10 m trench within the landfill, the perforated pipe will be placed at 2% slope draining towards outside of the landfill. The trench will be filled with recycled glass, and prior to replacing the excavated cover, a geotextile will be placed as the boundary layer between the glass and clay, as shown in Figure 03.

Three monitoring wells are proposed, 2 along the west property boundary and one monitoring well on the east side upstream of the site (groundwater direction is northwest). The monitoring wells will be installed adjacent to the leachate ponds to ensure the groundwater quality is not affected by the operation of the proposed ponds. The piezometer will be 5.5 m deep with 0.5 m stick-up and 4.5 m of 15 slot screen. The monitoring wells will be sampled every year following the Class 1 Environmental Act Licence No. 2274 S2RR requirements in conjunction with the yearly groundwater monitoring and sampling program for Libau Landfill and the four waste transfer stations in the R.M. The proposed location of the new monitoring wells is shown in Figure 03.

MW-A + PROPOSED MONITORING WELLS (3 REQUIRED)

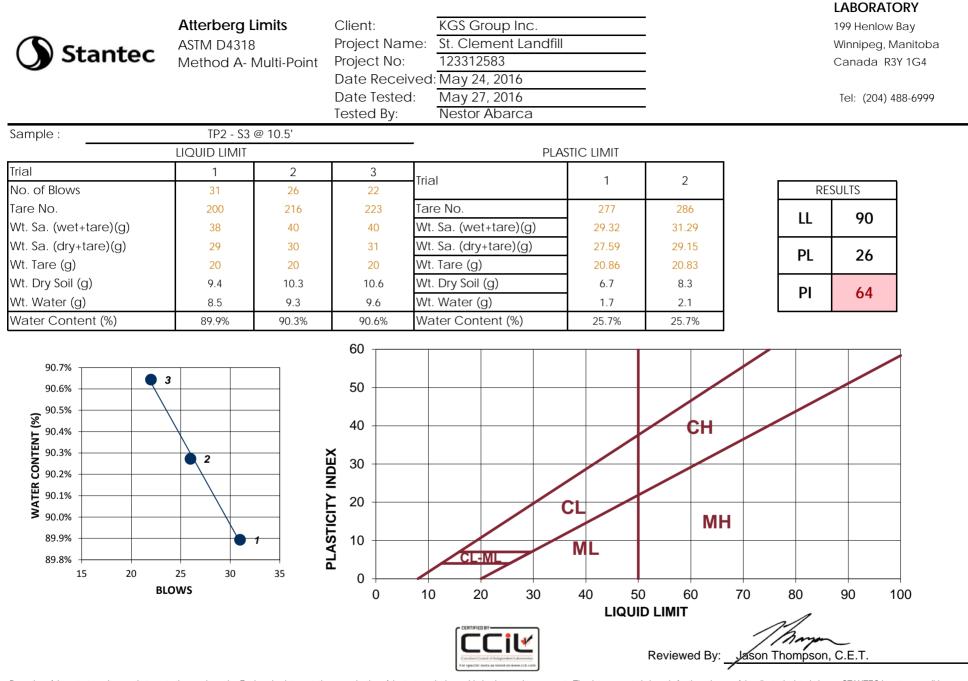
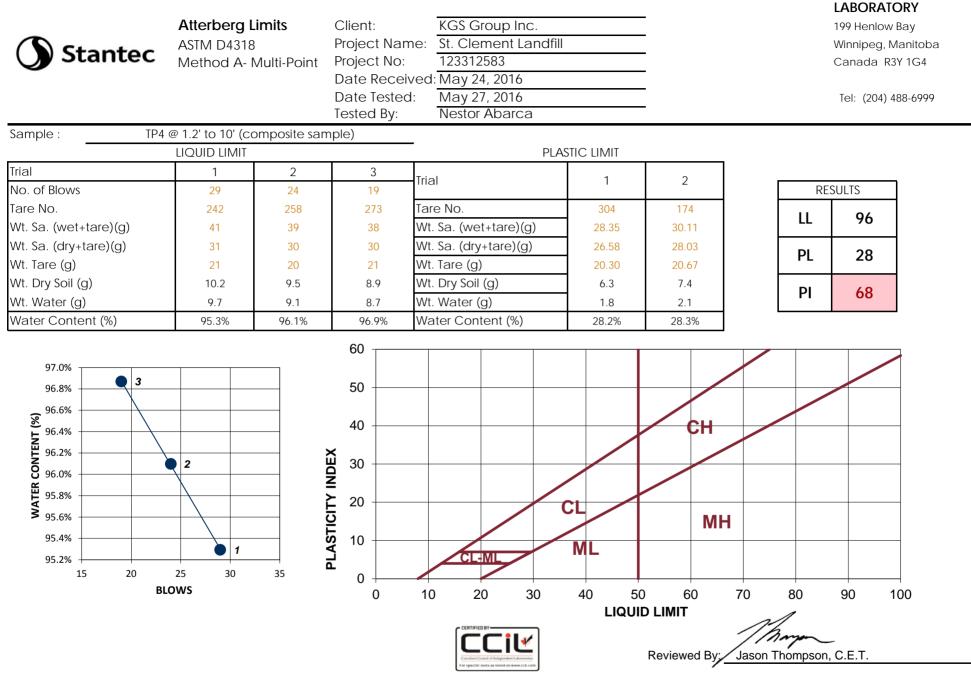
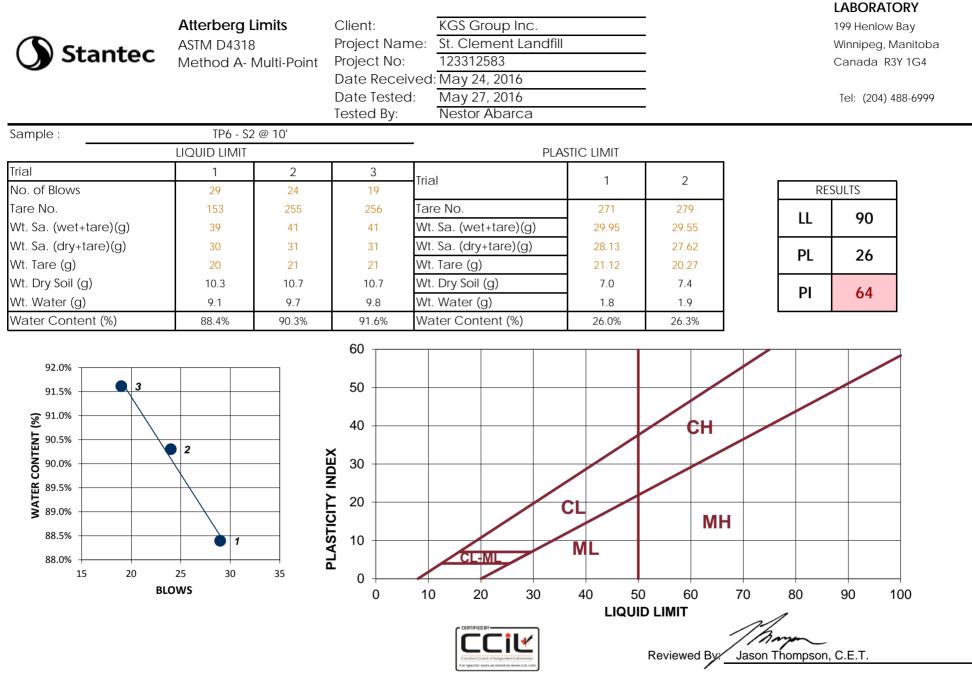
TABLE 1 ATTERBERG LIMITS TEST DATA

Laboroatory soil testing results for the existent clay/silty-clay deposit (Appendix B) showed that it is mainly a intermediate to high plastic clay with a Liquid Limit range of 92% to 96%, a Plastic Limit range of 26 to 28% and a Plastic Index range of 64 to 68%. A moisture-density relationship test (Standard Proctor Maximum Dry Density) conducted on the clay yielded a maximum Dry Density of 1,389 kg/m³ and an optimum moisture content of 28%. The target moisture content during construction will be about 30% or 2% wet of optimum. A laboratory hydraulic conductivity test was conducted on one composite recompacted sample and the results demonstrated a hydraulic conductivity of 1x10-⁸ cm/sec. Based on the liquid limits over 90% suggests strongly that the actual hydraulic conductivity would be an order of magnitude and possibly lower. The results indicate that suitable clay for leachate evaporation ponds is available across the whole proposed lagoon area.

Field	Donth	Denth					
Testpit	Sample No.	Plastic Limit	Plasticity Index					
TP2	S3	10.5	90	26	64			
TP4	composite	1.2 -10	96	28	68			
TP6	S2	10	90	26	64

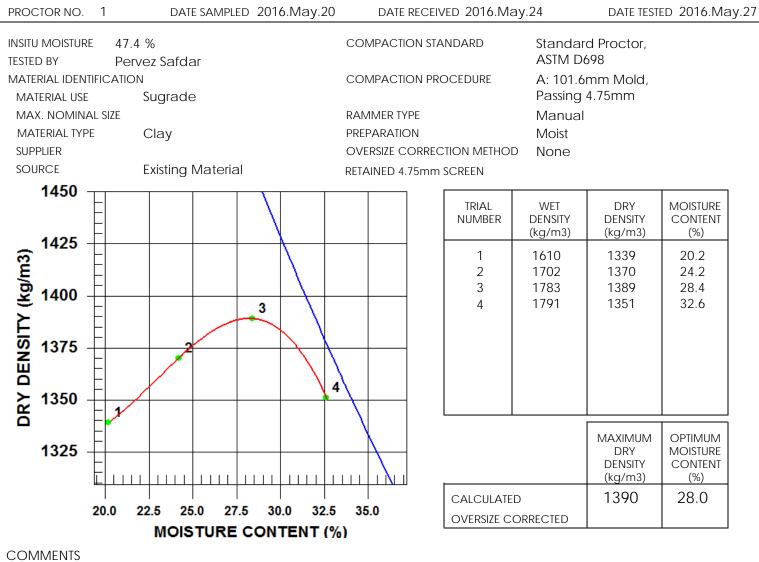
PROCTOR TEST REPORT

Material tested was identified by the client as being a composite sample of materials taken from depths of 1.2' to 10' at testpit no. 4.

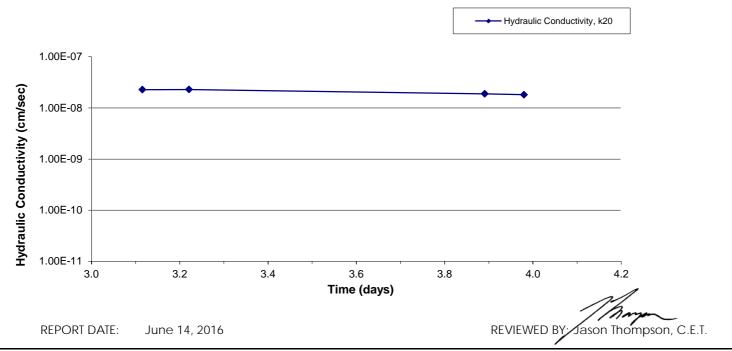
199 Henlow Bay Winnipeg MB R3Y 1G4 Tel: (204) 488-6999 HYDRAULIC CONDUCTIVITY ASTM D5084

TP4 @ 1.2' - 10' composite remoulded HC sample June 1 to June 7, 2016 137.9

DATE TESTED: CONFINING PRESSURE (kPa): EFFECTIVE SATURATION STRESS (kPa): ASSUMED SPECIFIC GRAVITY: HYDRAULIC GRADIENT: TYPE OF PERMEANT LIQUID: HYDRAULIC CONDUCTIVITY, "k" (cm/s): HYDRAULIC CONDUCTIVITY, "k₂₀" (cm/s): June 1 to June 7, 2016 137.9 34.5 2.71 18.8 De-aired Water 2.3E-08 **2.1E-08**

Height (mm)	Diameter (mm)	Wet Mass (g)	Dry Density (g/cm ³)	Water Content (%)	Saturation (%)
Initial Reading	77.5	70.9	577.5	1.431	31.5	95.6
Final Reading	79.1	72.0	596.2	1.342	38.1	101.3
