Bipole III Transmission Project

2015 Biophysical Monitoring and Mitigation Report

Report to Manitoba Sustainable
Development (Licence No. 3055)

Submitted December 2016

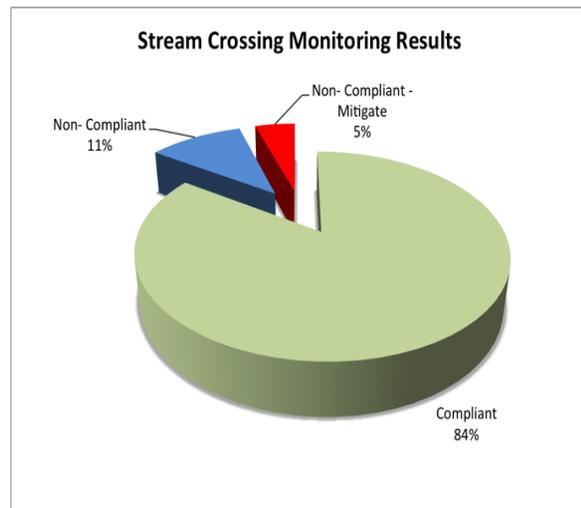
Figure 6-1 Stream Crossing Monitoring Results

Monitoring activity was greatly expanded for stream crossings in 2015 as clearing and construction work accelerated from the start-up winter in 2013 - 2014. Aerial surveys were conducted on 326 crossings in June 2015 allowing some re-vegetation to occur after the winter construction period. Ground surveys were conducted on a subset of stream crossings that had higher valued fish habitat or a non-compliance issue identified during the aerial reconnaissance. Nine of the inspections included follow-up visits based on 2014 monitoring report results for the northern AC collector lines in the Keewatinohk area. The ground surveys consisted of evaluating the stream crossing sites against the list of prescribed mitigation to determine level of compliance as well as recording observations of the conditions of sites. Riparian buffers, vehicle crossings, tower and anchor locations, and rutting and erosion were some of the parameters evaluated. Construction at most stream crossings was compliant with prescribed mitigation. Of the 37 sites that were non-compliant follow-up remediation is recommended at 16 sites or 5% of the 326 sites surveyed (Figure 6-1 Stream Crossing Monitoring Results).

The most frequent non-compliance measure related to exposed soils along the stream banks or within the buffer zones (13 sites). Slash used in temporary stream crossing construction or felled trees across the channel potentially inhibiting flow (seven sites) and excessive clearing of the riparian buffer (nine sites) were the other two common measures not in compliance. Remediation measures included erosion control measures at seven of the 13 sites, removal of the slash/trees from four sites, and active re-vegetation of two sites. Follow-up visits at an additional three sites were conducted to evaluate bank stability.

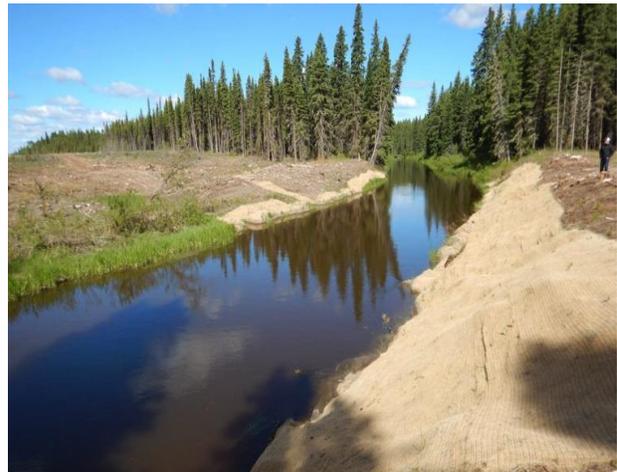
Photo 9 Erosion Control Blanket installed at Mitishito River crossing.

As a result of recommendations in the 2014 monitoring report nine sites were re-visited on the Construction Power Line in 2015, where excessive vegetation clearing, rutting or bank damage had left areas of exposed soil. Erosion was not observed and natural re-vegetation was occurring at all sites surveyed in 2015. In 2014 an area of sediment deposition was observed in the creek at CLCP-Aqua-113. The re-inspection showed that no new sedimentation was occurring and the previous accumulation was no longer apparent. The follow-up inspection of crossings on the Construction Power Line that occurred during clearing and foundation work in 2013/14 required no further remediation and the potential impact on fish habitat was minimal. The monitoring results so far are indicating that at a large majority of crossings, most mitigation is being implemented but more importantly the negative environmental effects have been minimal for sites where non-compliance issues were identified. Rehabilitation work and follow-up monitoring has provided assurance that Bipole III construction is meeting environmental and regulatory objectives. MCWS has conducted inspection of the ROWs and found them to be in compliance with the work permit and Environment Act licence conditions.

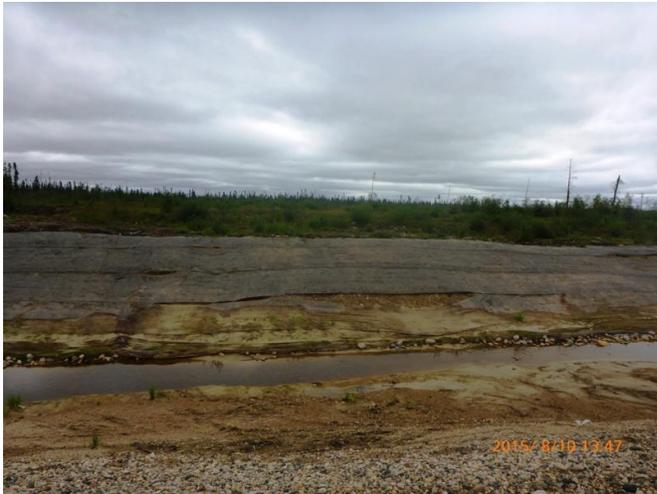
Photo 10 Damaged erosion control blanket on Keewatinohk Converter Station perimeter.

Erosion and sediment control measures installed at the Keewatinohk converter station in 2014 were monitored for effectiveness in 2015. Installed measures included rock lining of collector drains, use of rock berms, and natural contouring of landscape as well as silt fencing, coconut fibre mats and permanent geo-textiles. In addition to inspections a turbidity monitoring program was implemented in 2015 to determine how effective the measures were at keeping sediment out of site drainage. A total of ten stations were monitored after five significant rainfall

events. Turbidity measurements showed rainfall impacts to waterways and ditches were minimal for small precipitation events. Several larger events on June 14 and August 29, 2015 caused some site damage and sediment runoff which was reflected in the water quality readings. Widespread erosion was observed on the parking lots, dirt roads, and unprotected ditches. It was also noted that erosion and sediment control measures require maintenance and replacement to create permanent solutions. Overall, the monitoring program has shown that for most precipitation events little sediment is moving through the drainage systems as evidenced by relatively low turbidity readings, however for sudden intense storms additional measures need to be implemented to reduce potential water quality impacts.

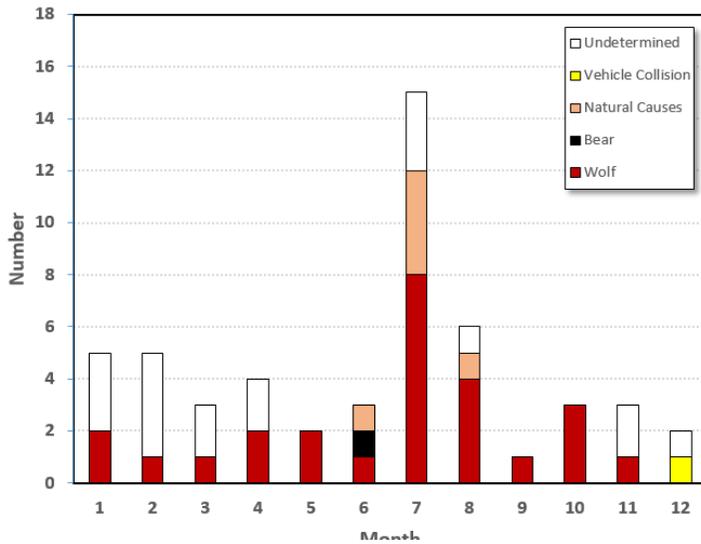
Figure 6-2 Boreal Woodland Caribou Mortality by Source (2010-2015)

Mortality investigations of collared boreal caribou continued in 2015 when a mortality signal from an active satellite collar is received. As shown in Figure 6-2, almost 80% of recovered collars indicated death by predation. Wolves were the most frequent predator to take down a collared caribou accounting for three quarters of all mortalities. There was only one confirmed kill by black bear indicating the limited impact this species has on caribou predation and population. It was also noted that it is highly unlikely these kills were influenced by the presence of the transmission line ROW. The closest collar recovered was almost 4 km from the line and the majority were over 15 km away.

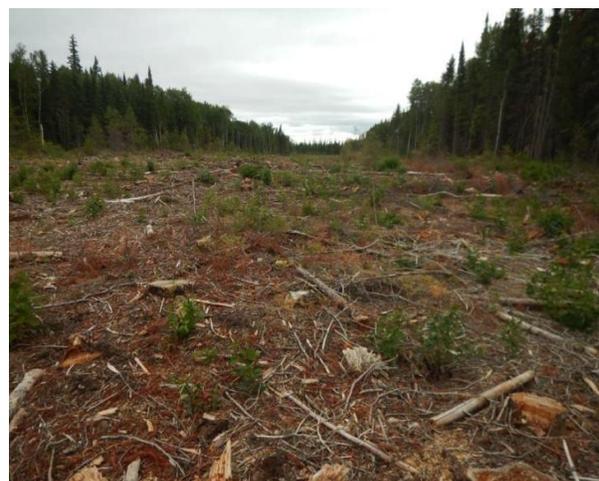
Photo 16 Cleared ROW after 1 year

cleared areas of the zone. Two species of blueberry plants were observed during the surveys: velvetleaf blueberry and low sweet blueberry - but at only two of the eight sites surveyed, with total blueberry cover averaging 1.5% within the surveyed sites. Species occurrence of the two blueberry species seemed to change between years as one site recorded an increase in occurrence and the other a decrease. Low sweet blueberry also did not recur in two plots where it was noted in 2014. Future monitoring will help determine the effects of clearing and recovery of blueberry in the resource area.

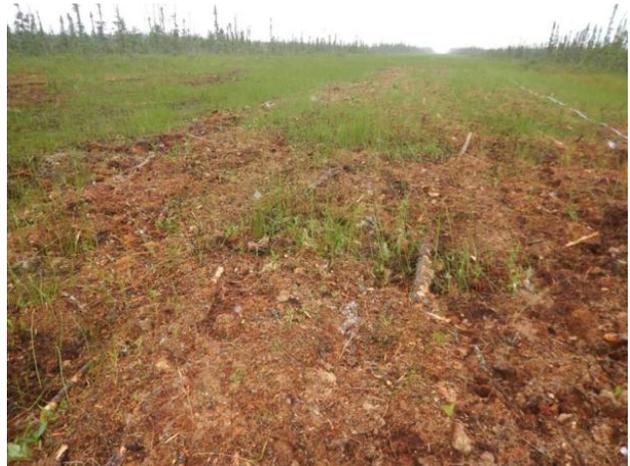
Photo 17 Some ground disturbance in wetland area

Generally the wetlands sites showed low disturbance and the overall effect was largely seen as a change in appearance from the clearing work. There were, however, wetland sites that exhibited moderate disturbance from shearblading tree removal. Natural re-vegetation is expected to occur at these wetland sites and will be monitored over successive years.

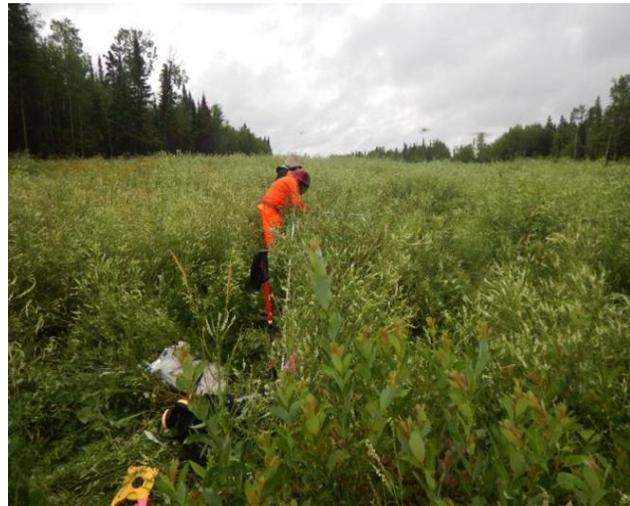
Photo 18 White clover spread on cleared ROW

In 2015 a comparison was made of the effect of different clearing techniques on the presence of invasive and non-native species. Most right-of-way sections are cleared using a shear blade which cuts the vegetation close to ground level. Some sections use mulching as an alternative to vegetation removal and disposal of tree debris. Only slight differences occurred in average total species percent cover, which was slightly higher for shear blading than mulching. No significant differences were noted for total species cover, species richness, diversity or evenness. This helped to demonstrate that either clearing method can be used with similar results on vegetation recovery.

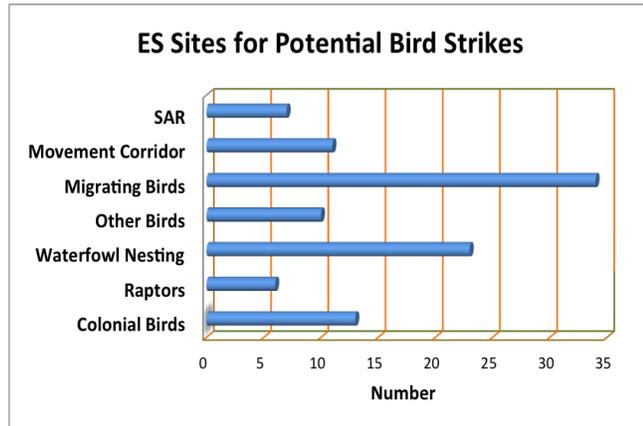
Figure 6-4 ES Sites for potential bird strikes

The Bipole III environmental assessment identified 144 sites where there was potential for bird-wire collisions based on desktop assessment from multiple data sources. Bird habitat qualifying as ESS included presence of bird colonies, raptor nesting habitat, and waterbird nesting or migration stopover habitat in vicinity of the ROW. Initially in 2014 spring and fall surveys, 56 sites were considered high risk for bird collisions and the installation of bird diverters recommended. It was recognized at that time that a further spring waterbird survey would be required to refine or expand the number of sites. An additional 16 sites were added in 2015 for a total of 72 sites recommended for bird diverters on the transmission line route based on various criteria (Figure 6-4 ES Sites for potential bird strikes). Installation will coincide with conductor stringing.

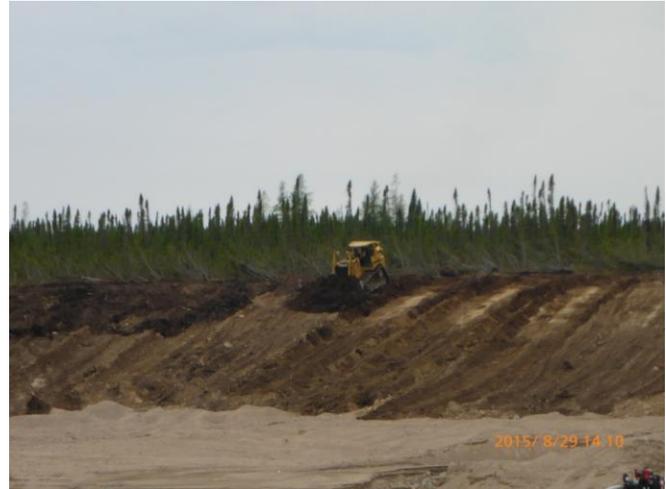
Photo 23 Spreading of stockpiled soils over borrow pit slopes.

At two aggregate borrow sites (N6 and N8) the restoration work consisted of re-sloping the side walls of the excavation to an overall grade of 4:1. Stockpiled soil was then replaced on the re-graded slopes to promote establishment and growth of native vegetation. The surface soils were roughed in with minimal smoothing resulting in shallow pockets that will trap both seed and water.

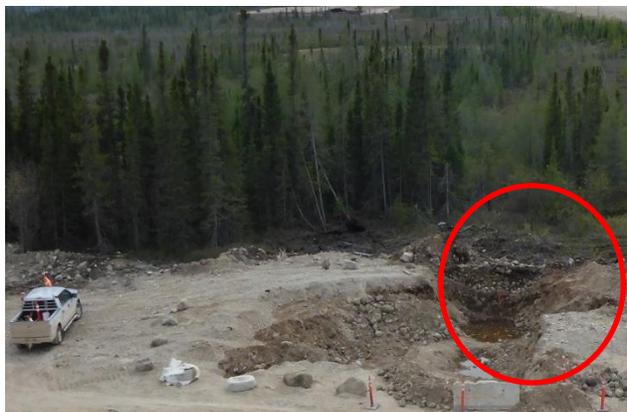
Photo 24 Excavation of Petroleum Fuel Storage Area at Keewatinohk

Other areas in the Bipole III Transmission Project, namely the converter station project sites, will require decommissioning and remediation of petroleum storage facilities of various sizes. The N8 Petroleum and Storage Area at Keewatinohk was decommissioned in June 2015, with a full site remediation plan submitted and approved by the Contaminated Sites Program, Environmental Approvals Branch of Manitoba Conservation and Water Stewardship. Soil samples were taken from points around the excavation and sent to an accredited laboratory for analysis. The timeline for this project was June 8 to 15, 2015. Photo 15-3 shows the site completely remediated and backfilled.

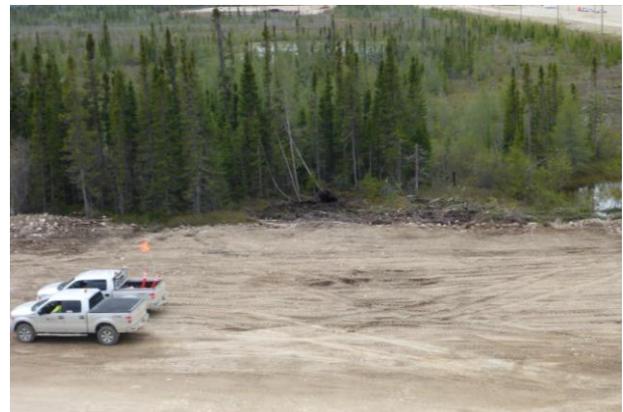
Photo 25 Completed Excavation of Petroleum Fuel Storage Area at Keewatinohk

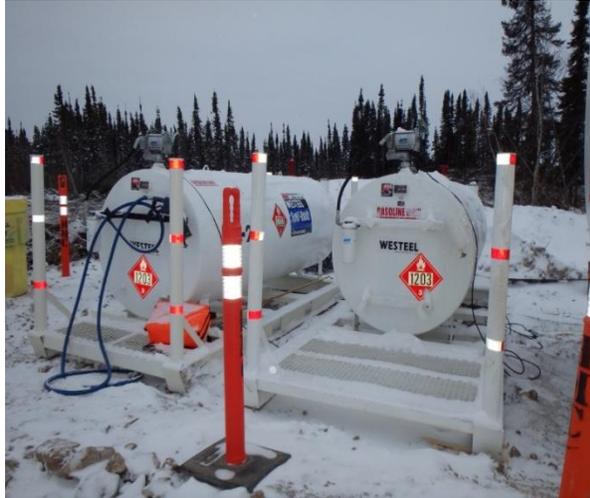
Photo 26 A spill containment system for the safe storage of gasoline

To properly manage all hazardous materials, Manitoba Hydro requires contractors to have spill response and prevention plans that outline procedures, notification, and training. All contractors are made aware that releases, regardless of quantity, are to be reported to Manitoba Hydro for further action or regulatory reporting.
