Lake Winnipeg East System Improvement Transmission Project

Environmental Effects Monitoring Report

Prepared by:
Manitoba Hydro
Winnipeg, Manitoba
December 2017

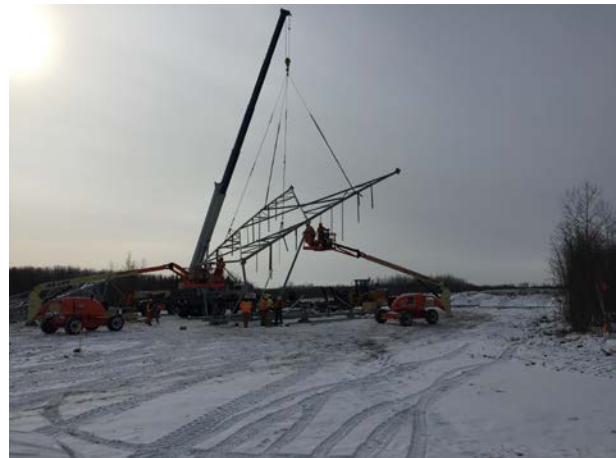
Photo 1: Construction crews installing a tower

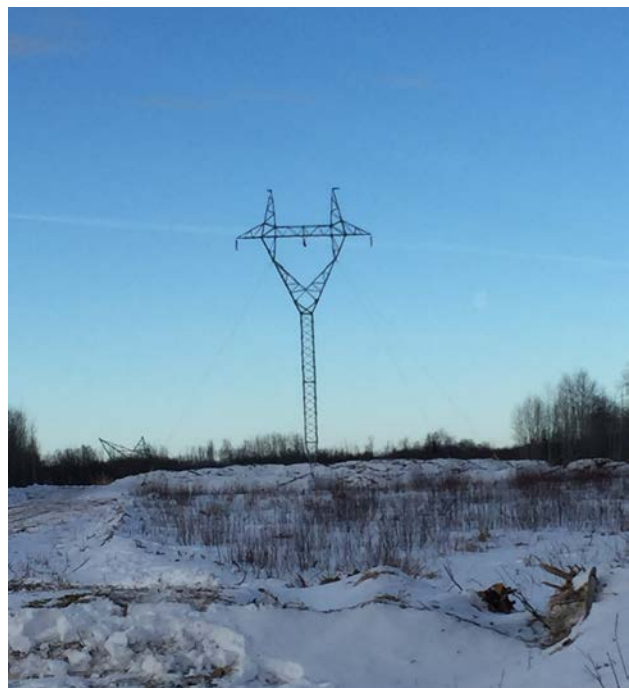
Photo 2: Newly assembled tower installed on the ROW

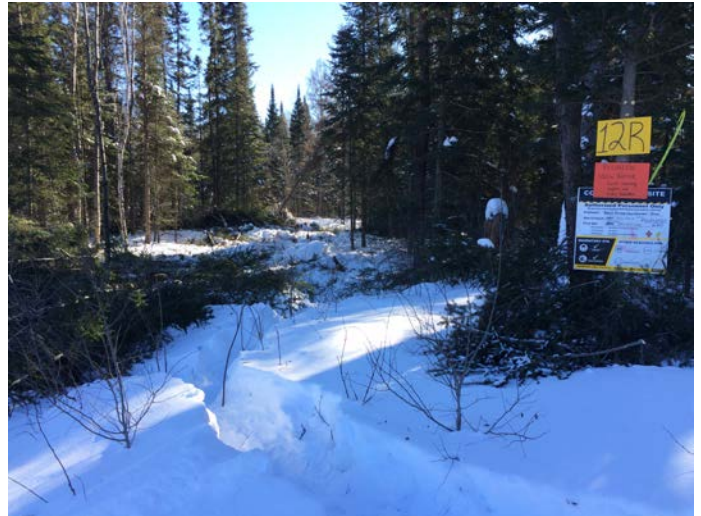
Photo 3: Environmental protection signage installed to assist construction crews

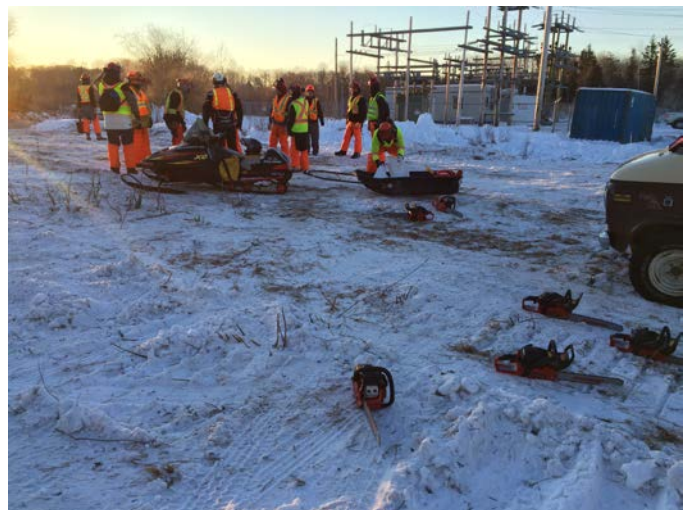
Photo 4: Crews preparing to travel to an environmentally sensitive site to conduct hand clearing, an important mitigation measure to protect certain environmental features

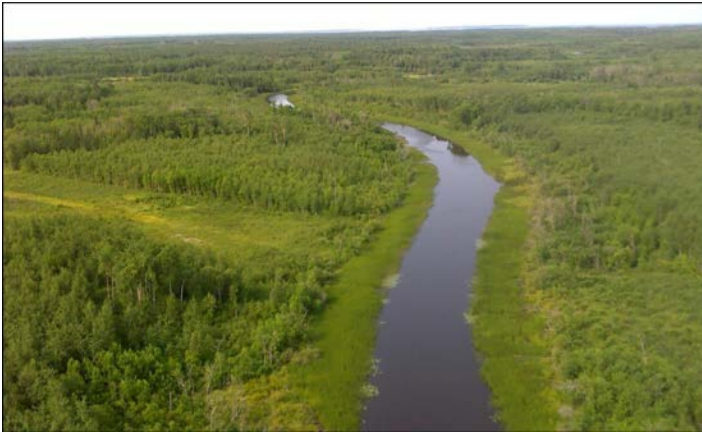
As predicted in the EA, project effects on stream crossings were minor. All 24 sites observed were, constructed and cleaned up in accordance with the

mitigation measures outlined in the EnvPP, and the crossing and site conditions met the EnvPP and EAL requirements.

The implementation of mitigation recommendations outlined in the construction Environmental Protection Plan was effective. The three sites identified in 2016 as being non-compliant with the prescribed mitigation due to erosion, exposed soils, debris, and slash in watercourse were rehabilitated and showed signs of successful natural revegetation, with no further remediation warranted.

Photo 5: View looking east of the crossing at the Black River showing the preservation of the riparian zone and regrowth of vegetation along the ROW

Due to the natural revegetation of disturbed locations, no further remediation is required. At the O'Hanley river crossing a single rubber tire was observed caught in natural debris along the river channel (of unknown origin). This rubber tire will be removed during 2018 construction activities.

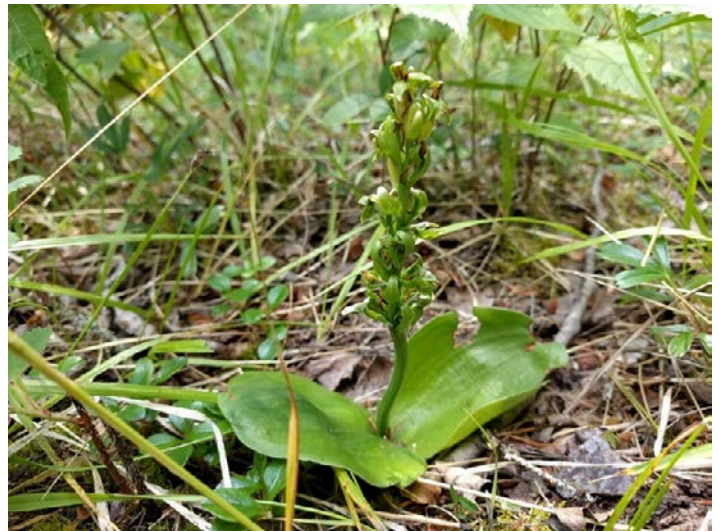
Surveys conducted in July 2017 at seven plots identified that most species of conservation concern (SCC) were in good condition with some potentially benefiting from the right-of-way clearing activities as a result of additional sunlight and reduced competition afforded to herbaceous plants.

Photo 6: Hooker's Orchid (*Platanthera hookeri*) found within the ROW

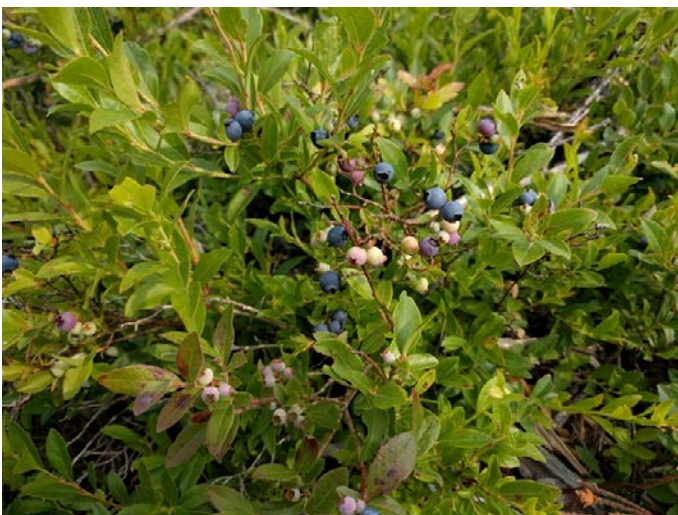
As predicted in the EA, some loss of habitat has occurred for plants important to Indigenous peoples within the Project area. However many species were having an excellent year for fruiting with blueberry and cranberry species fruiting profusely within the cleared right-of-way.

Photo 7: Early lowbush blueberry (*Vaccinium angustifolium*) in fruit within the ROW

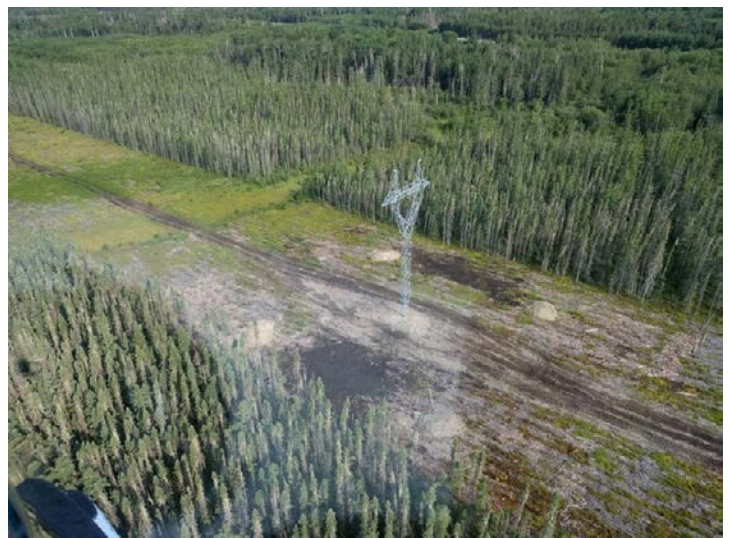
Surveys were conducted in July 2017 at key locations along the ROW. White sweet clover (*Melilotus albus*) and Canada thistle (*Cirsium arvense*) were identified in a few locations.

Photo 8: Aerial survey for invasive species occurrences and disturbed areas

Manitoba Hydro and its contractors will continue to apply a clean equipment protocol to limit the spread of these species.

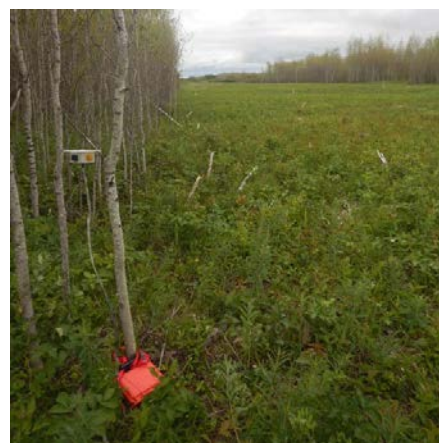
During the 2016 monitoring program passive audio recorders were deployed at 58 locations around the Project site during the breeding season in a paired control-impact study design.

Data analysis showed that common nighthawk and eastern whip-poor-will appeared common in the study area, as indicated by their presence at more than half of the sites surveyed and by the frequency of their calls. There was no statistically significant difference between common nighthawk and eastern whip-poor-will activity at sites on the ROW and at comparison sites in similar habitat. The similarities in detection rate between ROW and comparison sites suggest that there were no measurable adverse effects of the cleared transmission line ROW on either species to date. It is well understood that both species forage and nest in forest clearings and edges (Environment Canada 2015, 2016), so no detectable effect was hypothesized. Portions of the cleared transmission line appeared to provide suitable habitat for common nighthawk and eastern whip-poor-will. However, other factors affecting these populations in the study area, such as insect populations, predation rates and reproductive success, are unknown.

Photo 9: Passive audio recorders were used to monitor for common nighthawk and whip-poor-will
