Lake Winnipeg East System Improvement Transmission Project Environmental Effects Monitoring Report

Prepared by:
Manitoba Hydro
Winnipeg, Manitoba
November 2020

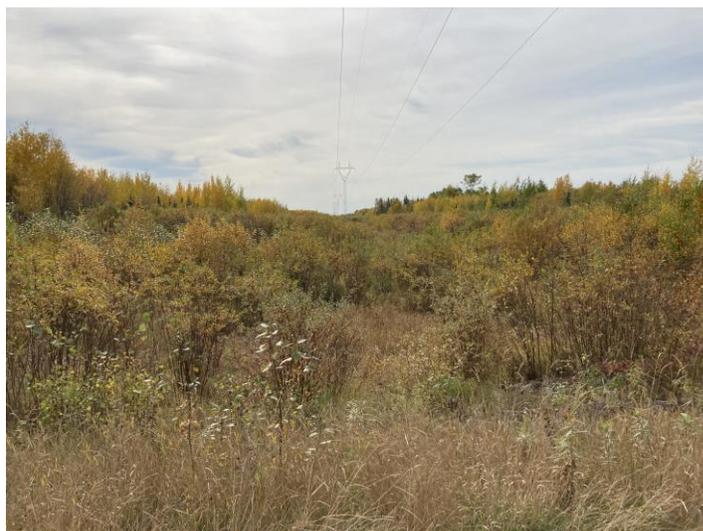
Photo 1: The Lake Winnipeg East System Improvement Project officially came in-service on June 30th, 2018. Photo taken in September 2020.

Construction of the Project began in August 2015. The project officially came into service on June 30th, 2018.

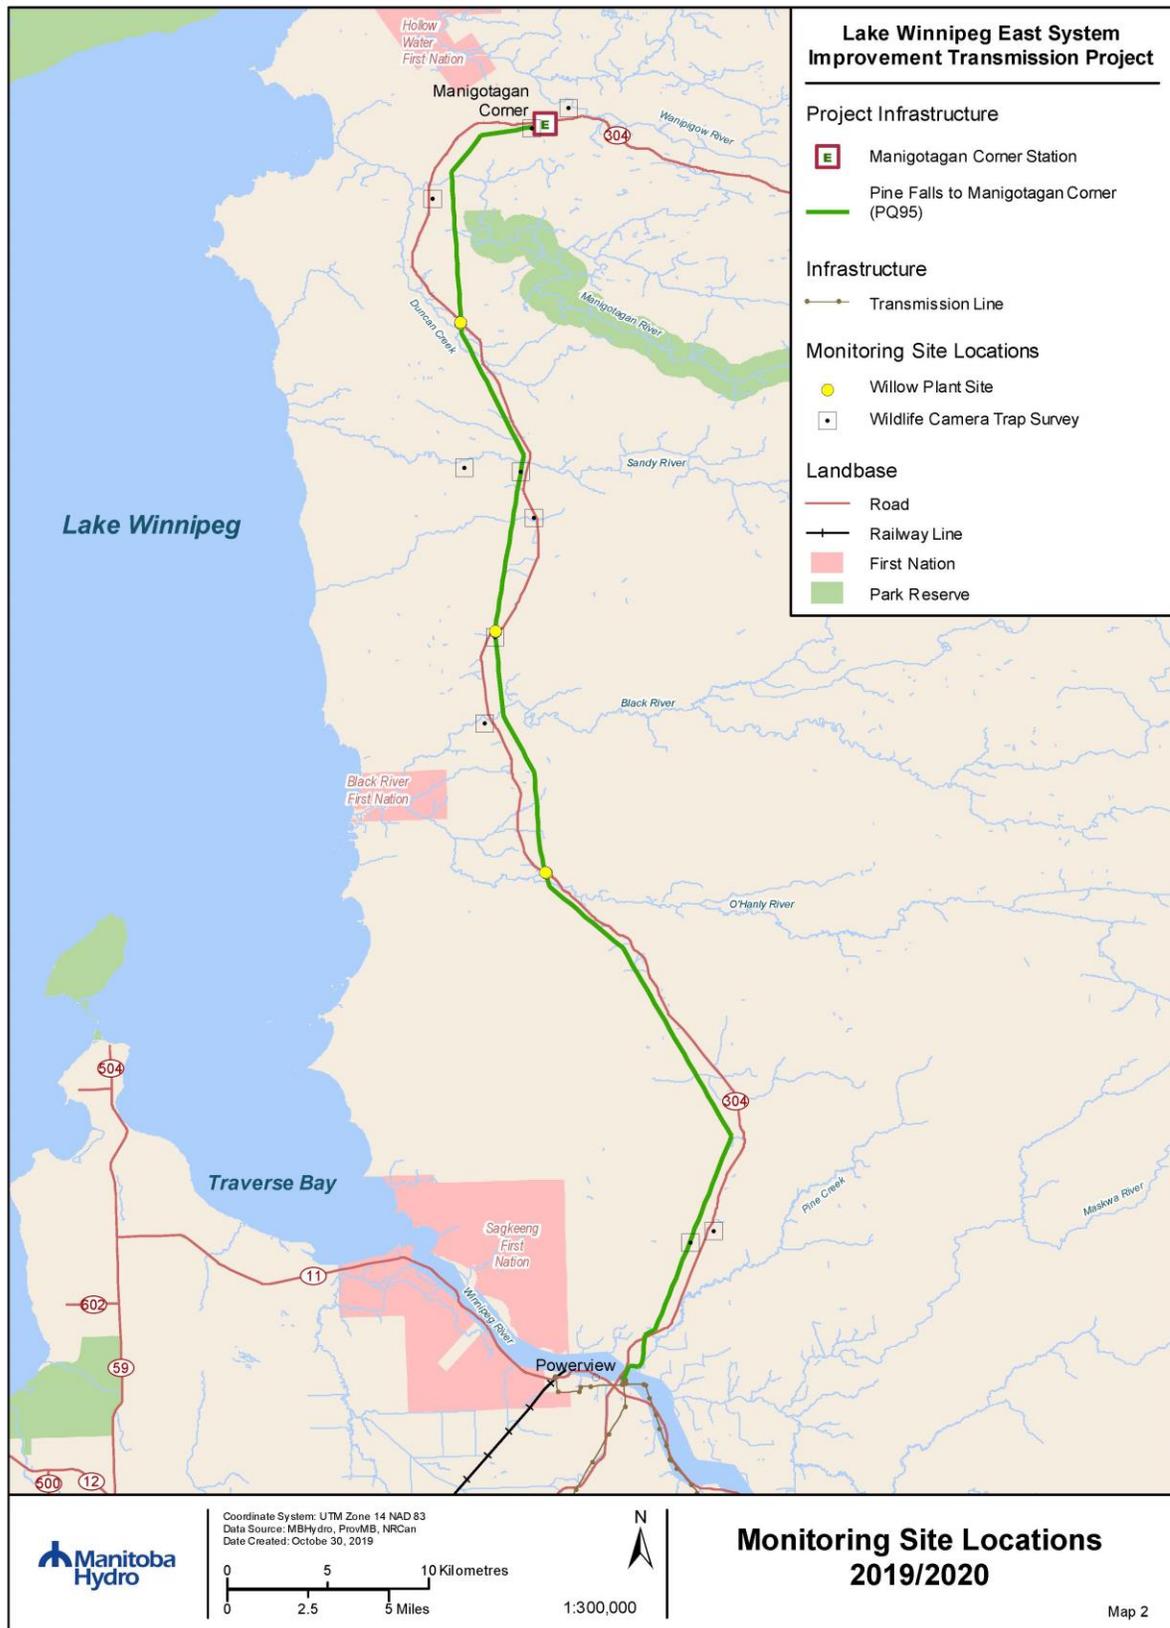
Map 2: Lake Winnipeg East System Improvement Transmission Project Monitoring Site Locations

Multiple environmental components were identified for follow-up in the environmental assessment and technical reports. For each environmental component, one or more environmental indicators were selected to focus monitoring and follow-up efforts as indicated in the EEMP (Table 1). Map 2 shows an overview of monitoring site locations.

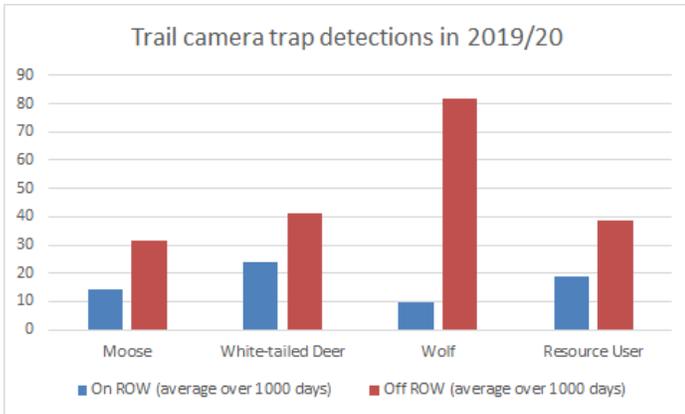
Figure 1. Trail camera trap detections in 2019/20.

Results from the 2019/20 camera trap survey have shown the presence of moose occurring at 2 of 3 ROW monitoring sites and 4 of 5 control monitoring sites over an average 360 trap days. When data was pooled, significantly more moose were detected at control monitoring sites than on ROW monitoring sites (p-value = 0.005). Camera trap data is summarized in Figure 1.

Results from the 2019/2020 camera trap survey have shown the presence of white-tailed deer occurring at 2 of the 3 ROW monitoring and 4 of the 5 control sites during 360 trap days. When data was pooled, significantly more deer were detected at control monitoring sites than on ROW monitoring sites (p-value = 0.016). White-tailed deer were primarily detected in the central and southern portion of the study area. Only six were detected in the northern portion.

Results from the 2019/2020 camera trap program have shown that wolves have been detected on 1 of 3 ROW monitoring sites, and 2 of 5 control monitoring sites after 360 trap days. When data was pooled, significantly more wolves were detected at the control monitoring sites than at ROW monitoring sites (p value = 0.0001). This may be partially due to one of the control monitoring sites being located near a confirmed wolf denning site (by coincidence), resulting in an increased number of detections.

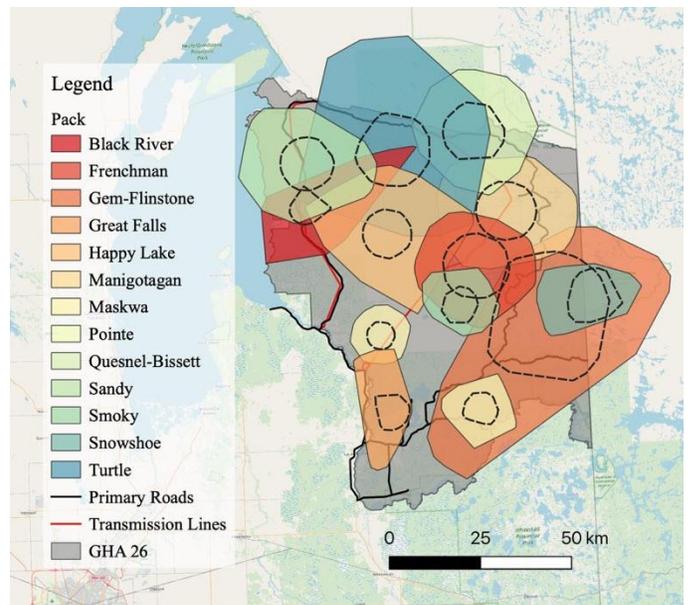
Figure 2. Home range and movements of wolves as collected by graduate students from Memorial University (data from 2016-2019).

Results of the study to date indicate that most wolves avoid locations close to major highways, all wolves select to be closer to secondary roads and waterways and have a neutral response to tertiary roads.

Transmission ROWs with an adjacent major highway, including the Lake Winnipeg East System Improvement Project were generally avoided by wolves. The continuation of this multi-year study will help improve our understanding of wolf movements.

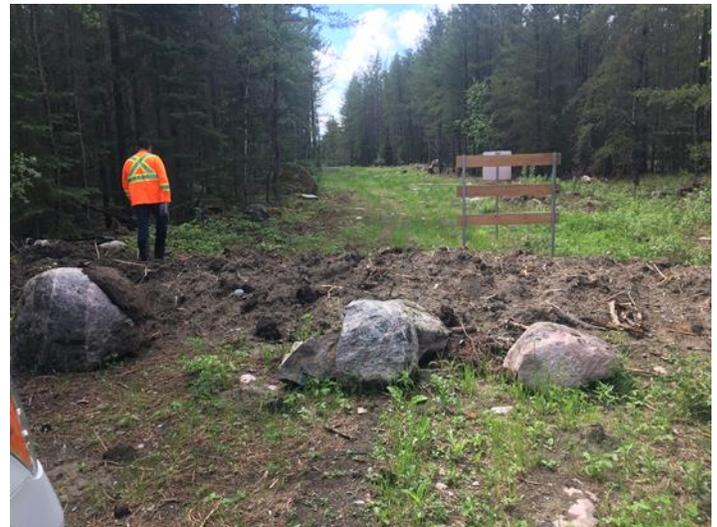
Photo 7: Access camera servicing at a decommissioned site with signage and boulders.

Access trail decommissioning was conducted after construction. This involved placing large boulders, trenching, and felling trees over unnecessary access trails to prevent future vehicular traffic. These decommissioning efforts appear to have been effective. The Pine Falls District Conservation Officer has reported to Manitoba Hydro that recreational vehicle traffic appears to be generally low on the ROW.
