# MANITOBA MINNESOTA TRANSMISSION PROJECT

## POST-CONSTRUCTION WATER COURSE CROSSINGS MONITORING REPORT – 2020

February 2021

Manitoba Hydro

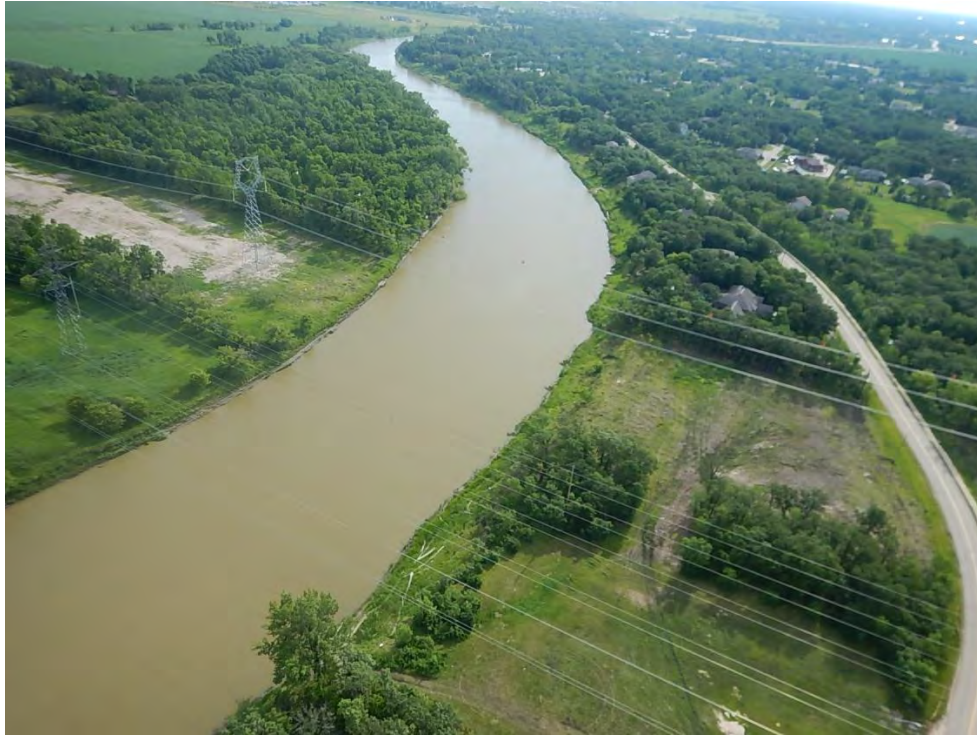
Photo 1. Aerial photo of Aqua-103 (Assiniboine River) showing full compliance with prescribed mitigation, June 29, 2020.

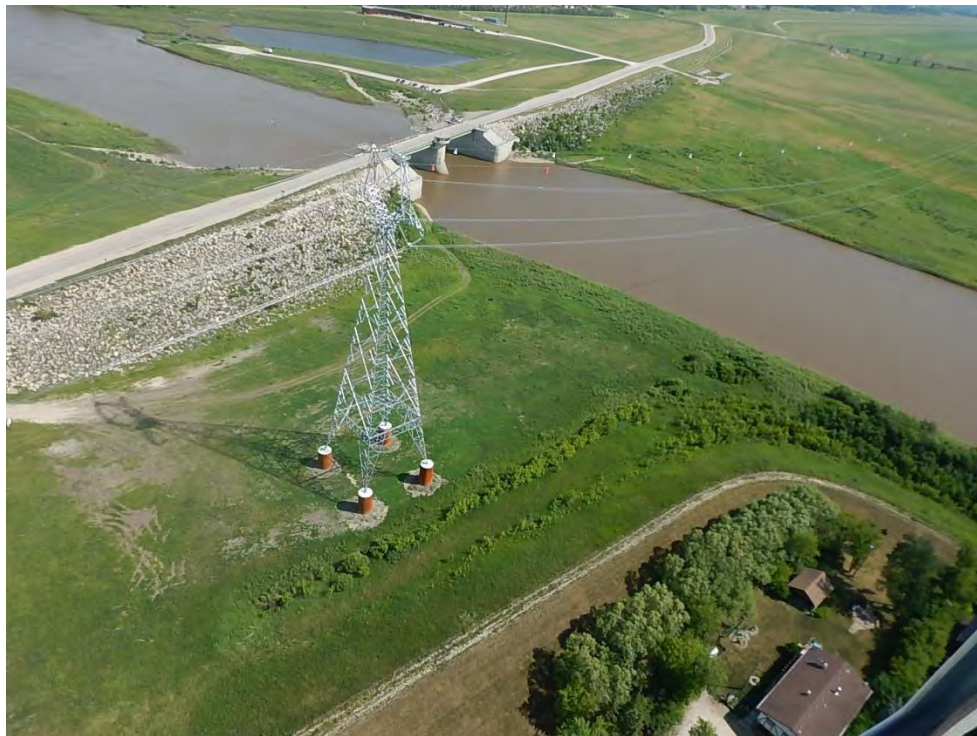
Photo 2. Aerial photo of Aqua-109 (Red River) showing full compliance with prescribed mitigation, June 29, 2020.

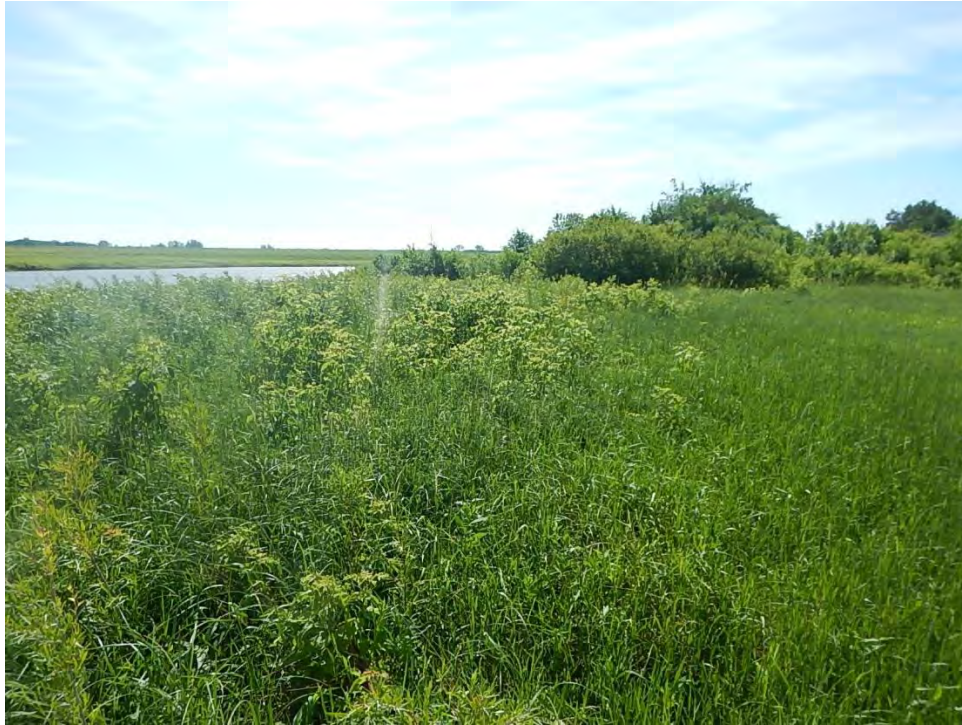
Photo 3. Ground visit at Aqua-109 (Red River) showing good riparian coverage and growth. June 29, 2020.

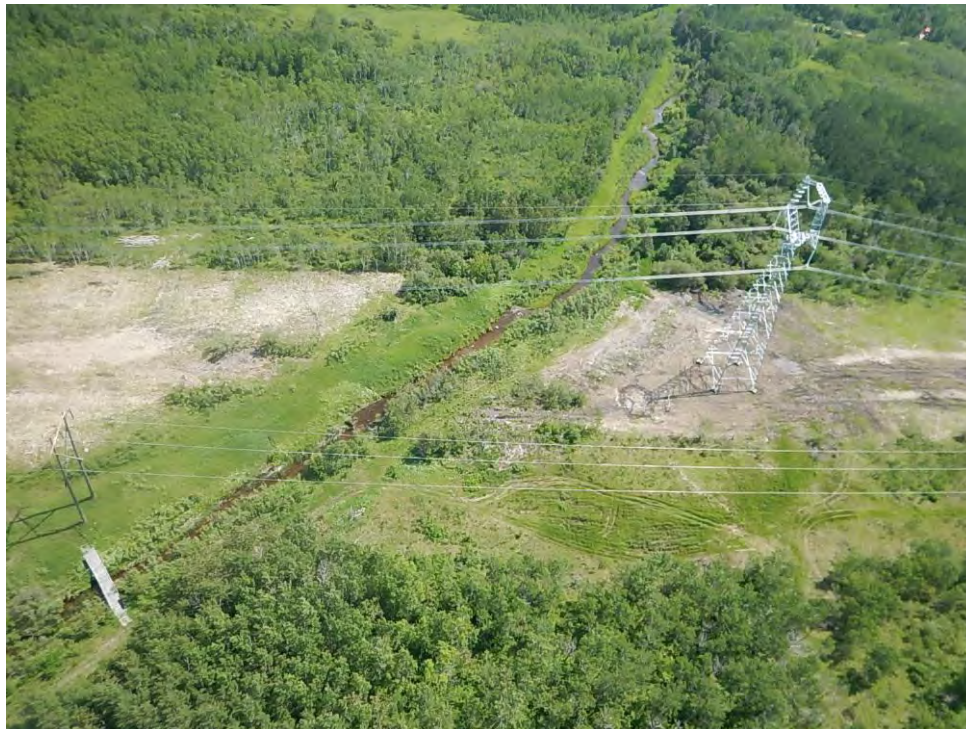
Photo 4. Aerial photo of Aqua-117 (Cooks Creek) showing full compliance with prescribed mitigation, June 29, 2020.

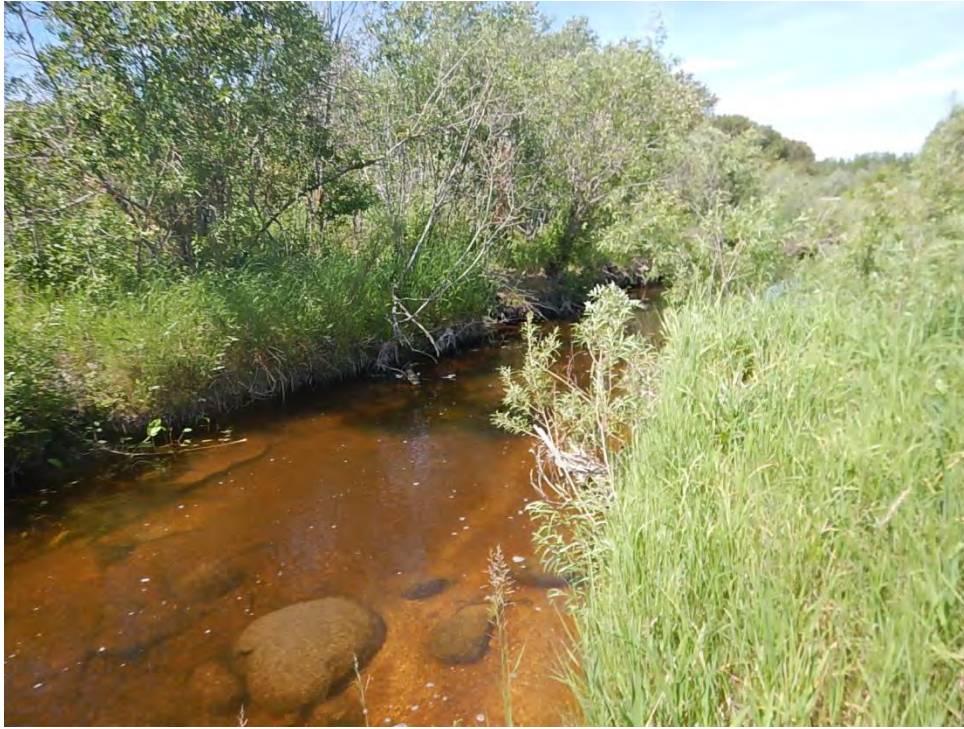
Photo 5. Ground visit at Aqua-117 (Cooks Creek) showing good riparian growth and stable banks. June 29, 2020.

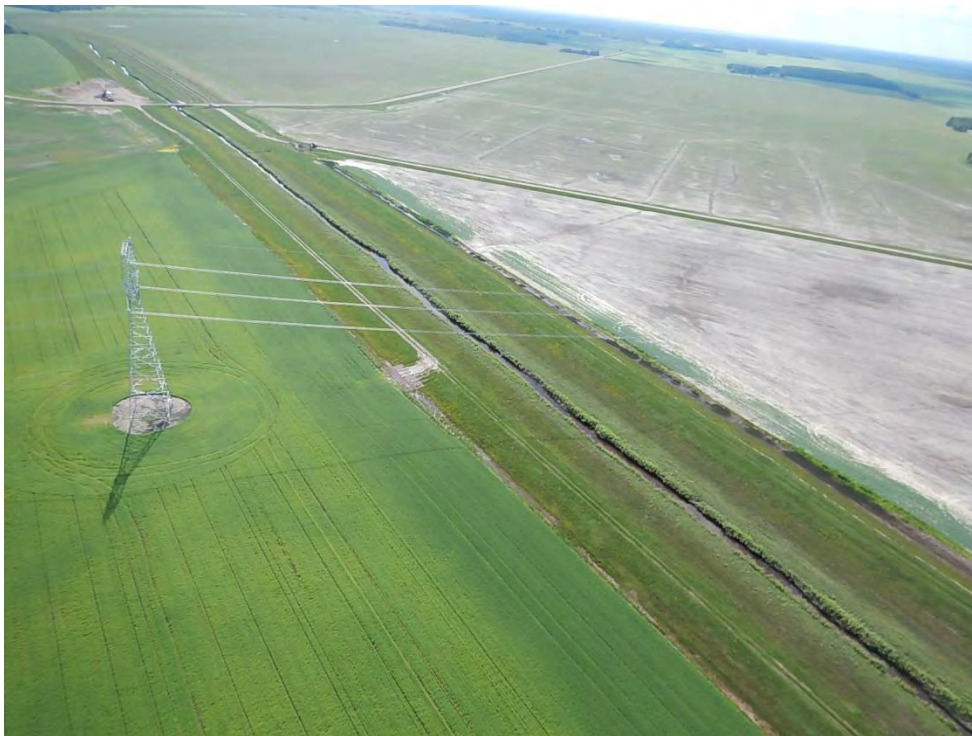
Photo 6. Aerial photo of Aqua-129 (Pine creek Diversion) showing full compliance with prescribed mitigation, June 29, 2020.

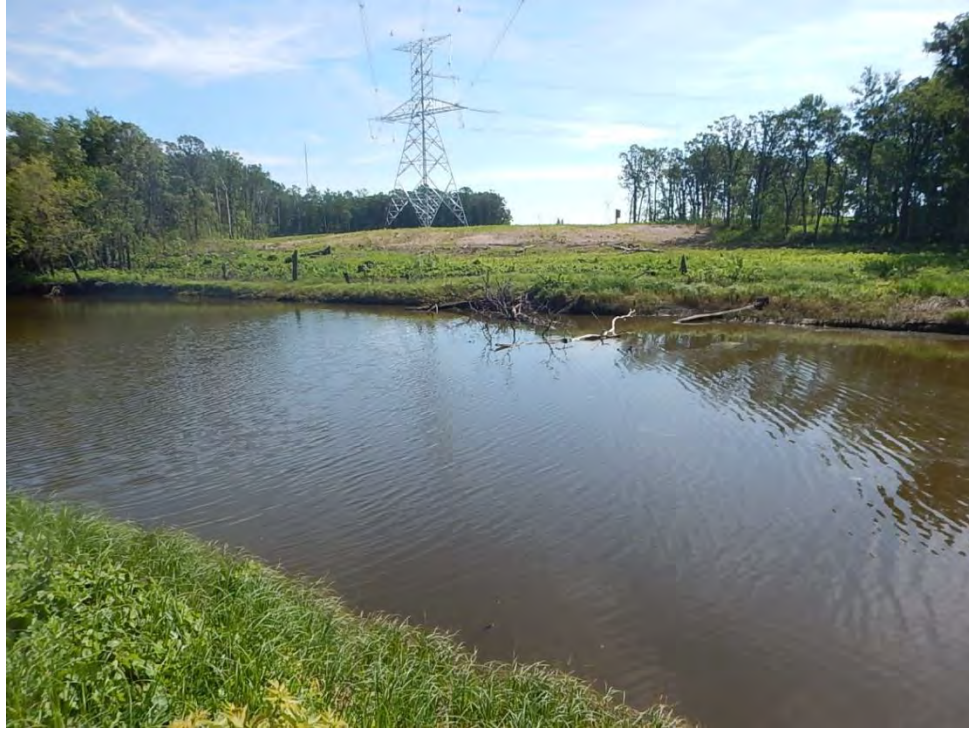
Photo 7. Large woody debris observed in the channel at Aqua-108 (La Salle River), June 29, 2020.

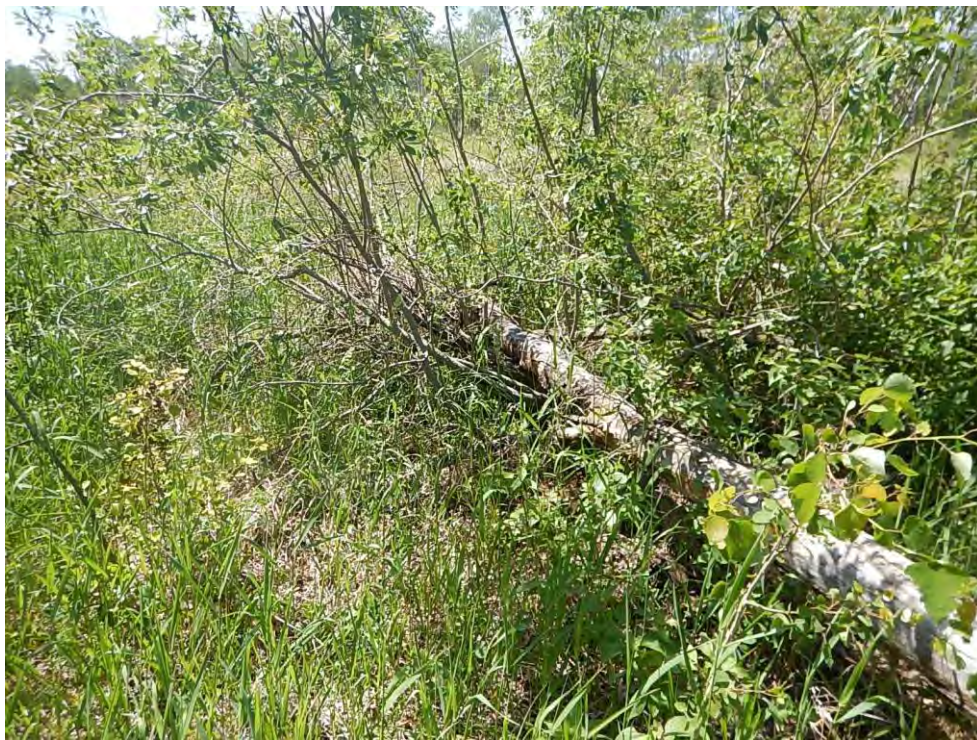
Photo 8. Large woody debris observed at Aqua-118 (Fish Creek) on the edge of the RoW within the riparian zone and near the water course crossing, June 29, 2020.

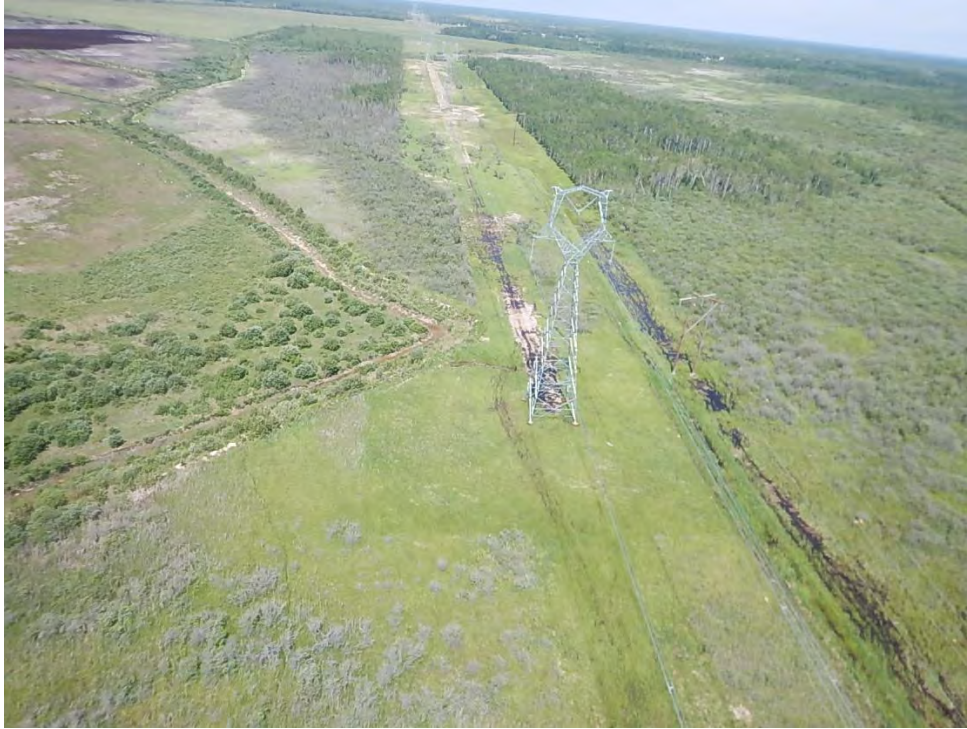
Photo 9. Minor centerline rutting observed at Aqua-119 (Unnamed Creek), June 29, 2020.

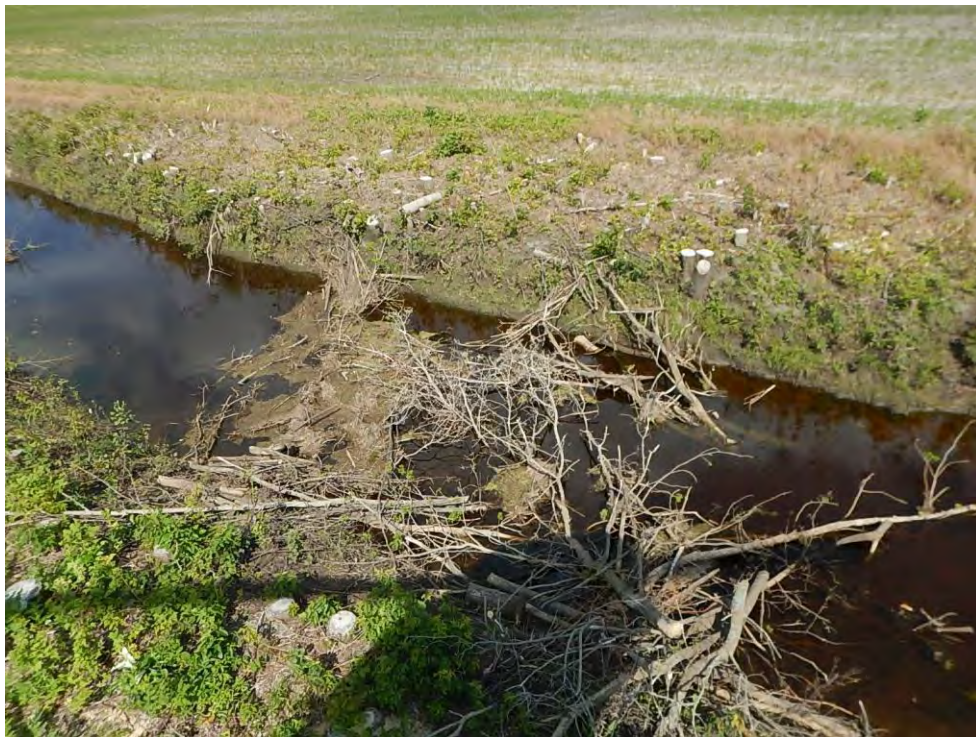
Woody debris from riparian clearing was observed in the channel at Aqua-130 during aerial surveys in June (Photo 10). According to the EnvPP cleared trees and woody debris should not be pushed into (or adjacent) to standing timber, or within the high-water mark of wetlands or waterbodies (Manitoba Hydro 2019; Appendix 1). It is recommended the woody debris be removed from the channel in order to prevent blockage of the watercourse during spring run-off and potentially inhibiting the movement of fish.

Photo 10. Cleared woody debris present within the channel at Aqua-130 (Pine Creek), June 29, 2020.

Based on the above recommendations, the Project contractor at the request of Manitoba Hydro removed the woody debris from Aqua-130. Removal of the woody debris from the channel was

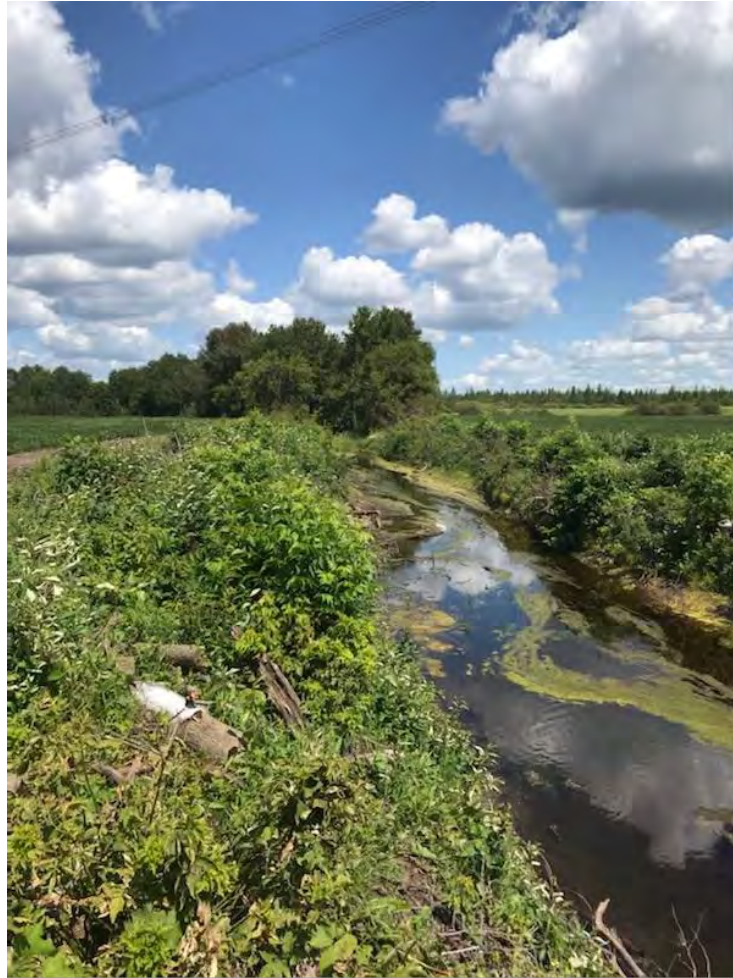
Photo 11. Manitoba Hydro inspector photo from August 5, 2020 showing the removal of woody debris from Aqua-130 (Pine Creek) noted during aerial surveys on June 29, 2020.

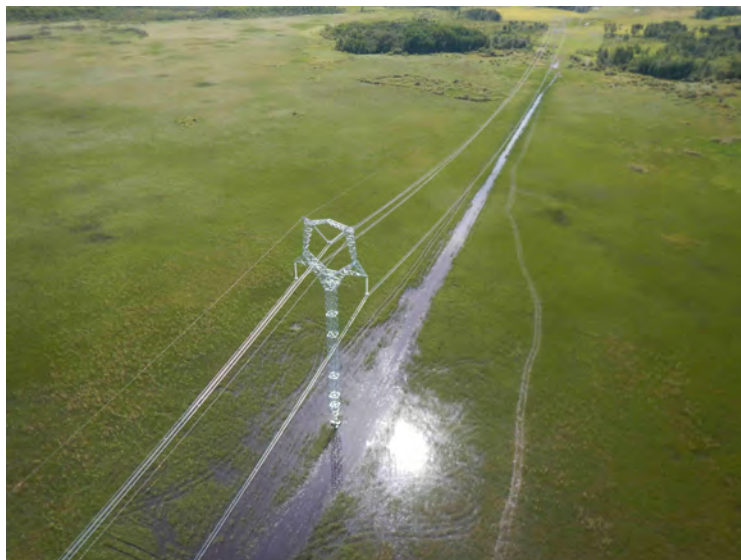
Photograph 4-1a. Rutting in wetland at site WET-197.

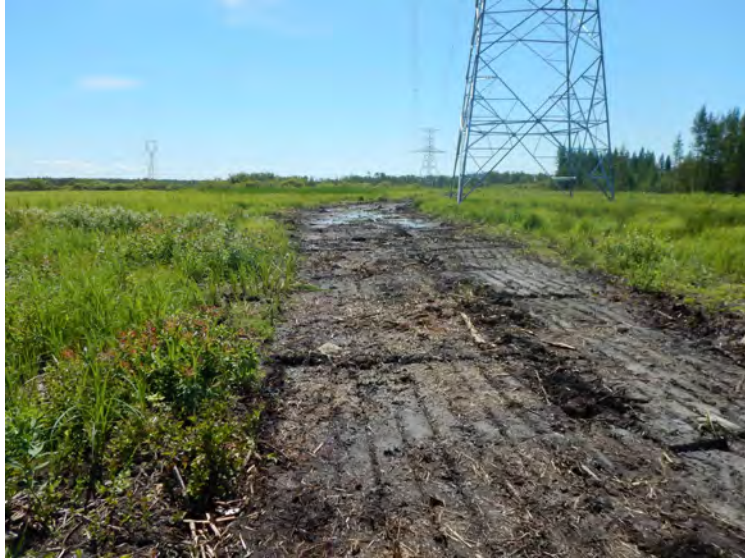
No major disturbances were noted at any wetland sites, and surface soils appeared relatively undisturbed, without major rutting observed. Few wetland sites had areas with minor amounts of exposed soil (e.g., WET-120, -125). Some vegetation disturbance and possible rutting along the equipment path was apparent at WET-197 (Photograph 4-1a). Disturbance appeared to be at least partially caused by use of ATV. Seasonal vegetation damage was observed around towers and where construction matting occurred. Site WET-123 had vegetation growth suppressed as a result of matting used along the equipment path (Photograph 4-1b).

Photograph 4-1b. Vegetation growth suppressed at site WET-123.

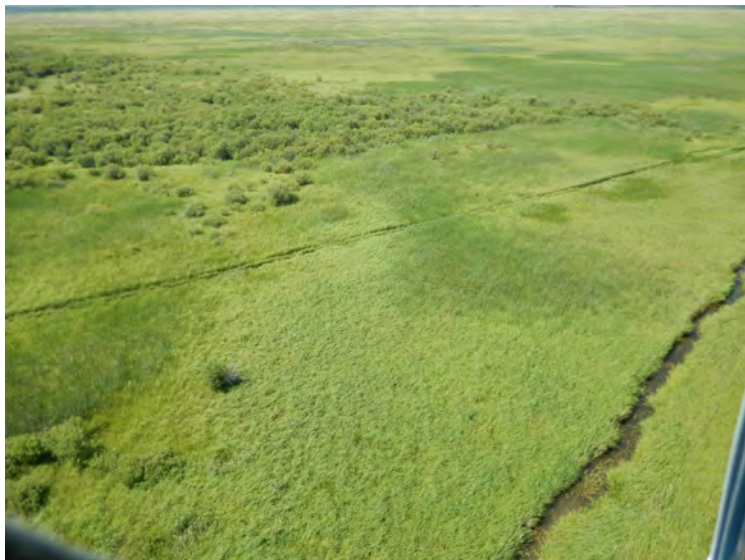
During a low-level flight, seasonal damage to vegetation was noted in certain areas on the RoW especially around tower placements and the equipment path, (e.g., near WET-123, -125). Several sites sampled also had abundant mulch cover present, with reduced species cover in these areas of the RoW (e.g., WET-188, -209). As a result of low disturbance to wetlands in 2020, wetland loss was determined to only include the area displaced by the tower foundations. Minor disturbances in monitored wetlands are anticipated to naturally recover along the RoW, as seen in other transmission projects (Manitoba Hydro 2020b). Photograph 4-1c shows typical RoW disturbance seen at most wetland sites.

Photograph 4-1c. RoW disturbance (upper linear feature) at site WET-142.

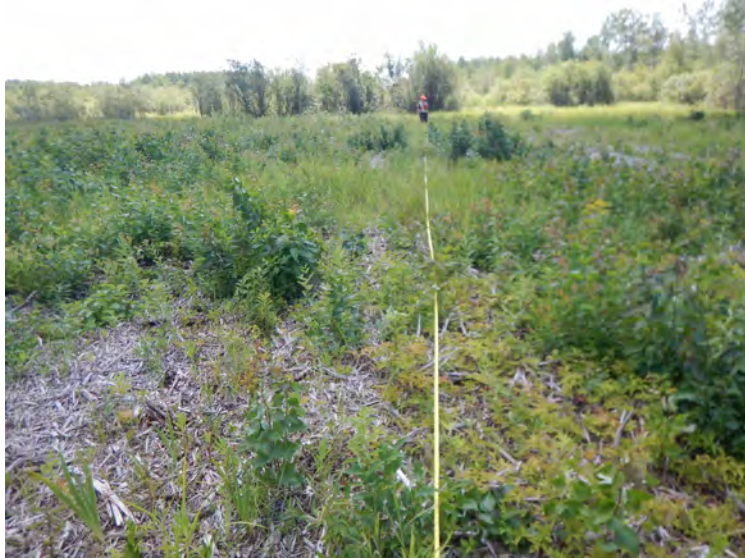
The RoW was generally totally cleared of previous tree canopies, although in some sites, intermittent tall willows remained as isolated and small patches were maintained on the RoW (e.g., ATK-165, -179; and INV-164, -187, -203), with some tall shrubs to tree height (<4 m). High-bush cranberry (*Viburnum opulus*) and speckled alder were tall shrubs also recorded in ATK-179. No other original tall shrub vegetation structure was retained in other sites after clearing on the RoW. Sites were generally covered with mulched wood. Regeneration of trembling aspen and tall shrubs was moderately to well-developed in some sites (i.e., ATK-215, -219, -220). Other sites were still in early stages of recovery as evidenced by low species numbers and cover. Photograph 4-2a shows traditional site ATK-165 with remaining and regenerating vegetation.

Photograph 4-2a. Well-developed herb and low shrub stratum, and regenerating and remaining tall shrubs.

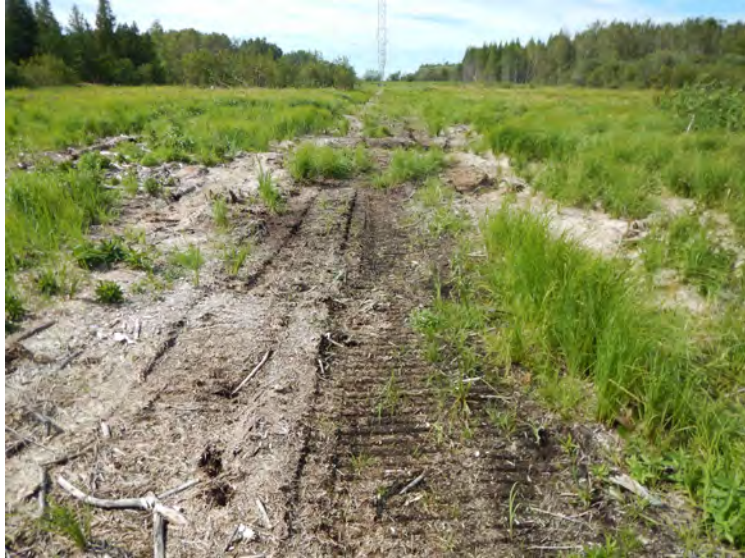
Two monitoring sites for traditional use plants had applications of straw mulch, sites ATK-226 and INV-203. The equipment path in the vicinity of these sites was covered extensively with a wide swath (>20 m) and thick mat of straw mulch, stretching from Provincial Highway 201 and encompassing several towers, Photograph 4-2b. Scattered volunteer barley (mature *Hordeum vulgare*) had sprouted from the straw mulch throughout the equipment path. Off-RoW, eastern white cedar (*Thuja occidentalis*) and tamarack (*Larix laricina*) dominate the tree canopy. It was not possible to determine whether underlying soils may have been disturbed by any construction activities. The equipment path was relatively level under moist ground conditions, and possibly more compacted than the surrounding area on the RoW.

Photograph 4-2b. Swath of straw mulch along equipment path at ATK-226.

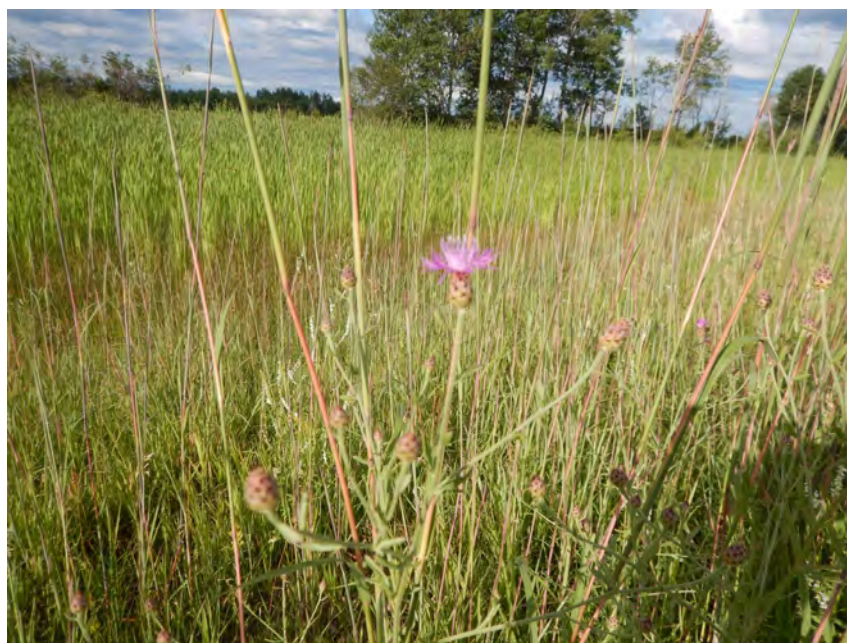
Photograph 4-3a. Spotted knapweed observed at site INV-377-R.

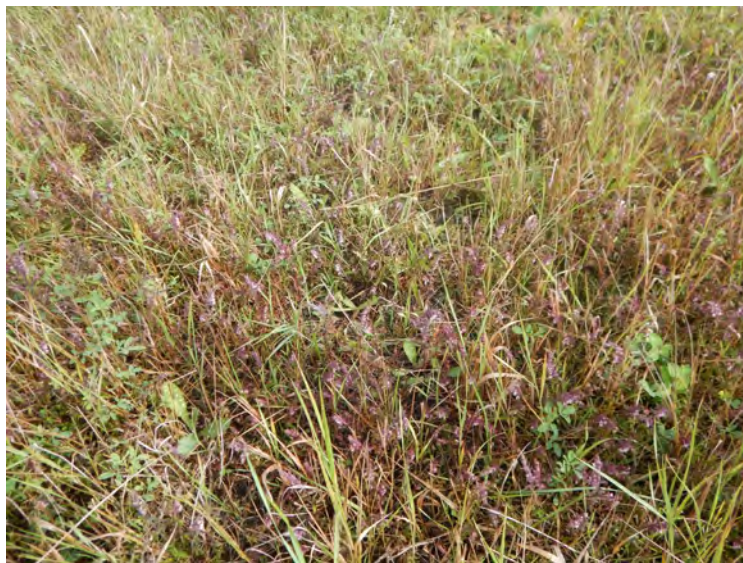
Photograph 4-3b. Red bartsia observed at ECO-400A.

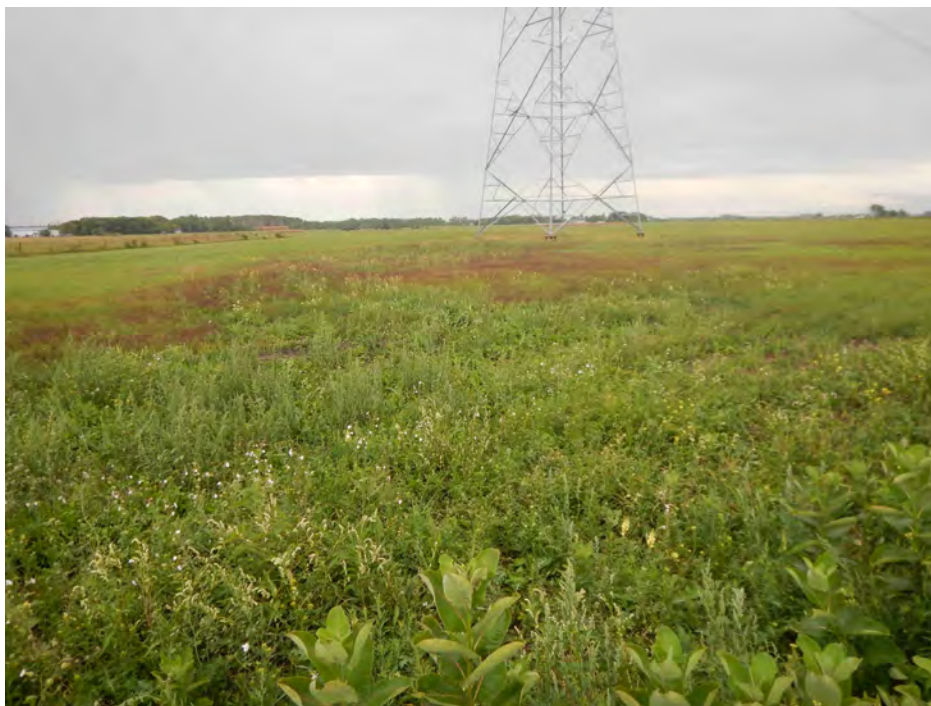
Photograph 4-3c. Red bartsia observed on the RoW at ECO-401A (dark shade background).

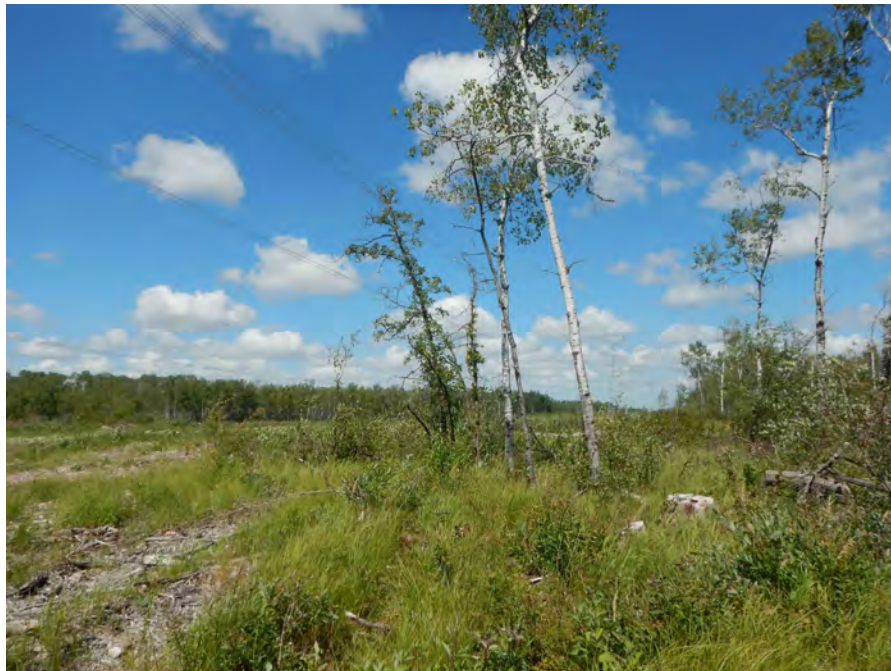
A change in landscape intactness is a result of transmission RoW clearing. Removal and long-term loss of forest cover from RoW clearing is an effect of transmission line development (Manitoba Hydro et al. 2003). Fragmentation of large-scale corridor projects is frequently an inevitable consequence (Joro Consultants 2011). Vegetation cover decreased from pre-construction values (2017) due to the removal of tree and shrub vegetation structure and associated species from the RoW (mean total species cover change of 107.6 to 49.5%). A change in habitat availability has also occurred on the RoW in critical GWW habitat. Vegetation has been selectively cleared in areas to enhance suitability for GWW, see Photograph 4-4a.

Photograph 4-4a. Selective clearing on RoW at GWW-013 with available habitat.

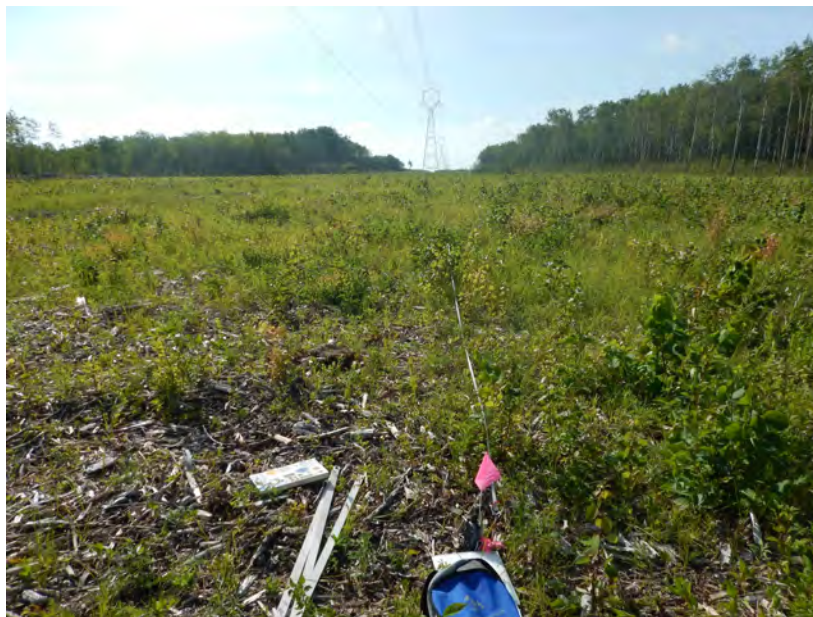
Mitigation at GWW sites includes whether: shrubs and herbaceous vegetation <4 m tall was retained to the extent possible; and whether five to ten perch trees were retained per span where feasible. Perch sites trees are small groups of three to five trees within 10 m of the cleared edge of the RoW. Pre-construction, golden-winged warbler sites were primarily open hardwood canopies, dominated by trembling aspen, with occasional balsam poplar and/or bur oak (*Quercus macrocarpa*). Construction clearing at GWW sites removed perch areas for GWW from seven sites monitored along the RoW (i.e., GWW-006, -009; -010; -015; -016; -018; -024). Photograph 4-4b shows RoW clearing at GWW-009, without obvious perch areas remaining. Linear RoW boundaries occasionally had individual or small clumps of trees remaining just inside the RoW edges, which may provide perch opportunity for GWW.

Photograph 4-4b. RoW clearing at GWW-009.

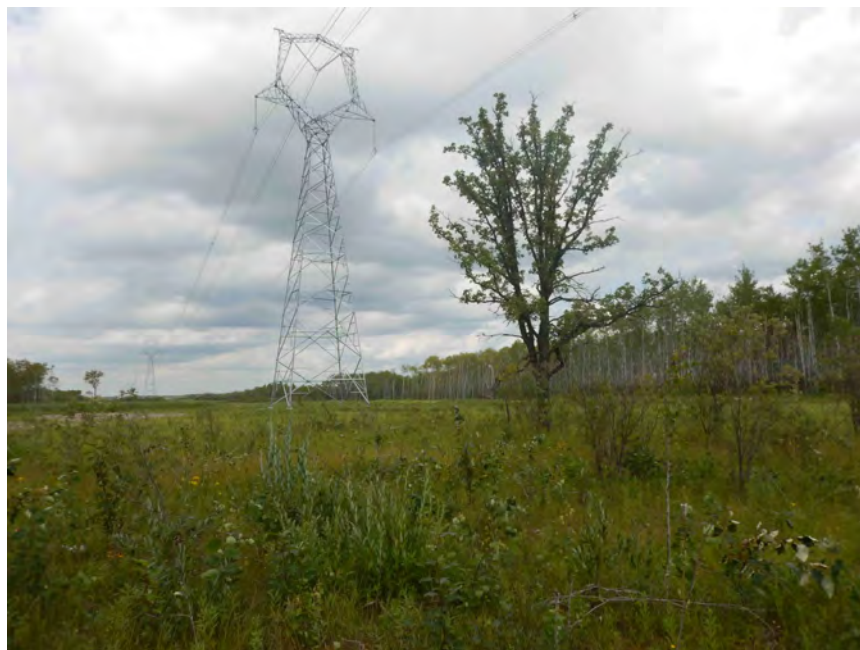
A large mature oak tree remains unaffected on the RoW at HERT-201, approximately 12 m from the center line, near GWW-008 (Photograph 4-4c). Although not aged, this tree is likely old growth (>100 years) due to the size of the trunk diameter. Such slow growing old growth trees can remain on the RoW, where they do not interfere with vegetation clearance requirements for safe operation of the transmission line. Site GWW-008 has been selectively cleared to enhance golden-winged warbler habitat.

Photograph 4-4c. Old growth oak tree remaining on RoW at selectively cleared site GWW-008.

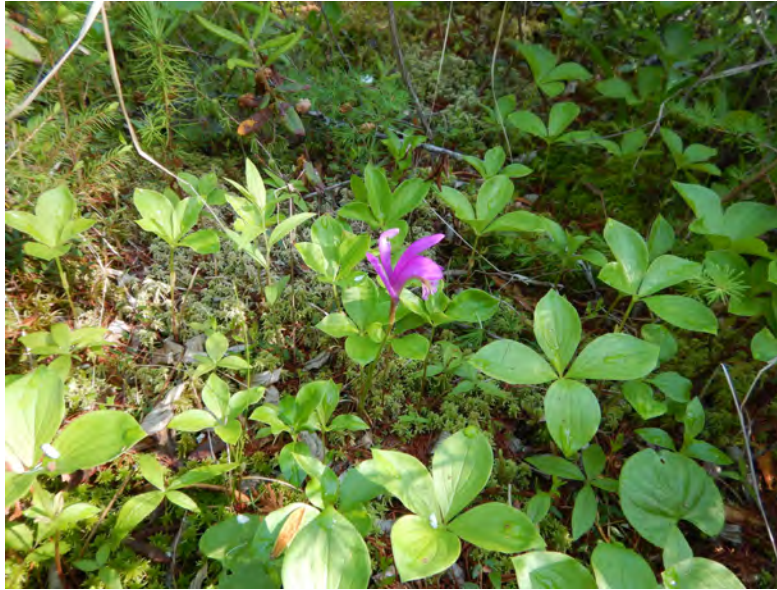
Photograph 4-5a. Dragon's-mouth orchid observed at REDACTED

Near REDACTED, surveys were conducted for dragon's-mouth orchid along a proposed access trail that was avoided during clearing and construction activities. A new access trail was shifted west to avoid the environmentally sensitive sites. In 2020, dragon's-mouth orchid was observed at three of the five sites along the originally proposed trail, REDACTED. A fourth site was also observed to support this species REDACTED. Greater than 35 plants were observed at all sites combined. Photograph 4-5a shows dragon's-mouth orchid observed at REDACTED. These plants were observed along the forest edge, within the opening of the wet trail. Tall shrubs and trees included willows,

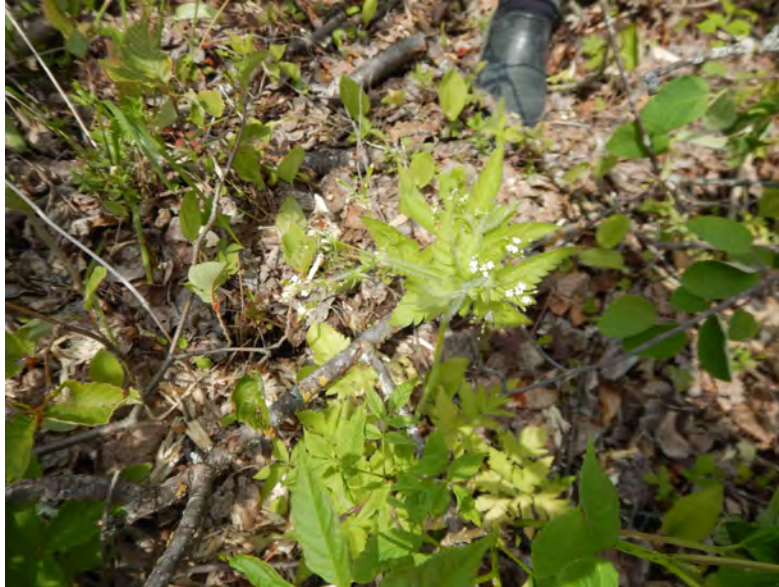
Photograph 4-5b. Hairy sweet cicely observed at REDACTED.

Near Provincial Road 201, hairy sweet cicely was observed at REDACTED. Photograph 4-5b shows hairy sweet cicely observed at REDACTED. Both black ash seedlings and wild ginger (*Asarum canadense*, S3S4) were observed in the understory at these sites. At REDACTED, black ash saplings were present in the tall shrub stratum (<3 m). Danger trees were removed at the site but eight black ash individuals were recorded with minor amounts of shrub and herbaceous vegetation remaining.

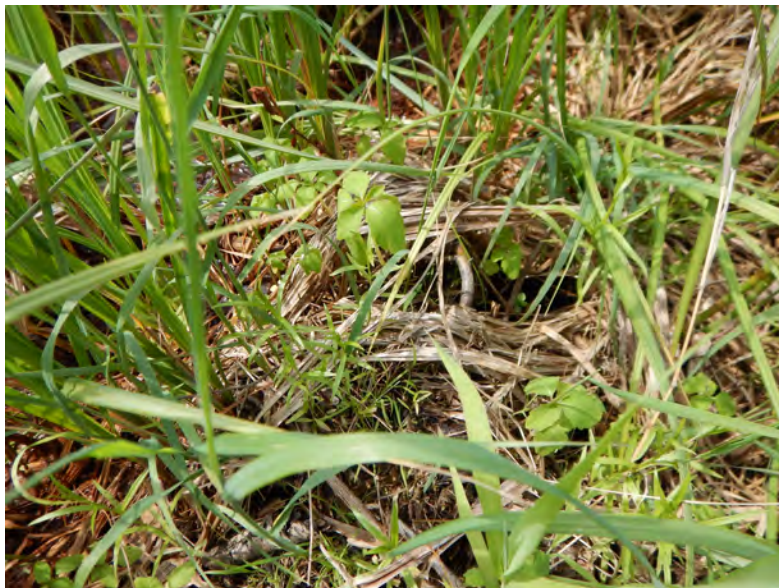
Photograph 4-5c. Western jewelweed observed at REDACTED.

West of Road REDACTED, western jewelweed was observed at REDACTED, where numerous individuals (>100) were recorded at this site (Photograph 4-5c). At REDACTED, a meander search was undertaken for hop-hornbeam saplings and seedlings, which are found throughout the vicinity of the site.

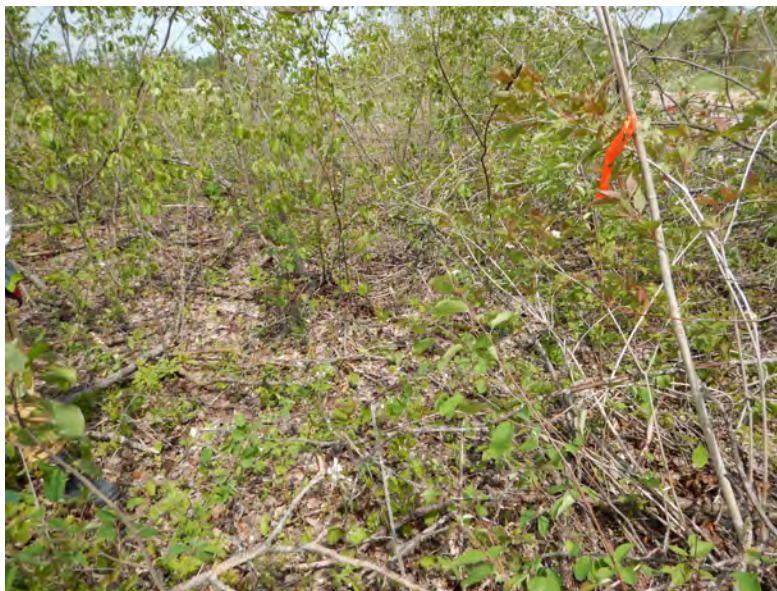
Photograph 4-5d. Vegetated buffer remaining at ECO-307.

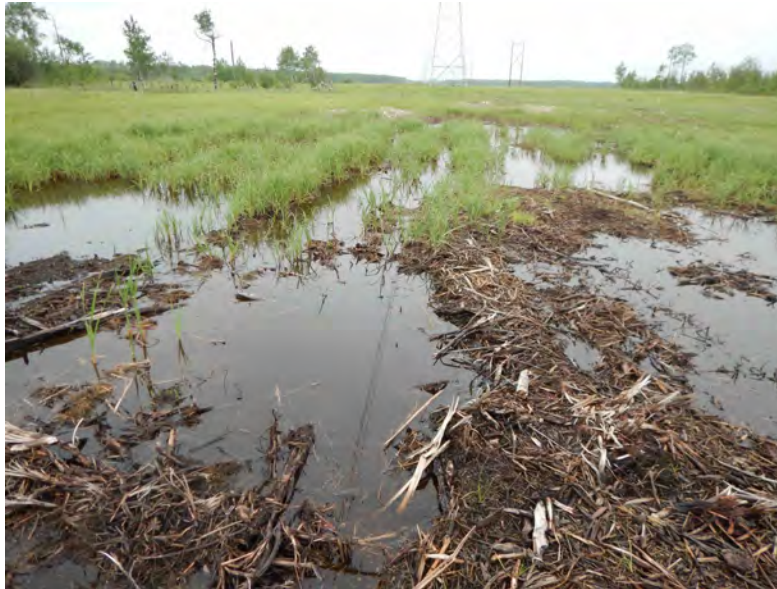
Photograph 4-5e. Site disturbance observed at ECO-302A.
