MANITOBA MINNESOTA TRANSMISSION PROJECT

AMPHIBIAN MONITORING PROGRAM 2020

TECHNICAL REPORT

March 2021

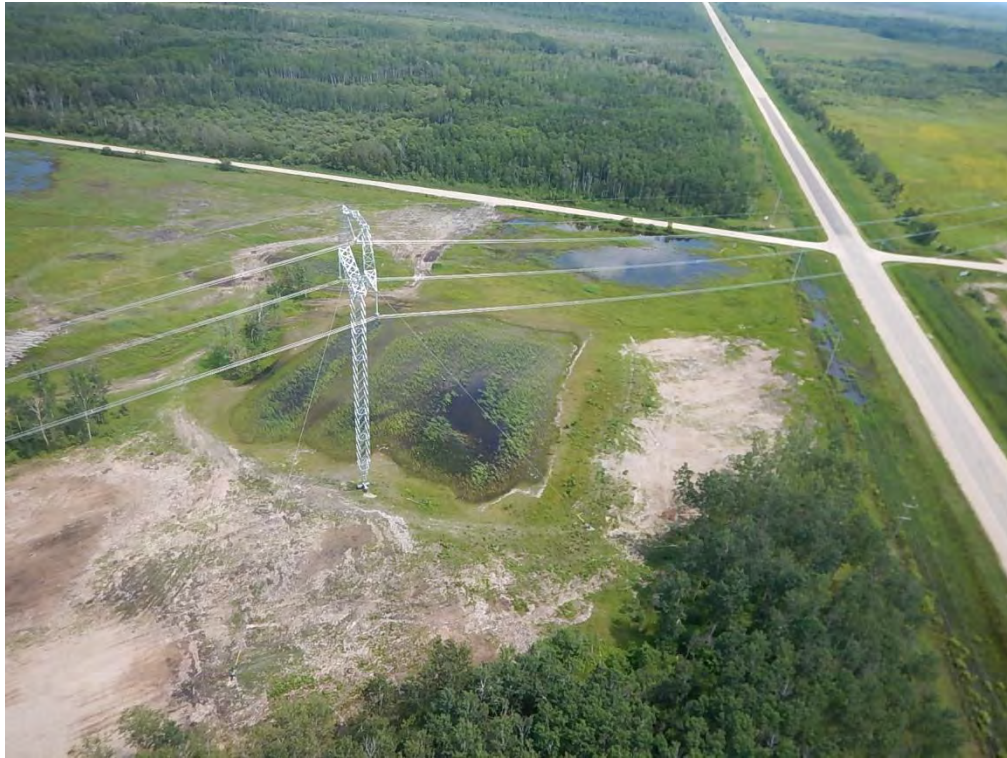
The wetland buffer was less than 30 m at the northern corners of Site 17.5 (Photo 31). According to the CEnvPP (Manitoba Hydro 2019; Appendix Table A1-5), natural vegetated buffer areas of 30 m will be established around wetlands and riparian zones will be maintained to the extent possible (EC-8.03). It is recommended that a follow up survey be conducted at the site to monitor for the re-establishment of vegetation. It should be noted that despite the absence of a vegetated buffer, other mitigation measures such as winter construction appear to have maintained the integrity of the wetland; rutting, erosion, and sedimentation were not observed, and water quality and amphibian abundance did not appear to be affected.

Photo 31. Aerial view of Site 17.5 during fly over surveys June 29, 2020.

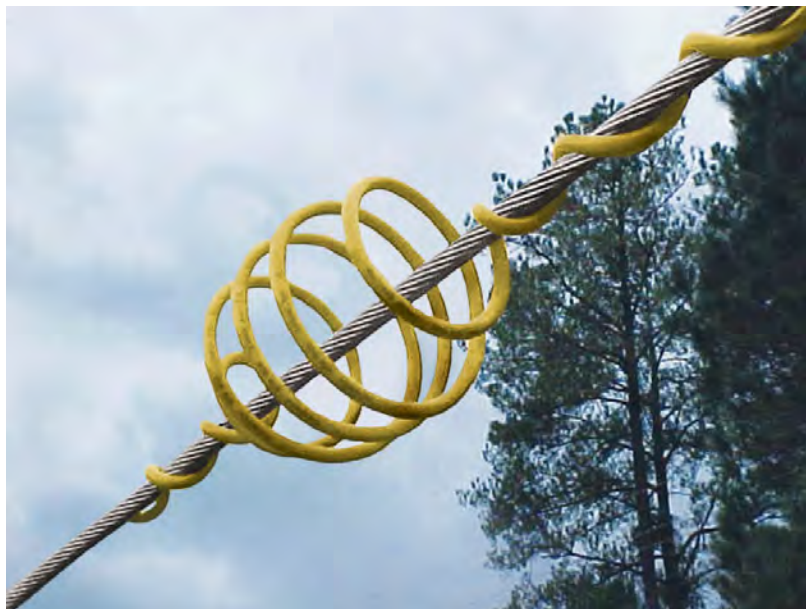
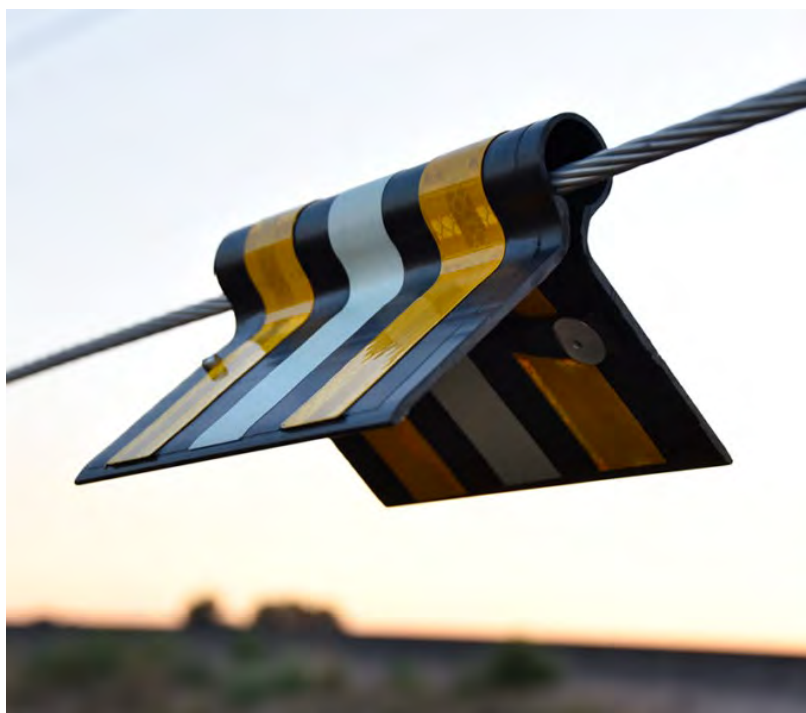
Photo 1. Swan-Flight Bird Diverter (top) and Bird Flight Diverter (bottom) (Linestar Utility Supply 2021; Preformed Line Products 2021)

To mitigate some risk of bird-wire collisions posed by the MMTP, Environmentally Sensitive Sites (ESS's) were identified during pre-construction surveys and fitted with bird diverters during construction. Bird diverters were installed on the ground conductor wires, including an alternating sequence of Swan-Flight™ Bird Diverters and Bird Flight Diverters, and in some areas additional aircraft cone line markers, that also served to make the transmission line visible to aircraft (Photo 1; Photo 2).

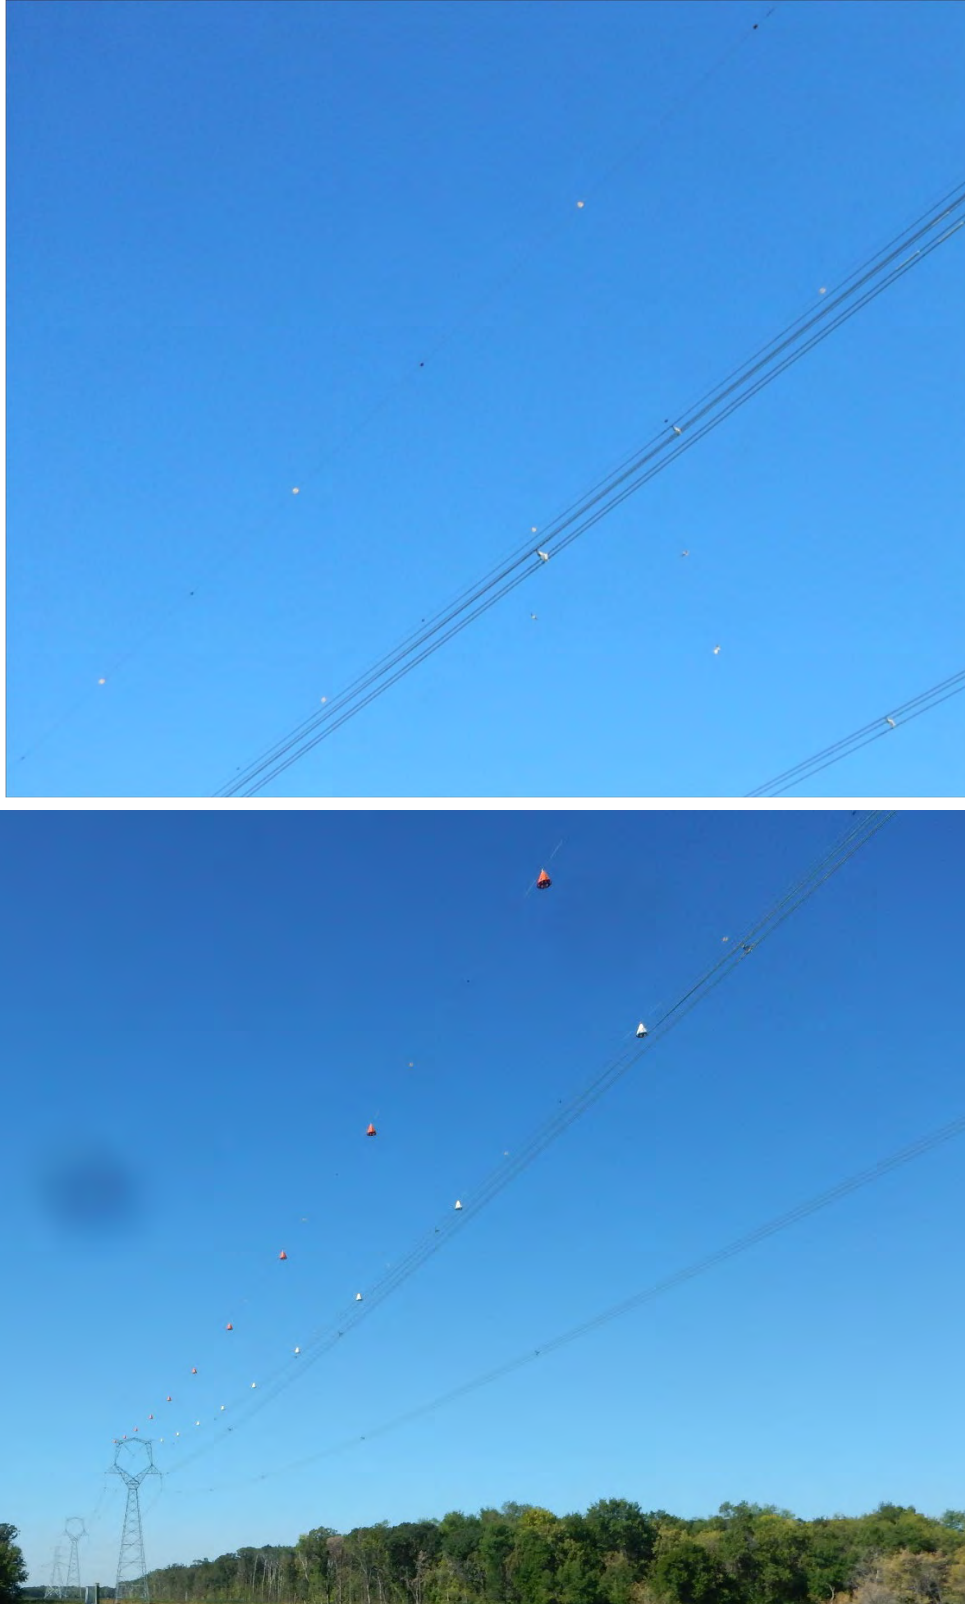
Photo 2. Alternating Swan-Flight Bird Diverters and Bird Flight Bird Diverters (top), and additional aircraft cone markers (bottom) on the Manitoba-Minnesota Transmission Project

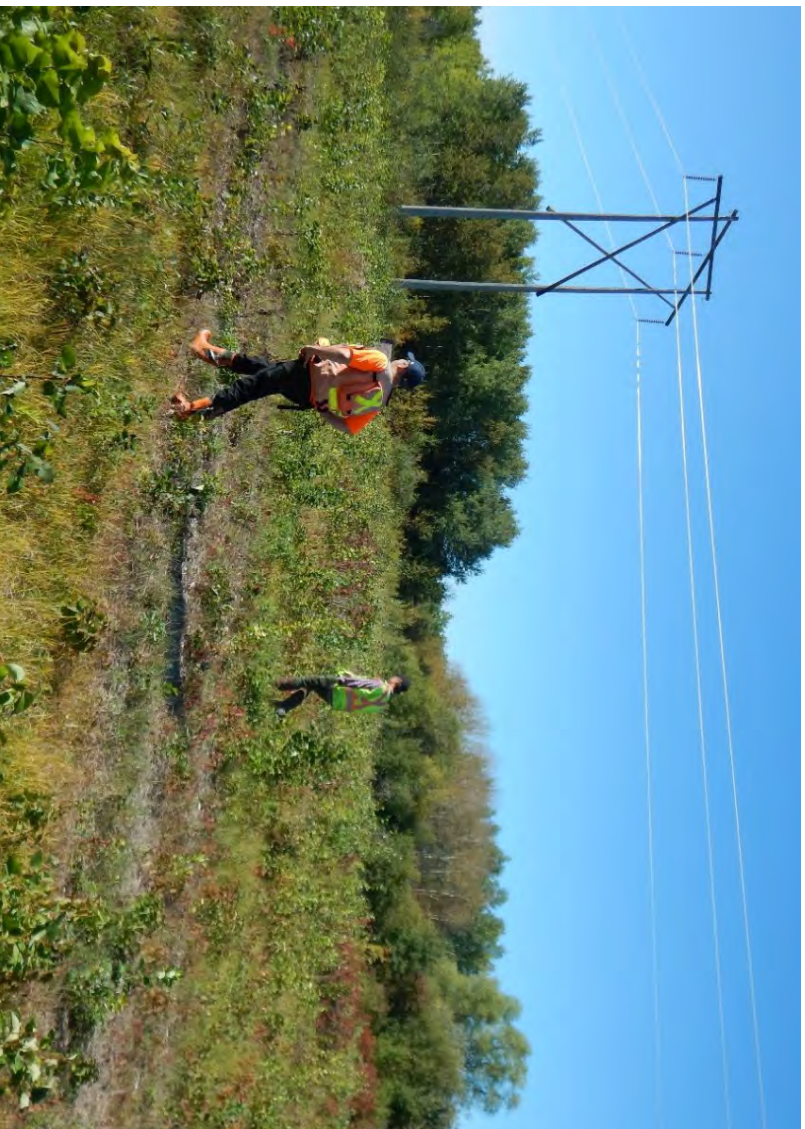
Photo 3. Personnel Conducting a Bird-mortality Collision Survey along the MMTP right-of-way, September 2020. Note: the R49R transmission line in the background.

Each site was surveyed twice during the 2020 fall migration season with each survey separated by five to seven days (Table 1). Surveys for bird-wire collisions were conducted at each site by four personnel that walked parallel lines spaced 5-10 m apart, for the entire length of the site, below the cleared right-of-way (ROW) (CWSEC 2007; Photo 3). The spacing of personnel varied slightly depending on the relative density of vegetation and terrain. Personnel visually inspected the search area for signs of bird collisions (*i.e.*, carcasses and clusters of feathers). Collisions were recorded when the remains found consisted of more than five feathers in a square meter (Barrientos *et al.* 2012). The location of the collision was recorded using a handheld global positioning system (GPS), collision evidence was identified to species where possible and photographed.

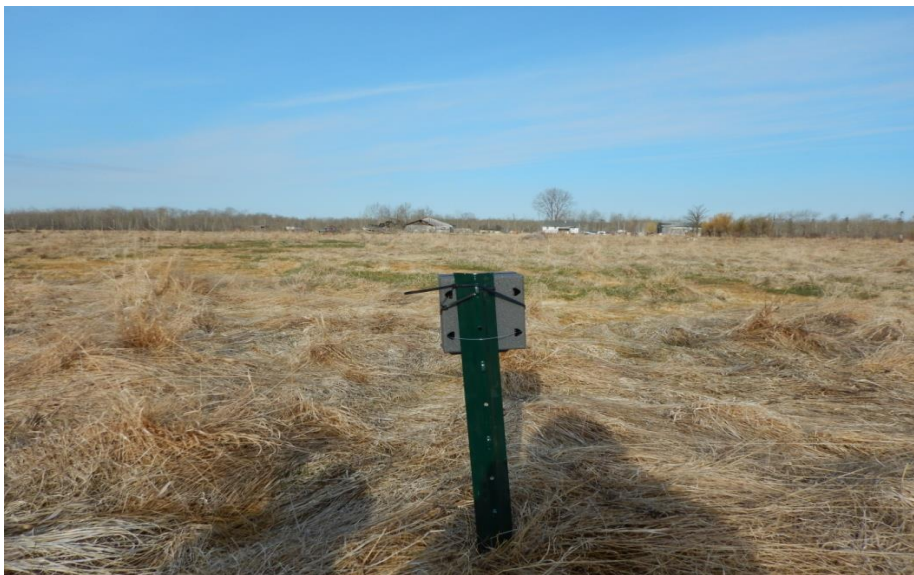
Photo 1: Trail camera at a sharp-tailed grouse lek

Pre-construction surveys for sharp-tailed grouse conducted in spring 2017 and 2019 were repeated in 2020, the first year after Project construction. From March 27 to April 13, 2020, trail cameras were placed at eight known leks after receiving permission from landowners (Map 1). Surveyors walked to the lek, marked its location with a Global Positioning System (GPS) unit, and conducted an active count, where all birds in the area were flushed out and counted. Data were collected in a manner similar to sharp-tailed grouse lek survey protocols previously established by Manitoba Sustainable Development (B. Kiss 2017, pers. comm.). Two Reconyx™ PM35C31 trail cameras, one facing north and the other east, were set up to photograph sharp-tailed grouse activity (Photo 1). Short metal stakes were driven into the ground, to which trail cameras were fastened with zip ties. Cameras were programmed to take a series of 30 rapid-fire photos every five minutes from 4:00 a.m. until 8:00 a.m.
