AGRICULTURAL SOIL PRODUCTIVITY MONITORING FOR THE MANITOBA- MINNESOTA TRANSMISSION PROJECT

POST-CONSTRUCTION YEAR 2 (2021)

Final Report

Prepared for:
Manitoba Hydro

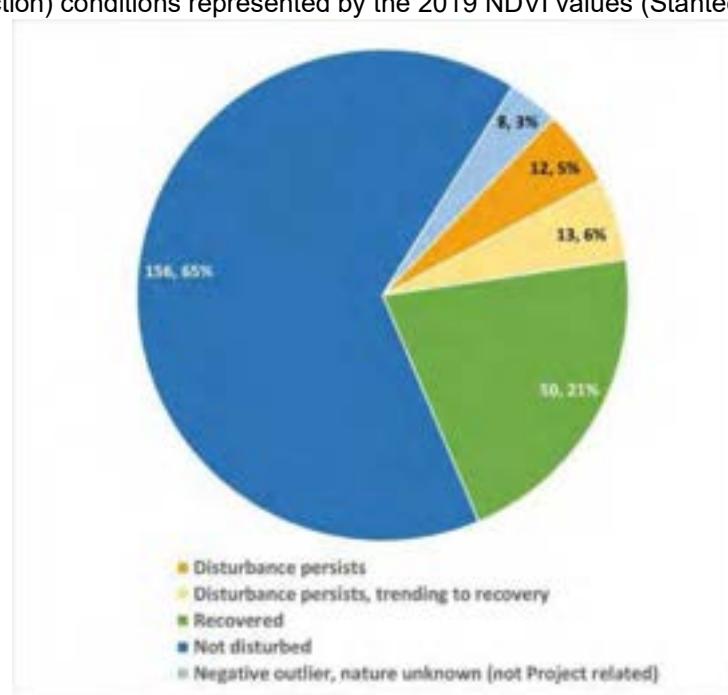
A summary of counts and proportions of individual On RoW FMUs in each of the disturbance categories in post-construction year 2 (2021) is found in the figure on the right. A total of 25 of the 239 On RoW FMUs (10.4% of all

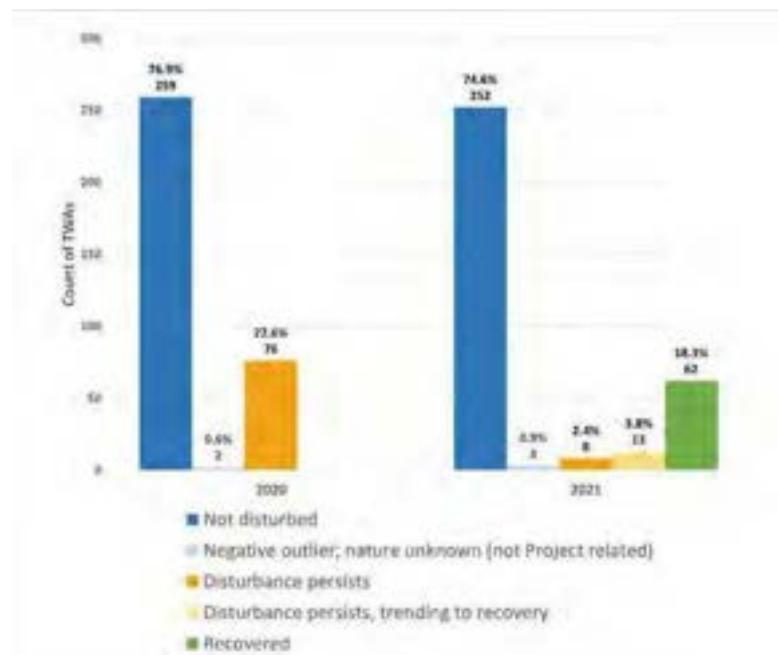
recovery (i.e., positive trend in NDVI difference between TWAs and Off RoW comparable areas), while the remaining 8 were found to have disturbances persisting with NDVI difference values not trending in the direction of recovery. A total of 62 TWAs (18.3% of all TWAs) considered disturbed by Project activities in the 2020 monitoring season were considered recovered in 2021.

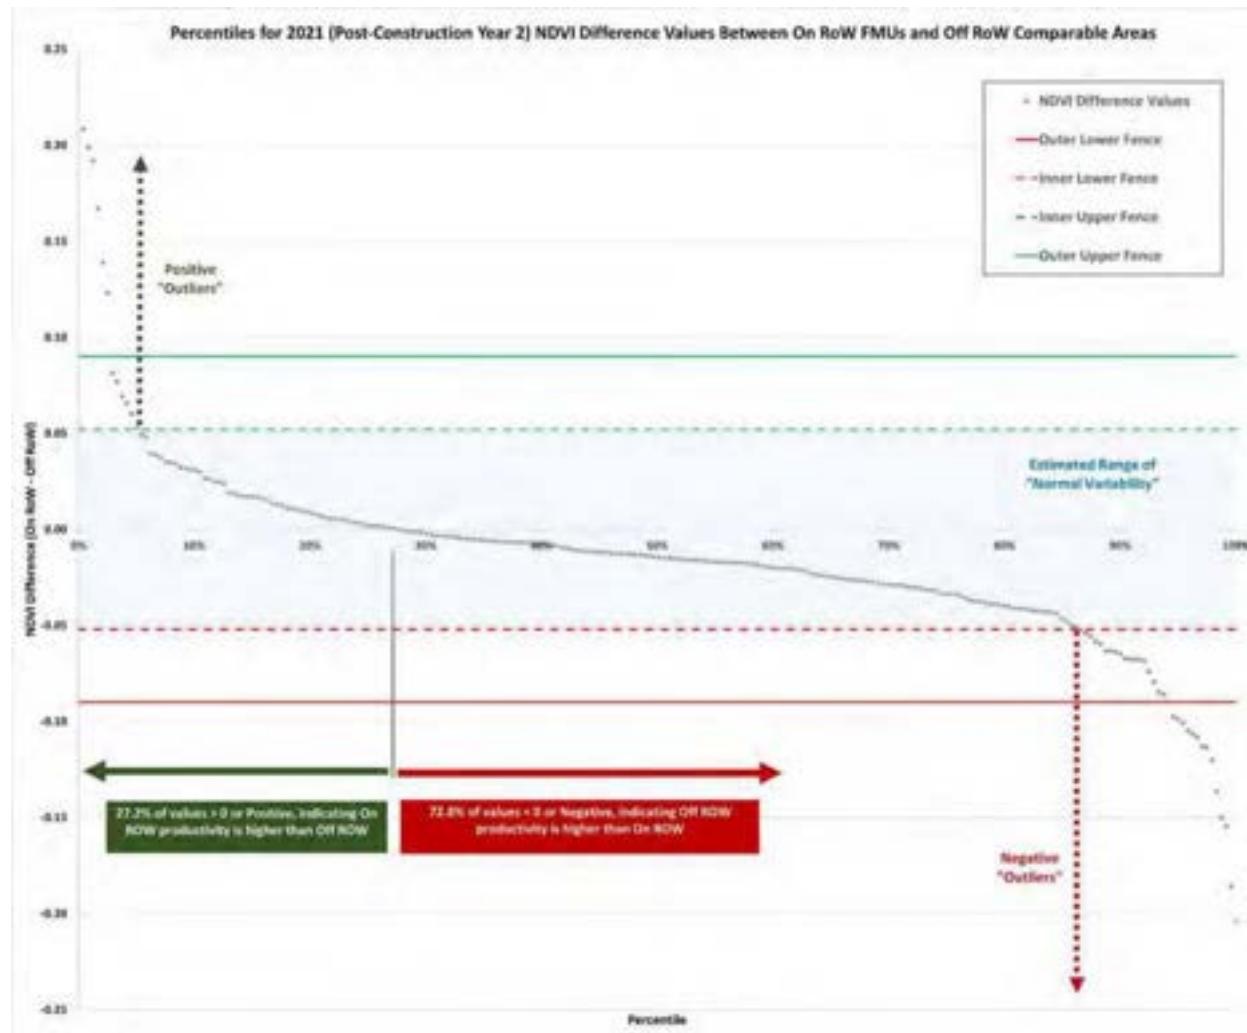
Figure B.1.4 Percentiles for 2021 NDVI Differences Between On RoW FMUs and Off RoW Comparable Areas

The percentiles chart provides a visual display of the difference values for individual FMUs. Approximately 27% of differences were found to be positive (On RoW FMU – Off RoW comparable area = >0), while 73% were found to be negative (On RoW FMU – Off RoW comparable area = <0). This is further evidence of the negative skewness of the data. The estimated range of “normal variability” around an expected difference of 0 is estimated to be -0.052 to +0.052. Therefore, values above 0.052 can be considered “positive outliers” while values below -0.052 can be considered “negative outliers”. Based on this analysis there are many more “negative outliers” than “positive outliers”. Approximately 13.8% of On RoW FMUs (33) are considered in the “negative outlier” range, while 5.0% of On RoW FMUs (12) are considered in the “positive outlier” range.

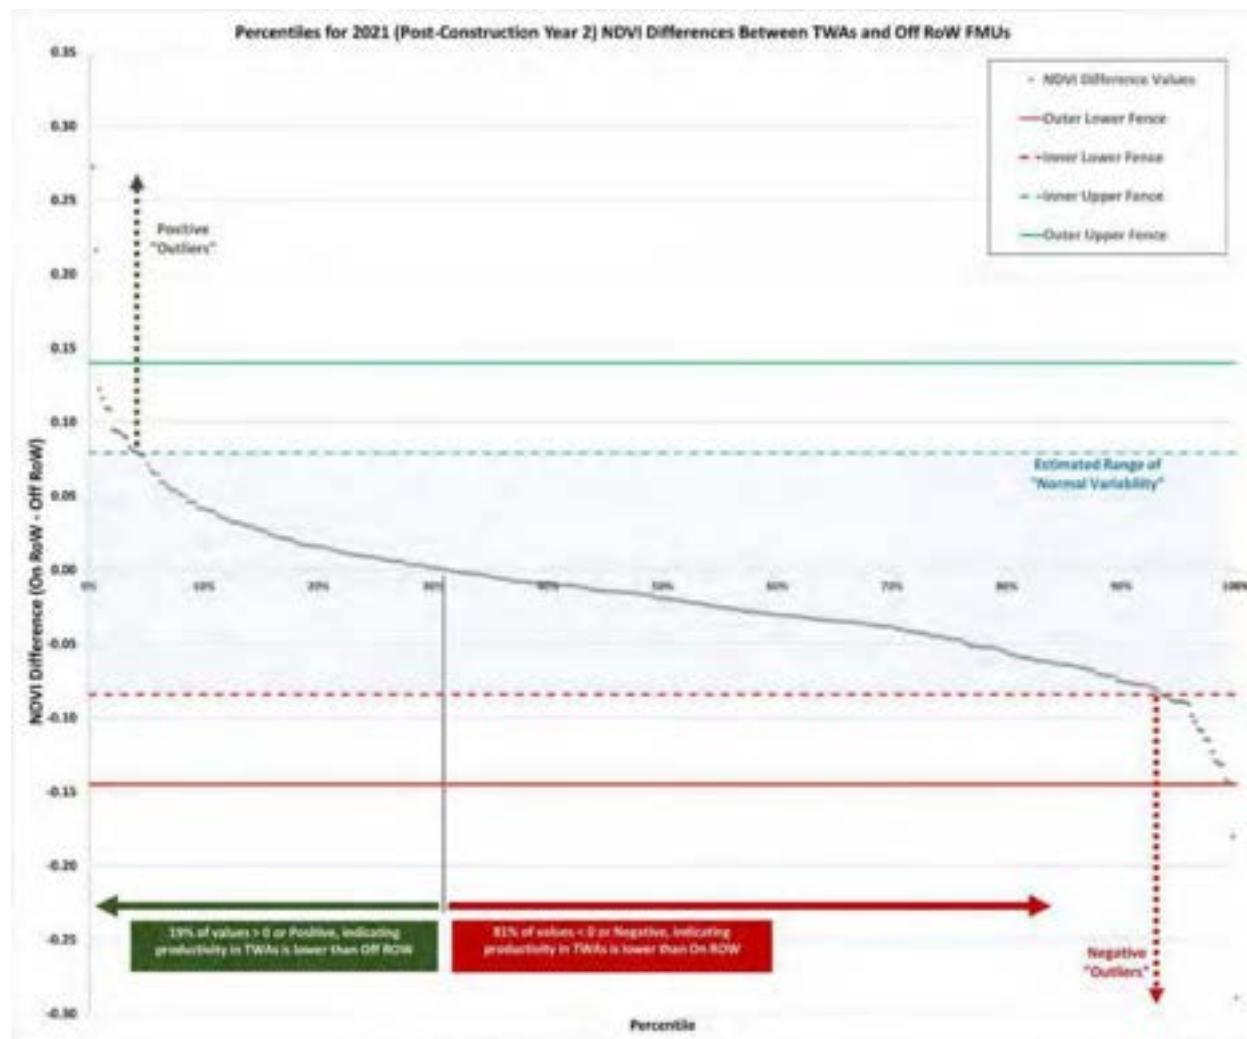
Figure B.2.4 Percentiles for 2021 NDVI Differences Between TWAs and Off RoW Comparable Areas

The percentiles chart provides a visual display of the difference values for individual TWAs. Approximately 19% of differences were found to be positive ($TWA - \text{Off RoW comparable area} = >0$), while 81% were found to be negative ($TWA - \text{Off RoW comparable area} = <0$). This is further evidence of the negative skewness of the data. The estimated range of "normal variability" around an expected difference of 0 is estimated to be -0.052 to +0.052. Therefore, values above 0.052 can be considered "positive outliers" while values below -0.052 can be considered "negative outliers". Based on this analysis there are many more "negative outliers" than "positive outliers". Approximately 6.8% of TWAs (23 individual TWAs) are considered in the "negative outlier" range, while 4.2% of TWAs (14 individual TWAs) are considered in the "positive outlier" range.
