# Manitoba-Minnesota Transmission Project

## Post-Construction Environmental Monitoring Report

Certificate EC-059

January 31, 2023

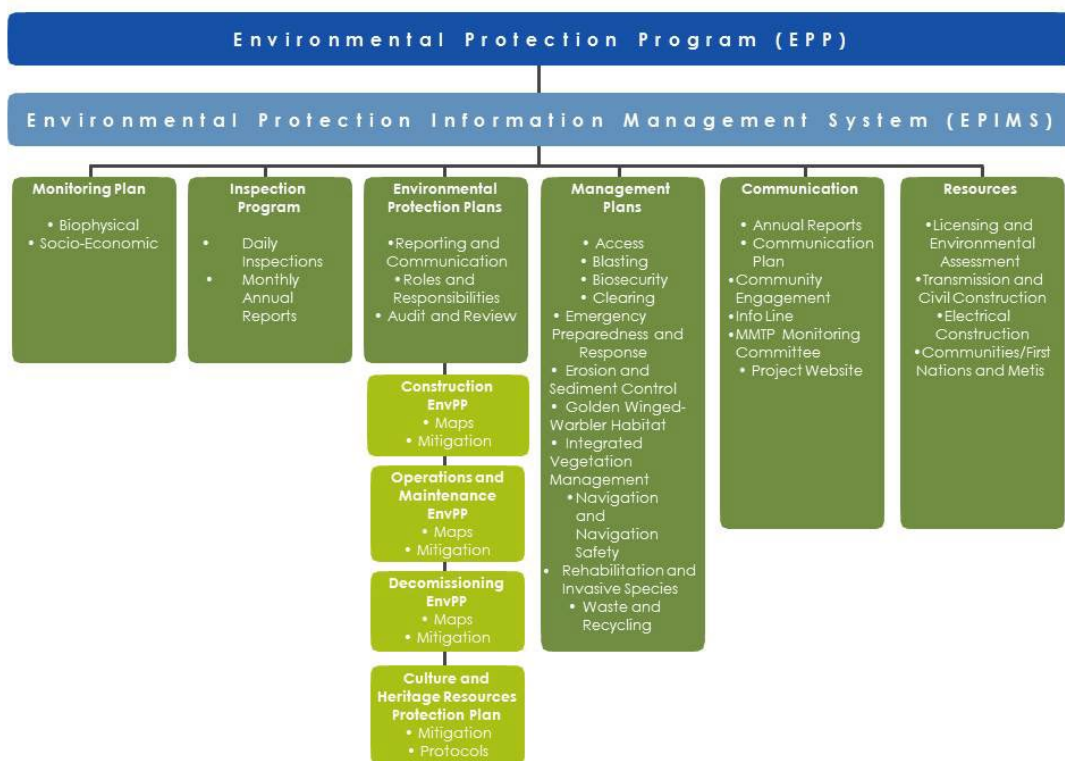
Figure 1: Environmental Protection Program Chart

Part of Manitoba Hydro's commitment to environmental protection includes the development of a comprehensive Environmental Protection Program (EPP), this is further described in chapter 22 of the EIS, found here at NEB Ex. [A81182-38](#). The purpose of the EPP is to provide the framework for implementing, managing, monitoring and evaluating environmental protection measures that are consistent with regulatory requirements and environmental guidelines. This EMP is a component of the EPP as illustrated in Figure 1.
