Reference: Meadowbrook Village Lagoon

Subject: Request for Interim Use of Primary Cell

RE: Hydraulic Conductivity Test Results, Meadowbrook Lagoon Cell 1

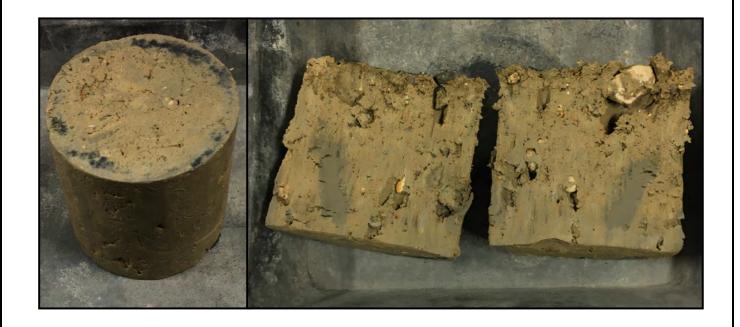
PHOTOGRAPH #1: Sample ST2 after completion of hydraulic conductivity testing.

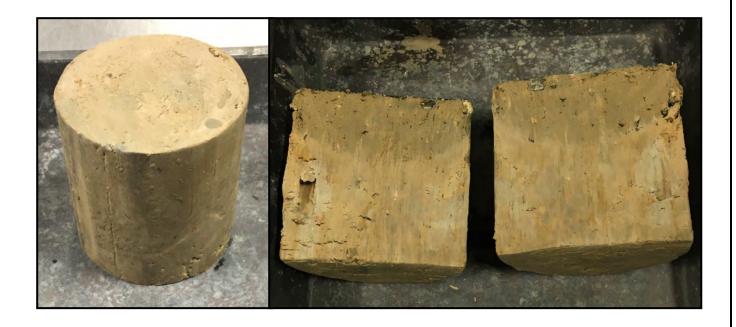
PHOTOGRAPH #2: Sample ST4 after completion of hydraulic conductivity testing.
