MUNICIPALITY OF NORFOLK TREHERNE

**ROAD 54W REALIGNMENT
MANITOBA ENVIRONMENT ACT PROPOSAL**

KGS Group 17-2571-003
October 2017

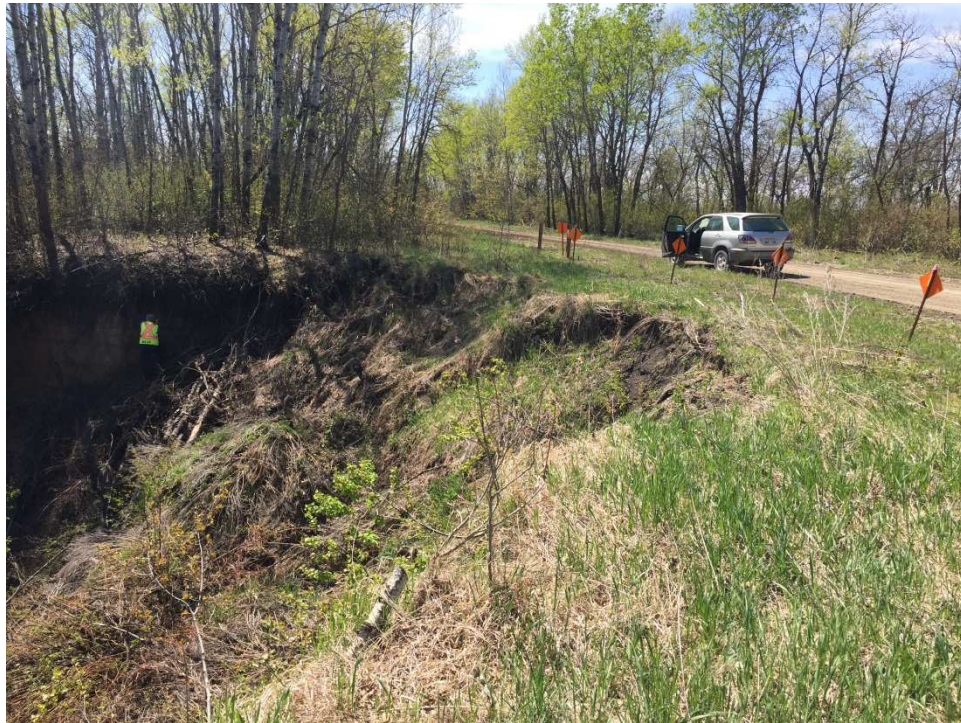
Photo 1 – Slope failure encroaching Road 54W at Site #94 (looking south).

Kontzamanis Graumann Smith MacMillan Inc. (KGS Group) was retained by the Municipality of Norfolk Treherne to prepare an Environment Act Proposal (EAP) for the realignment of a 2-lane municipal road within the Whitemud Watershed Wildlife Management Area (WMA). The road realignment is required due to erosion and bank failure encroaching on the road (Appendix A: Photos 1-4).

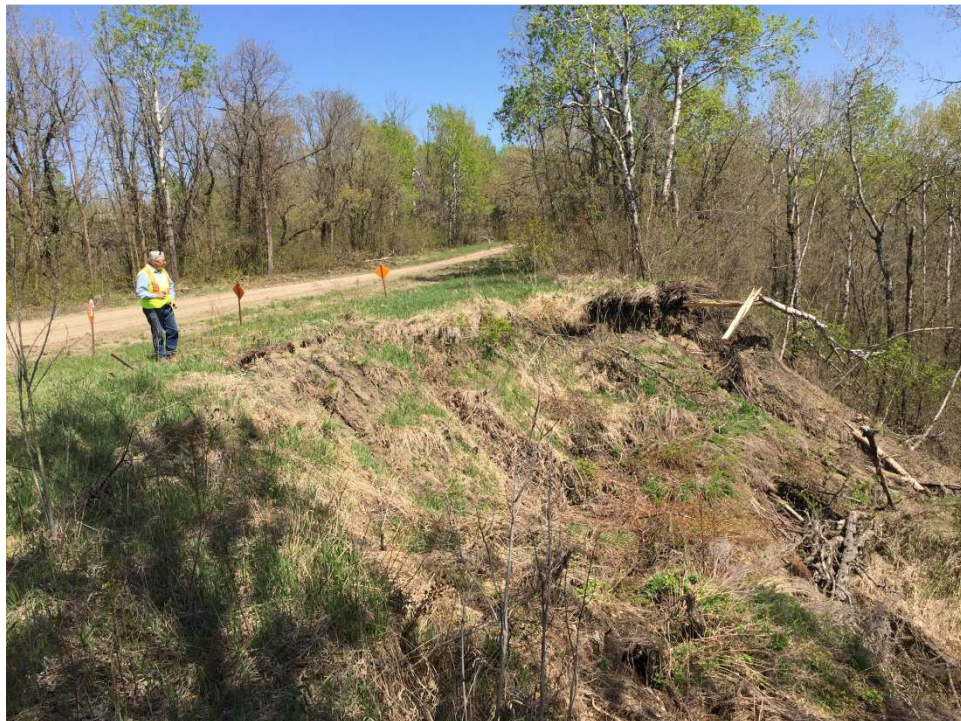
Photo 2 – Slope failure encroaching Road 54W at Site #94 (looking north).

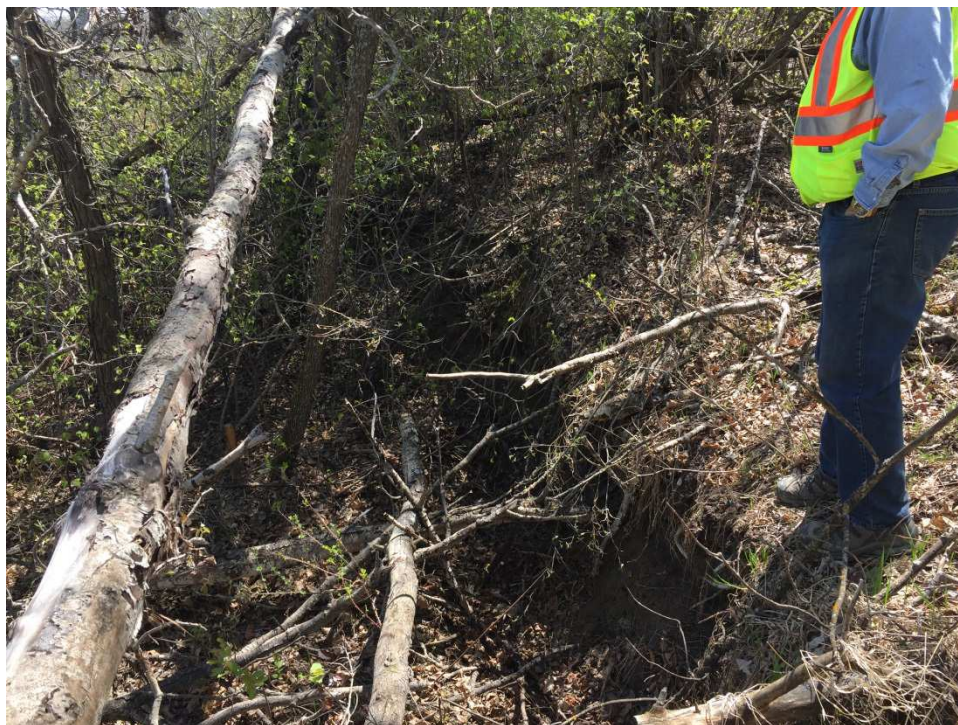
Photo 3 – Slope failure encroaching Road 54W at Site #93.

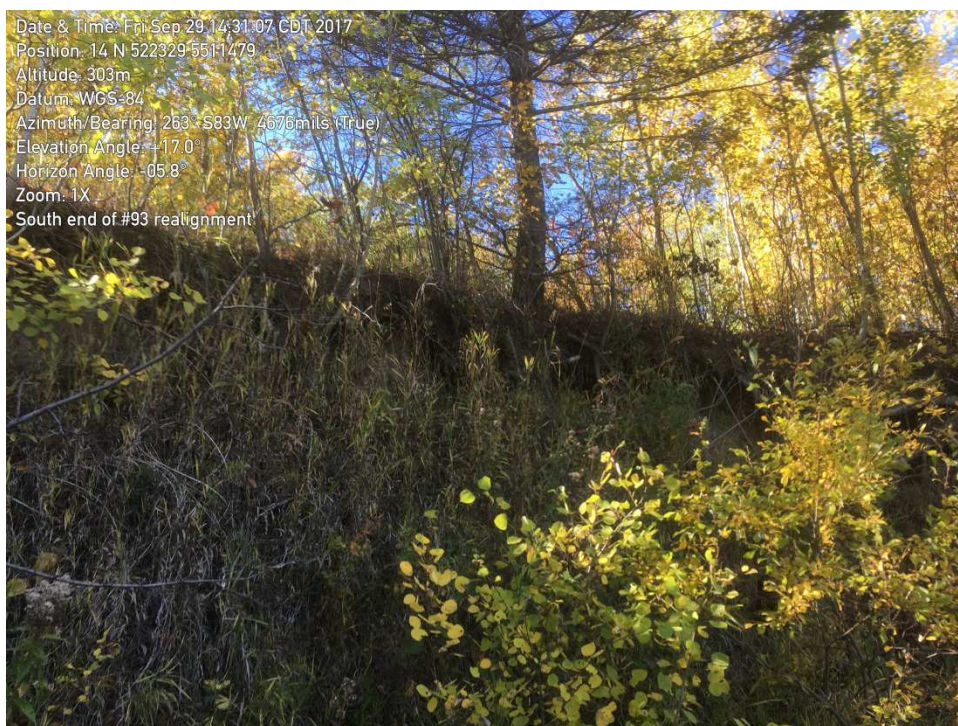
Photo 4 – Slope failure encroaching Road 54W at Site #93 (looking up at road).

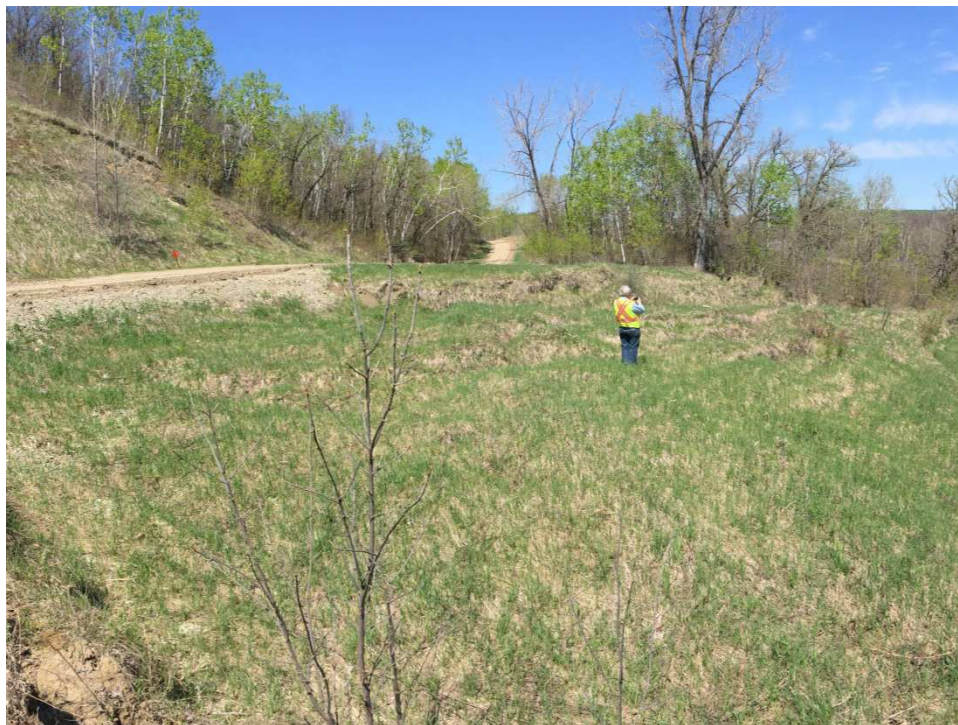
Photo 5 –Bank slip adjacent to road at Site #91 (looking north).

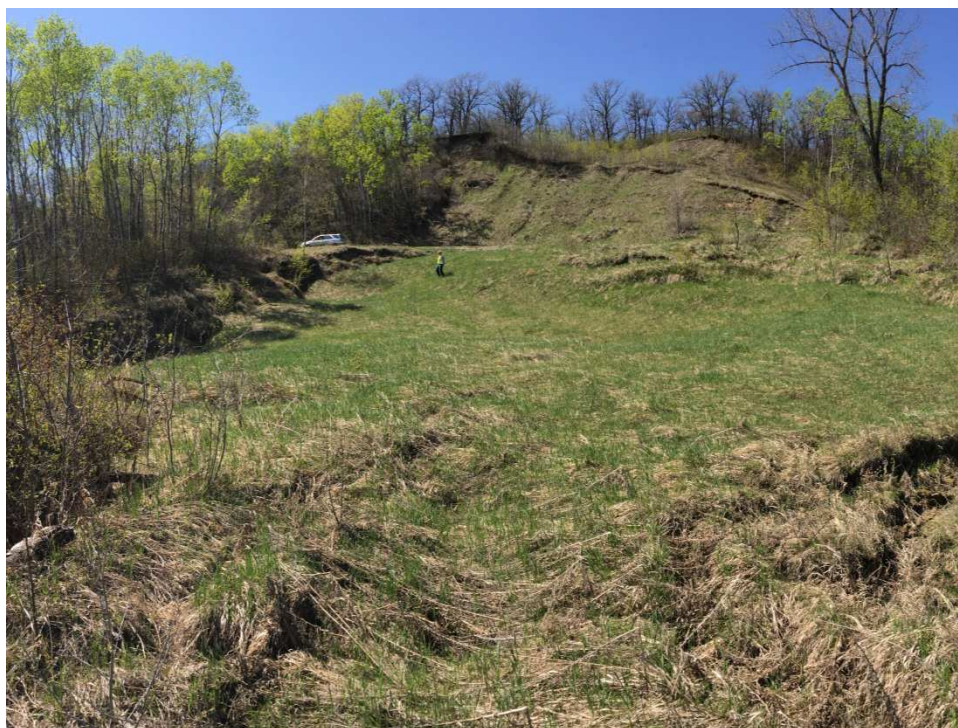
Photo 6 – Bank slip adjacent to road at Site #91 (looking up at road).

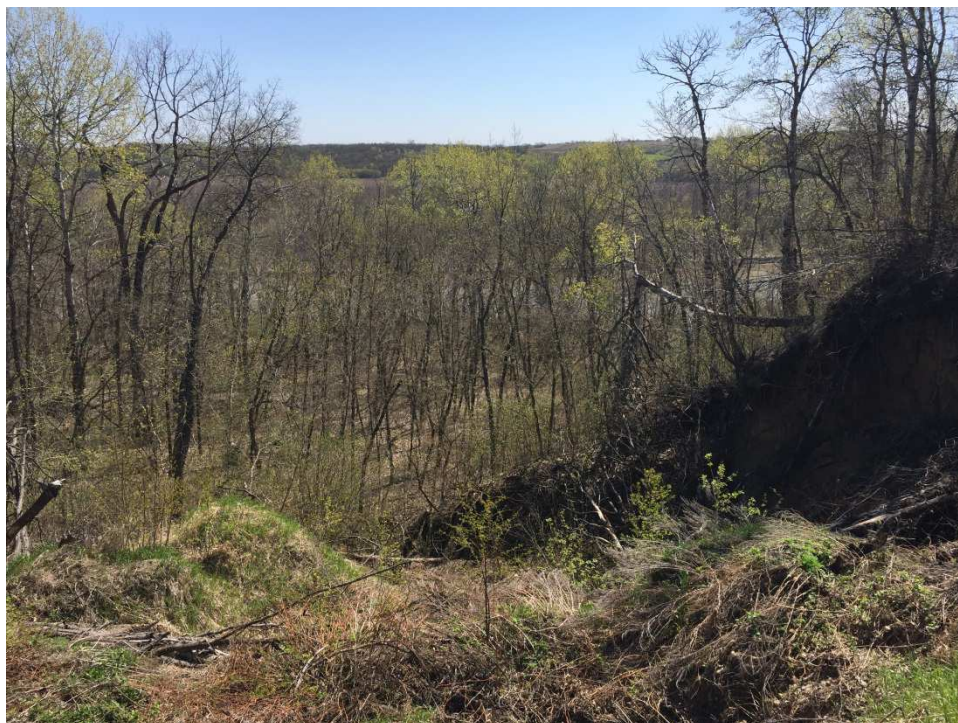
Photo 11 – Erosion gully downslope from Site #94 (looking east).

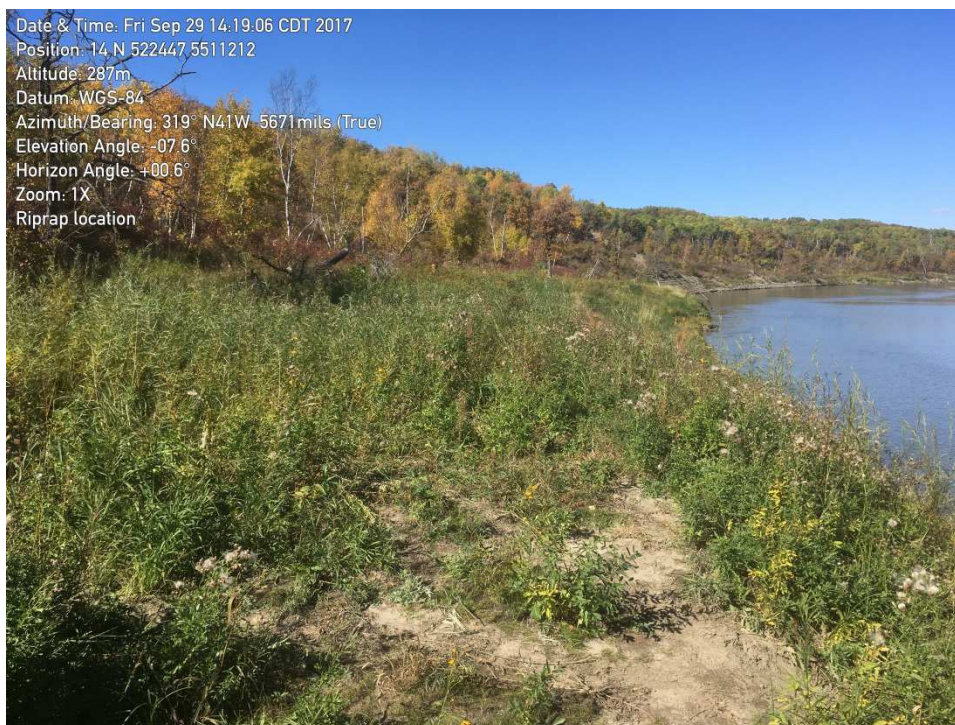
Photo 21 – Southern limit of proposed riprap area (looking north).

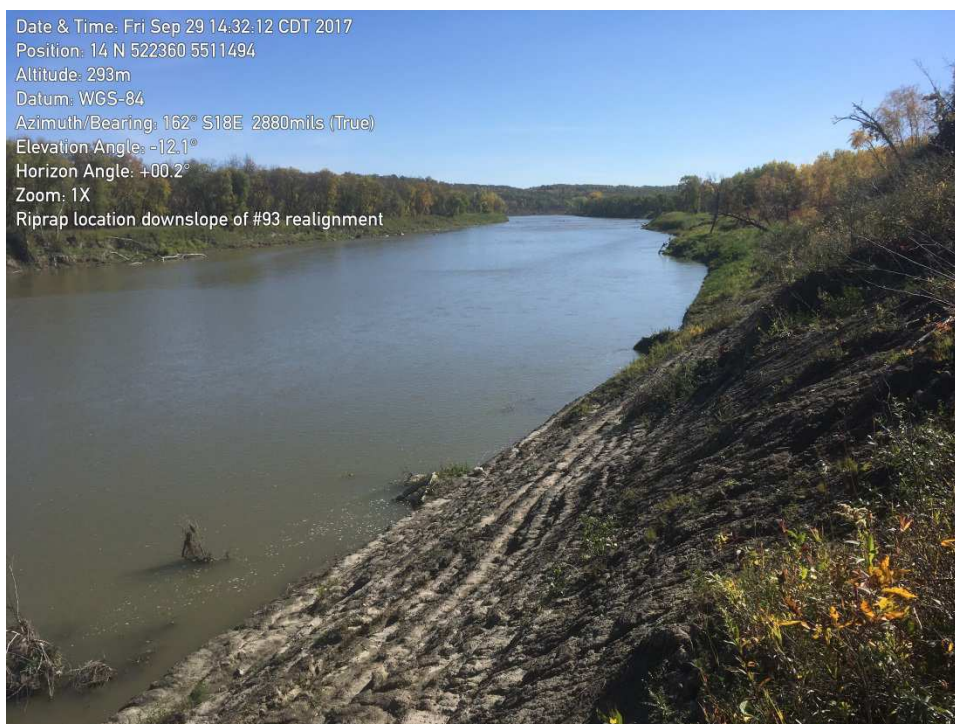
Photo 22 – Northern limit of proposed riprap area (looking south).

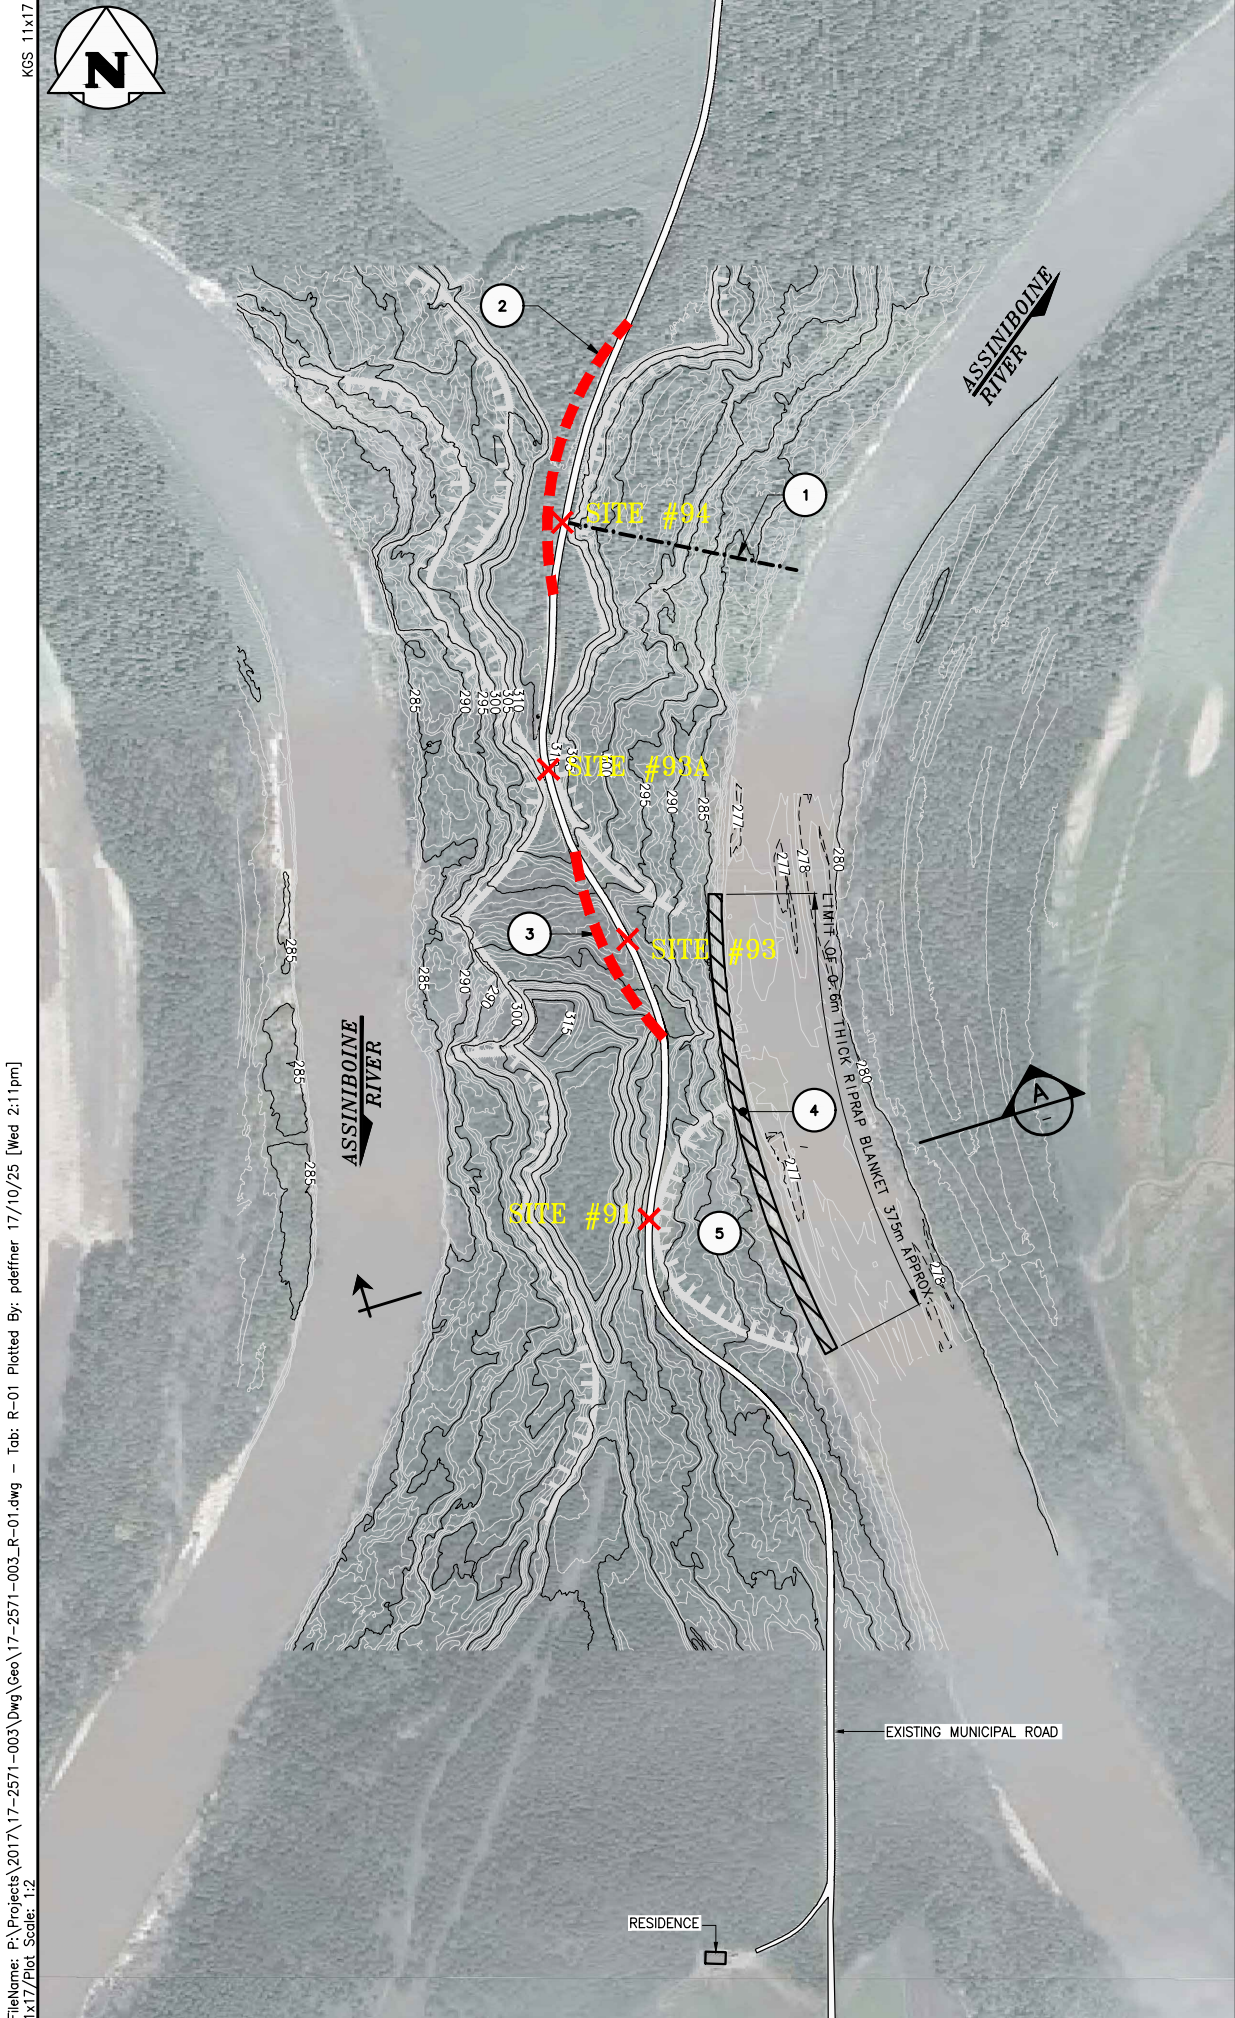
- CONSTRUCTION ITEMS:**
- 1 SITE #94 - OPTIONAL GULLY RESTORATION TO IMPROVE DRAINAGE
 - 2 SITE #94 - RELOCATE ROAD TO THE WEST (200m±).
 - 3 SITE #93 - RELOCATE ROAD TO THE WEST (150m±).
 - 4 RIPRAP EAST - SITES #91 AND #93 (375m±).
 - 5 SITE # 91 - SLOPE REGRADING (TO SEAL TENSION CRACKS) AND REVEGETATION

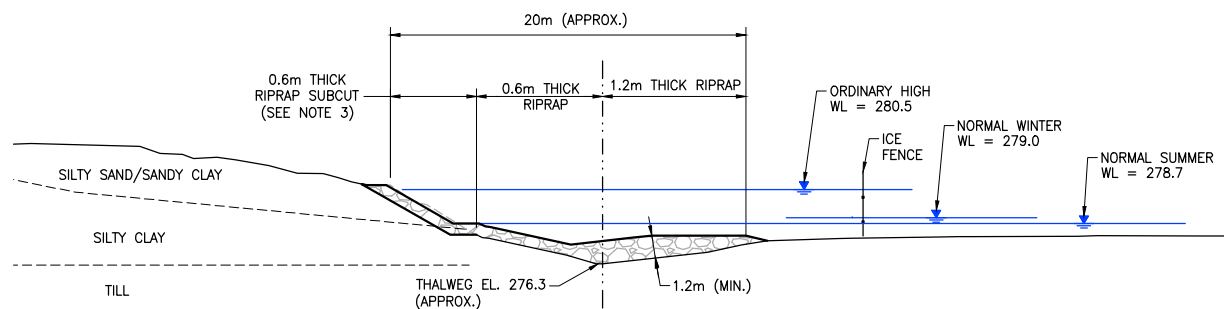
1 TYPICAL RIPRAP CONSTRUCTION SECTION
SCALE: 1:200 (24x36)

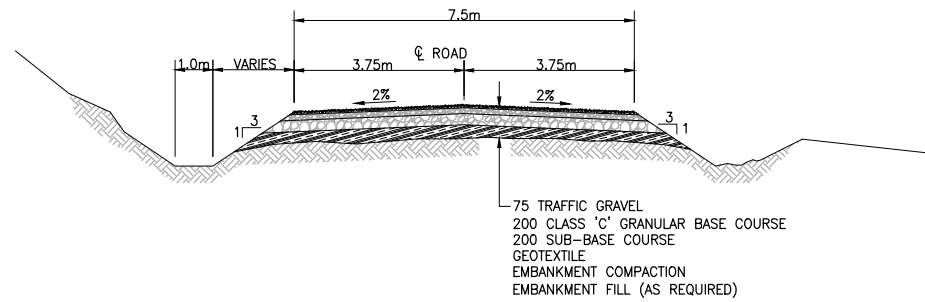
2 TYPICAL ROAD CONSTRUCTION DETAIL
SCALE: N.T.S.

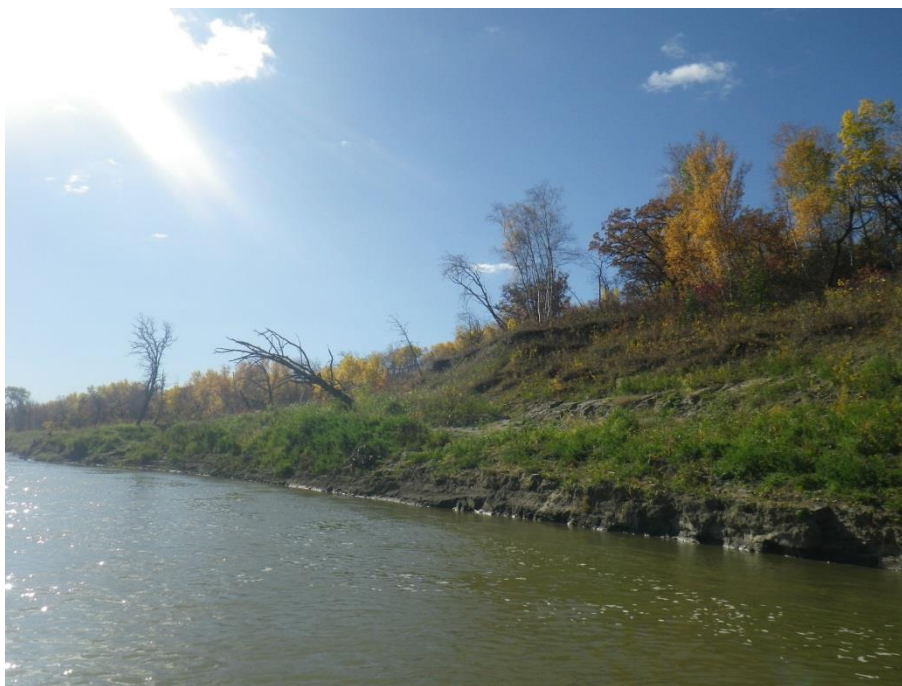
Photo 4. The Assiniboine River showing the eroding banks at the bank stabilization site (October 5, 2017).

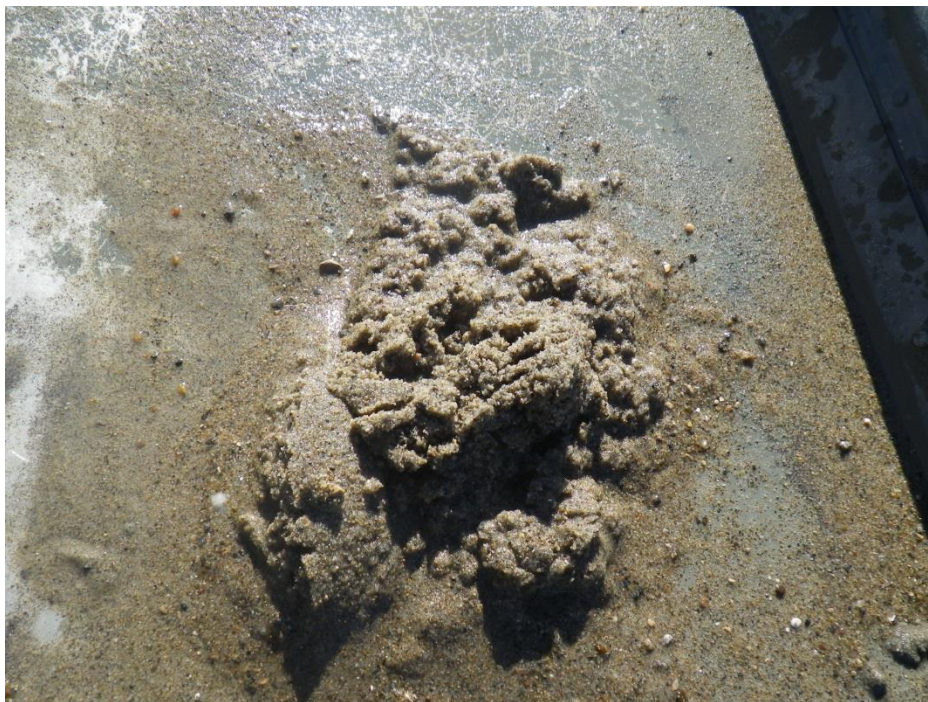
Photo 7. Ponar substrate grab consisting of sand from Ponar #12.

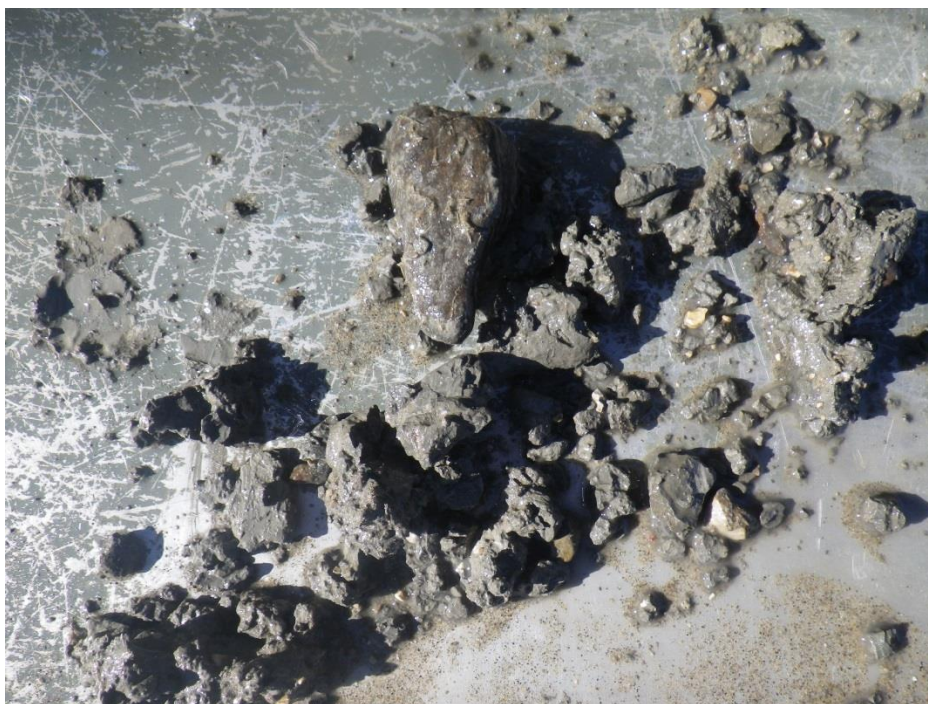
Photo 8. Ponar substrate grab consisting of clay, sand and some gravel from Ponar #25.

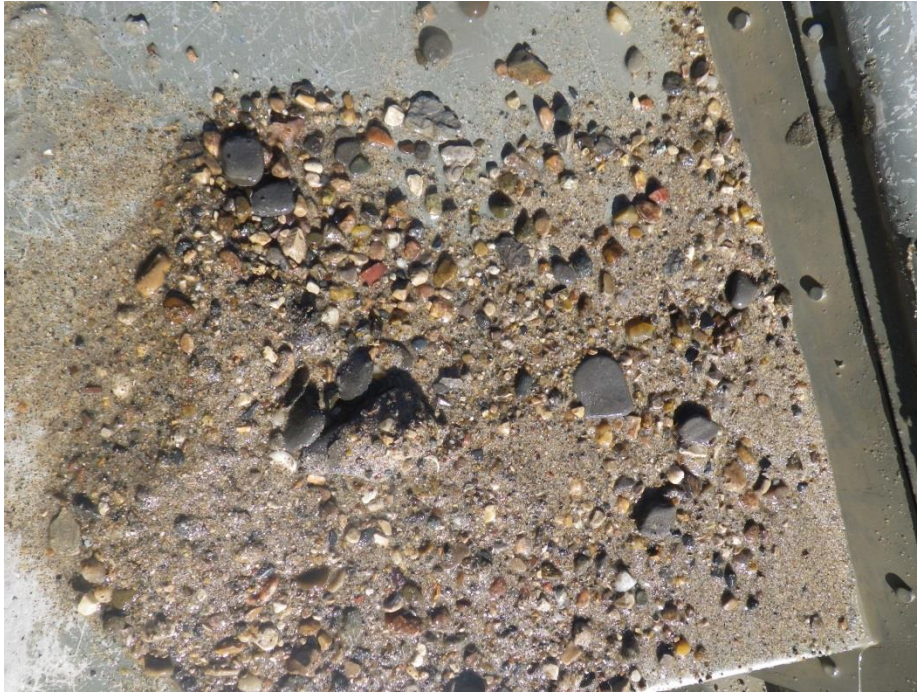
Photo 9. Ponar substrate grab consisting of gravel and sand from Ponar #27
