Springfield Mixing Plant Development Project

Environmental Act Proposals for Bulk Material Handling Facility

**Environmental Assessment and Licensing Branch
Manitoba Conservation and Climate**

July 2020

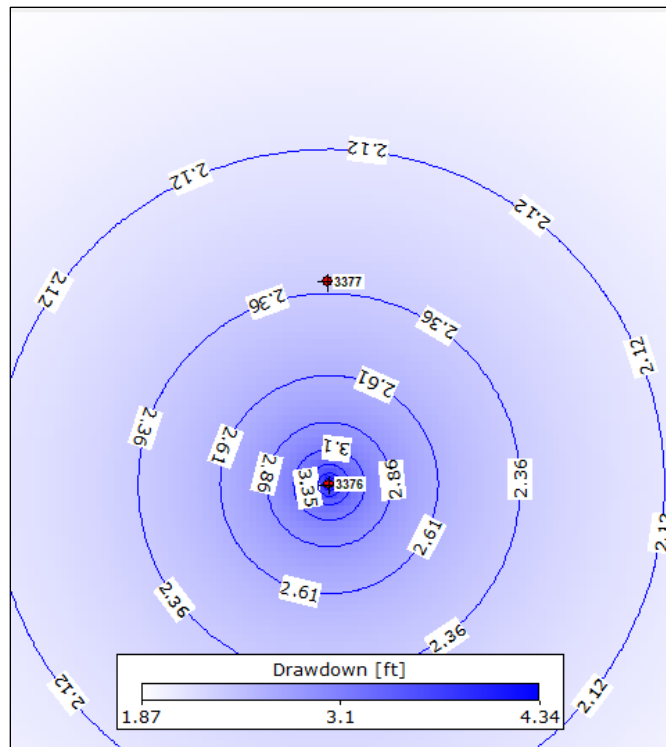
Figure 11 – Drawdown cone generated after 226 days pumping at 80 U.S.G.P.M. (total volume of 100 dam³).
(Plotted with AquiferTest V.2016.1)

Assuming a regional transmissivity of 40,000 U.S.G.P.D./ft., the drawdown at a radial distance of 2,000 ft. from the well field was calculated to be about 1.0 ft. after pumping at a rate of 80 U.S.G.P.M. (Walton, 1979/1983). This analysis is considered to be very conservative; it assumes that no recharge occurs during the pumping. This amount of drawdown is within the range of natural fluctuations shown on nearby hydrograph stations and is not anticipated to cause any issues for nearby groundwater users.

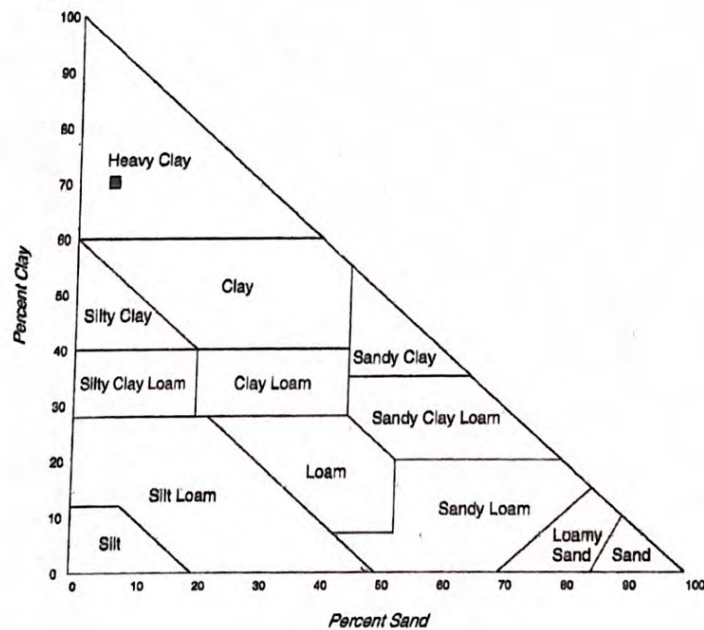
Parameter	Result	Units
% Gravel (>4.5mm)	0	%
% Sand (4.5mm - 0.075mm)	5.8	%
% Silt (0.075mm - 0.005mm)	23.8	%
% Clay (<0.005mm)	70.4	%
Texture	Heavy Clay

*Analysis performed by and particle size classes determined according to test method ASTM D 422 - 63.
 Texture class and triangle plot determined by using clay fractions and combined sand and gravel fractions.*

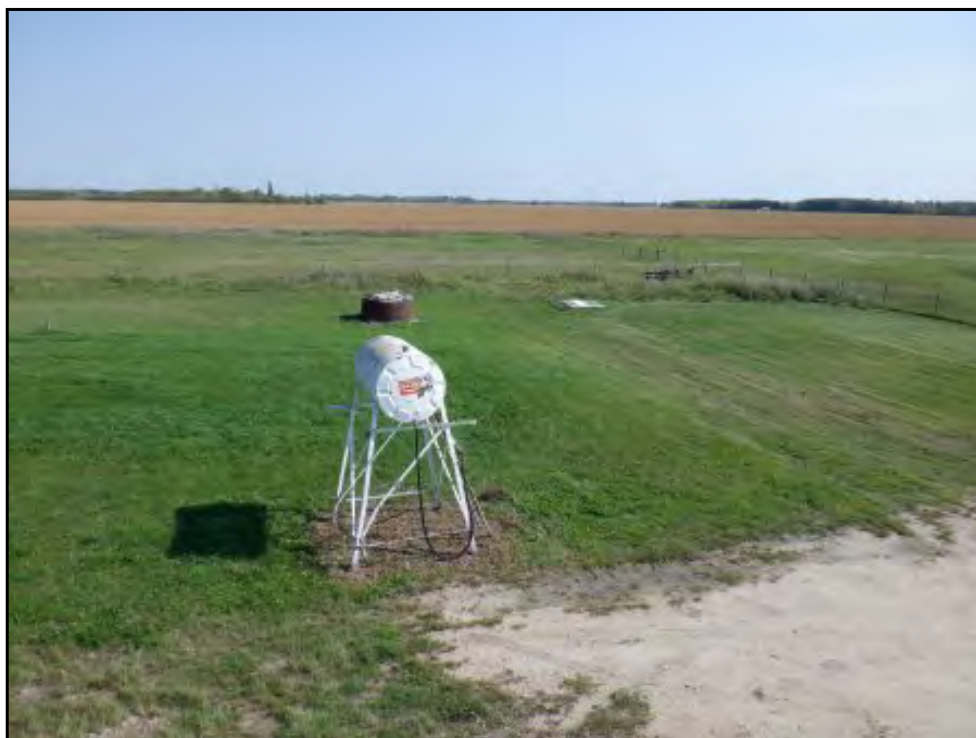
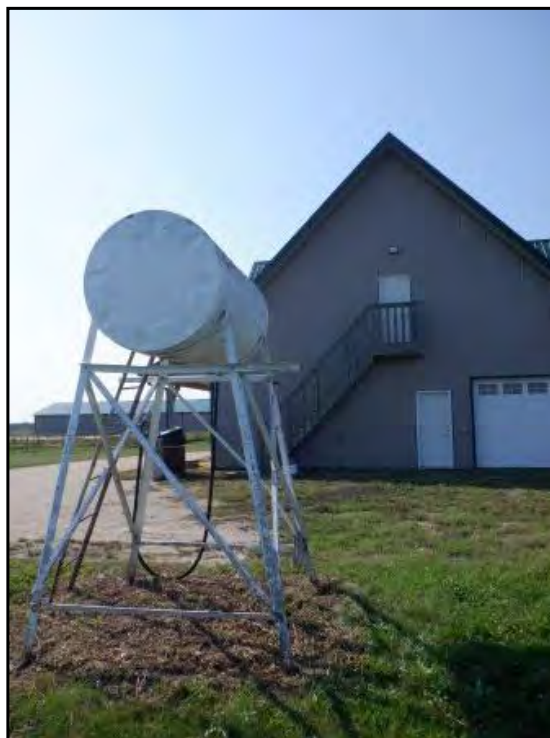
View of AST on the east side of the house. Note the stressed vegetation under the tank (1/2).

View of AST on the east side of the house.
Note the stressed vegetation under the tank
(/2).

Annex 6 presents a Phase 1 environmental assessment by HLC Consulting Ltd of the site prior to the acquisition. The assessment was to validate if there were any environmental issues for due diligence purposes. While stressed vegetation (dead grass) was observed under an aboveground storage tank, lacking secondary confinement, located east of the house, there was no apparent leaking or malfunction from the tank, which was subsequently removed.

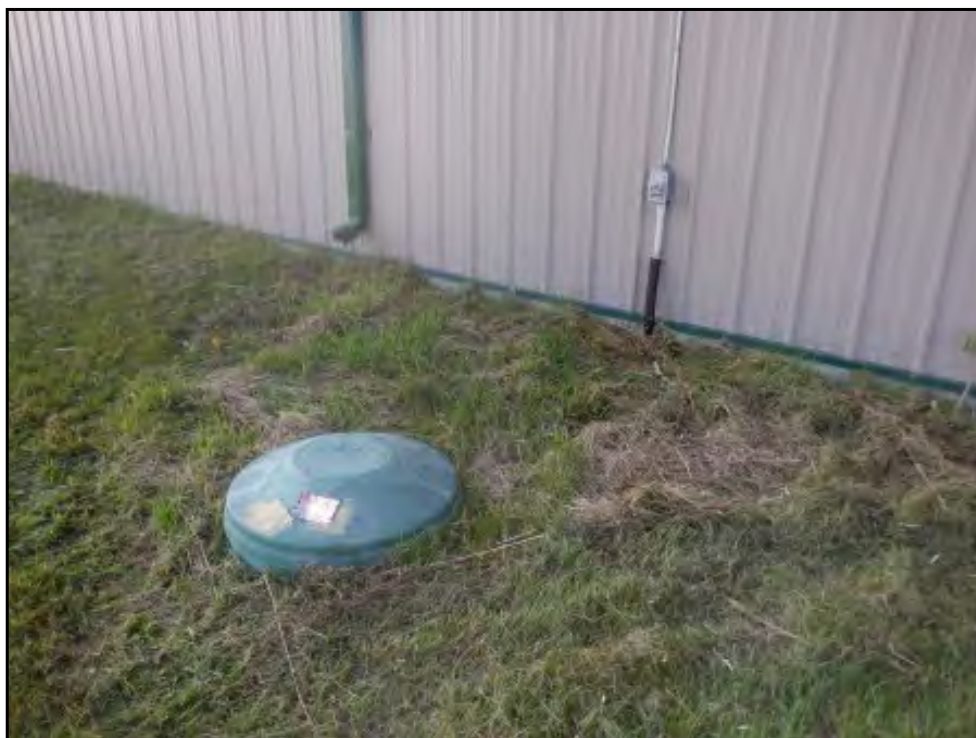
View of septic tank on east side of the stables.

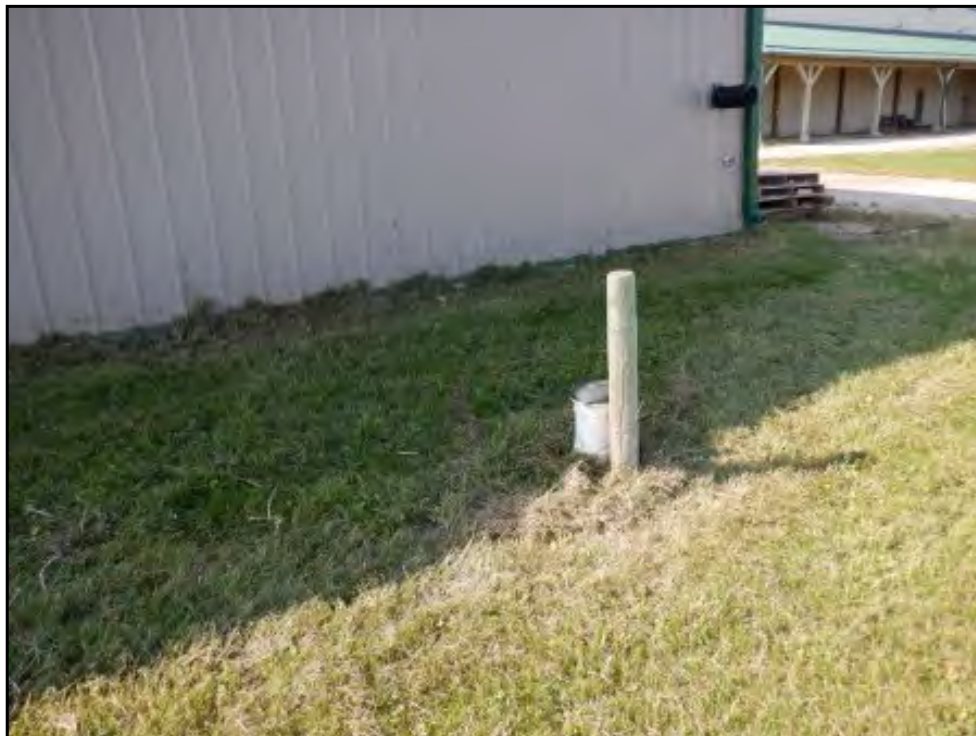
View of well located on-site near the northeast corner of the stables.
