# **Critique of CanWhite Sands Minor Notice of Alteration, Jan. 22, 2021**

**On Behalf of What the Frack Manitoba**

**Feb. 23, 2021**

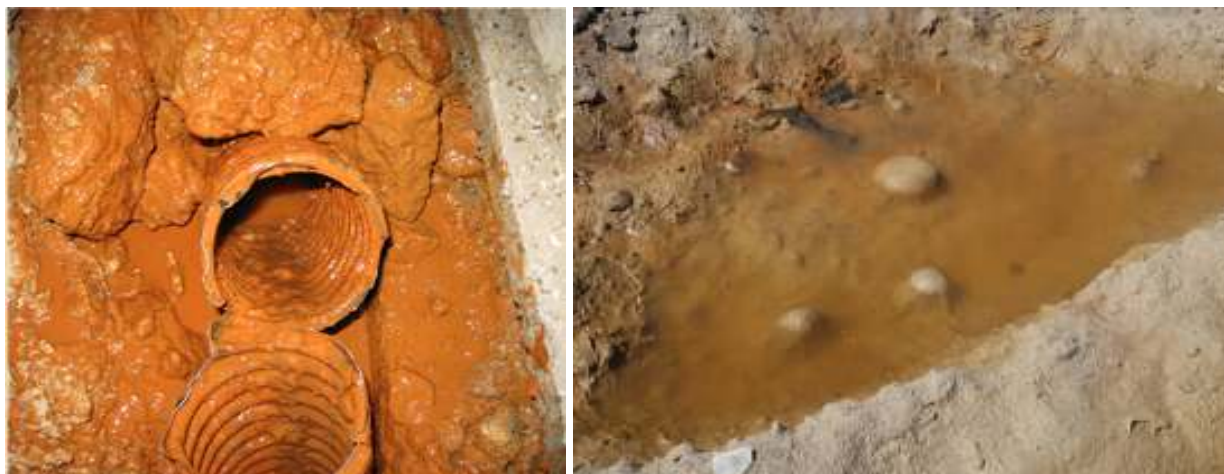
**Figure 1. a.** Deposits from iron bacteria plugging a drain pipe (from DiStart.com)

**b.** Gelatinous deposits consistent with iron bacterial activity at the base of CWS sand piles at Centre Line Road

Analysis of sand from Vivian collected by local residents showed the iron oxide content to be 0.49%. Iron oxide presence on the sand is verified by oxide content in the Vivian sand given on a slide from an online presentation by Mr. Somji at the Noble conference in 2019. The documentation for the iron content of Vivian sand is given in the submission to the CWS Vivian Sand Facility Project by D. M. LeNeveu, Aug. 20, 2020. Iron oxide on the sand must be removed in the wash plant for the silica sand to be useful for most glass making operations and for solar panels and electronics, the stated uses in the CWS EAP. Iron oxide would be present in the 15% water in the sand stockpiles as specified in the CWS EAP. The iron oxide would be in the runoff captured by the French drain. Iron bacteria are known to proliferate in wet surface environments rich in iron. Prolific growths of filamentous iron bacteria in water supply systems have been called "water calamities." The gelatinous growth of iron bacteria and their associated deposits of ferric hydroxide have resulted in discoloured water, unpalatable taste and odours and reductions in flow through pipes.<sup>1</sup> Figure 1a shows a drain pipe clogged with deposits from iron bacteria. Figure 1b shows gelatinous deposits around CWS sand piles extracted at the Centre Line Road site in the spring of 2020. The gelatinous deposits at Centre line Road are consistent with iron bacteria activity. Such deposits would be expected to clog the on-site French drain.
