**Reference: Dangerous Goods Handling and Transportation Act
RM of Oakview, MB**

Transfer Station
RM of Oakview, MB

GEOTECHNICAL INVESTIGATION
RAPID CITY LANDFILL
SW-29-13-19W, RAPID CITY, MANITOBA

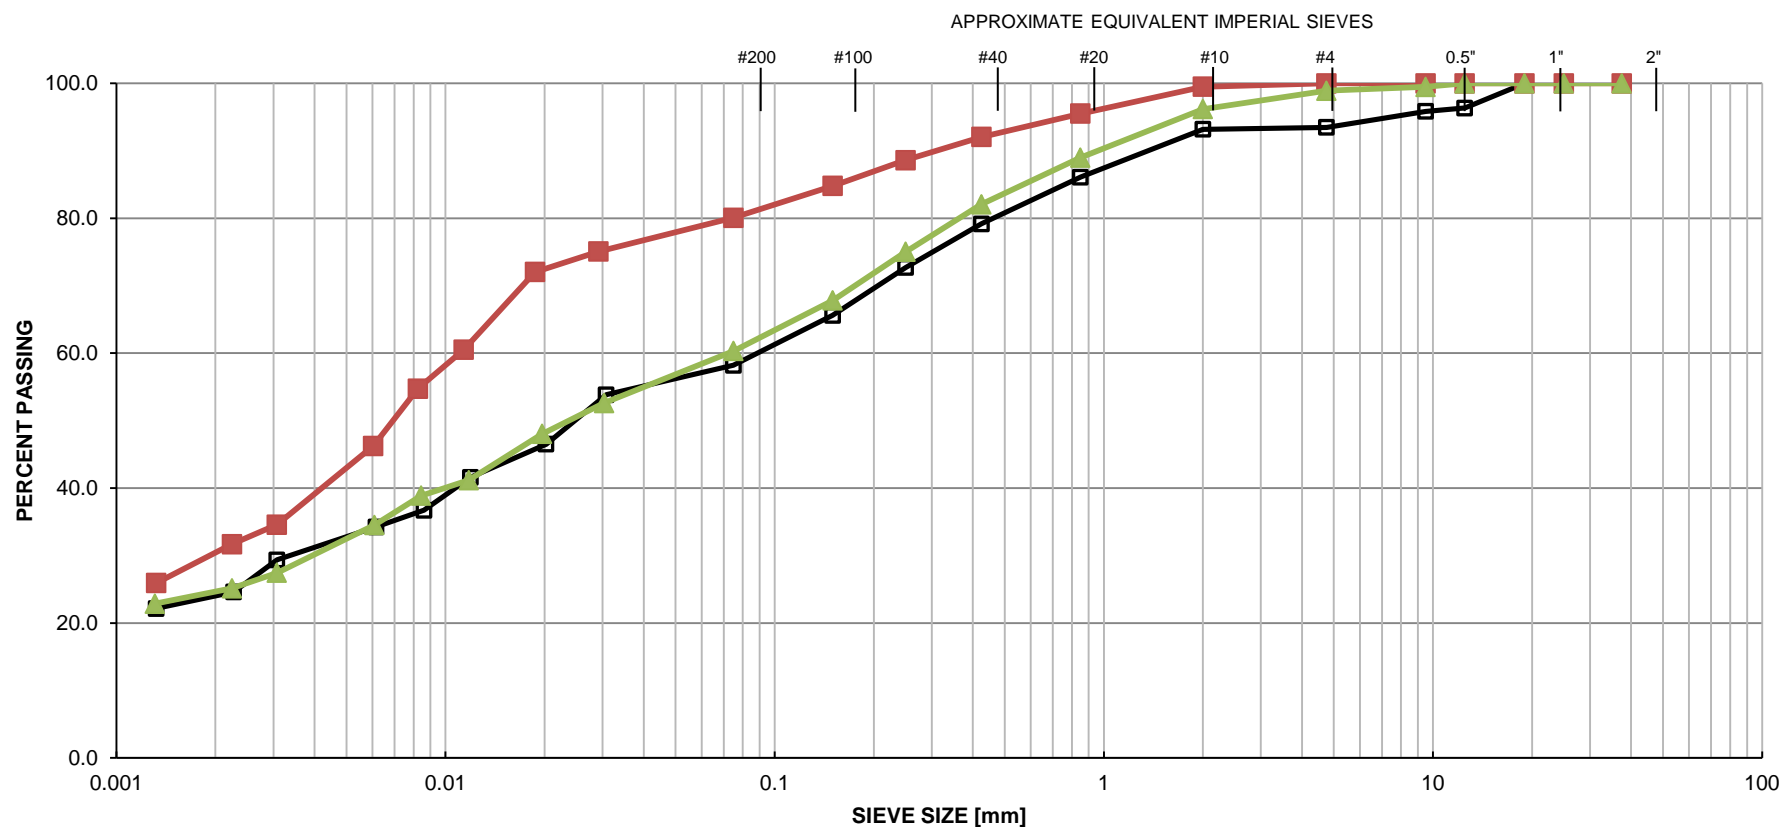
CLAY	SILT	SAND			GRAVEL	
		FINE	MEDIUM	COARSE	FINE	COARSE

Test Hole:	Sample:	Depth:	Reference No.:	Components:
1	S5	3.0 - 3.7 m	19-398-7-3	Gravel (6.5 %), Sand (35.3 %), Silt (34.1 %), Clay (24.0 %)
4	S2	0.9 - 1.5 m	19-398-7-6	Gravel (0.0 %), Sand (19.9 %), Silt (49.7 %), Clay (30.4 %)
5	S3	1.5 - 2.1 m	19-398-7-9	Gravel (1.1 %), Sand (38.6 %), Silt (35.6 %), Clay (24.7 %)

The analytical results for the moisture contents and Atterberg Limits are presented on the test hole summary logs. The laboratory results are summarized in Table 1 (Particle Size Analyses) and Table 2 (Hydraulic Conductivity Test Data).

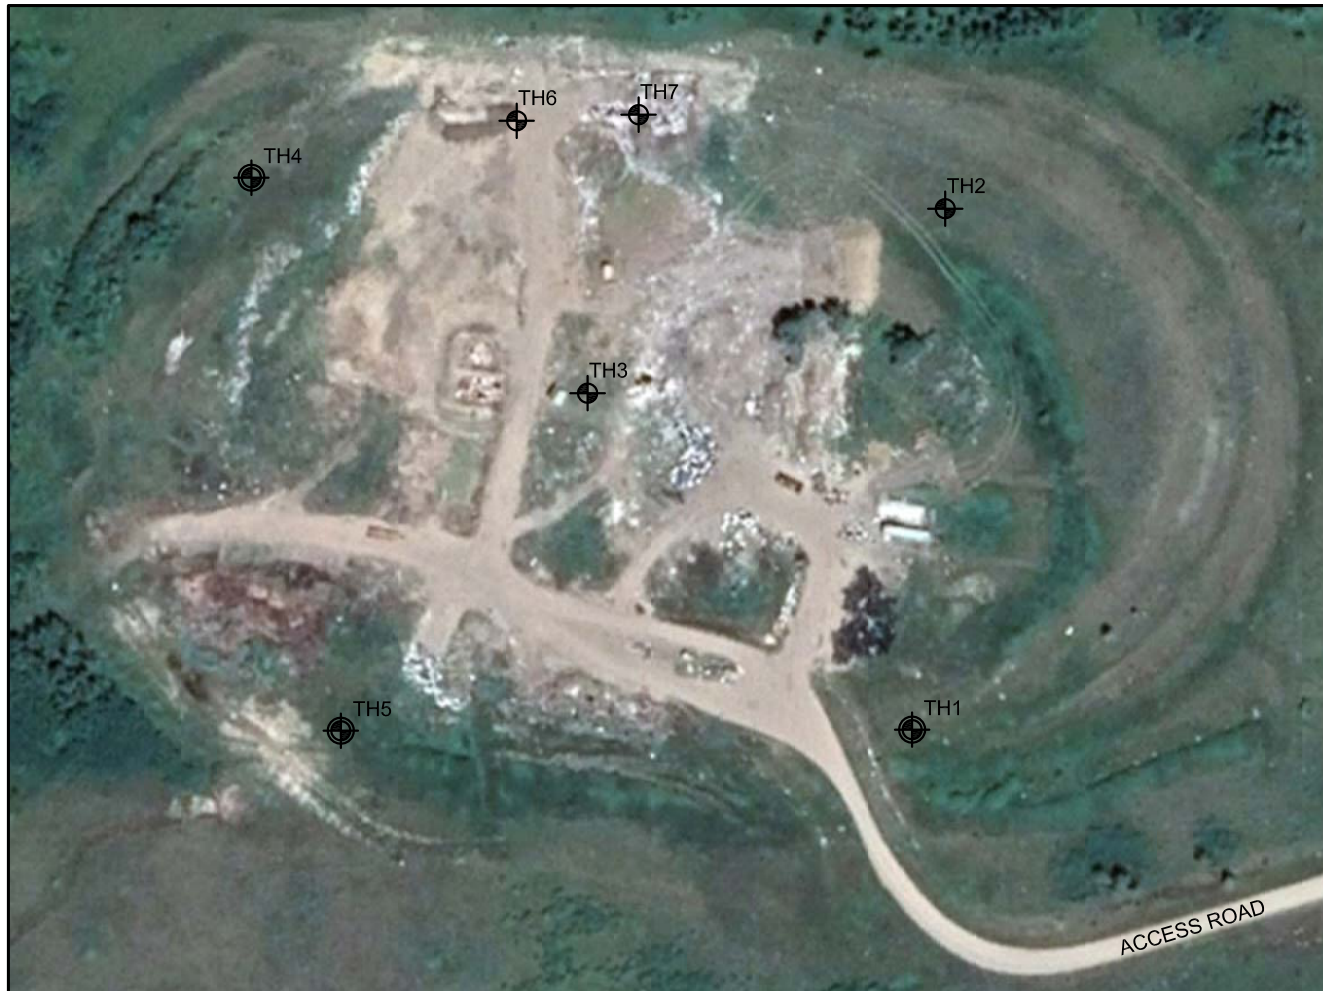
Figure 1 – Test Hole and Monitoring Well Locations

GPS COORDINATES OF TEST HOLES		
TEST HOLE	COORDINATE DATUM: WSG84	
	UTM	14U
TH1	5553404	425277
TH2	5553543	425288
TH3	5553495	425193
TH4	5553555	425104
TH5	5553406	425123
TH6	5553569	425174
TH7	5553571	425207

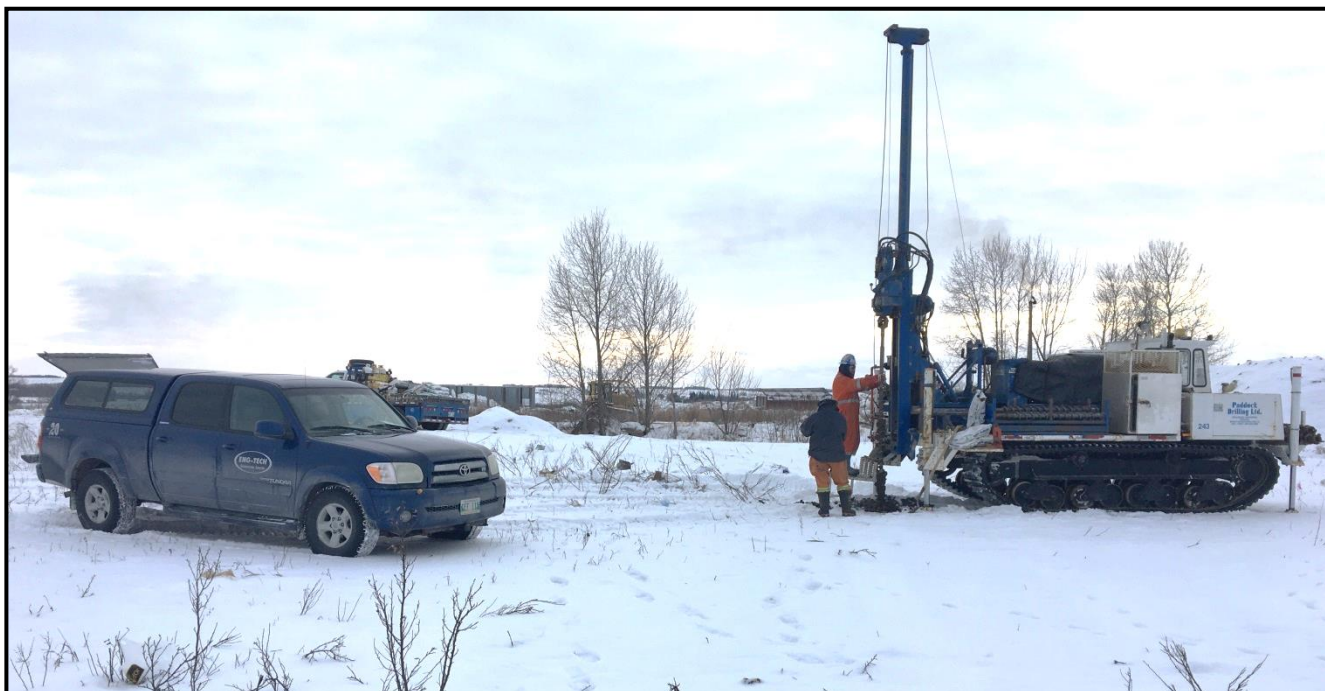
PHOTOGRAPH #1: Drilling at TH2 as seen facing southwest.

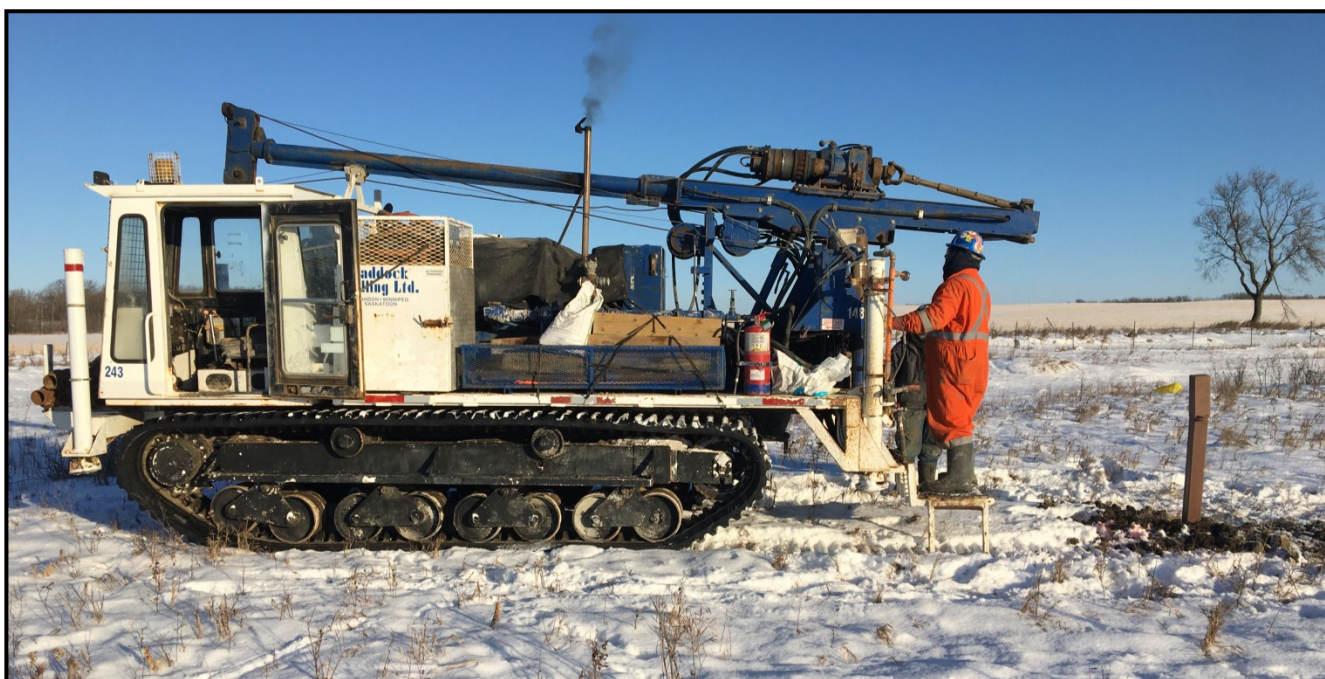
PHOTOGRAPH #2: View of TH4 as seen facing north.

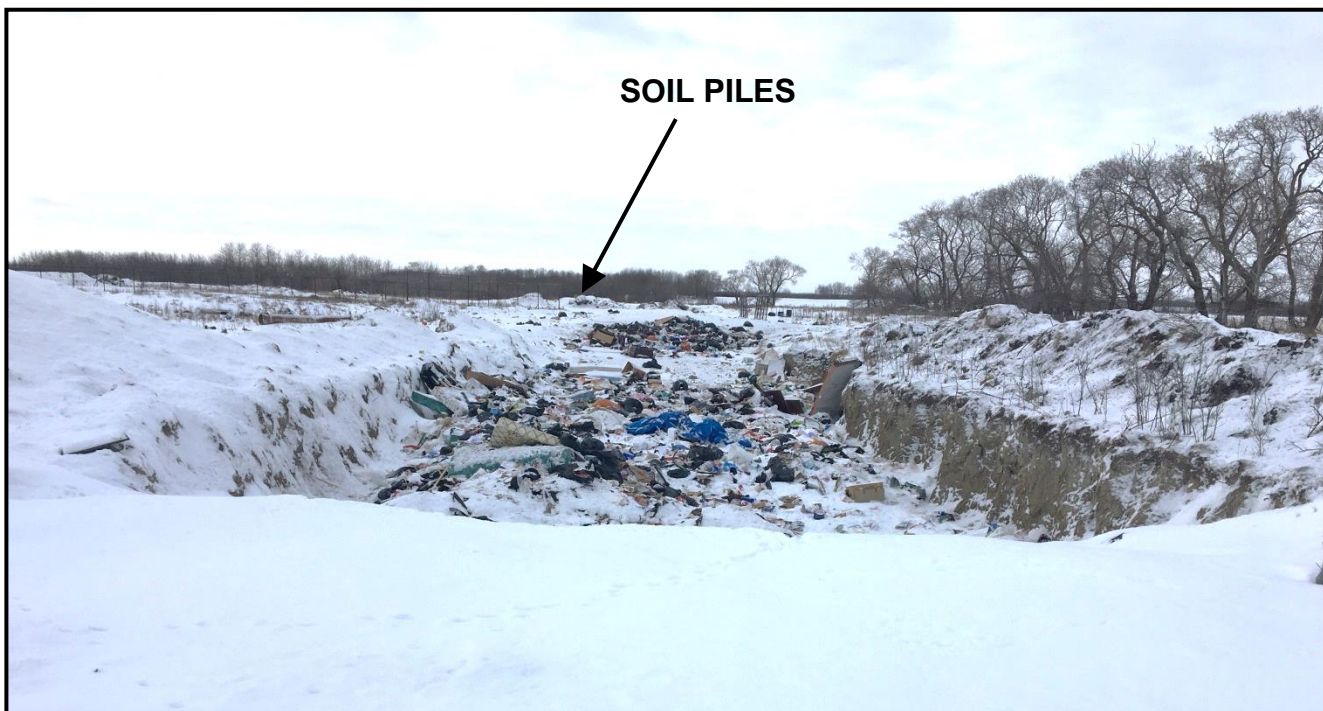
PHOTOGRAPH #3: Landfill cell at the northern portion of the Site.

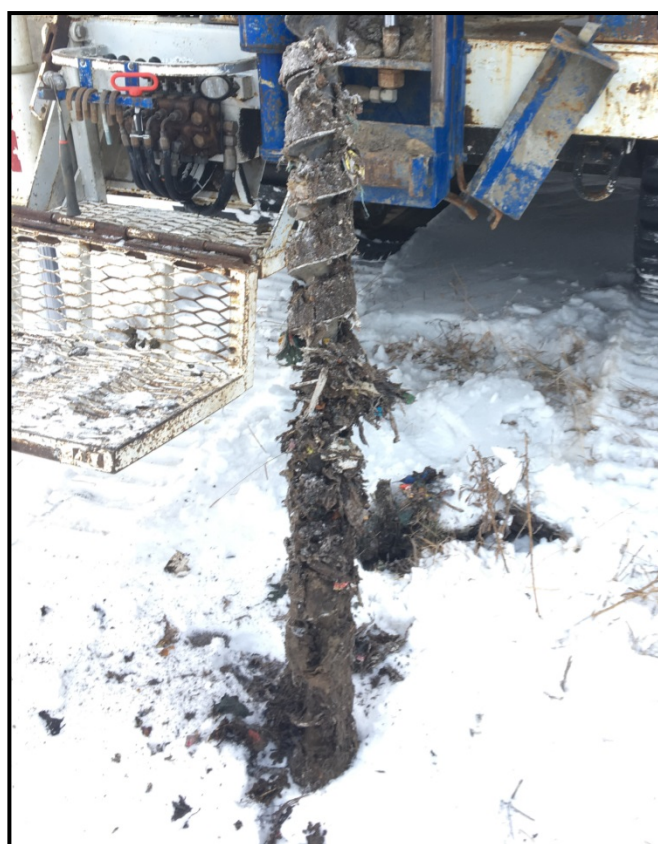
PHOTOGRAPH #4: Waste materials encountered during drilling at TH3.

At the time that the groundwater monitoring wells were installed, there was no water observed. Although free water was not observed during drilling (with the exception of TH3 where the garbage/debris was saturated), the change from brown to grey till may indicate the approximate water table. According to locals, groundwater may be deeper than the maximum depth drilled (i.e., 12.2 mbg). Groundwater monitoring was not included in the scope of work since this was to be completed by BMCE Ltd.

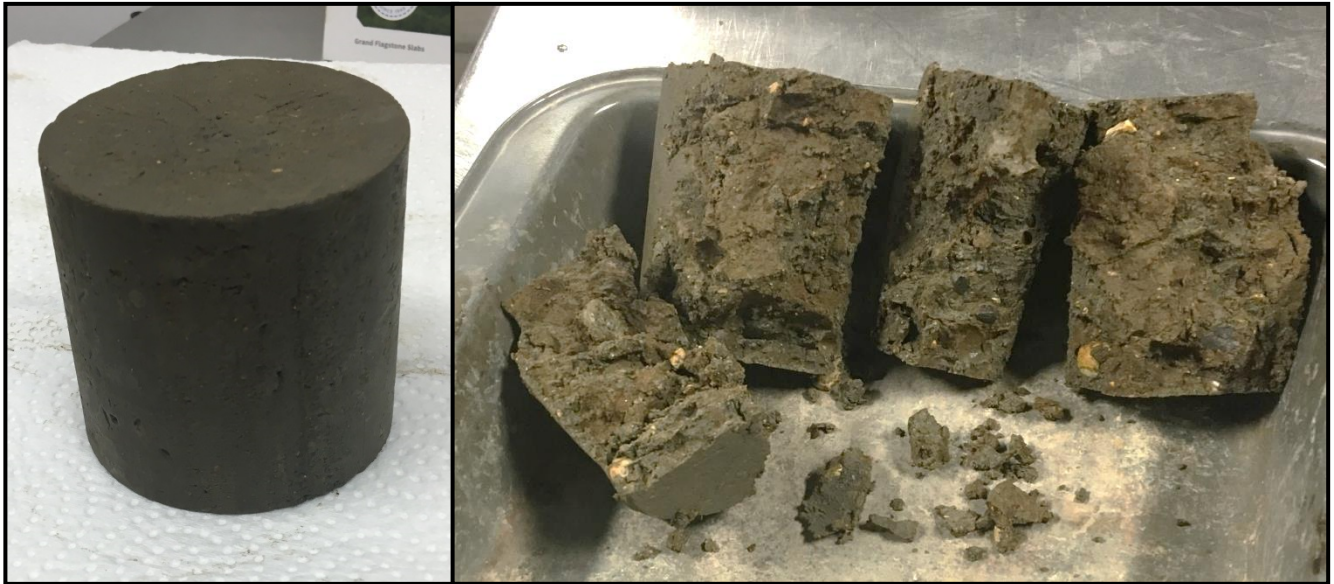
PHOTOGRAPH #5: Sample TH1-S5 after hydraulic conductivity testing.

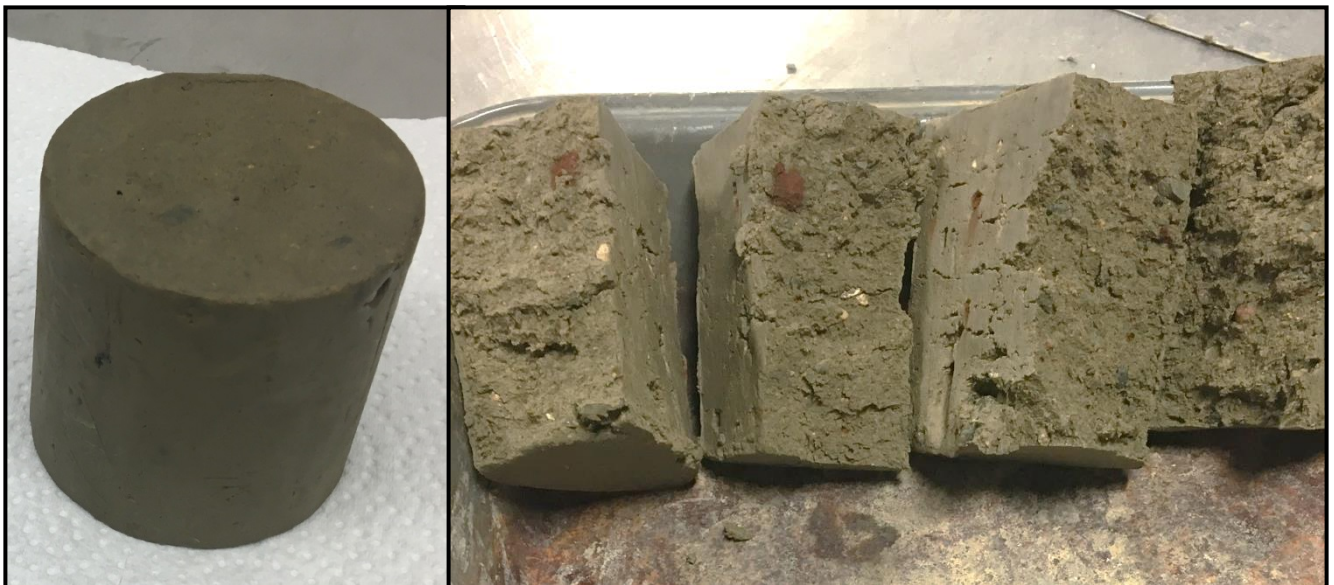
PHOTOGRAPH #6: Sample TH4-S2 after hydraulic conductivity testing.

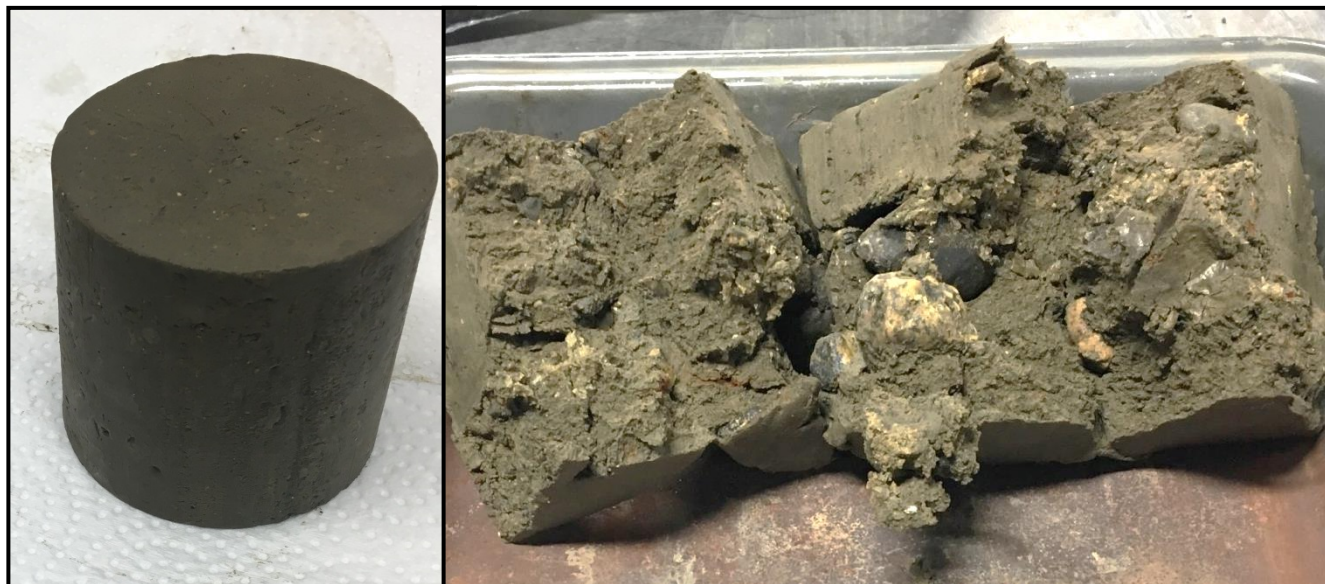
PHOTOGRAPH #7: Sample TH5-S3 after hydraulic conductivity testing.
