**SUBJECT: Manitoba Environment Act Proposal
Provincial Trunk Highway 5 Bridge Replacement and Flood Relief Bench**

MANITOBA ENVIRONMENT ACT PROPOSAL REPORT

PTH 5 Assiniboine River Bridge Replacement and Relief Bench Construction Project

**PTH 5 BRIDGE REPLACEMENT
ASSINIBOINE RIVER
AQUATIC HABITAT ASSESSMENT**

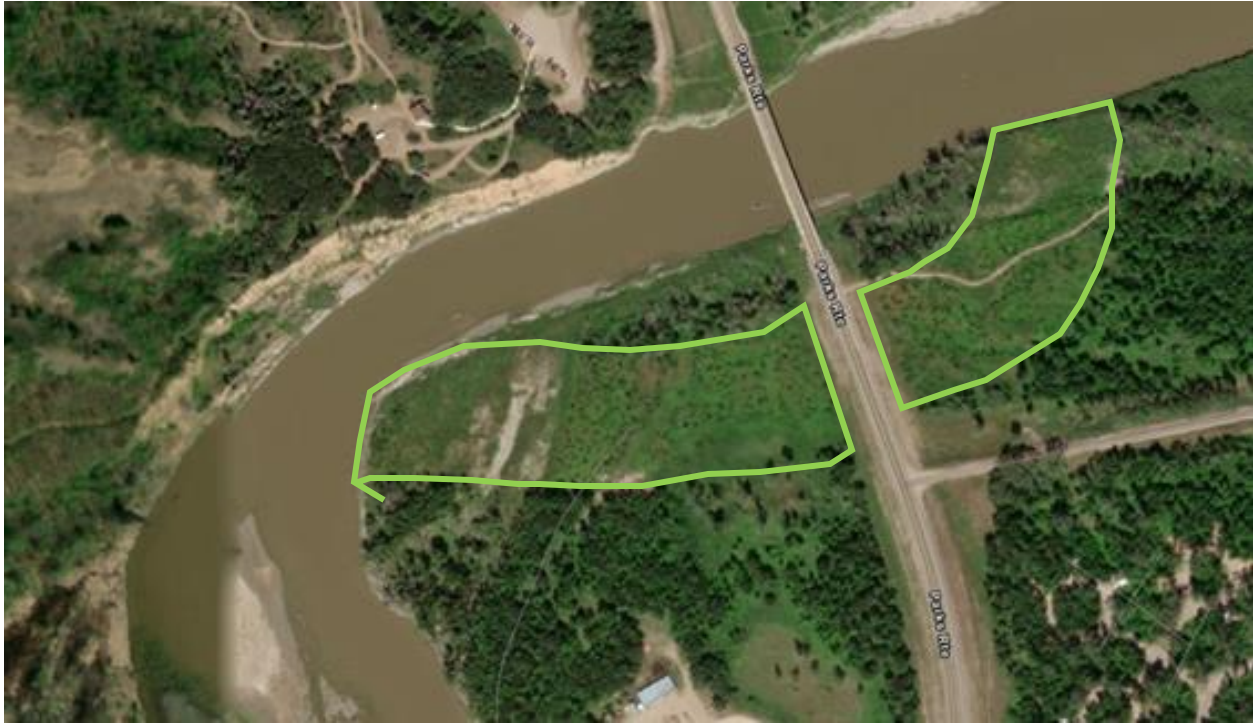
Figure 5. Satellite imagery from April 2023 (WMTS-ESRI 2023). Highlighted area was cleared in 2015 as part of plans for a relief plug which was ultimately not constructed.

In 2015, portions of the proposed flood relief bench were cleared to accommodate a proposed flood relief breach plug south of the existing bridge that would allow for temporary passage of flood flow through an armoured weir section built into the foundation of PTH 5 (Figure 5). The breach plug was not constructed however the proposed breach channel was cleared of trees (~27,000 m²).

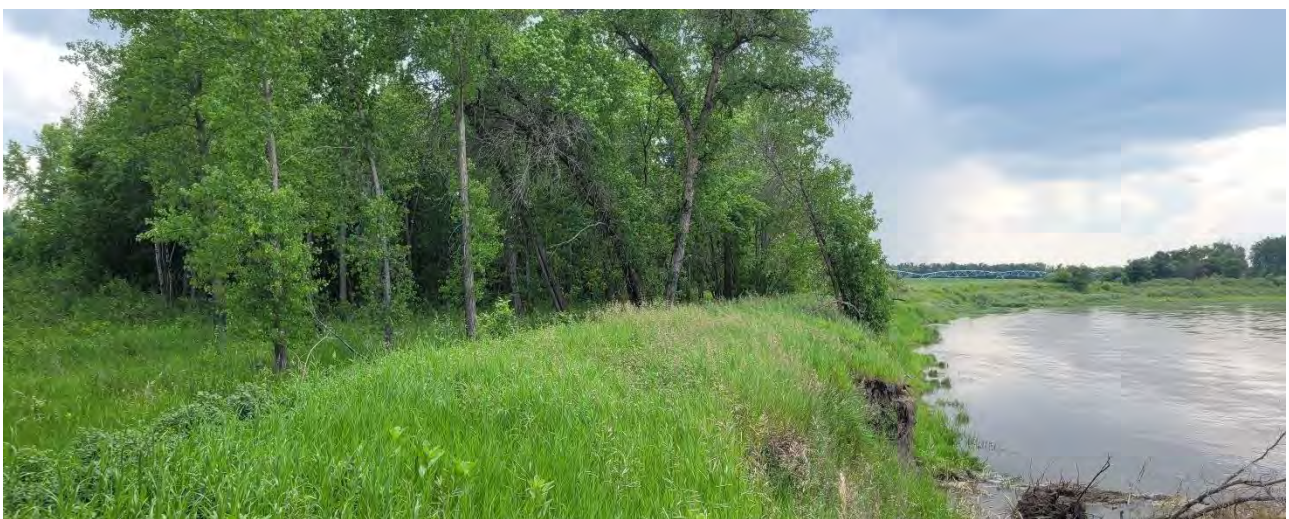
Figure 5. Riparian zone in upstream area, right bank facing upstream. The riparian zone thins to the south as it approaches the adjacent cultivated agricultural land, visible in background. Tree cover is predominantly bur oak and green ash, with some cottonwood noted in the southern portion of the assessment area.

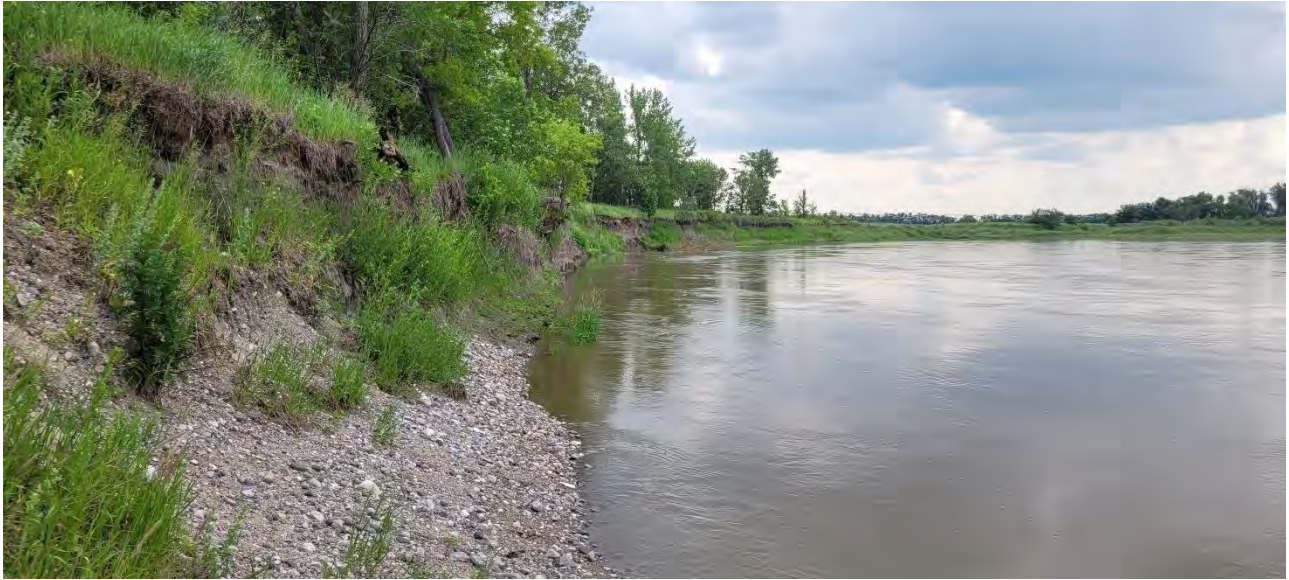
Figure 6. Steep bank erosion along the right bank is present throughout, characteristic of coarse gravel and sand material.
