RE: Remedial Action Plan for 1600 Erin Street

REMEDIAL ACTION PLAN  
1600 ERIN STREET  
WINNIPEG, MANITOBA

REMEDIAL ACTION PLAN  
1600 ERIN STREET

### **PHASE II ENVIRONMENTAL SITE ASSESSMENT S.E CORNER BROOKSIDE BLVD. AND JEFFERSON AVE. WINNIPEG, MANITOBA**

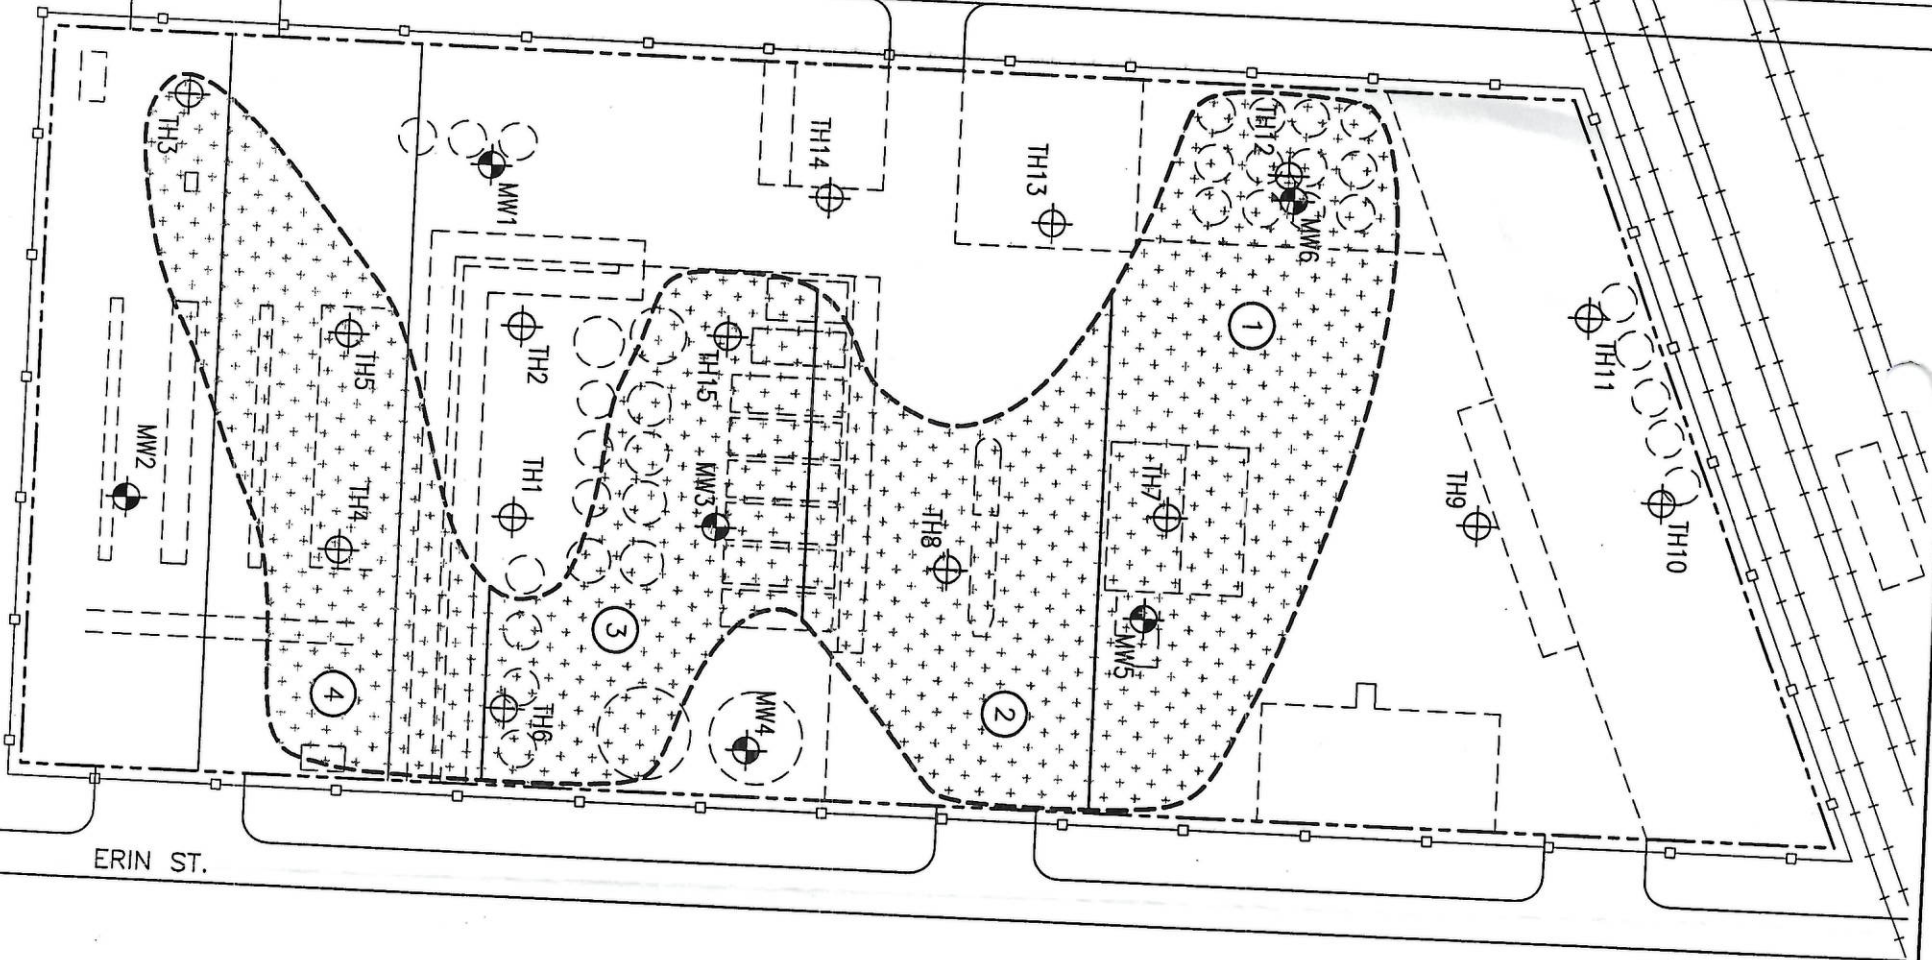
Figure 1 - Excavation Limits and Sequence

EXCAVATION LIMITS: CONCENTRATION OF  
BTEX, AND/OR TPH, AND/OR TSVH IN SOIL  
ELEVATED ABOVE APPLICABLE CRITERIA

- 1 AREA TO BE EXCAVATED IN 2002
- 2 AREA TO BE EXCAVATED IN 2003
- 3 AREA TO BE EXCAVATED IN 2004
- 4 AREA TO BE EXCAVATED IN 2005

The property limits of the 1600 Erin Street site are shown on Figure 1. The site is currently being used by Maple Leaf Construction (MLC) to store equipment including machinery, trailers and piping. It was previously used by Gulf Canada (now Petro Canada) as a bulk fueling facility from the early 1960's to the early 1980's. As documented in the Phase II ESA, the site was previously occupied by several buildings including a drum-filling warehouse in the center of the yard, a three-bay garage on the west-central boundary and a truck unloading facility. Several ASTs containing gasoline, fuel oil, naphthalene, solvent and aviation gas had been present across the site, while gasoline and diesel pump islands had been located on the north-central portion.

The remaining impacted soil at 1600 Erin Street will also be excavated and treated in this manner. Excavation will begin at the northern, upgradient end of the site and will proceed southward, as shown on Figure 1. It was noted in the Phase II ESA that a diesel underground storage tank (UST) was at one time located in the southwest corner of the site; however, Manitoba Conservation has no record of a diesel UST having been removed from the site.
