DILLON
CONSULTING

Remediation Plan for North West Smelting and Refining

Final Report

*Remediation Plan for North West Smelting and Refining, 2185 Logan Avenue,
Winnipeg, MB*

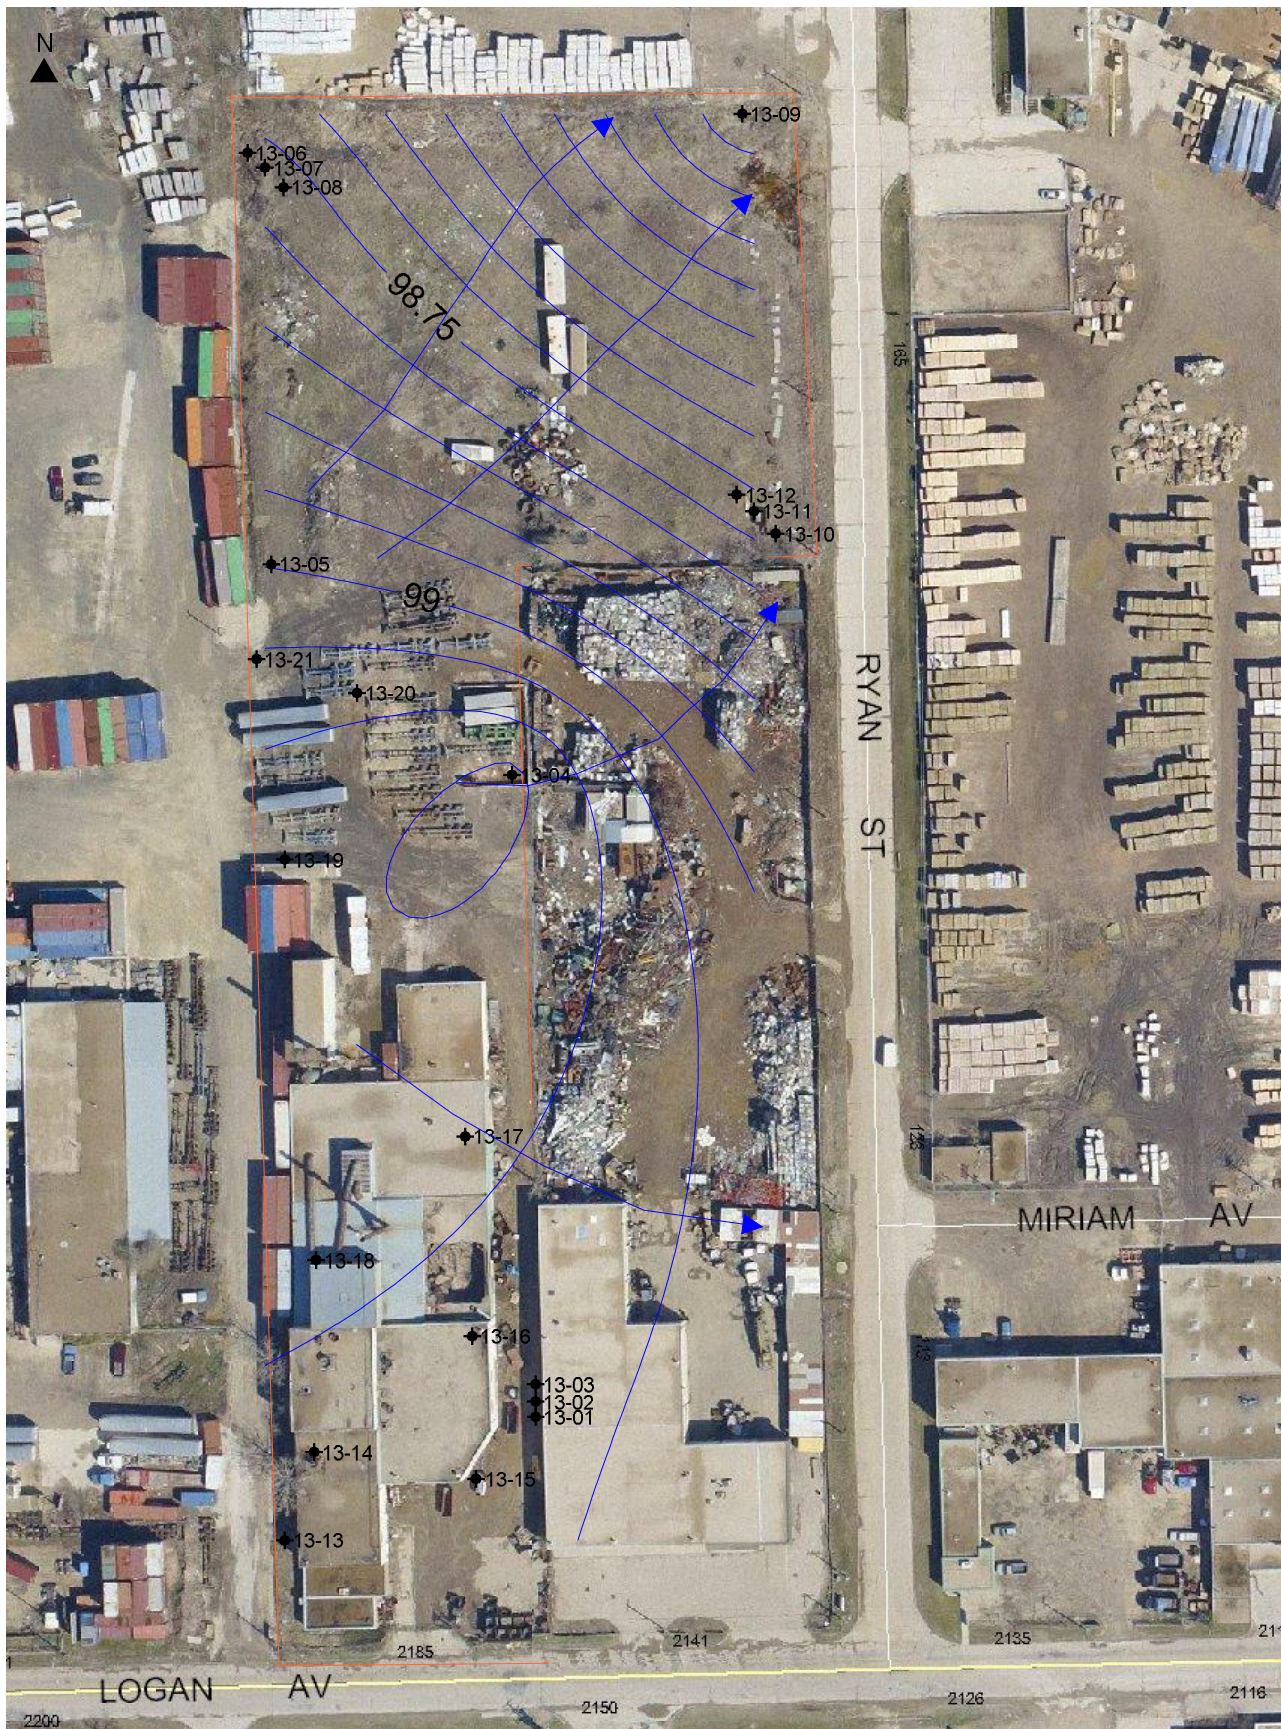
FIG. NO.
 7

Arrows Indicate Observed Groundwater Flow Direction

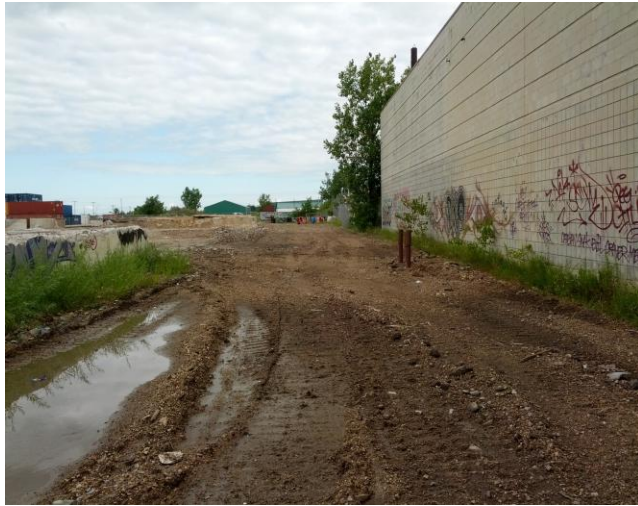
Photo 1: View looking north at 13-01, 13-02 and 13-03

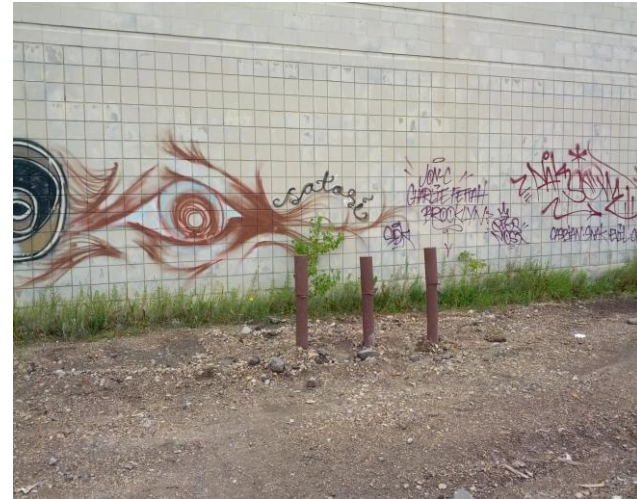
Photo 2: View looking east at 13-01, 13-02 and 13-03

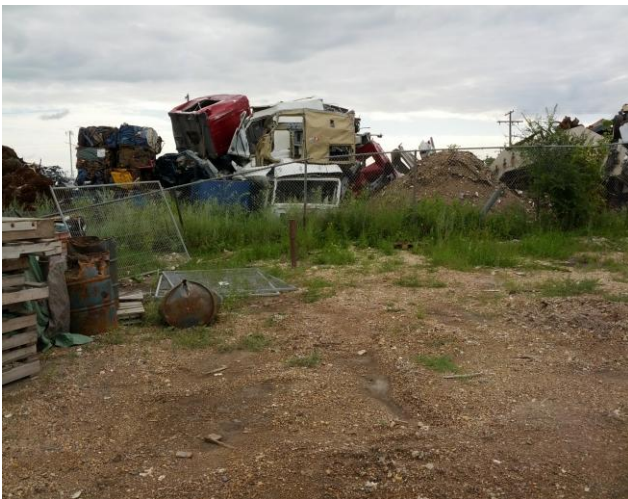
Photo 3: View looking east at 13-04

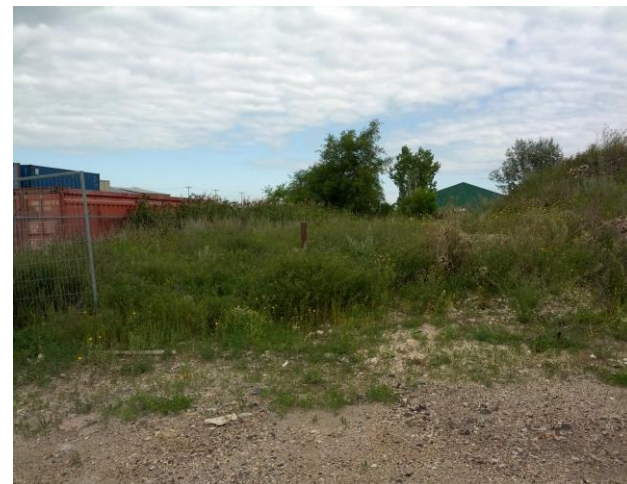
Photo 4: View looking north at 13-05

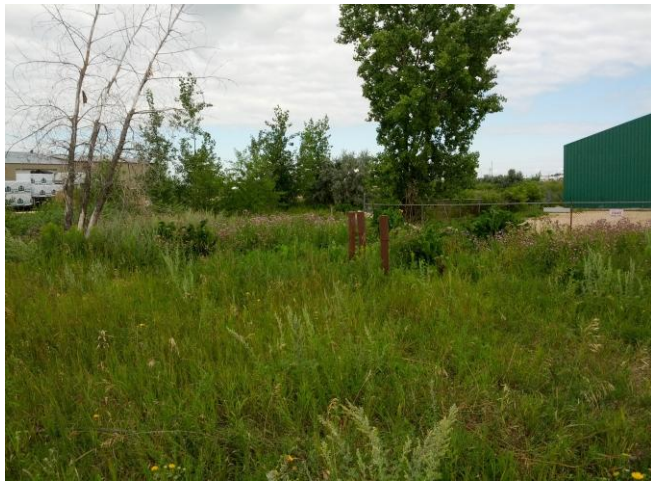
Photo 5: View looking north west at 13-06, 13-07 and 13-08

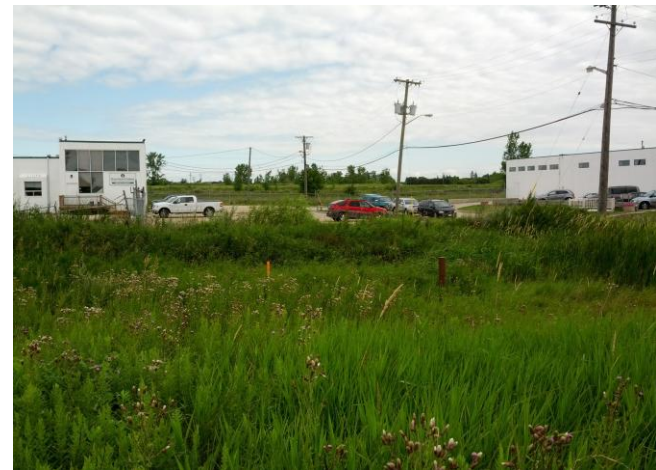
Photo 6: View looking north east at 13-09

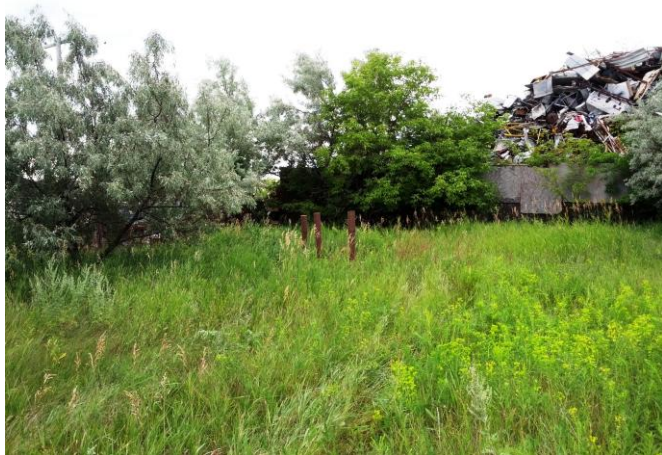
Photo 7: View looking south east at 13-10, 13-11 and 13-12

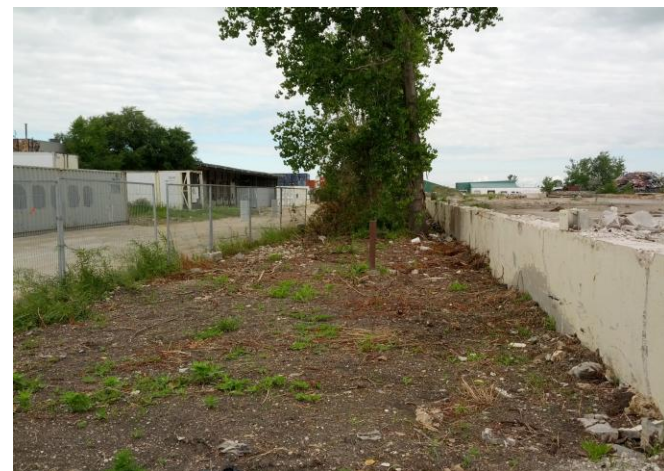
Photo 8: View looking north at 13-13

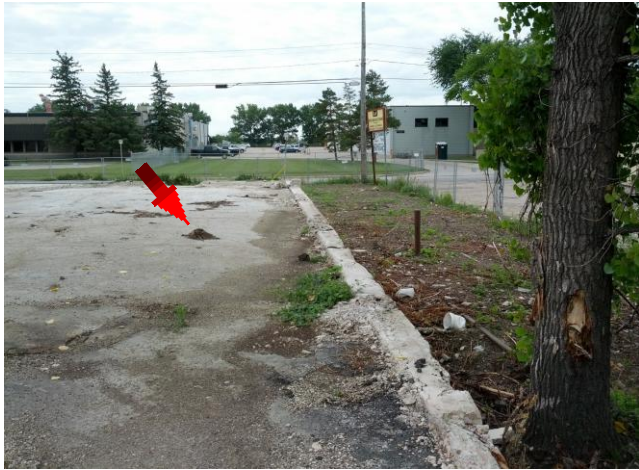
Photo 9: View looking south at 13-14 and 13-13

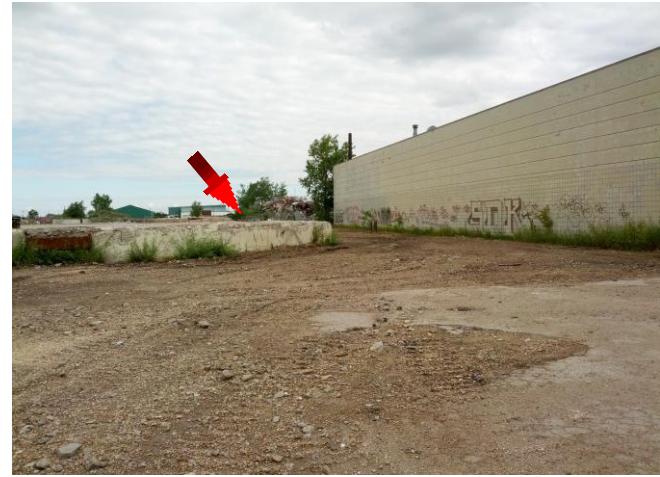
Photo 10: View looking north east at 13-15

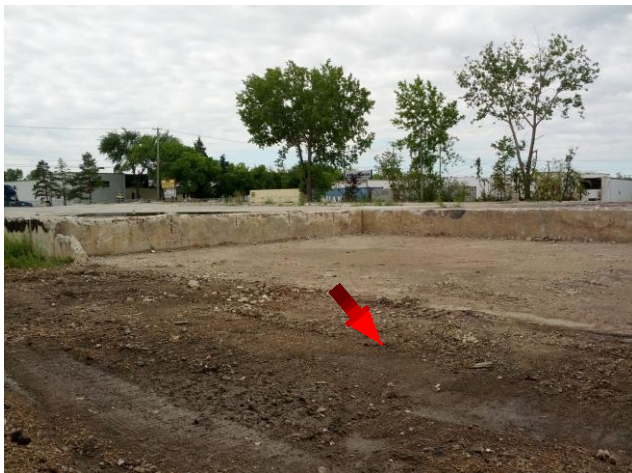
Photo 11: View looking south west at 13-16

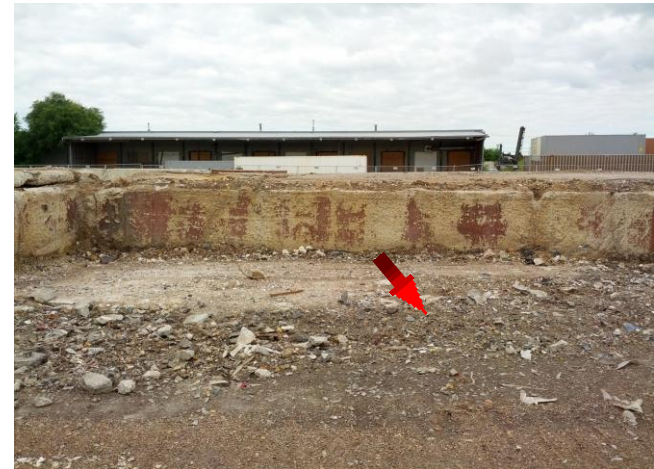
Photo 12: View looking west at 13-17

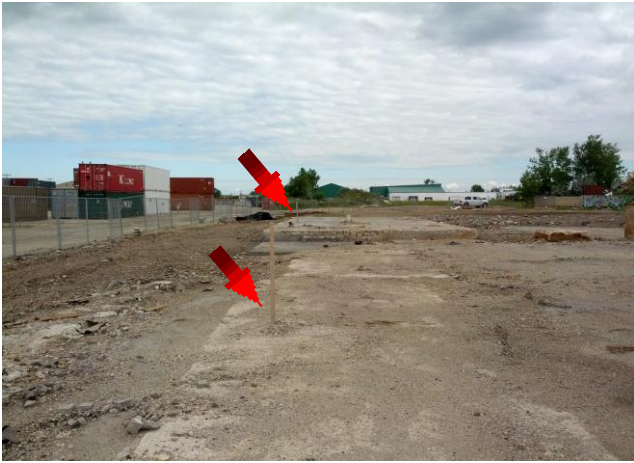
Photo 13: View looking north at 13-18 and 13-19

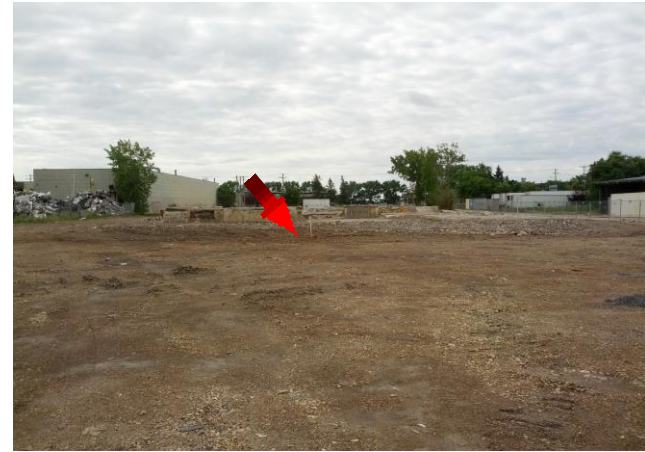
Photo 14: View looking south at 13-20

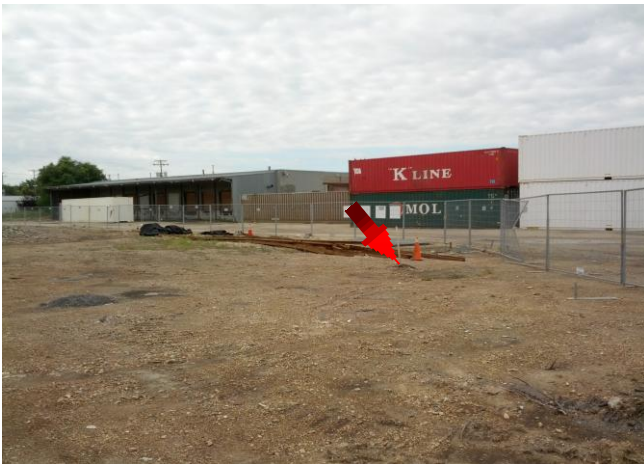
Photo 15: View looking south west at 13-21

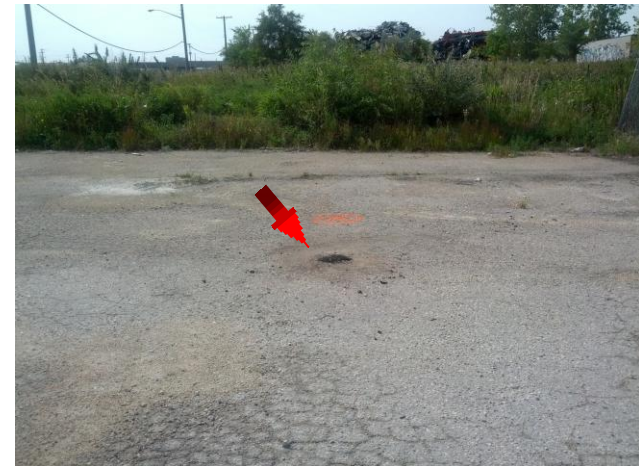
Photo 16: View looking south at 13-22 (offsite)

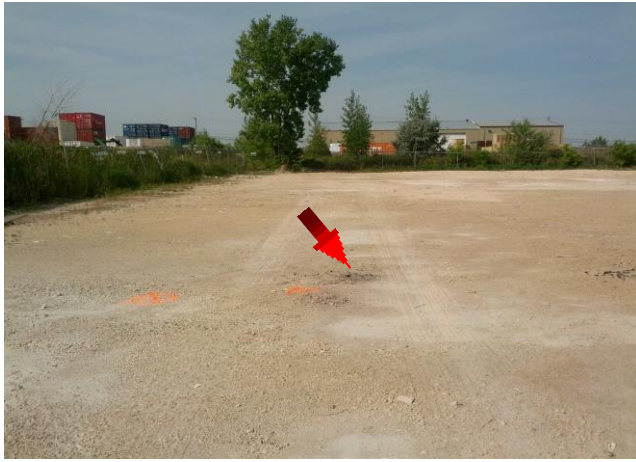
Photo 17: View looking west at 13-23 (offsite)

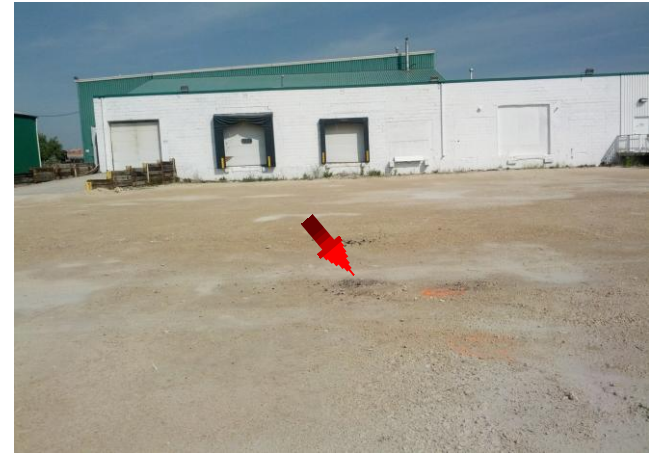
Photo 18: View looking north at 13-23 (offsite)

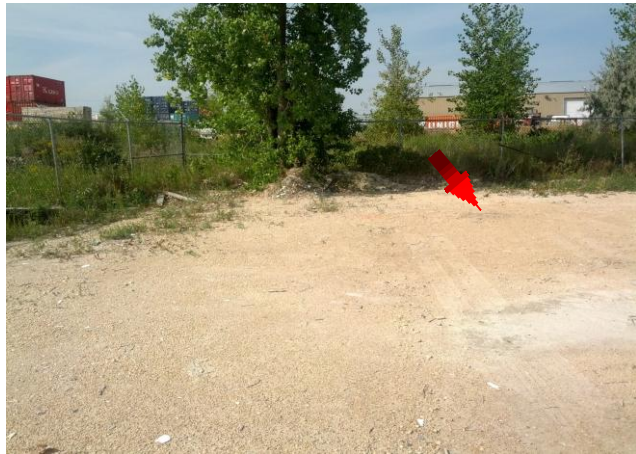
Photo 19: View looking west at 13-24 (offsite)

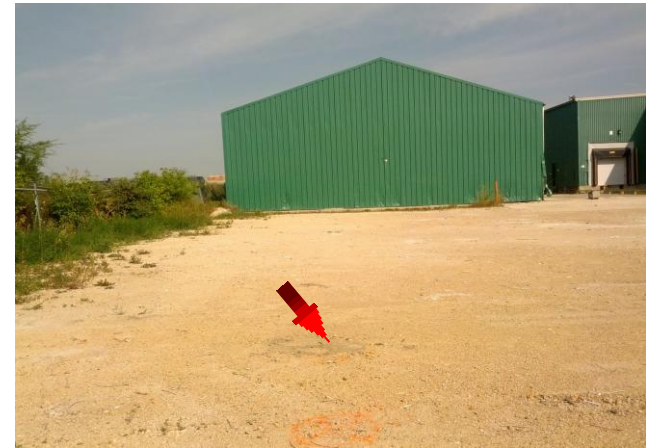
Photo 20: View looking north at 13-24 (offsite)
