CP RAIL

PHASE I - SITE ASSESSMENT
WESTON YARD
WINNIPEG, MANITOBA

DECEMBER 1991

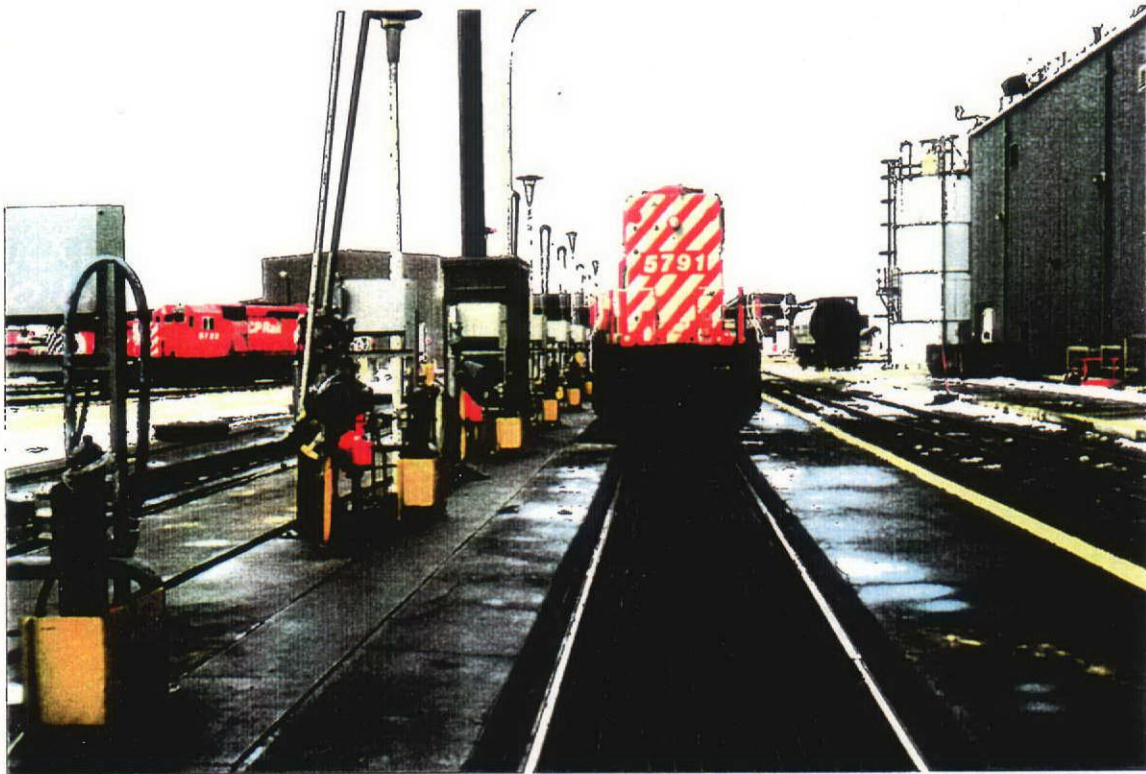
Photo 1 Winnipeg Diesel Shop Fuelling Station

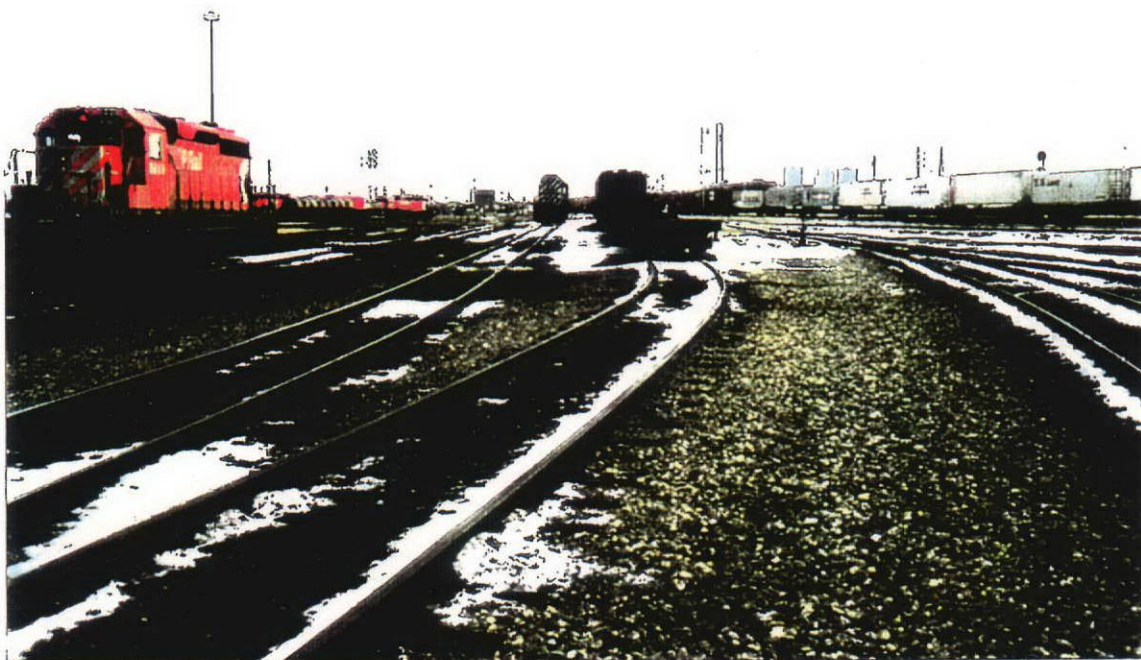
Photo 2 Vicinity of Former Fuelling Facility (mid 1960s to 1984)

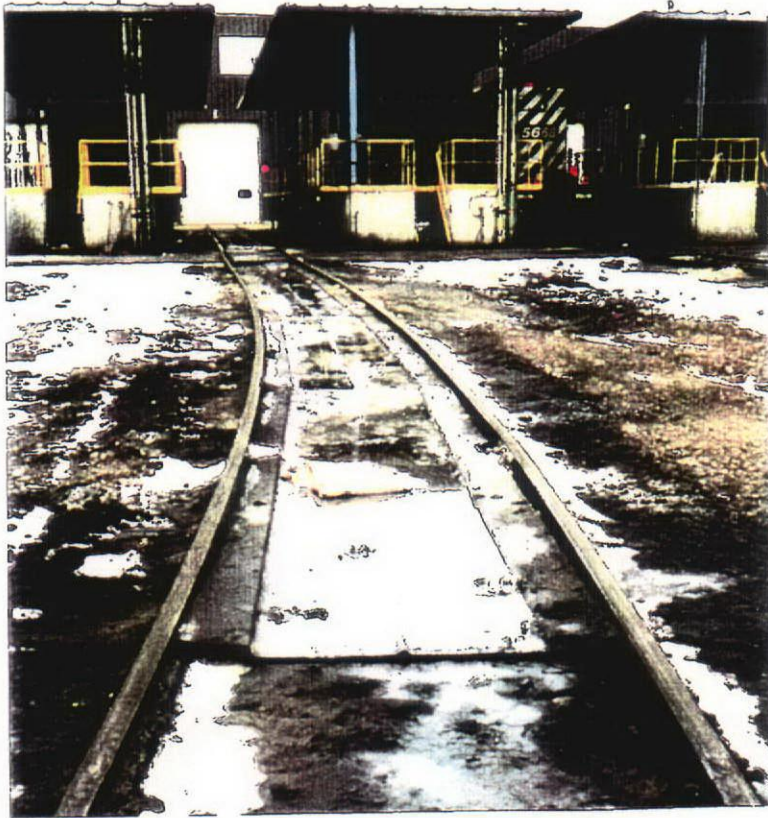
Photo 3

Locomotives waiting in line to be fueled drip small amounts of fuel, lubricating oil, and oil associated with air box drainage. Consequently the track ballast in these areas has become oil stained.

Trackage Directly East of Winnipeg Diesel Shop Showing Stained Ground

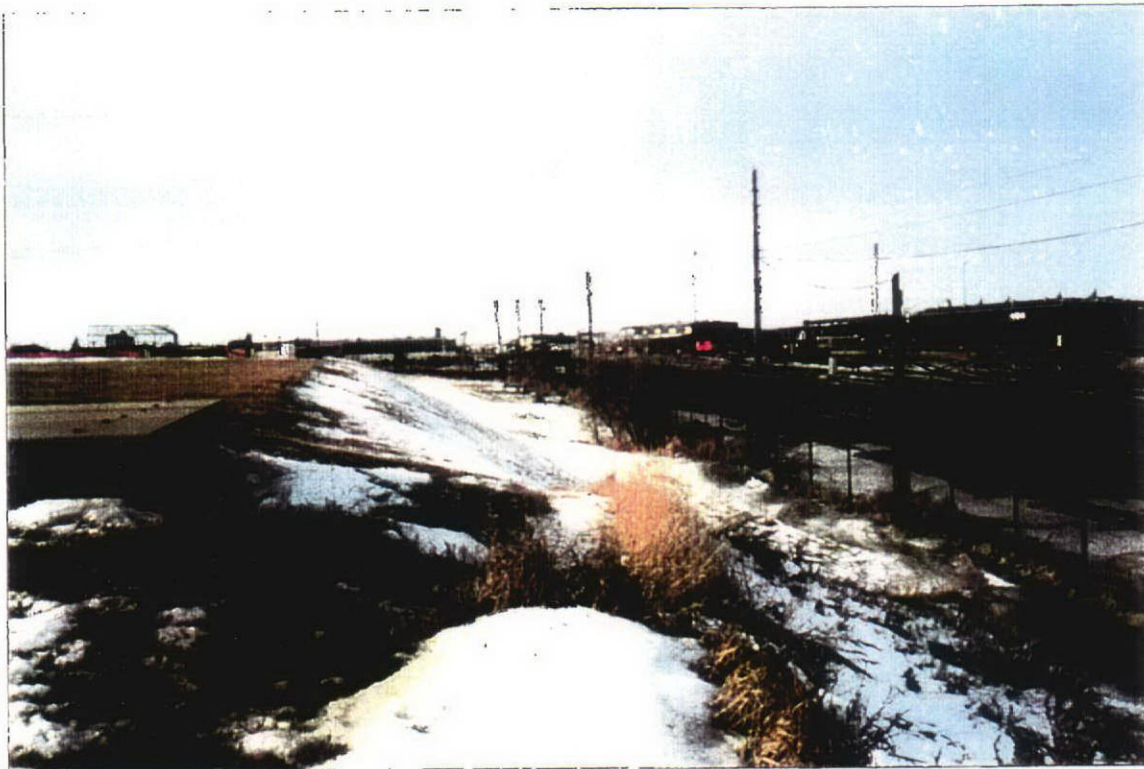
Photo 4

Slope of Covered McPhillips Reservoir, Adjacent to Weston Yard

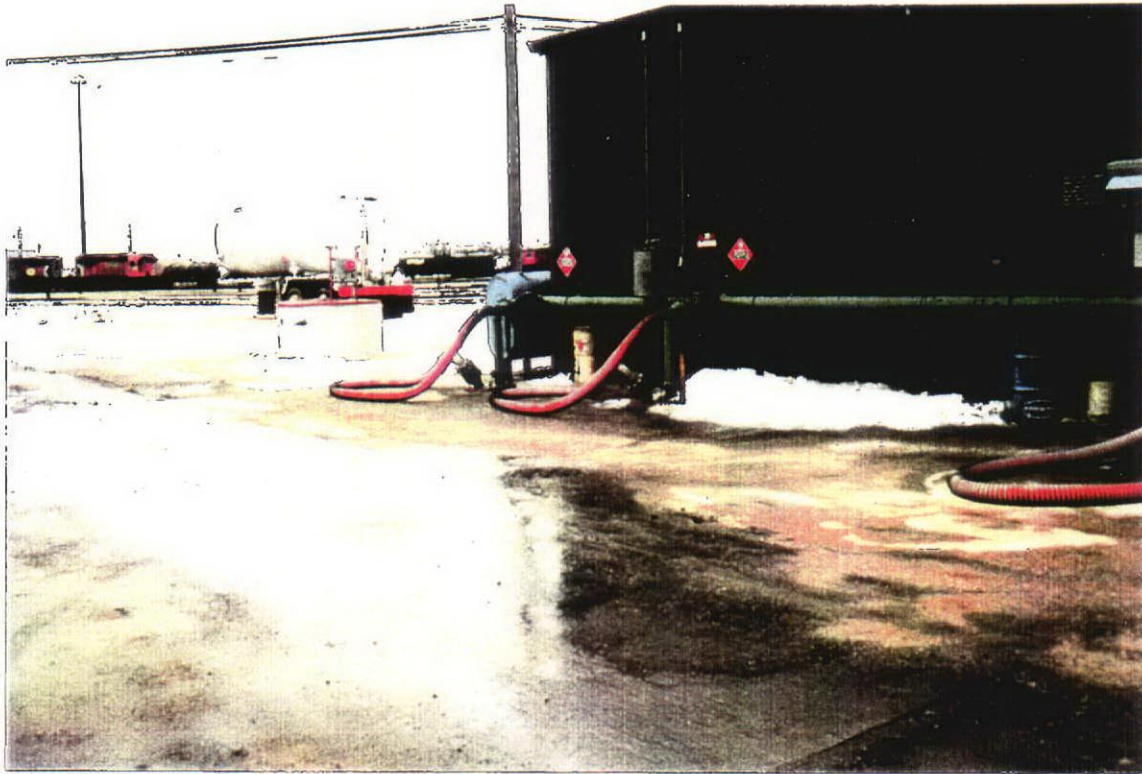
Photo 5 Truck Transfer Point at Current Fuel Storage Facility

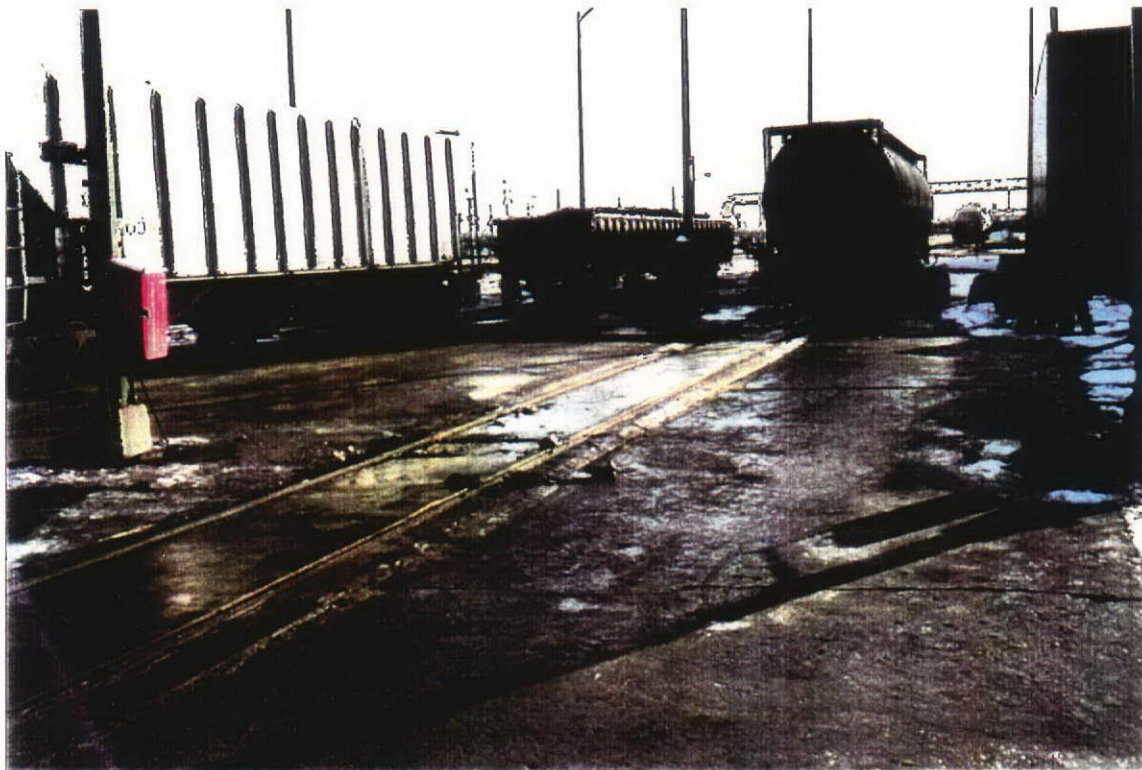
Photo 6 Leaking Tank Car Storage Area Northwest of One Spot Car Repair Shop

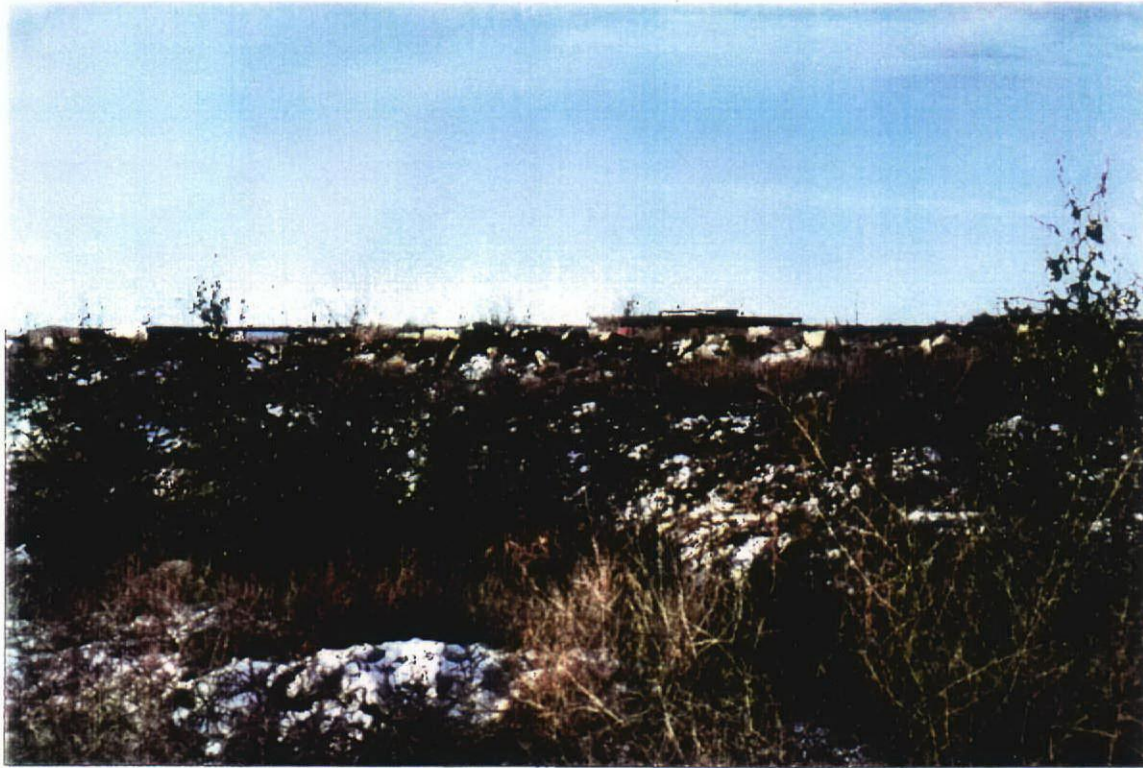
During the construction of the new Winnipeg Diesel Shop [21], approximately 13,800 cubic metres of fill and natural soil were excavated, and placed in an area within the northwest quadrant of the yard. It is believed that foundation soils and sections of concrete floor slab originating from upgrading modifications to the Diesel Heavy Repair Shop [20] were also placed in that area.

Photo 7 Earth Fill with Concrete Rubble in Northwest Quadrant of Weston Yard

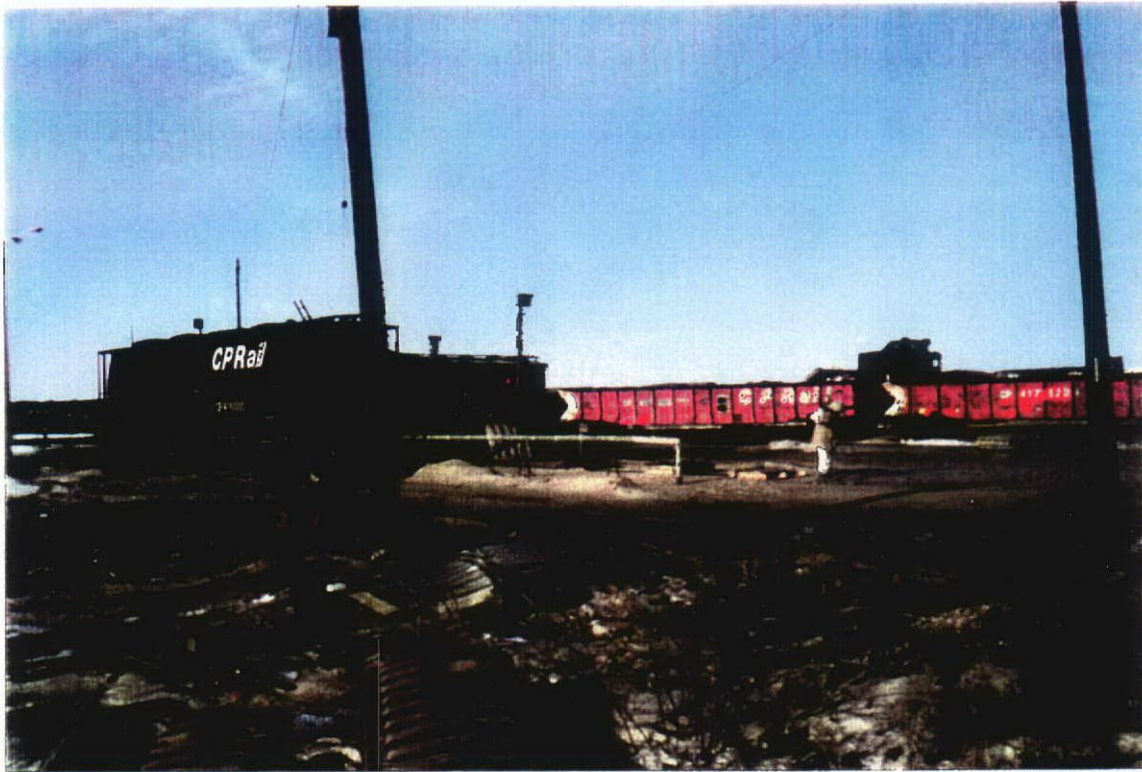
Photo 9 Activity in Current Outdoor Sand Blasting Area

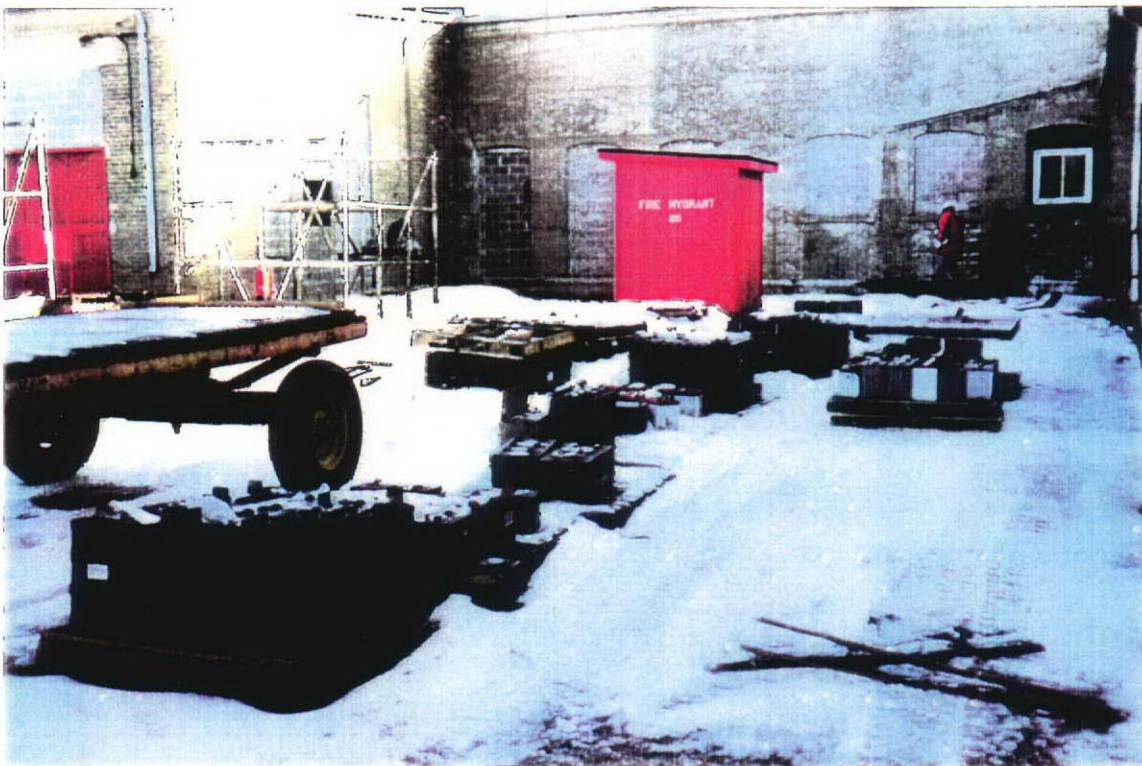
Photo 10 Battery Storage Area at Southwest Corner of West Maintenance of Way Shop
