A Phase II Environmental Assessment was conducted of a transformer oil storage area at an industrial property located at 1995 Logan Avenue, in Winnipeg, Manitoba. This assessment was conducted to determine the extent of possible soil and ground water contamination by transformer oil, and to investigate mitigative measures. In order to derive background information on the site, the findings of a Phase I Audit conducted by ENSIS were reviewed, and historic air photographs were assessed. Further, a tour of the facility was undertaken. Potentially applicable environmental legislation was also reviewed. Borehole drilling, and soil and ground water sampling were conducted at selected locations, to determine whether the soils and shallow ground water have been impacted by transformer oil, and if any potential contaminant concentrations are in compliance with the applicable environmental regulations.

Wardrop Engineering was retained by Carte International Inc. to conduct a Phase II Environmental Assessment of a transformer oil storage tank area at 1995 Logan Avenue, Winnipeg. These investigations were undertaken to determine if there are any environmental concerns regarding the site that

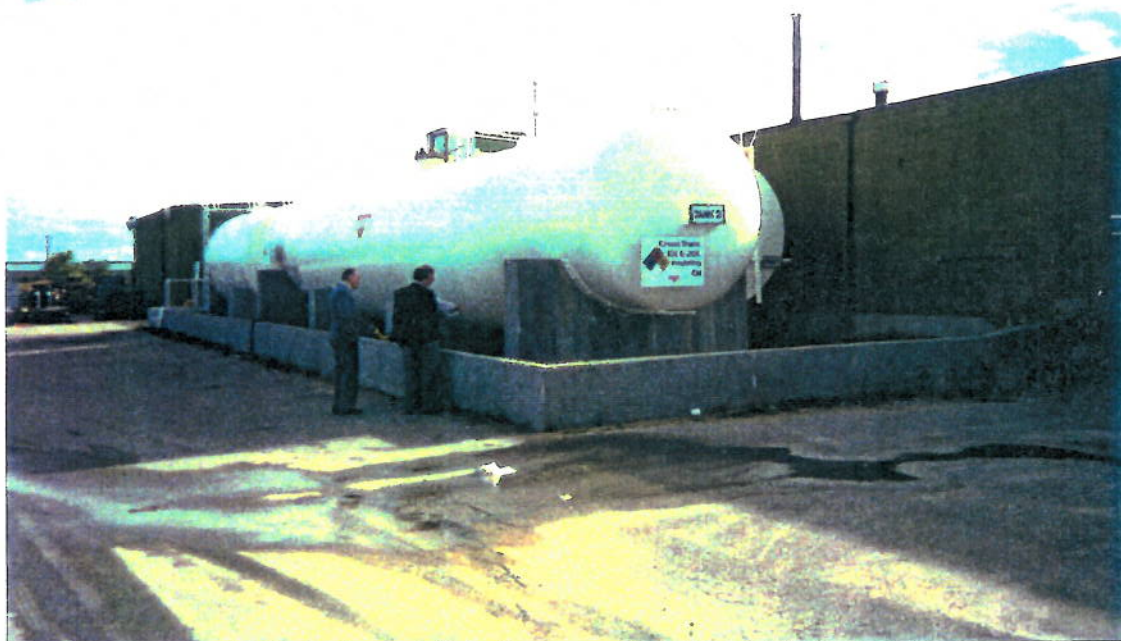
**Photo 1 - View of tank compound looking northeast. MW-1 is located at south end of Tank 2. MW-4 is located at southeast corner of compound, at right of photograph.**

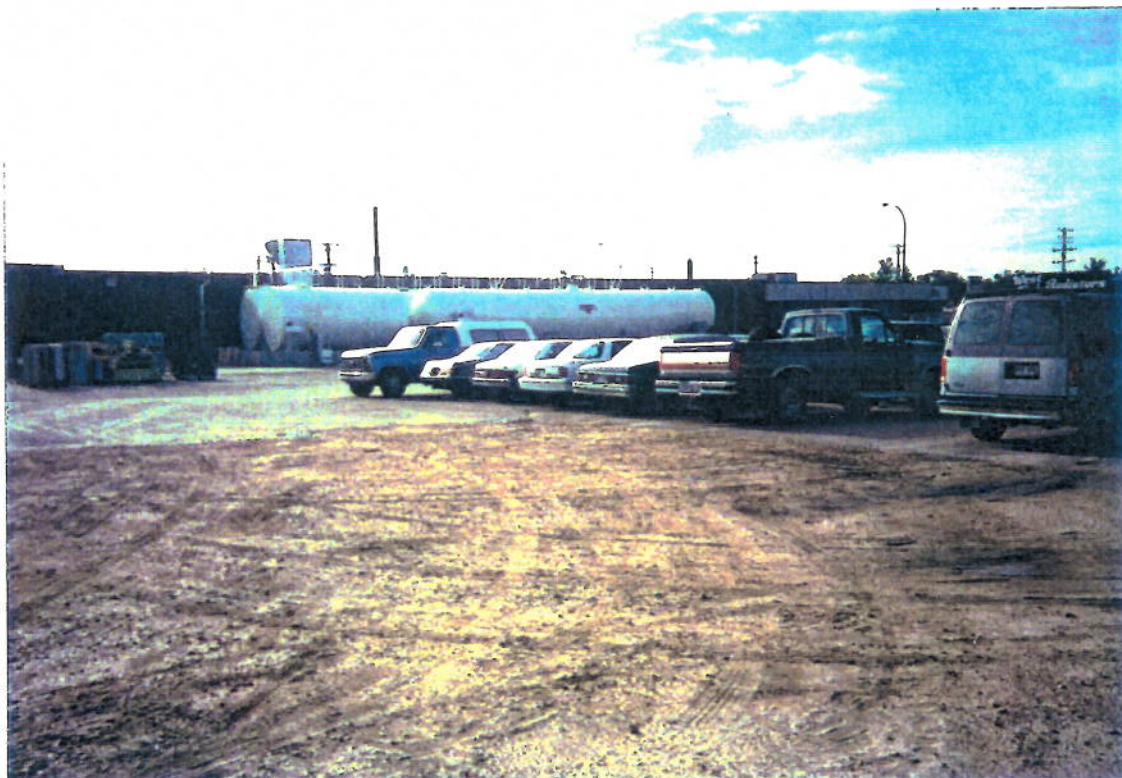
**Photo 3 - View of tank compound and parking lot to the west of tank compound, looking southeast.**

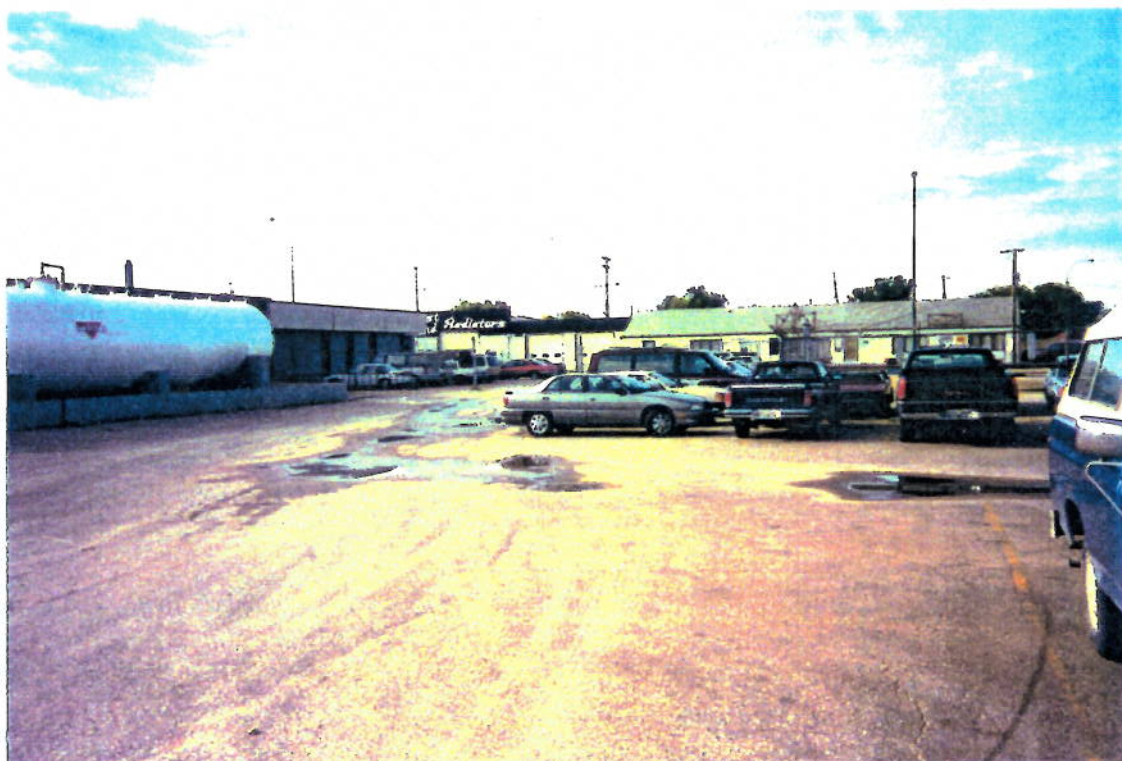
**Photo 4 - View of tank compound and parking lot area looking south. Note location of catchbasin (pooling water) in centre of photo between tanks and cars.**

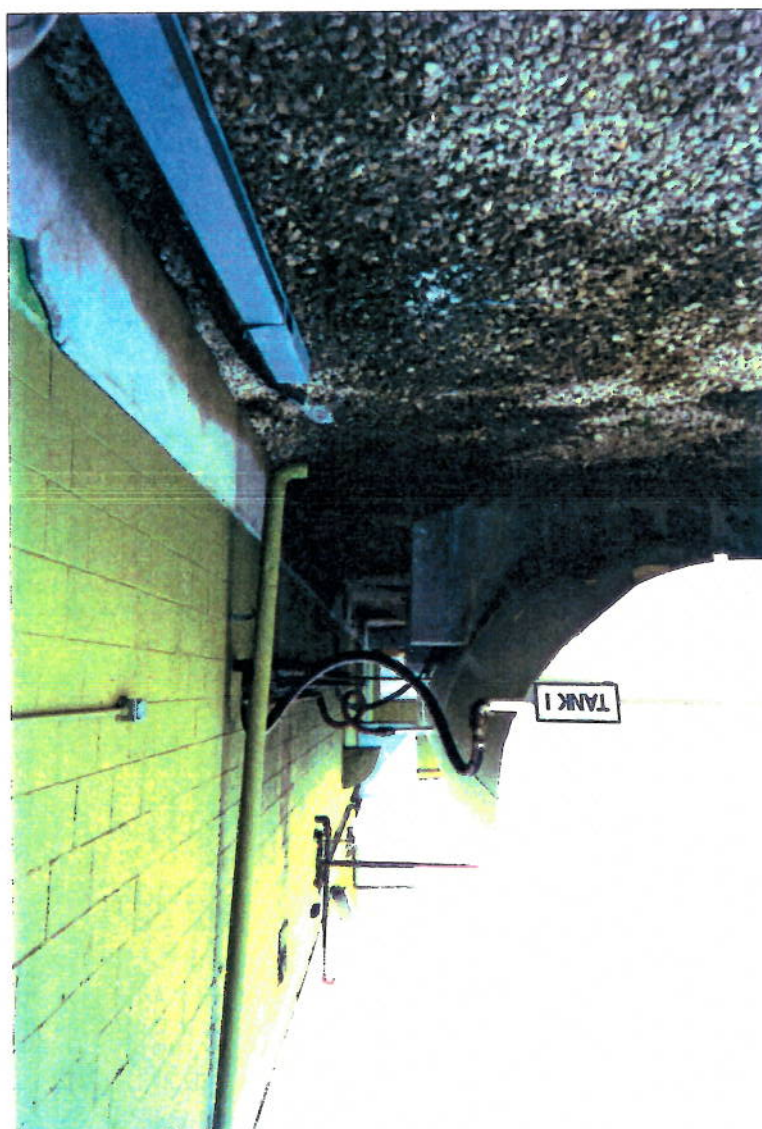
The results of the Phase II Assessment indicate that the southeast corner of the tank compound has been adversely impacted by Mineral Oil and Grease. The elevated Mineral Oil and Grease concentrations is likely the result of the 1993 spill of 45 000 L, that occurred within the tank compound. The oil likely pooled in the southeast corner of the compound where it infiltrated the soil and impacted the shallow ground water.

Photo 5 - View of southeast corner of tank compound looking north.  
MW-4 is located at bottom right corner of photo, at base of Tank 1.  
Note oil-stained gravel.

According to the Manitoba Environment Guideline, the soils within the southeast corner of the tank compound will require remediation. Since Mineral Oil and Grease is not very volatile, the most effective means of remediating the site would be the removal (i.e., excavation) of the impacted soils. The soils can be treated at the Manitoba Hazardous Waste facility near St. Jean Baptiste, Manitoba. Once the impacted soils have been removed, contaminated ground water may drain into the excavation from the remainder of the compound and from beneath the building. This should be accommodated by allowing the excavation to remain open for a few days. The accumulated water could then be removed by suction truck and properly disposed of. The excavated area should then be lined to prevent further migration of any contaminants, then backfilled.

In order to properly remediate the affected soils, consideration should be given to dismantling and rebuilding part or all of the oil storage tank system. In particular, Tank 1 and its accompanying foundation should be removed, the soils beneath it excavated and backfilled, and then the same tank (or a new tank) reinstalled on a liner.

- The impacted soils should be removed by excavating and shipped to the Manitoba Hazardous Waste Treatment facility located near St. Jean Baptiste.
- Part or all of the transformer oil storage compound should be dismantled and properly reconstructed to facilitate excavation of the contaminated soils.
- The potential of contamination beneath the building adjacent to the storage tank area should be further investigated, by drilling through the floor slab and sampling the soils beneath.
- Manitoba Environment should be made aware of these findings, and remediation requirements discussed with them, prior to conducting any further work including remediation.
