February 9, 1999
Project: WX-04010

**RE: SUMMARY OF ACTIVITIES AND FINDINGS
INVESTIGATION OF THE SOURCE OF COAL TAR RESIDUES
CENTRA GAS SUTHERLAND AVENUE OPERATIONS SITE
WINNIPEG, MANITOBA**

AGRA Earth & Environmental Limited	CENTRA GAS MANITOBA INC. LOCATION OF PIPELINES AND CONTAMINANT PLUME			Figure: 1
Drawn: ASD	Scale: AS SHOWN	Date: JAN/99 Project No: WX-04010		Figure: 1

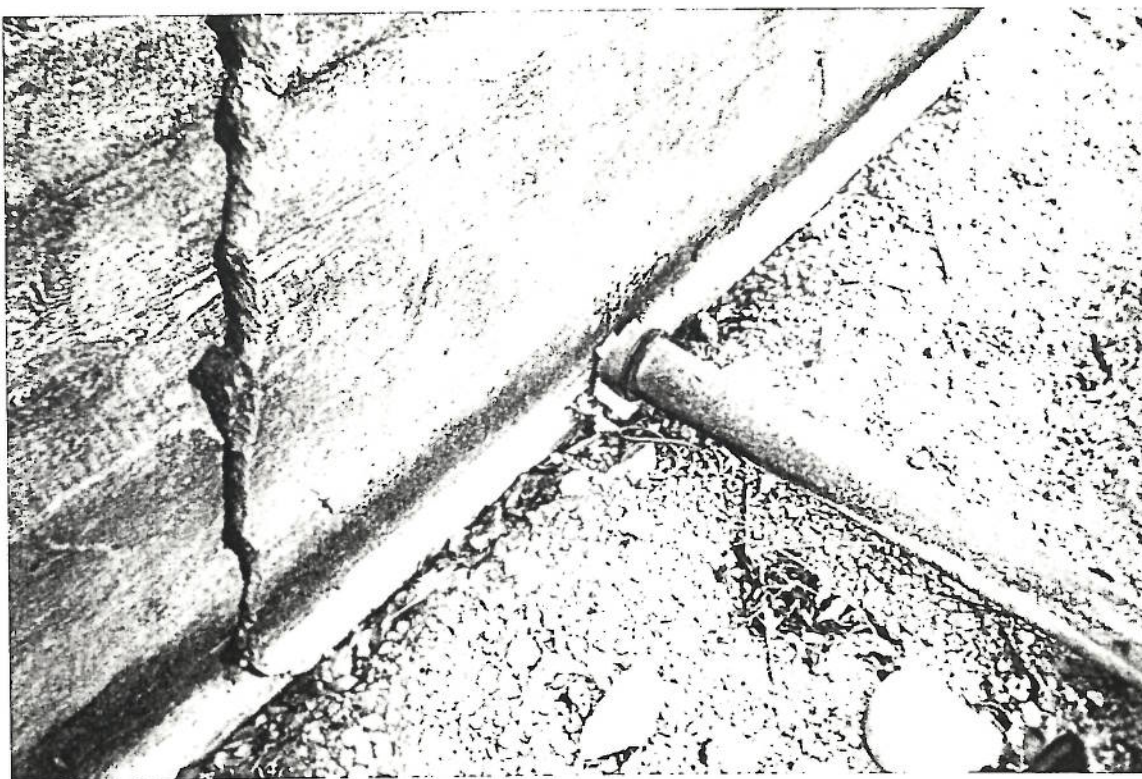
In an aerial photograph from 1950, a small structure immediately north of the Centra site is evident along the river bank. The structure appears to be a small pumping station and this is supported by Centra records (Plan R-2-A, discussed in Section 5.3.). A smaller structure of unknown purpose appears to the left of the pump house and may be the outlet for the two sewers which serviced the MGP site according to City of Winnipeg Plan 4502-14 (discussed in Section 5.6).

PHOTOGRAPH 1: Small abandoned pump house on west bank of Red River, north of Centra site.

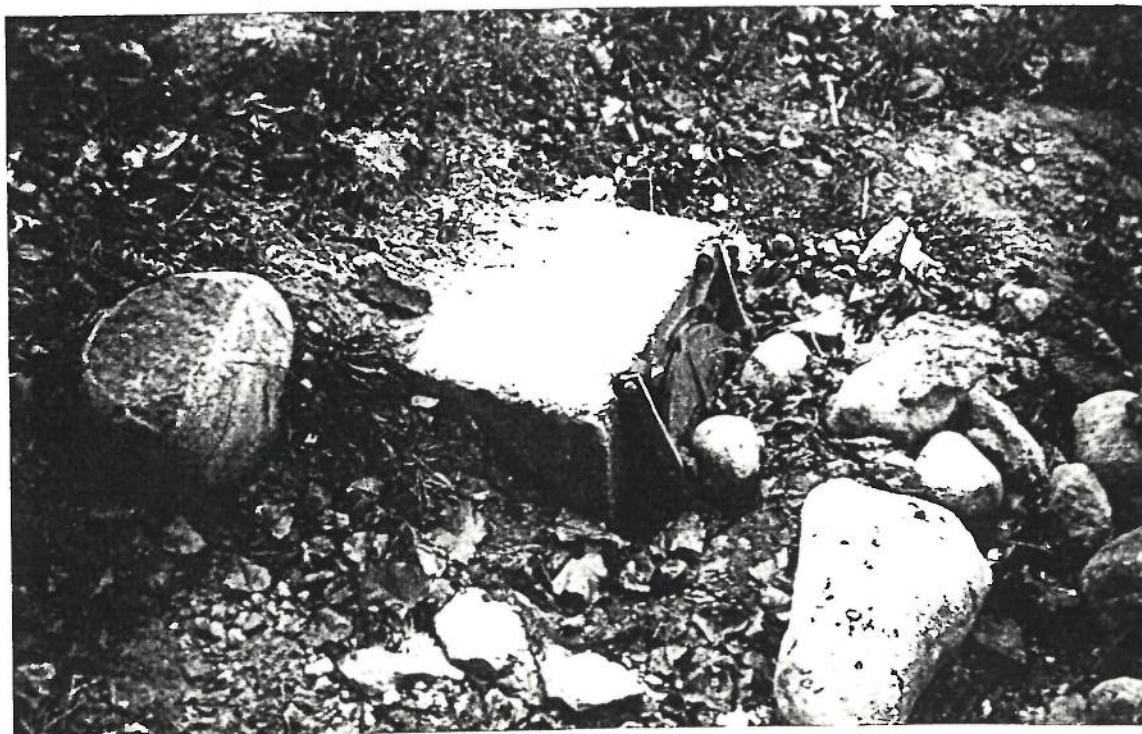
consistent with the description by the Bridge Maintenance Department. The bridge outfall invert (Plate 3, Photo 2) was covered by a gate and had stone rip rap. Approximately 3 m west of the drainage outfall, AEE identified water with a hydrocarbon sheen seeping from the midpoint of the river bank (Plate 4, Photo 3 and shown in Figure 1). The seepage could be associated with a buried pipe although this could not be verified.

PHOTOGRAPH 2: Outfall from deck drains, west of the Disraeli Bridge abutment.

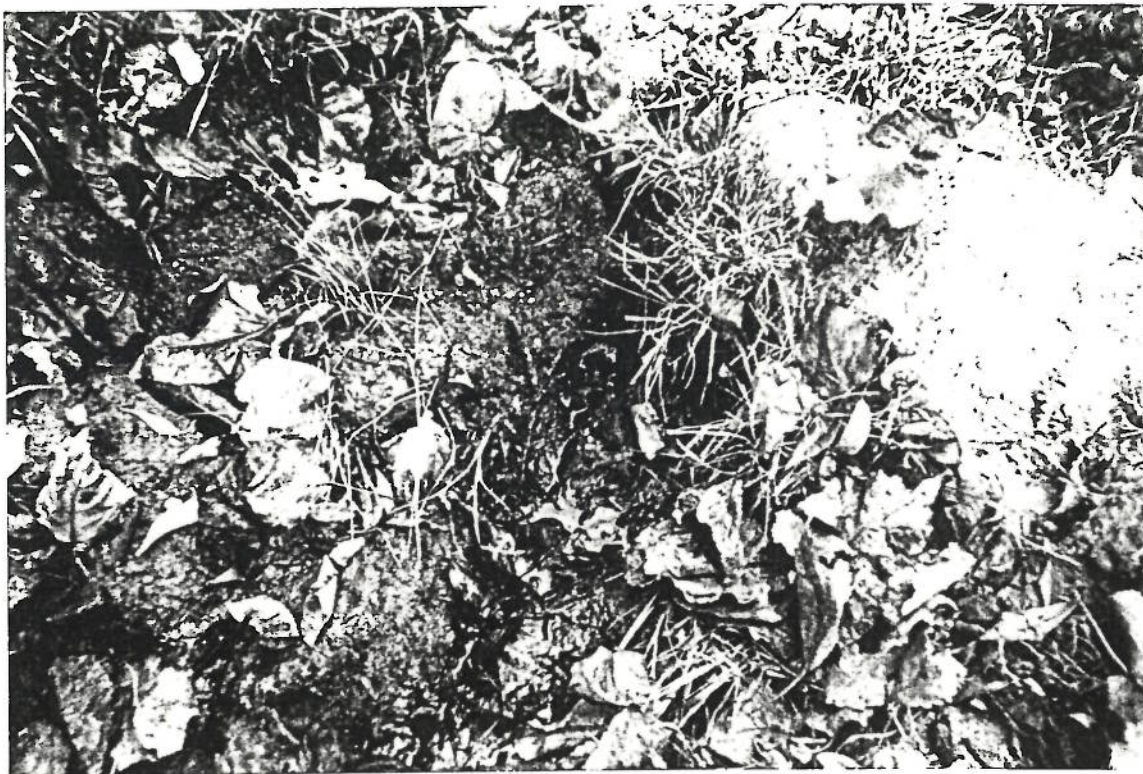
Seepage of water with a hydrocarbon sheen from the river bank west of the Disraeli Bridge was noted. This not considered to be a likely source of on-going migration, as no substantial ground staining was observed however, considering that the seepage point is in close proximity to the contamination plume, it may have acted as a contributing source at one time.

PHOTOGRAPH 3: Water with a hydrocarbon sheen observed to be seeping from the west bank of the Red River, west of the Disraeli Bridge abutment.

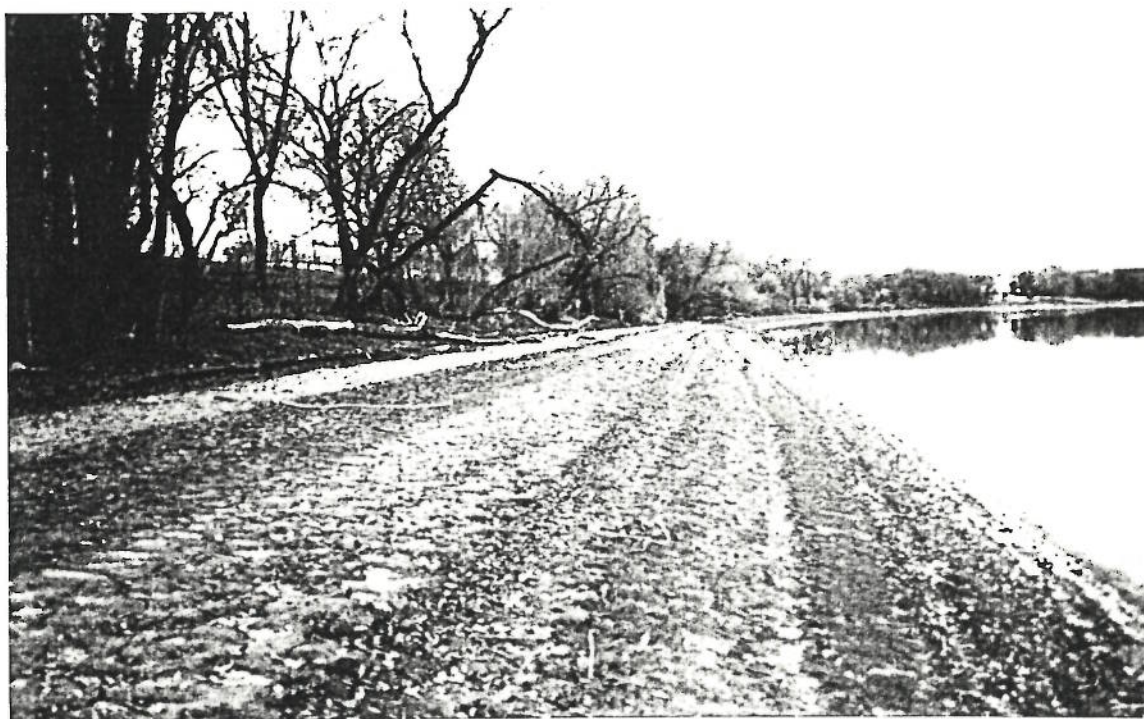
Coal tar residue was not observed along the river bank (Plate 4, Photo 4) immediately adjacent to the water's edge at any locations.

PHOTOGRAPH 4: West bank of Red River, west of the Disraeli Bridge.
