C.0463

ENVIRONMENTAL SITE ASSESSMENT
Red River Bank Adjacent to the
Former Sutherland Avenue
Manufactured Gas Plant
Winnipeg, MB
Manitoba Hydro/Centra Gas

W1801B
2001 09 17

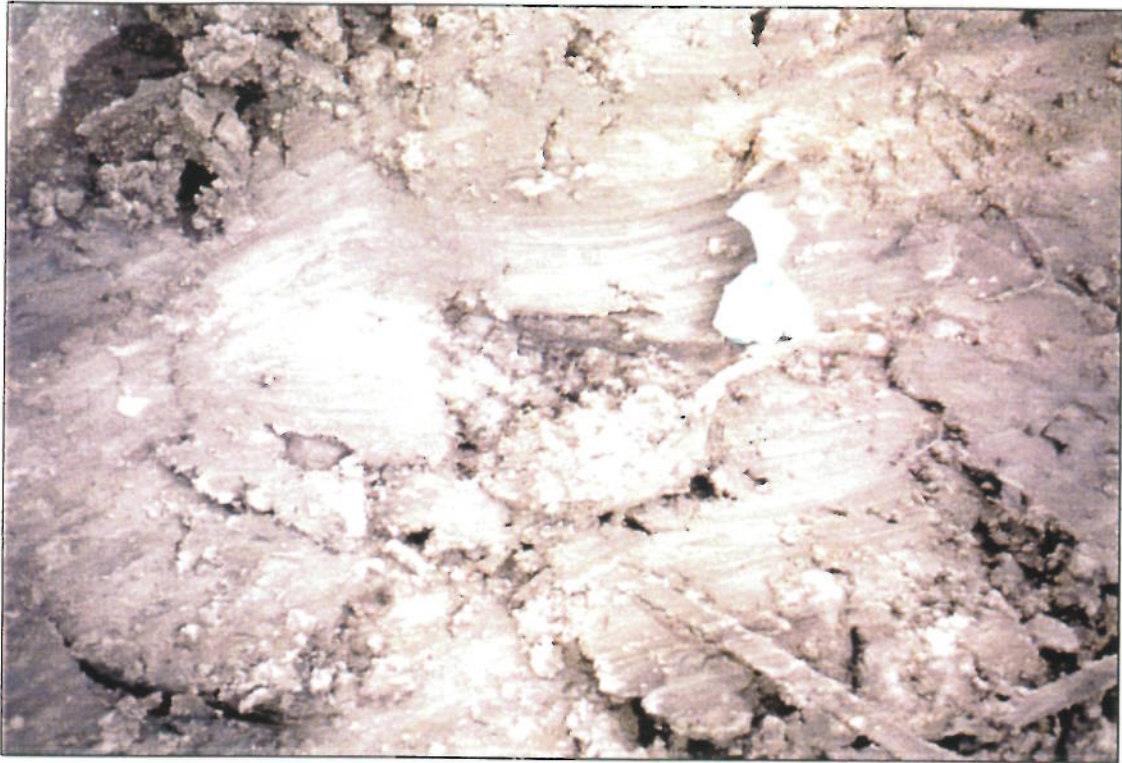
A test pit (TP01-01) was excavated at the base of an existing excavation for the installation of an outfall. The outfall excavation extended to native clay (to an approximate elevation 220.25 m), below which the test pit was excavated. Various clay and sand fill materials were noted on the base of the excavation. In general, the stratigraphy encountered in Test Pit 01-01, excavated in the base of the outfall structure excavation, consisted of clay to approximately 0.3 m below the base of the excavation. A silty sand layer approximately 0.1 m thick was encountered beneath the clay. Silt and sand extended from 0.4 m to 0.6 m below the base of the excavation and was underlain by a 0.05 m thick layer of sand. Sandy silt was encountered to approximately 1.0 m below the base of the excavation. Clay extended to the bottom of the test pit (2.0 m below the base of the excavation). Liquid coal tar was observed seeping from the silty sand layer at 0.3 m below the base of the outfall excavation. Black and grey staining and a mothball odour were noted from 0.3 m to 1.0 m below the base of the excavation. Photographs taken during the test pit program are provided in Appendix IV.

PHOTOGRAPH 1: OUTFALL EXCAVATION BASE SAMPLE LOCATION (TP01-01-BASE-CL-010220) AT AN APPROXIMATE ELEVATION OF 221m. NOTE BLACK COAL TAR STAINING IN SAND FILL.

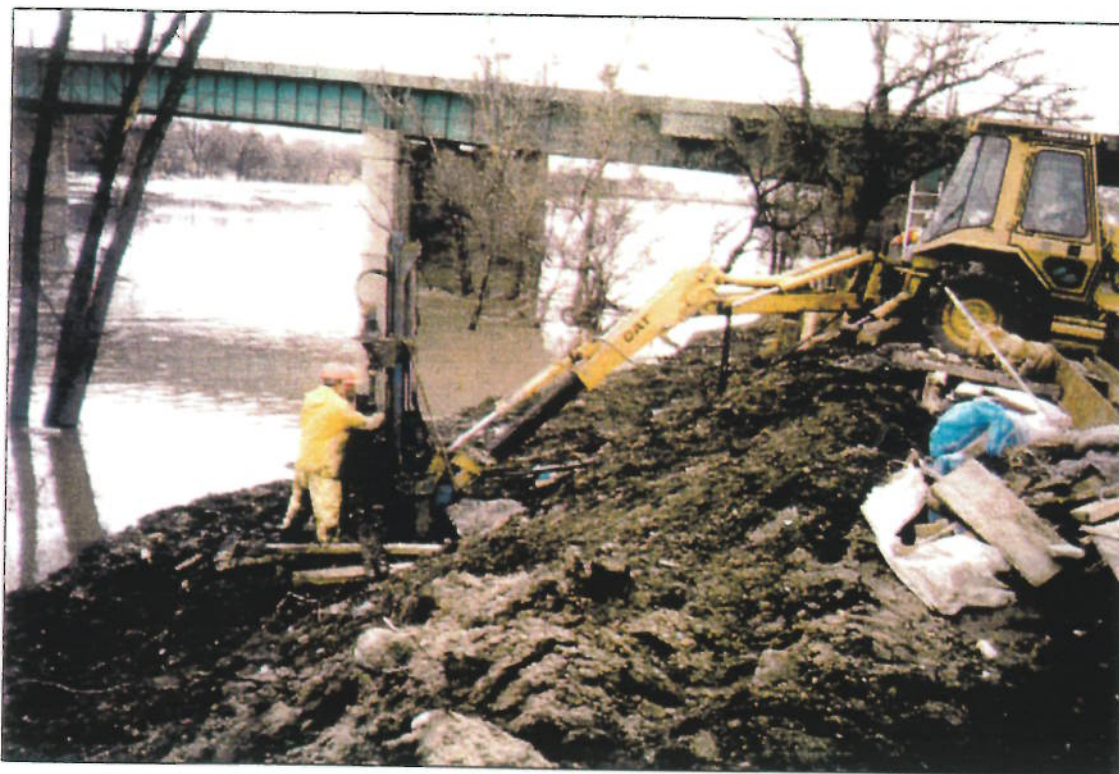
Boreholes 01-47 and 01-48 were drilled on the south bank of the Red River using a backhoe mounted drilling rig operated by Maple Leaf Drilling of Winnipeg, MB. The boreholes were both drilled to a depth of 12.2 m below grade using 125 mm diameter solid stem continuous flight augers. The area of investigation extended approximately 12 m west of the outfall gate control structure. The locations of the boreholes are presented on the Site Plan, Drawing W1801B-002, Appendix I.

PHOTOGRAPH 3: VIEW OF THE DRILL RIG WHILE DRILLING BH01-47. GATE CONTROL STRUCTURE IS IN THE BACKGROUND (BEHIND BACKHOE).

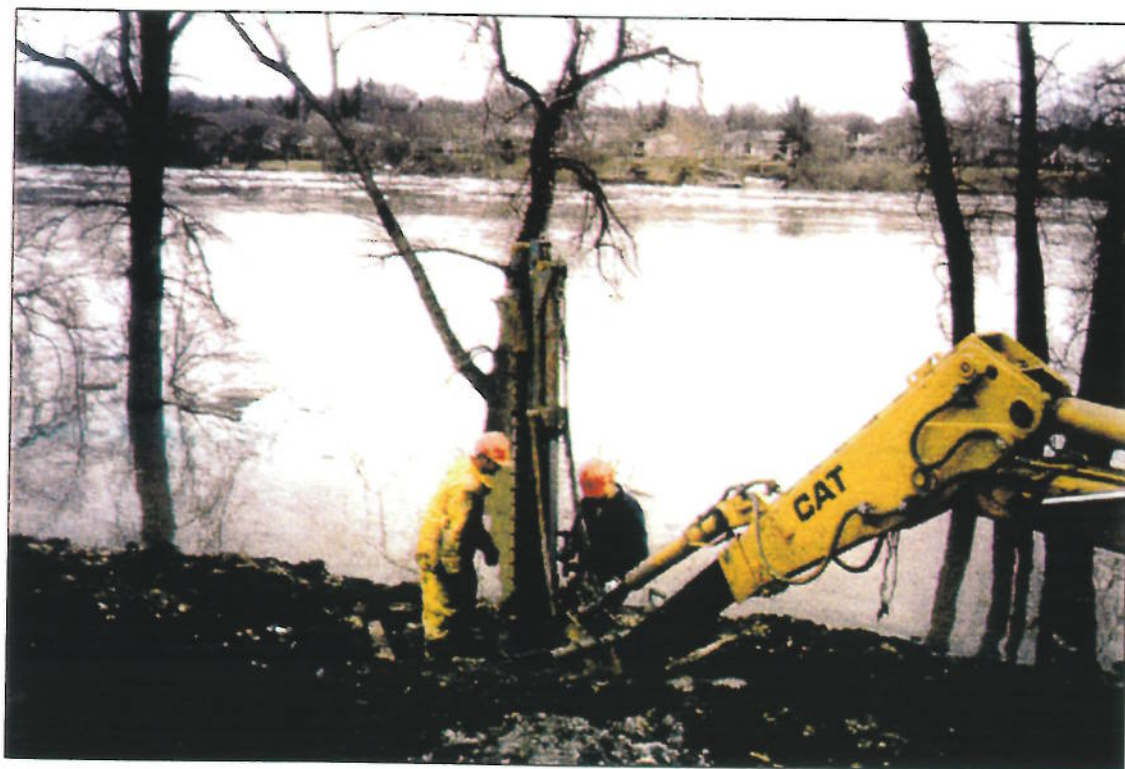
PHOTOGRAPH 4: VIEW OF DRILL RIG WHILE DRILLING BH01-48.
