Dauphin Lake Watershed Integrated Watershed Management Plan - Water Quality Report

October 2011

Dauphin Lake Watershed – Water Quality Report

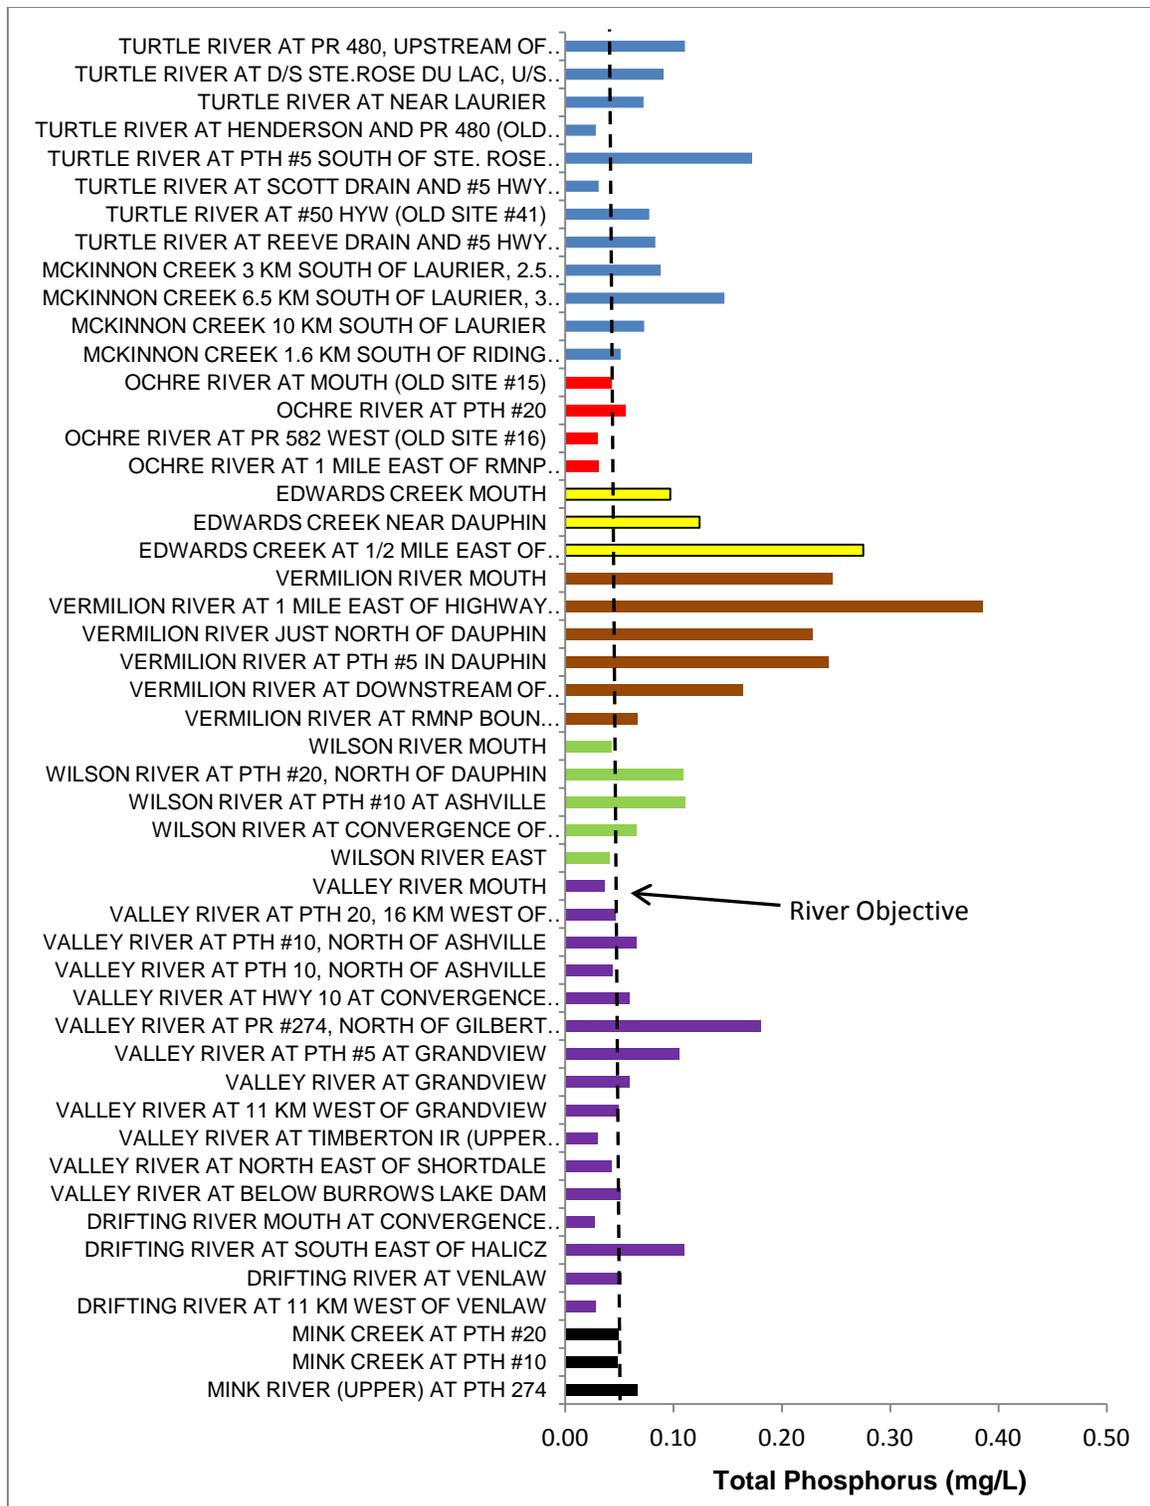
Figure 7: Mean total phosphorus (mg/L) concentrations for historic monitoring locations not part of the long term water quality monitoring program, in the Dauphin Lake watershed between 1974 and 2007. The different colours indicate different tributaries. Tributaries are listed from south to north along the watershed, and each tributary is listed in order of flow towards Dauphin Lake.

Figures 6 and 7 illustrate total phosphorus concentrations in the Dauphin Lake watershed. Typically, total phosphorus concentrations were above the Manitoba Water Quality Guideline for rivers of 0.05 mg/L (Williamson 2002). The five long term monitoring sites did not show a distinct increase or decrease over time (figure 6). This is also true for the non-long term monitoring sites which also showed little upstream to downstream trends in total phosphorus concentrations (figure 7). As part of the Lake Winnipeg Action Plan, Manitoba is implementing several strategies to better manage plant nutrients. Part of this Action Plan includes the development of more appropriate site-specific or regional-specific water quality objectives or guidelines for nutrients. In the meantime, the narrative guidelines will be retained for nutrients such as nitrogen and phosphorus until more site specific objectives are developed. It is generally recognized, however, that narrative guidelines for phosphorus likely do not apply to many streams in the Canadian prairie region since other factors such as turbidity, stream velocity, nitrogen, and other conditions most often limit algal growth. As well, relatively high levels of phosphorus in excess of the narrative guidelines may arise naturally from the rich prairie soils. It should be noted that most streams and rivers in southern Manitoba exceed this guideline, in some cases due to the natural soil characteristics in the watershed and/ or due to inputs from human activities and land-use practices.

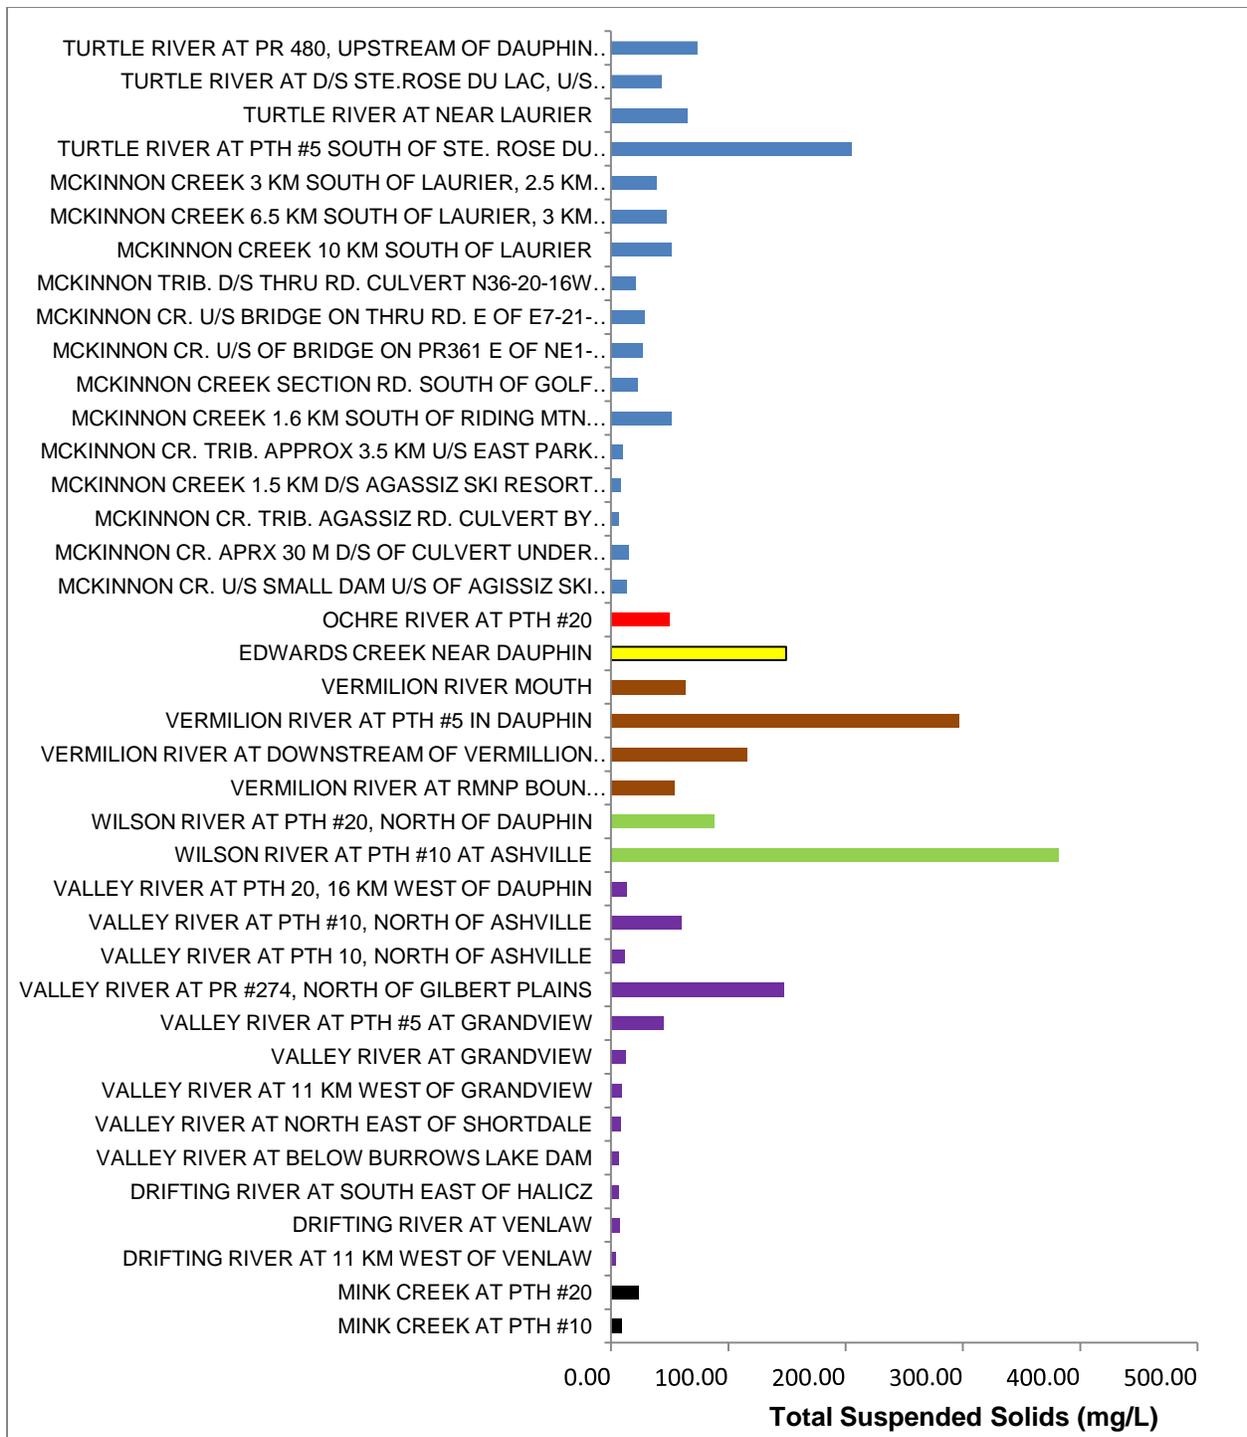
Figure 3: Mean total suspended solids (mg/L) concentration for historic monitoring locations not part of the long term water quality monitoring program, in the Dauphin Lake watershed between 1974 and 2007. The different colours indicate different tributaries. Tributaries are listed from south to north along the watershed, and each tributary is listed in order of flow towards Dauphin Lake.

From the data it appears TSS concentrations have remained relatively constant over time at the five long term water quality monitoring stations. This is with the exception of Edwards Creek and the Vermillion River which have shown pronounced peaks over time, and thus overall have significantly greater TSS concentrations than the other three rivers. In terms of historic data and stations not part of the long term program, the Vermillion River and Wilson River showed the greatest overall TSS concentrations, followed by one location on the Turtle River, Valley River and Edwards Creek.
