Stephenfield Reservoir and Upper Boyne River Watershed Provincial Fisheries Report

The Boyne River Upstream of Stephenfield Reservoir

In July 2002, Fisheries and Wildlife staff toured the upstream segment of the Boyne River and sampled at a number of sites. The following summarizes the results from that field trip.

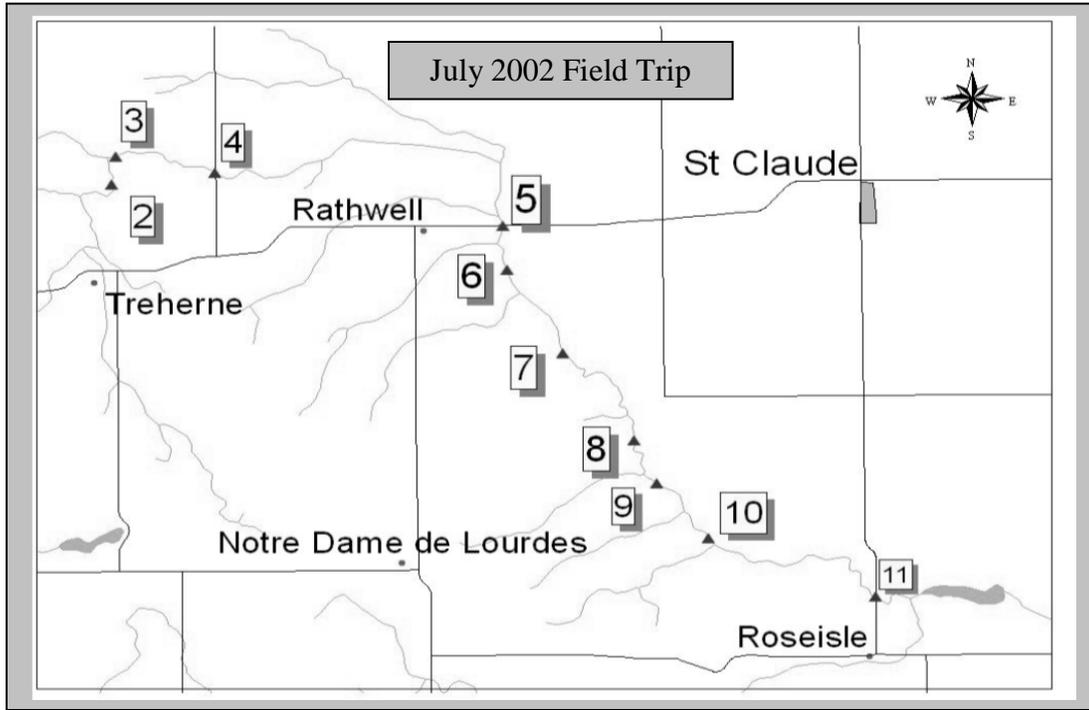
Site 1 at Treherne looking downstream from the Highway. Current land management practices may be affecting riparian vegetation and adding a source of nutrients to the river.

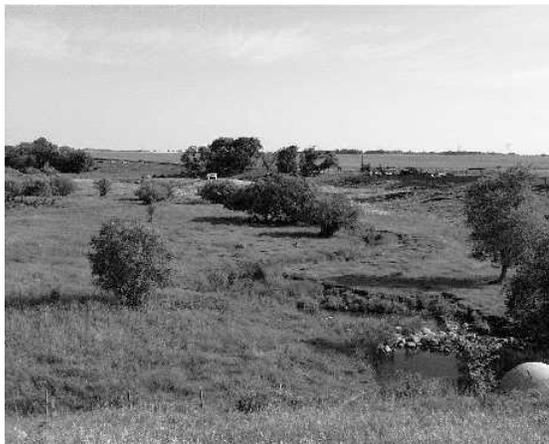
Site 2
 Good streambank vegetation. Rock riffle run below culvert, pool upstream of culvert. Downstream of culvert there were lots of dragonflies. Instream there were lots of young of the year crayfish, gammarus, mayflies and johnny darter.
 Temperature: 24.7 C Oxygen: 6.33 mg/l
 pH: 7.91

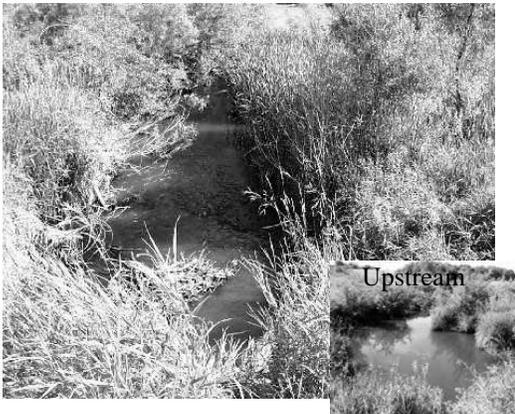
Downstream of the crossing

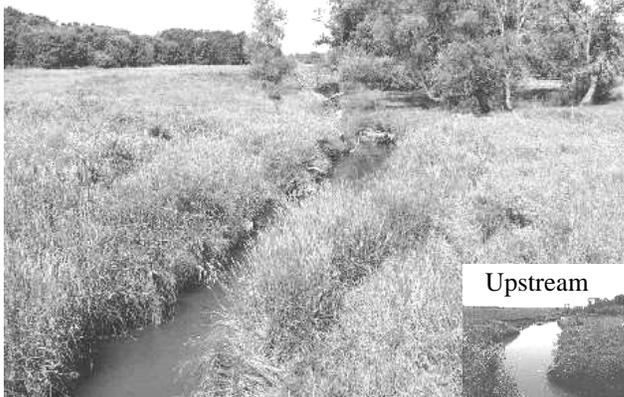
Site 4

Extensive riparian area limited as cattle appear to access the stream sometime during the year.

Downstream of the bridge was a pool/riffle run. Water depth about 2 ft deep. Young of the year white suckers, johnny darters and other cyprinids collected in the seine. Good clam bed in this reach.

Temperature: 23.7^oC

Oxygen: 6.12 mg/l pH: 8.10

pH values appeared to be reaching the upper end of the range suitable for supporting a diverse range of organisms (6.5-8.5), particularly at site 4 (8.10) and at the lake (8.67). When pH values are outside the acceptable range, fish start to have difficulty breathing as it interferes with the gas exchange across their gill membranes.

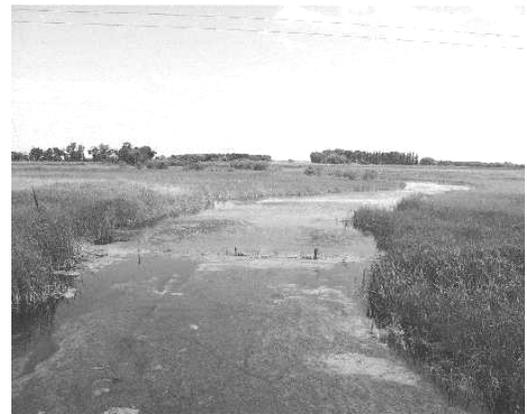
Site 5 - Hwy 2 Road Crossing

Watercourse choked with aquatic vegetation: pond weed, bladderwort and duck weed.

Bottom substrate is mud/silt and there are lots of snails attached to the vegetation and floating on the surface. Notice the river is wider here and according to the 1:250 map a large portion of the river upstream has been channelized to this point. The upstream photo (inset) gives a glimpse of the stream as it starts into a more natural segment.

Temperature: 21.7^oC Oxygen: 5.5 mg/l

pH: 7.8

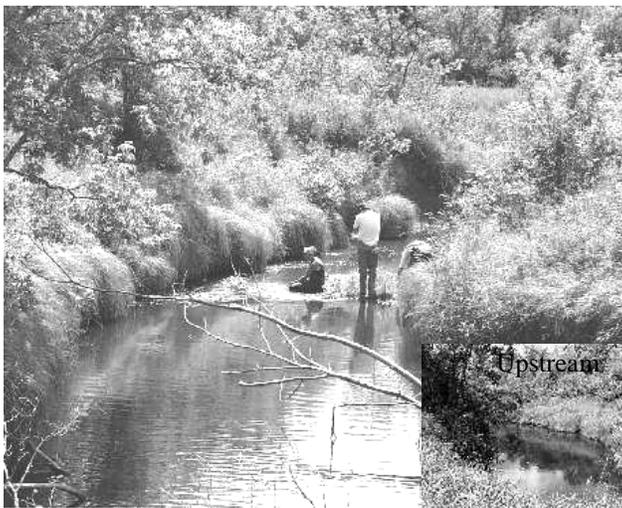
Site 8

Good riparian vegetation in a natural segment of stream. The culvert has constricted the flow, backflooding upstream of the culvert causing the river to widen and creating a deep pool. Seined the riffle reach and collected black-sided darters and johnny darters. Also collected a couple pond snails.

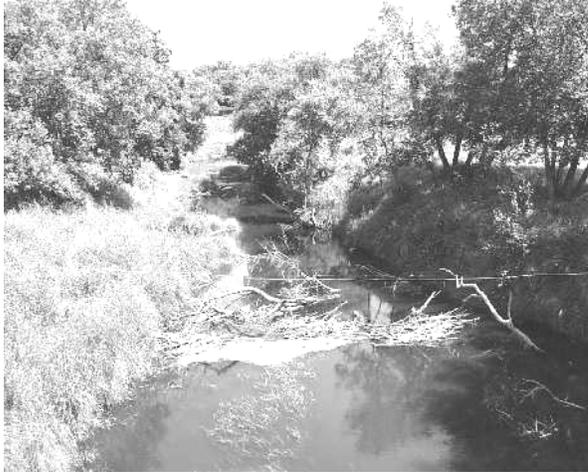
Site 10

Looking downstream, just around the bend in this photograph there is a riffle pool run. Northern pike, white suckers, black-sided darters, johnny darters and fathead minnows were collected in two seine runs. There were young of the year and one plus pike and perch indicating they may be year-round residents.

In the surber sampler dragonfly nymph, mayflies, damselflies, pond snails and clams were also collected. There were a lot of dead clams at this site.

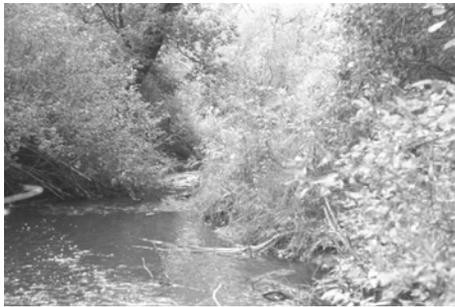
Healthy **streambank** or **riparian vegetation** is critical to fish, wildlife and water quality. The vegetation filters sediment, excess nutrients and toxic substances before they reach the water. The roots stabilize the banks reducing erosion and the amount of sediment entering the river. Overhanging vegetation shades the river, lowering the water temperature and provides a food source as leaves or the insects on the trees fall into the river.
