CROWN PILLAR ASSESSMENT

**Crown Pillar Assessment and Remediation
Plan for the Tanco Mine, Bernic Lake,
Manitoba**

Document No. 1301660300-REP-R0001-04

JUNE 2013

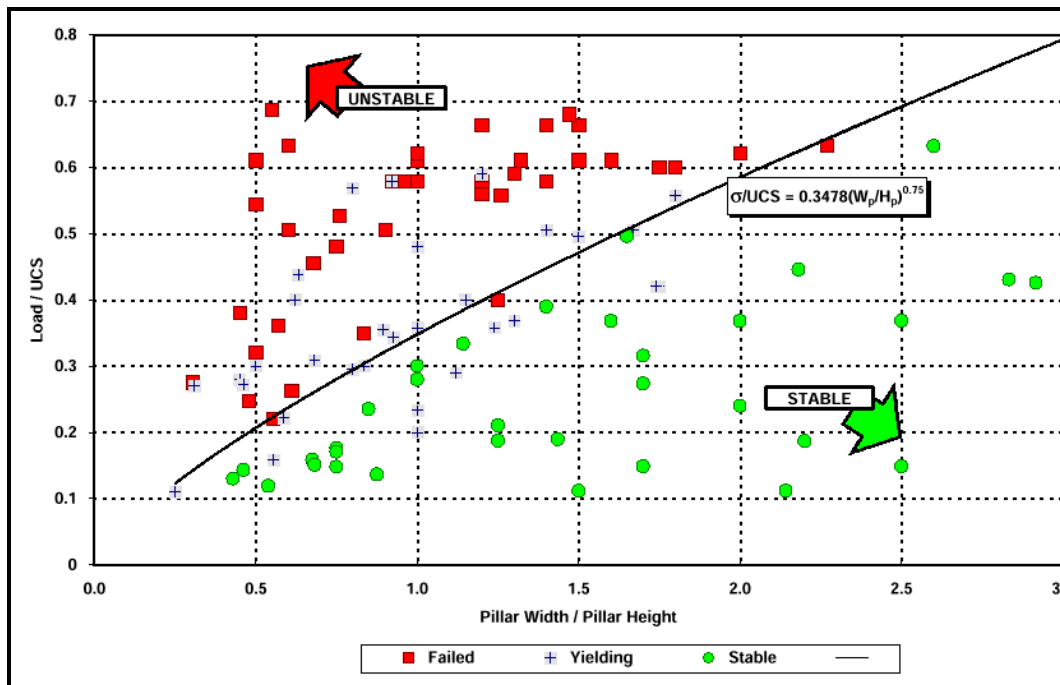
Figure 2.5 Empirical Method to Assess Pillar Strength after Carter (2002)

The following figure illustrates a compilation of pillar case studies and the proposed empirical design criteria. As can be seen, all the pillars in the 14-P area are falling well outside of the standard practice. Trying to plot these pillars on this graph, all the points would fall in the yielding/unstable zone. Our field observations show these pillars to be in a remarkable shape. As indicated earlier, the empirical methods provide good guidelines but are not exact. Nevertheless, considering these pillars are well outside usual mining practice, their safety factor can only be marginal at best. In our experience we did encounter cases at other sites where the empirical method was indicating stable conditions but a massive failure occurred as well as the reverse. When a given case falls on the boundary line or well outside of the usual data points, caution is advised before deriving definitive conclusions. Definitely, in such cases the engineer should use more sophisticated means of analysis.

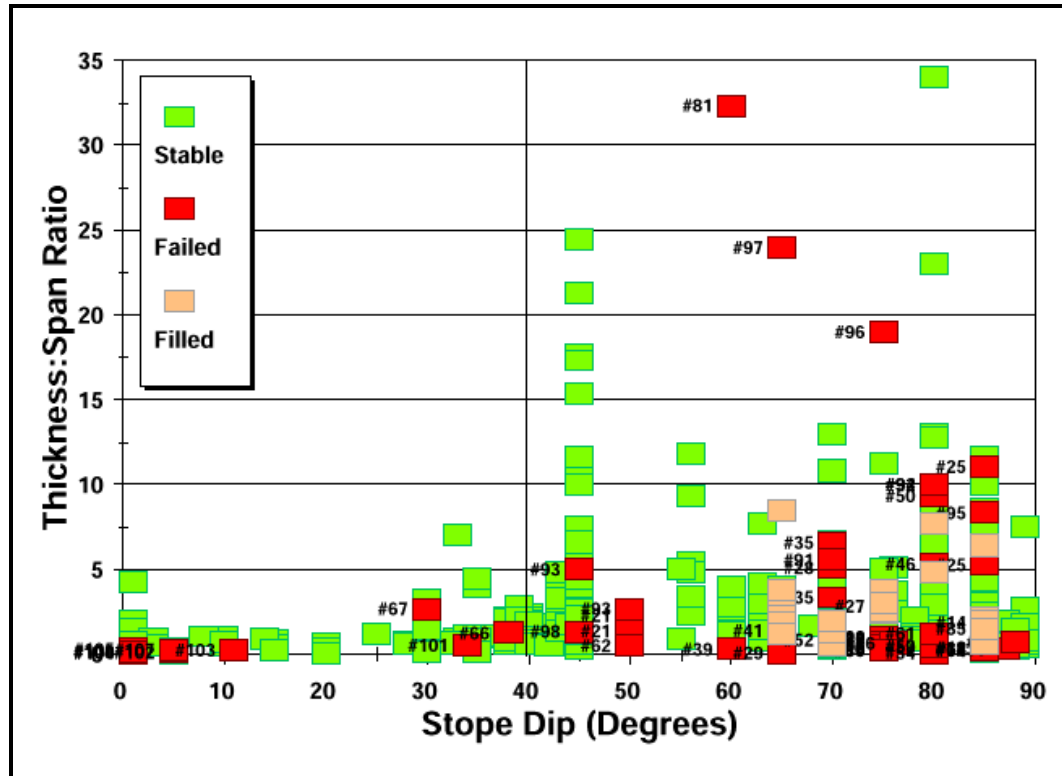
Figure 2.8 Compilation of Crown Pillars Case Studies Illustrating Stable vs. Unstable Conditions after Carter (2002)

In the case under consideration we have a high horizontal in situ stress (3.1 times the vertical stress), which is, as a general rule, a favorable condition to improve crown pillar stability. For the layered rock, the inclination would also have a favorable impact. In the case of the thickness and span the ratio is very unfavorable. Considering a thickness of 29 m (95 ft) for a span of 50 m (165 ft), we obtain a thickness to span ratio of 0.5. The general rule of thumb would call for a ratio of at least 1. Figure 2.8 presents a set of case studies compiled by various authors on crown pillar stability. As can be observed, the graphic presents no data for ratios less than 1. We could not find any compiled data for pillar geometries approaching the case at Tanco Mine. How the effective span is determined in a complex geometry as this one is not obvious. Using the maximum lengths may appear conservative. But all in situ observations indicate a condition of instability. So the conservative approach seems appropriate at this stage.

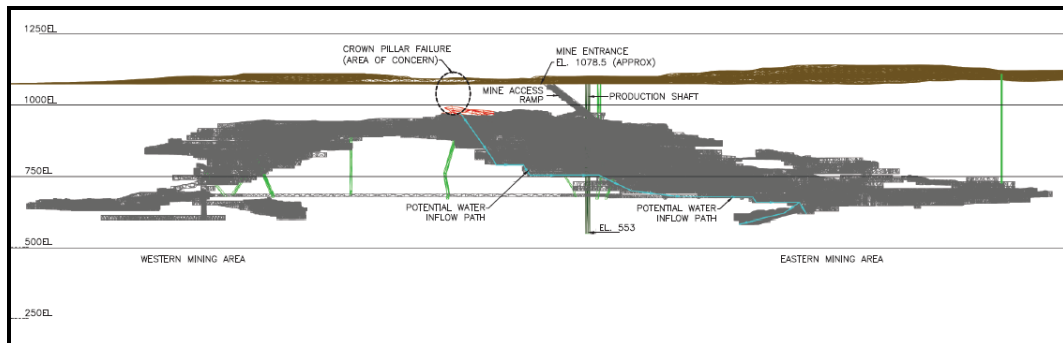
Figure 2.9 Long Section of Tanco Mine Showing Potential Path of Inflow

Water inflow from the degraded crown pillar will originate from the top central area of the mine and gradually flow outward towards the southeastern edge of the mine. Water will follow a path down through existing excavations to the lowest levels on the eastern side of the mine, as shown in Figure 2.9. Current mining activity is focused at the 511 elevation. This area will be one of the first areas of the mine to be affected if a water inflow were to occur.

Based on currently available information, inflow to the western side of the mine will not occur until the eastern side of the mine has been submerged to the 680 elevation. A ventilation drift at the 680 elevation, connecting the eastern and western side of the mine, will allow water to flow between both sides of the mine. At this time the mine will begin to fill evenly from the bottom up. In the event of a significant inflow miners will be able to safely egress from the lower eastern side of the mine to surface via the production shaft or the western side of the mine by vehicle through the main ramp.

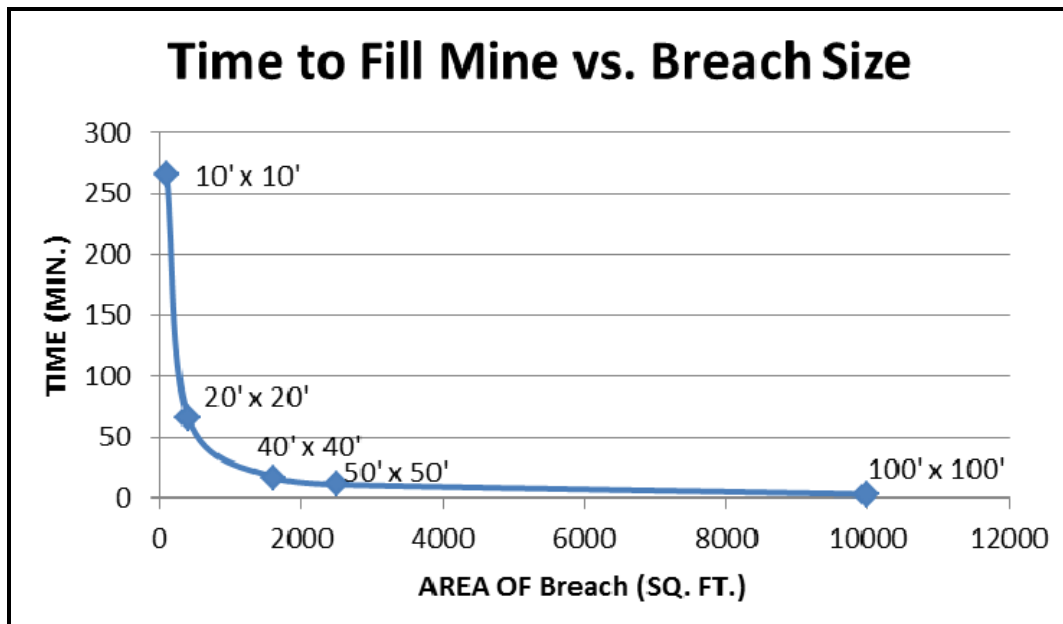
Figure 2.10 Time to Fill Mine versus Breach Size

Tabled values are plotted in Figure 2.10 so the reader can appreciate how the inflow rate changes dramatically relative to the comparatively small change in breach size.

The chart shows that if the crown pillar breached 6 m by 6 m (20 ft by 20 ft); the mine would flood within 60 minutes. Calculations show this would drop the lake level, currently averaging 7 m, to approximately 6 m within an hour. While the lake would not disappear, it could impact, any persons or infrastructure on the lake proximate to the breach.

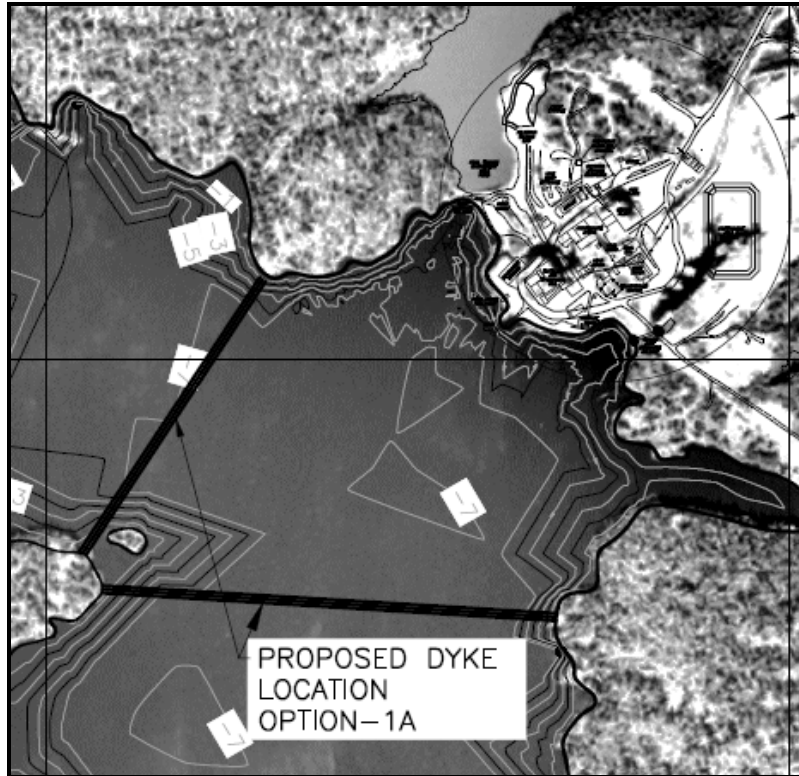
Figure 3.4 Option 1A, Dike Location Plan View

Our largest concern with this layout is the probability of getting the dike constructed, prior to the progressive failure of the crown pillar.

This option consists of two dikes converging on the Bernic Island, located as shown in Figure 3.4.

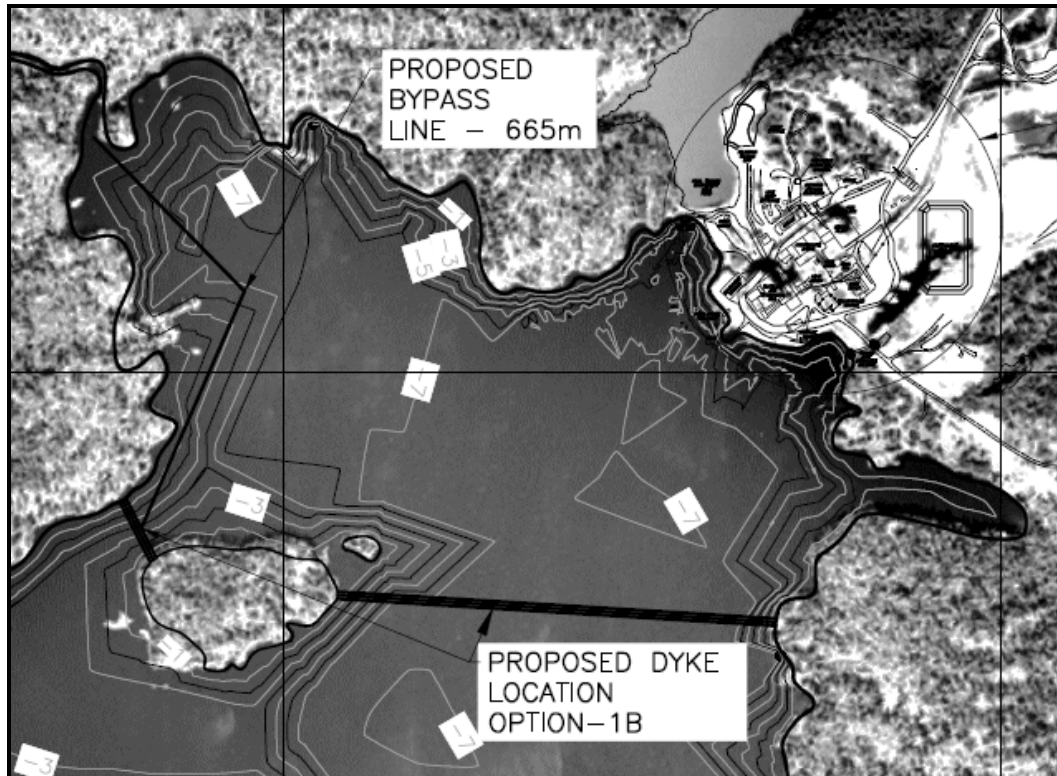
Figure 3.5 Option 1B, Dike Location Plan View

The biggest concern remains accomplishing the construction effort before the progressive failure of the crown pillar occurs.

This option is similar to Option 1A except that the north portion in Option 1A is replaced with a shorter dike west of Bernic Island, see Figure 3.5. The total dike length is estimated at 700 m (2,300 ft) and also has the potential to be constructed from both shores simultaneously. Difficulties in starting the dike from two points include getting a road built around the northern part of the lake and over Bernic Creek.
