# **Phase I Environmental Site Assessment**

## **515 Munroe Avenue**

## **Winnipeg, Manitoba**

June 18, 2009

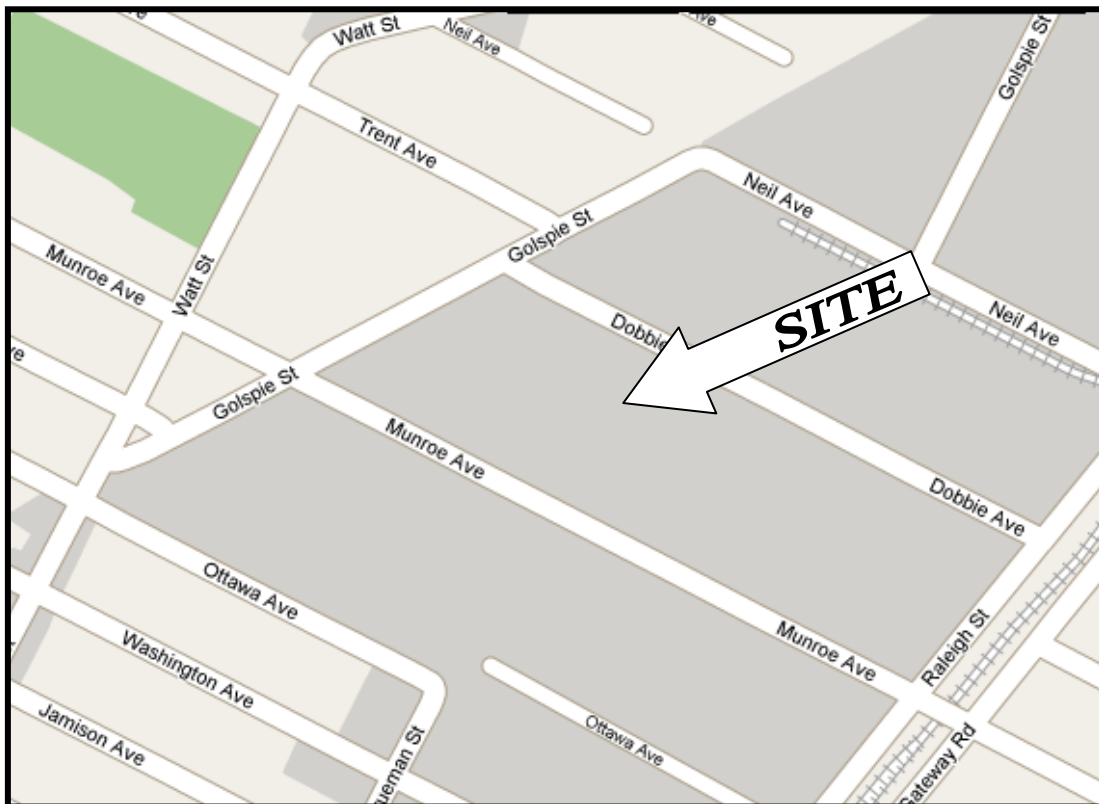
| PROJECT NAME | | | FIGURE No.<br><br><b>1</b> |

As indicated on Figure 1 (Key Map), the Site is located on the northeast corner of the intersection between Munroe Avenue and Golspie Street in Winnipeg, Manitoba. It should be noted that for purposes of this report, Munroe Avenue is inferred to be oriented in an east-west direction. The Site is situated in an area that predominantly consists of commercial, light industrial and residential land uses. Figure 2 illustrates the Site and surrounding area.
