**Figure 8  
ISOPACH MAP  
UPPER BAKKEN MEMBER  
SOUTHWESTERN MANITOBA**

DATE: DECEMBER 31, 1987  
GEOLOGY: C. MARTINIUK  
CARTOGRAPHY: M. McFARLANE

Manitoba Energy and Mines Petroleum

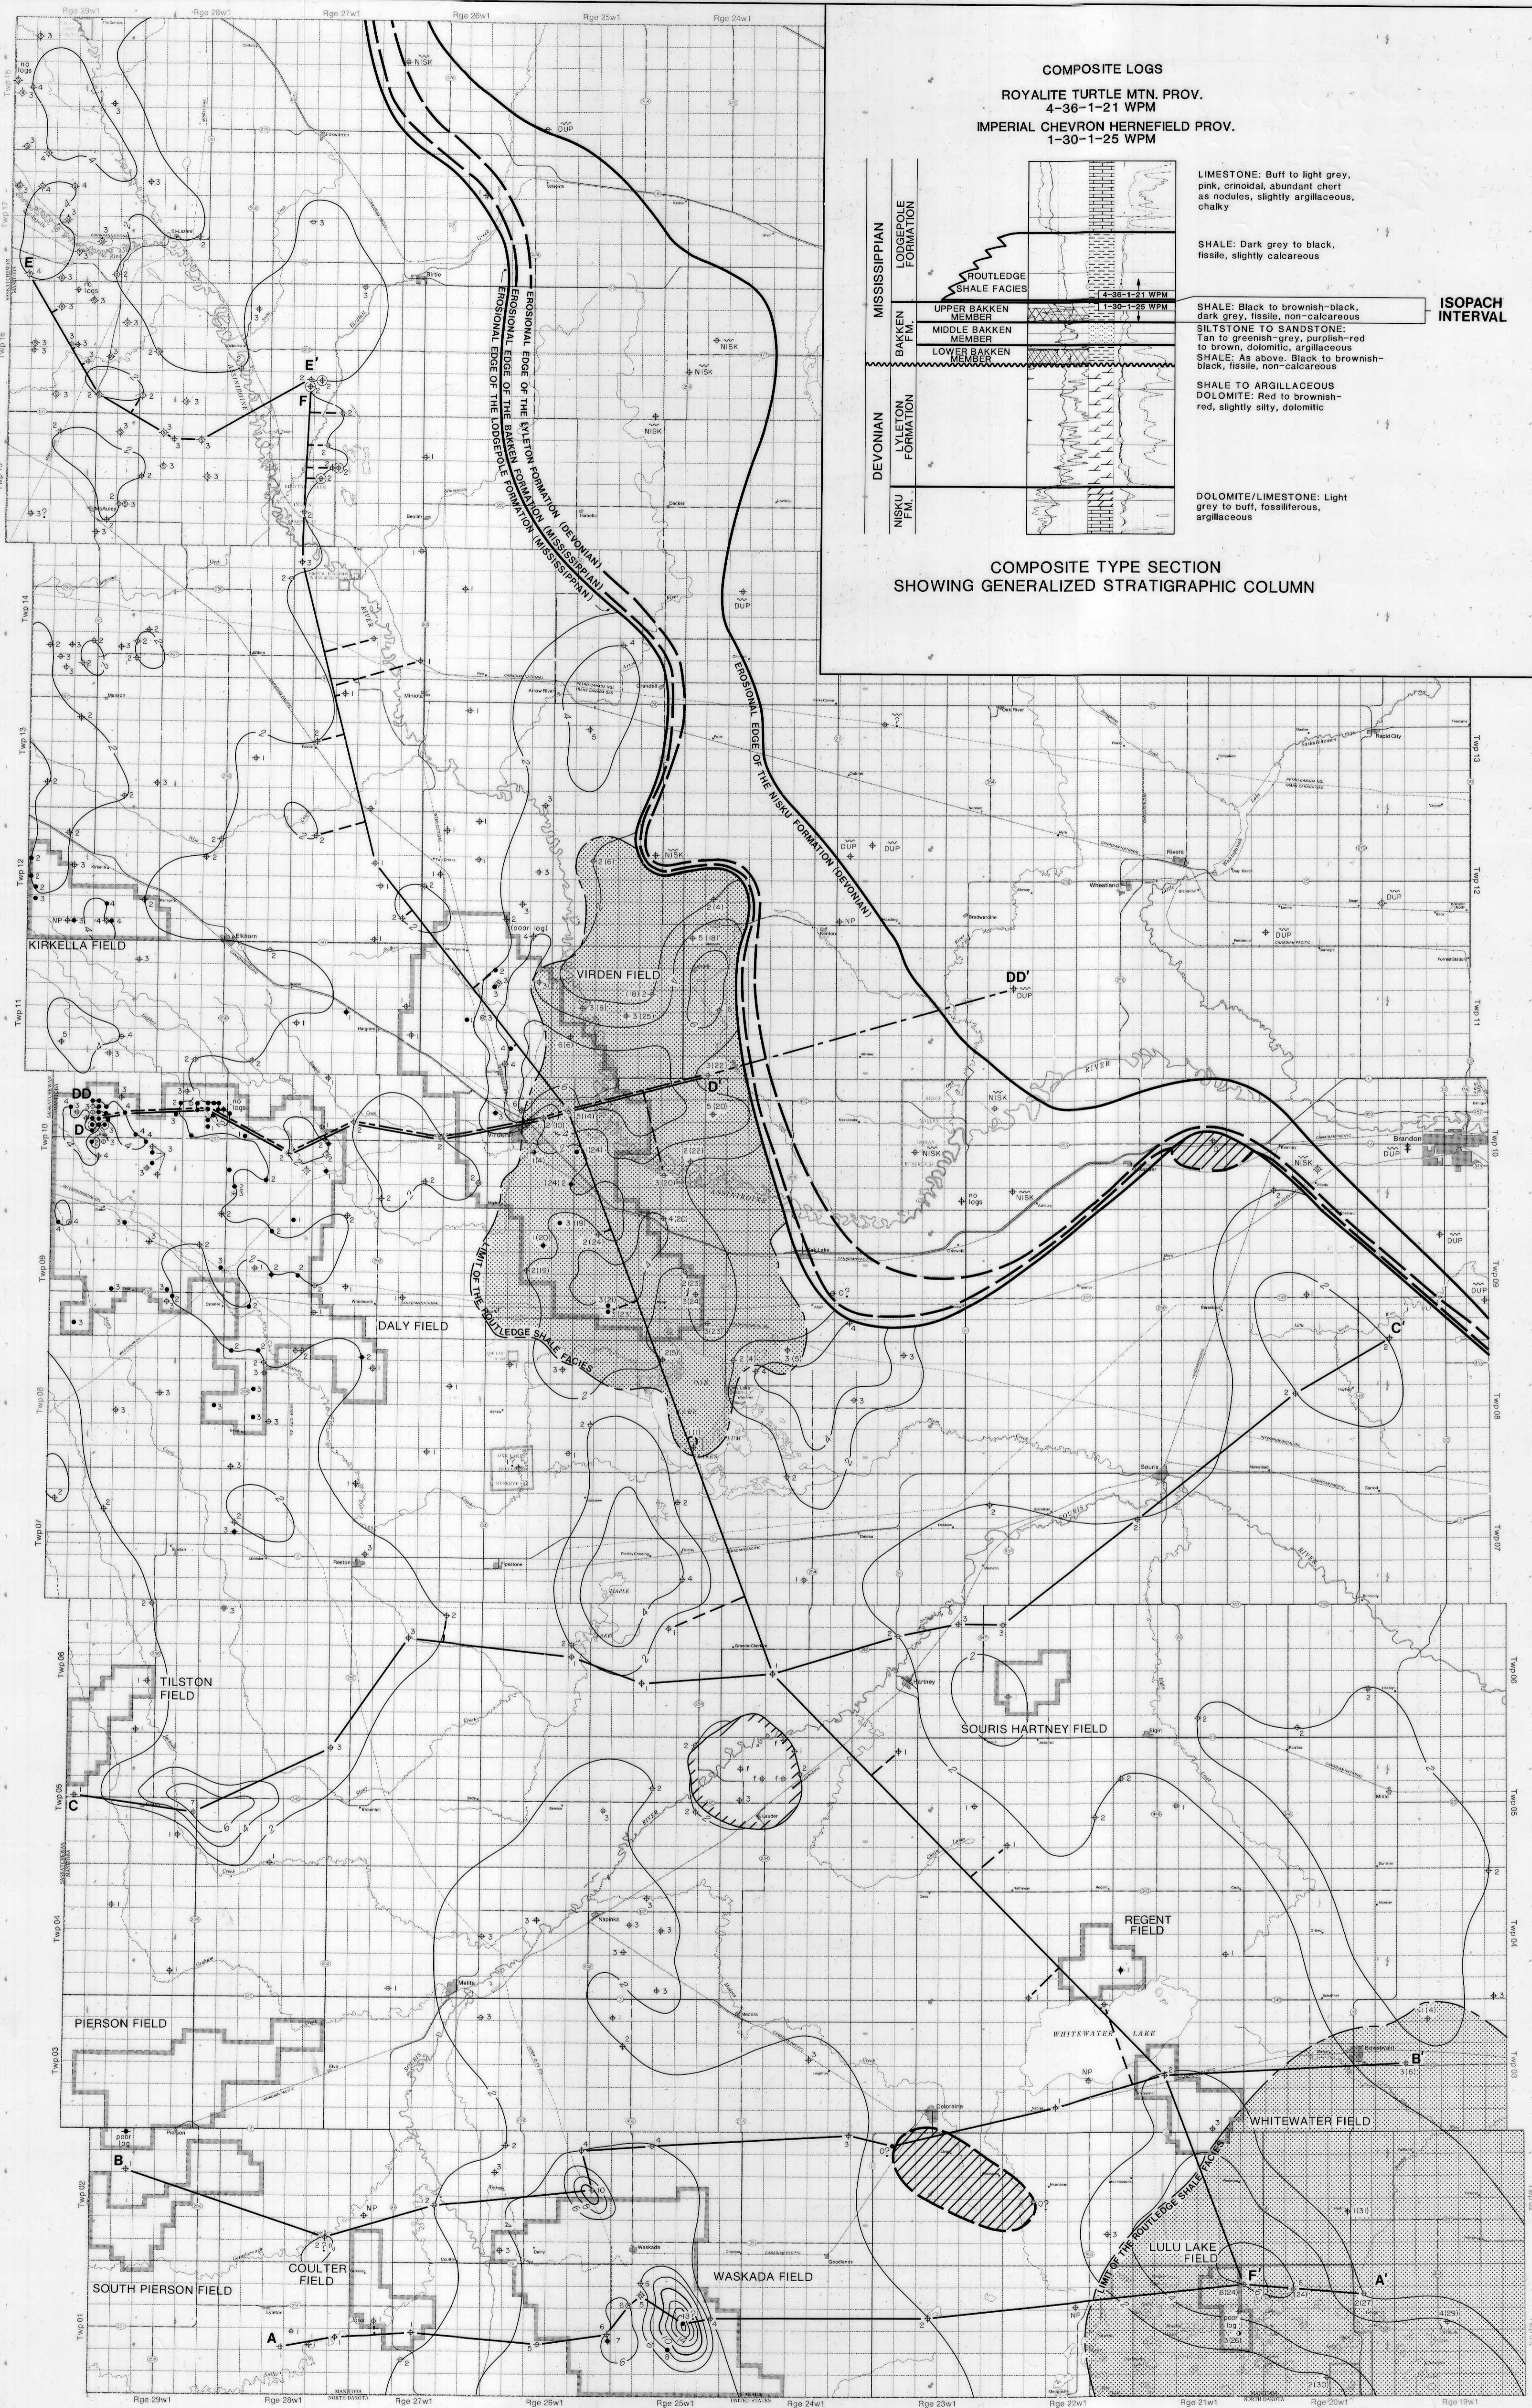
- Isopach (2m interval)
- Isopach values of the 'Routledge Shale Facies' (not contoured)
- Lines of cross-section
- Supplementary well control projected to the lines of cross-section
- Lyleton Formation partly eroded
- Nisku Formation partly eroded
- Duperow Formation partly eroded
- NP: Upper Bakken Member not completely penetrated
- Core examined
- Bakken Formation absent
- Hartney area (Twp. 5, Rge. 24) structurally complex. Contours not shown
- f - Bakken absent due to faulting
- Area of occurrence of Routledge Shale Facies

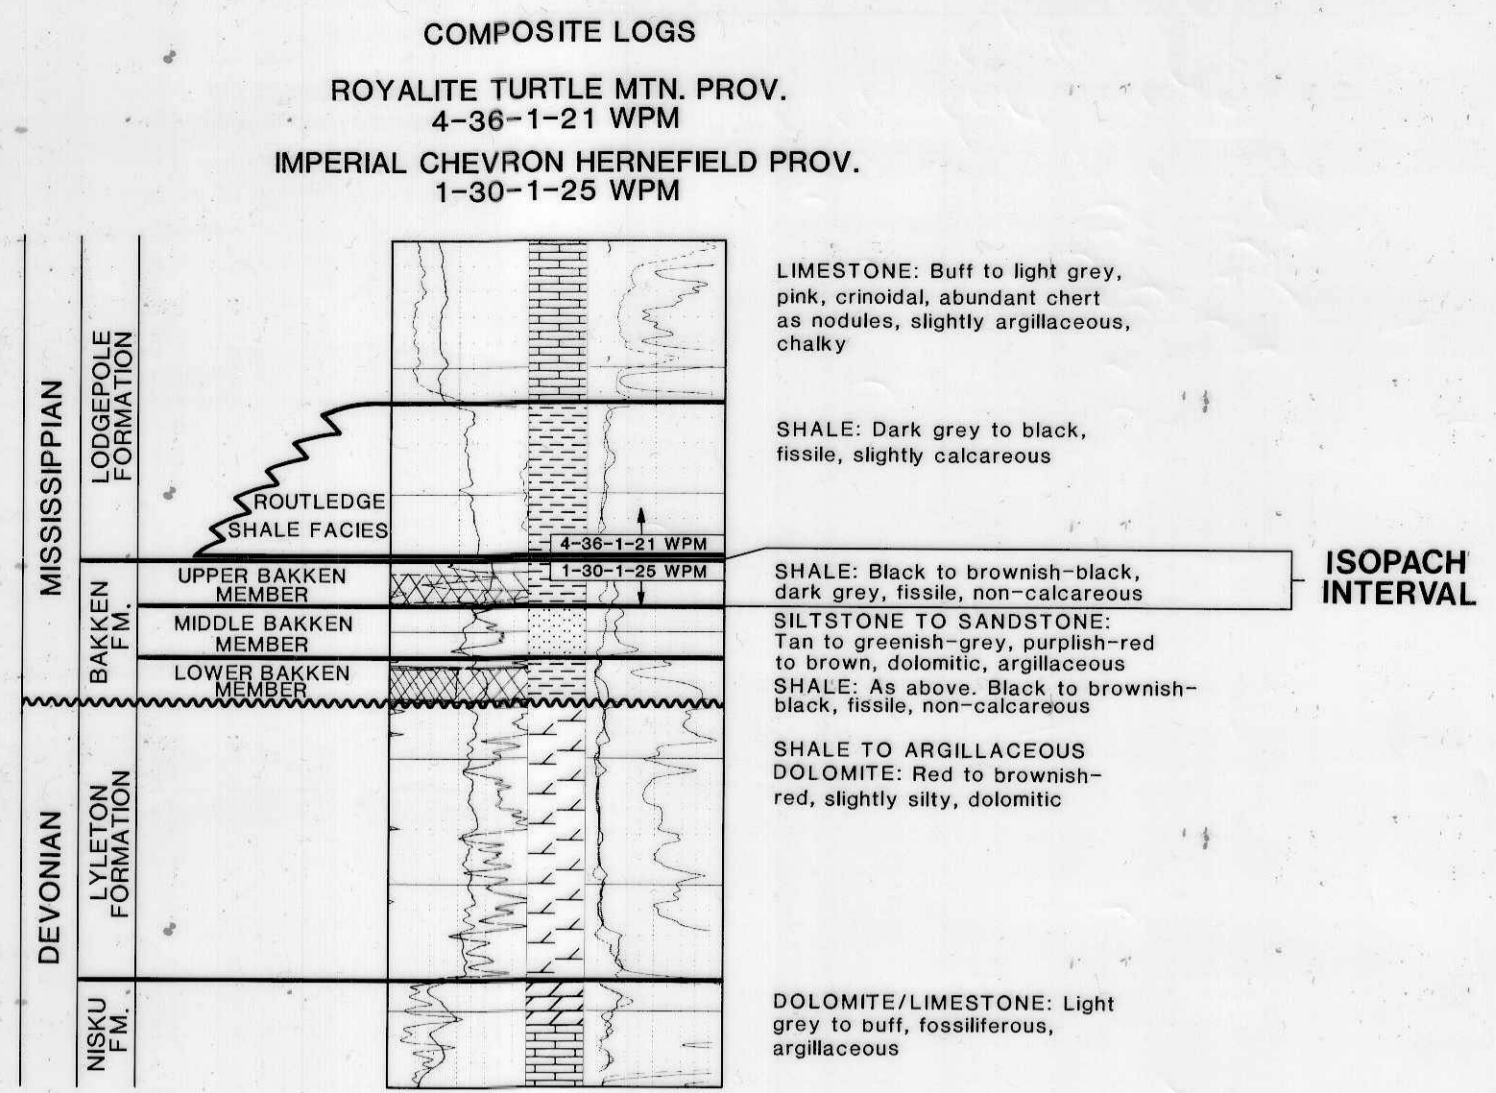
COMPOSITE TYPE SECTION  
SHOWING GENERALIZED STRATIGRAPHIC COLUMN
