Pembina Valley Water Cooperative Inc.
Supplemental Groundwater Supply System Evaluation

Lower Sand Groundwater Levels

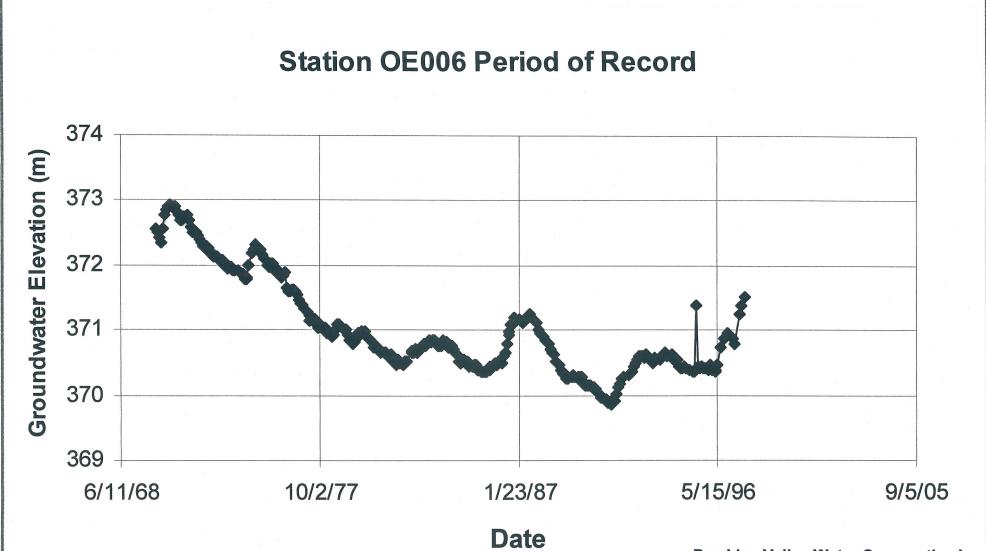
Figure - 09

NOTE: SCREENED IN LOWER SANDS WELL LOCATED NEAR WOODRIDGE, MB.
